# RAIB Bulletin 03/2009

## Locomotive struck by runaway train from quarry October 2008

**The events described above took place at Bedlam Quarry 6 October 2008.**

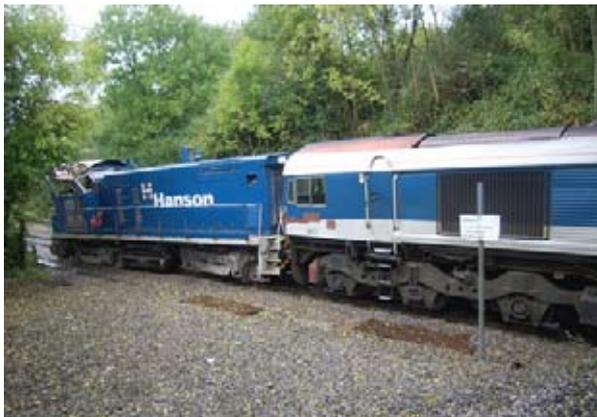
1. In October 2008 a main line locomotive, travelling at 16 km/h (10 mph) on a freight only branch line, was struck from behind by a runaway train travelling at 41 km/h (25½ mph). The runaway train weighed 1700 tonnes (1673 tons) and was formed of a 4-axle diesel shunting locomotive and 16 loaded 4-axle mineral wagons. The collision caused the shunting locomotive and five wagons to derail.

Figure 1: derailed shunting locomotive and mainline locomotive

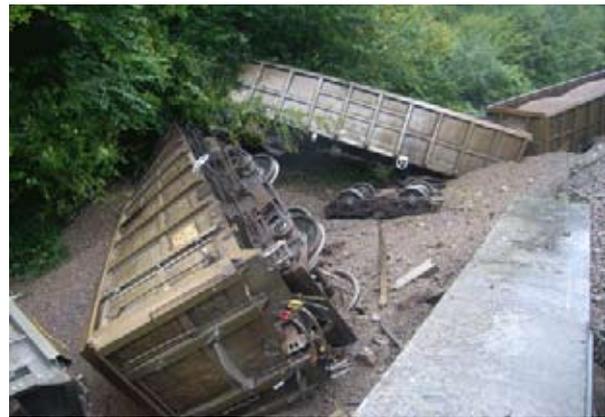
Figure 2: derailed wagons

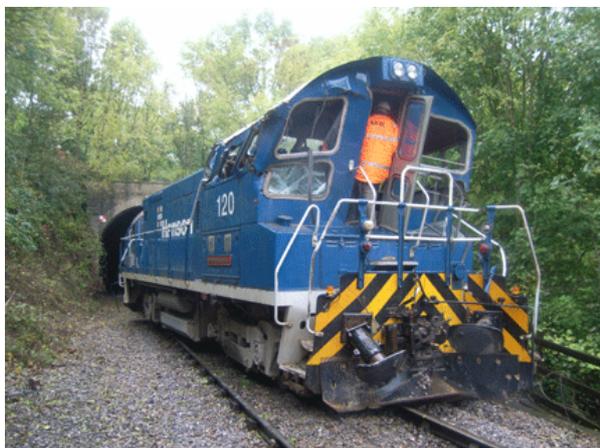
5. The shunting locomotive suffered significant damage from the collision, the derailment of its rear bogie and from hitting a bridge girder. The main line locomotive only received minor damage. The first four wagons were derailed and travelled down a steep embankment, sustaining serious damage. The fifth wagon, although derailed, remained in line with the track, a section of which was totally destroyed. No-one was seriously injured as a result of the collision.

Figure 3: collision damage to derailed locomotive

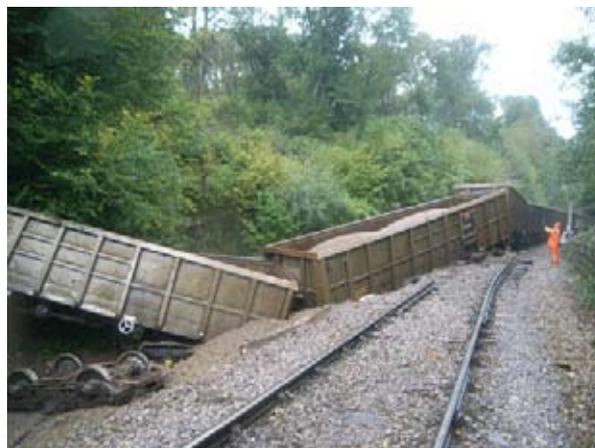
Figure 4: derailed 3<sup>rd</sup>, 4<sup>th</sup> and 5<sup>th</sup> wagons

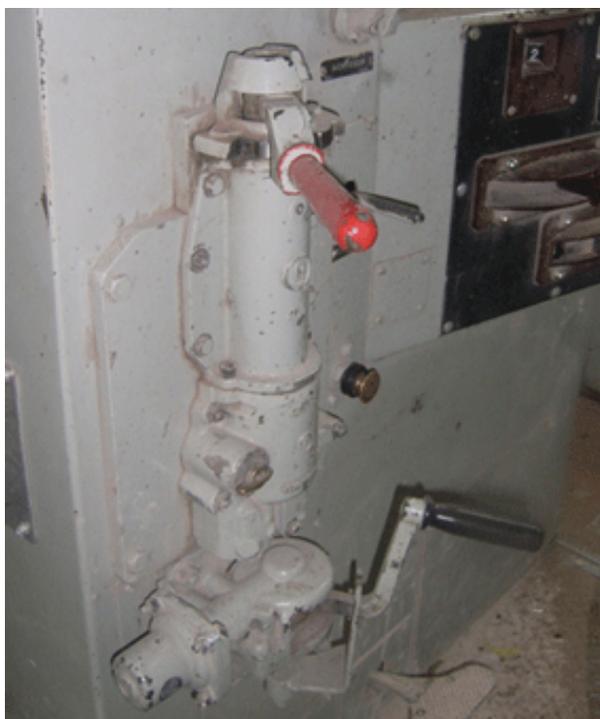
6. The cause of the brake failure was the double fracture of a 5 mm diameter roll pin on the shaft between the main brake handle and cams operating air valves on the train's brake pipe. This prevented any movement of the brake handle from exhausting the train brake pipe and thus causing an application of the train brakes.

Figure 5: brake handle

(The maintainer of the locomotive has already fitted a similar locomotive working in a nearby quarry with a train pipe exhaust cock to mitigate the risk of a similar failure. It is intended to fit the locomotive involved in the runaway during its repair).

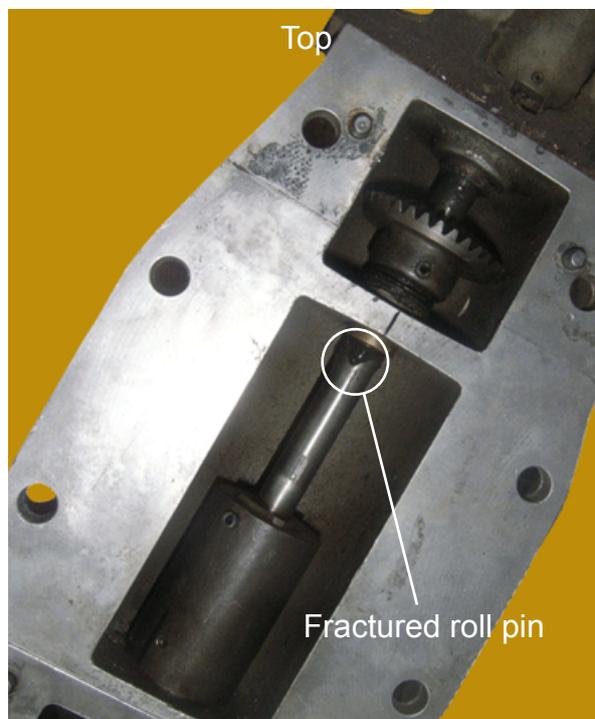
Figure 6: shaft in brake handle

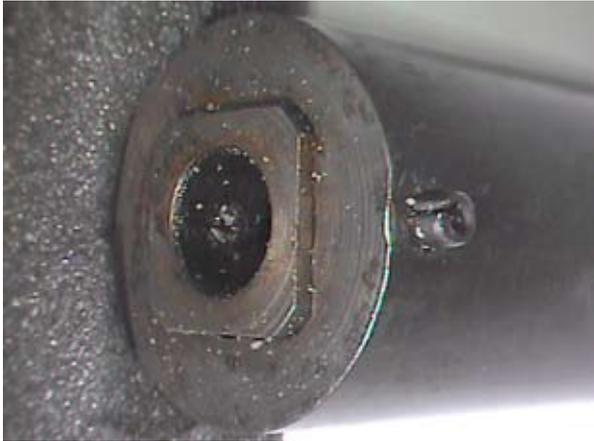
Figure 7: collar showing fractured pin

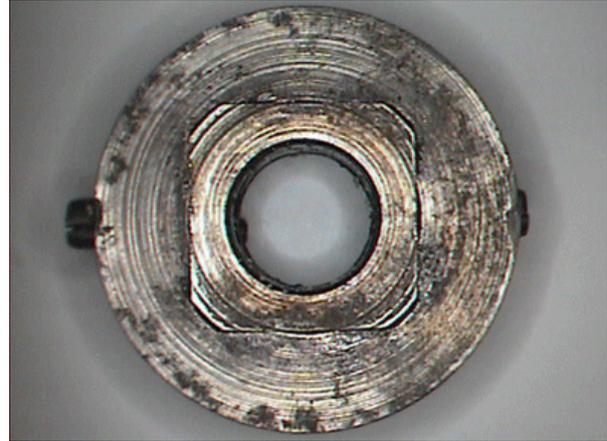
Figure 8: Top view of collar showing parts of fractured pin

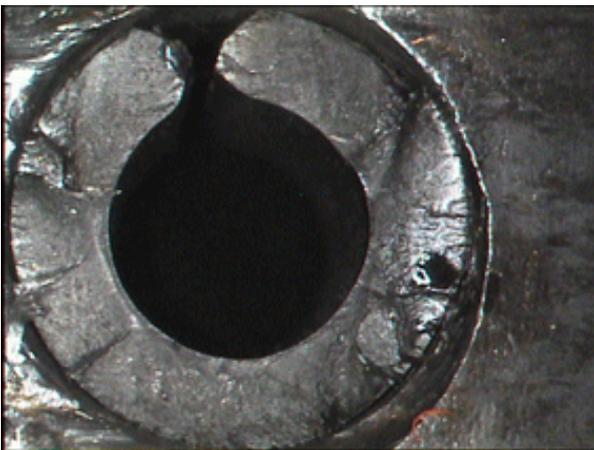
Figure 9: one of the fracture surfaces (photo taken with x50 magnification)

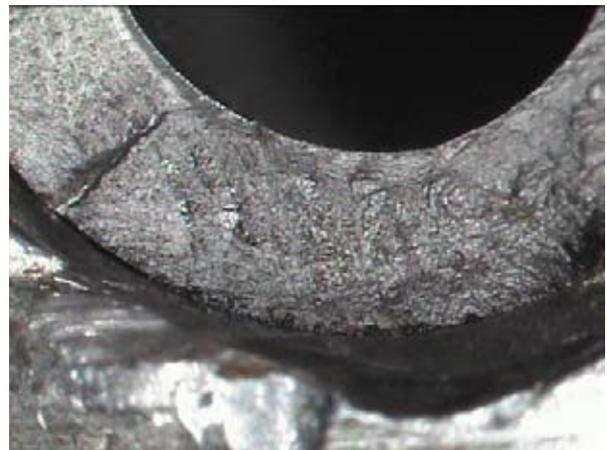
Figure 10: one of the fracture surfaces (photo taken with x100 magnification)
