Technical Investigation Report concerning the Fire on Eurotunnel Freight Shuttle 7412 on 11 september 2008

November 2010

Affaire n° BEATT-2008-015

**Technical Investigation Report
concerning the Fire on
Eurotunnel Freight Shuttle 7412
on 11 September 2008**

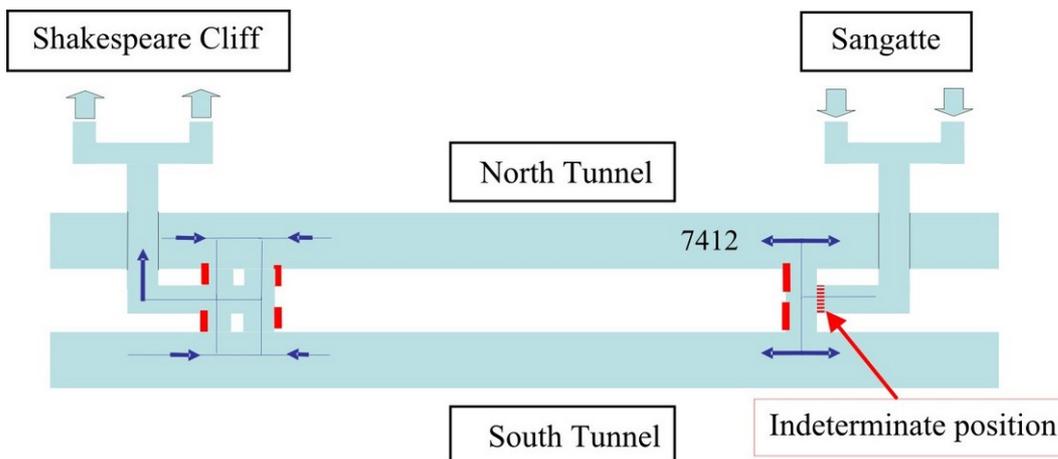
A malfunction in the main French damper is signalled at that time. The controller therefore concludes, as his instructions specify, that this damper is still closed and that there is no ventilation being provided on the French side¹⁷. To compensate for this assumed fault, he decides to have the two Shakespeare Cliff fans working in extraction mode in the North Tunnel only.

¹⁷ (it should be noted that the EMS controller does not think of checking the information on the rate of air being blown in on the French side. Had he done so, he would have noticed that the rate was normal and could have concluded that the main damper was open.)

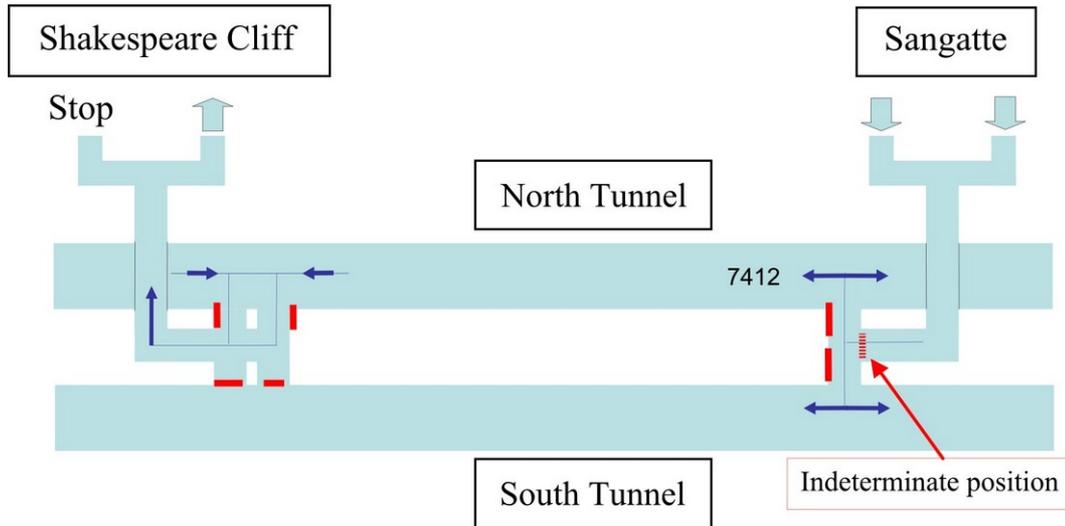
At 16:09'17'' a fan on the French side breaks down following the failure of the 21 kV cable. As the damper supplying the South Tunnel at Sangatte is still open, there is reduced air flow in the North tunnel.

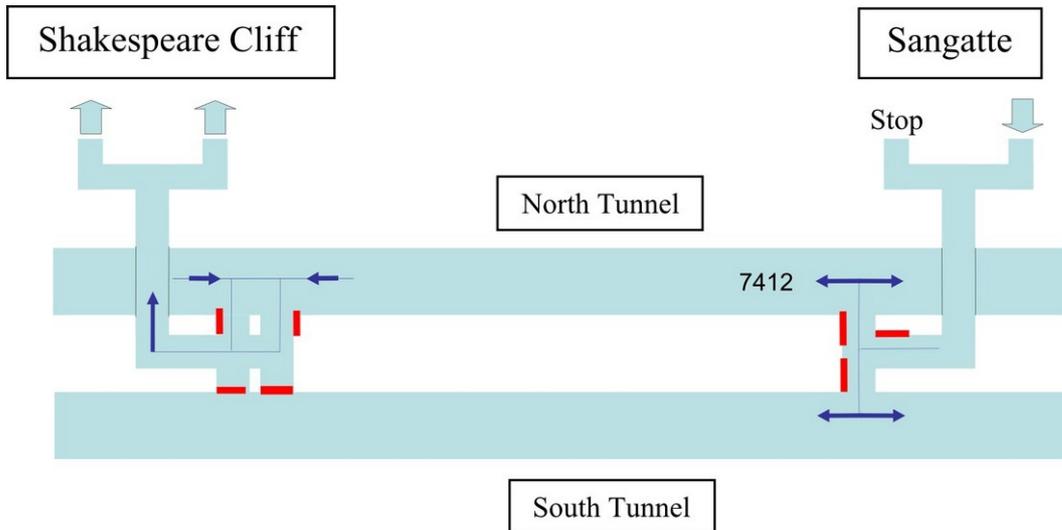
At about 16:26 hrs, the EMS controller realises that the French main damper malfunction message has disappeared. He then closes the damper for the Running Tunnel South, thus directing all of the air towards the North Tunnel. Although the SVS configuration on the French side is operating as it should, he keeps the UK SVS in Duplex mode, thus increasing the airflow in the North Tunnel. The configuration of the SVS is therefore still not compliant with Eurotunnel's rules for this scenario.

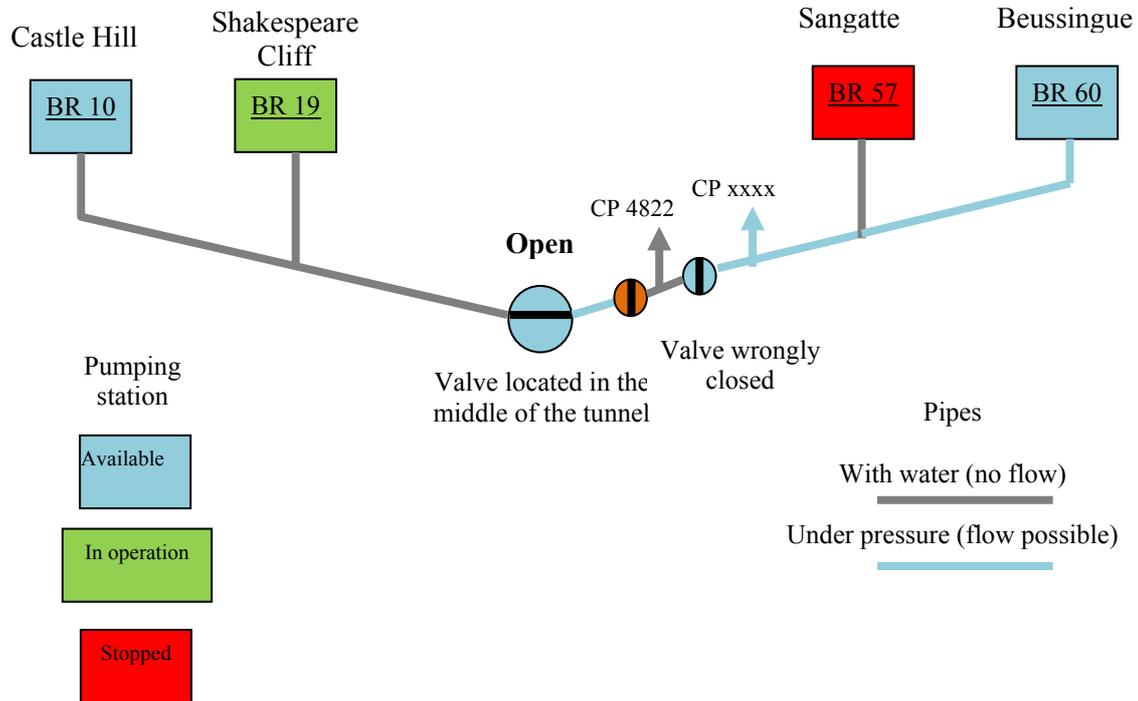
Figure 31: Loss of water supply at cross-passage 4822 between 19:01 hrs and 19:35 hrs

The diagram below shows the situation of the water system at 19:01 hrs and 19:35 hrs.

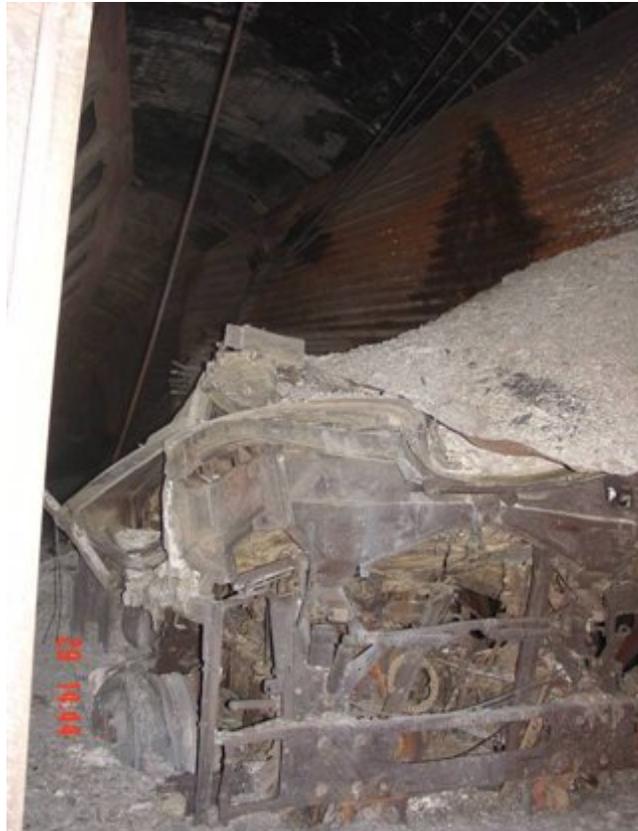
Figure 34: Damage suffered by one of the carrier wagons and its load

However, once it had stopped, the loaded carrier wagons suffered significant damage. For the most part, the side walls and the roofs were deformed by the heat of the fire and by debris falling from the roof of the tunnel.

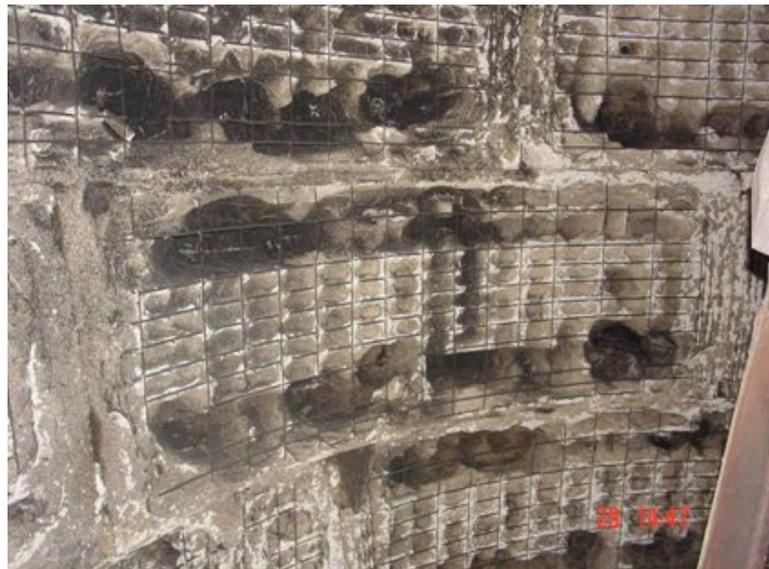
Figure 35: Damage suffered by the tunnel lining at the level of the tunnel roof

The equipment fastened in the area of the fire was destroyed.

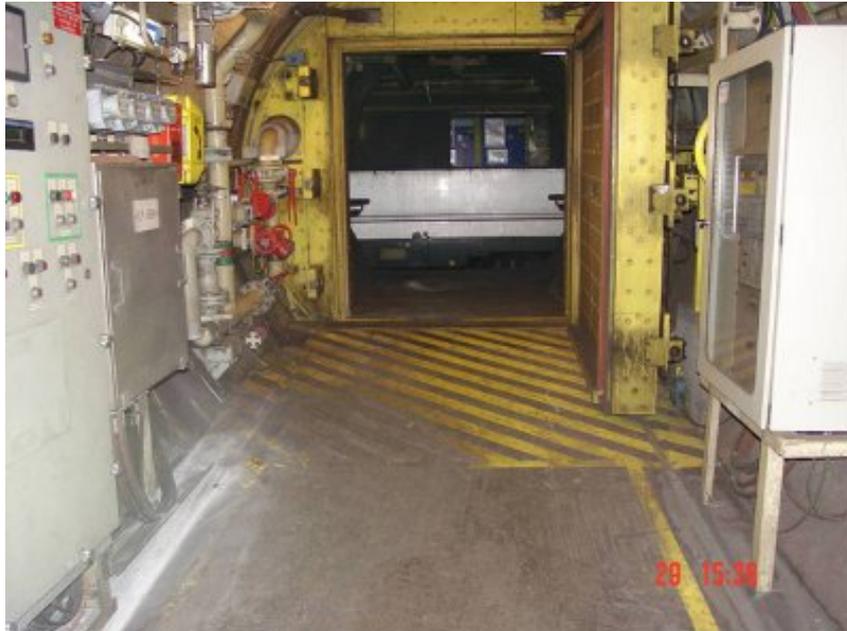
Figure 40: View of the amenity coach from the service tunnel through cross-passage 4898 (showing the window through which the majority of the passengers left)

Also, the window beside the cross-passage is broken by the passengers and used by 25 passengers and the member of the catering staff.
