RAIB Bulletin 02/2009

Tamping machine derailed in September 2008

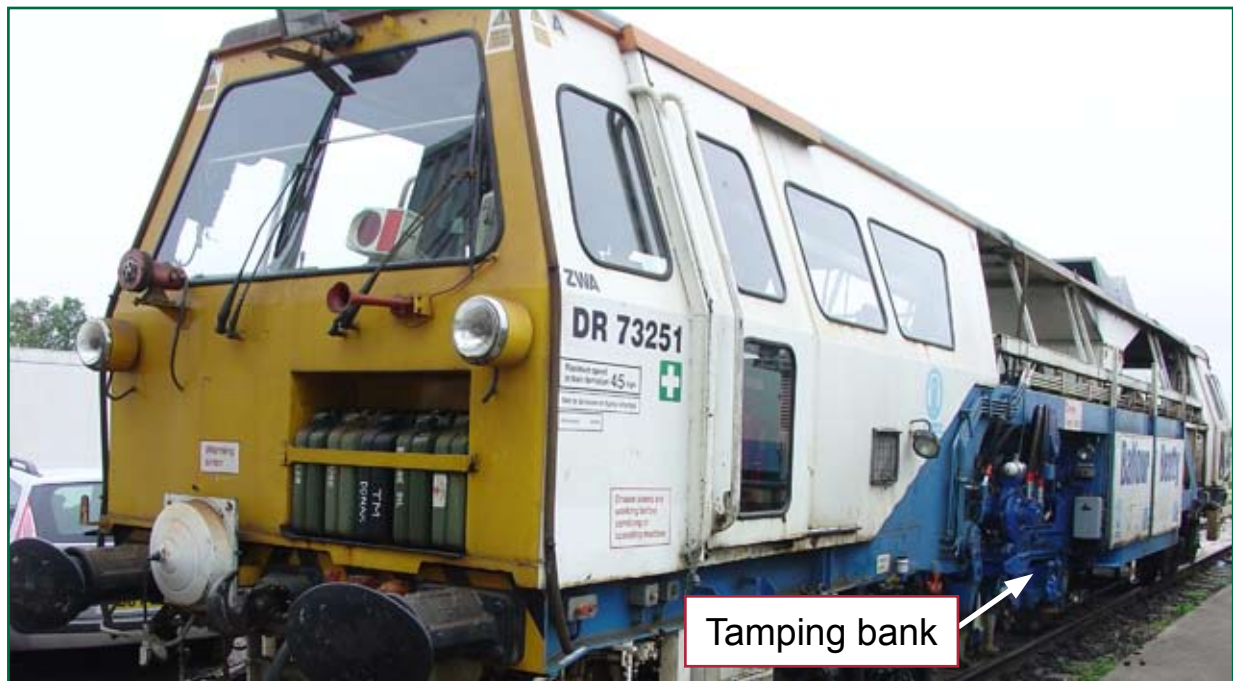
1. In September 2008 a Plasser 07 tamping machine (Figure 1) was proceeding from a stabling point to a worksite when it became derailed as it passed over a set of *trailing points* on the running line. Neither of the two operators travelling on the machine was injured, and no other train was in the vicinity, so there was no immediate risk to any other train.

4. The cause of the derailment was the uncontrolled lowering of one tamping bank; as a result the *tamping tines* had become lodged under the head of the *stock rail* in the points, forcing the tamper laterally, and derailing it.

Figure 1: Plasser 07 series tamping machine showing position of the tamping banks

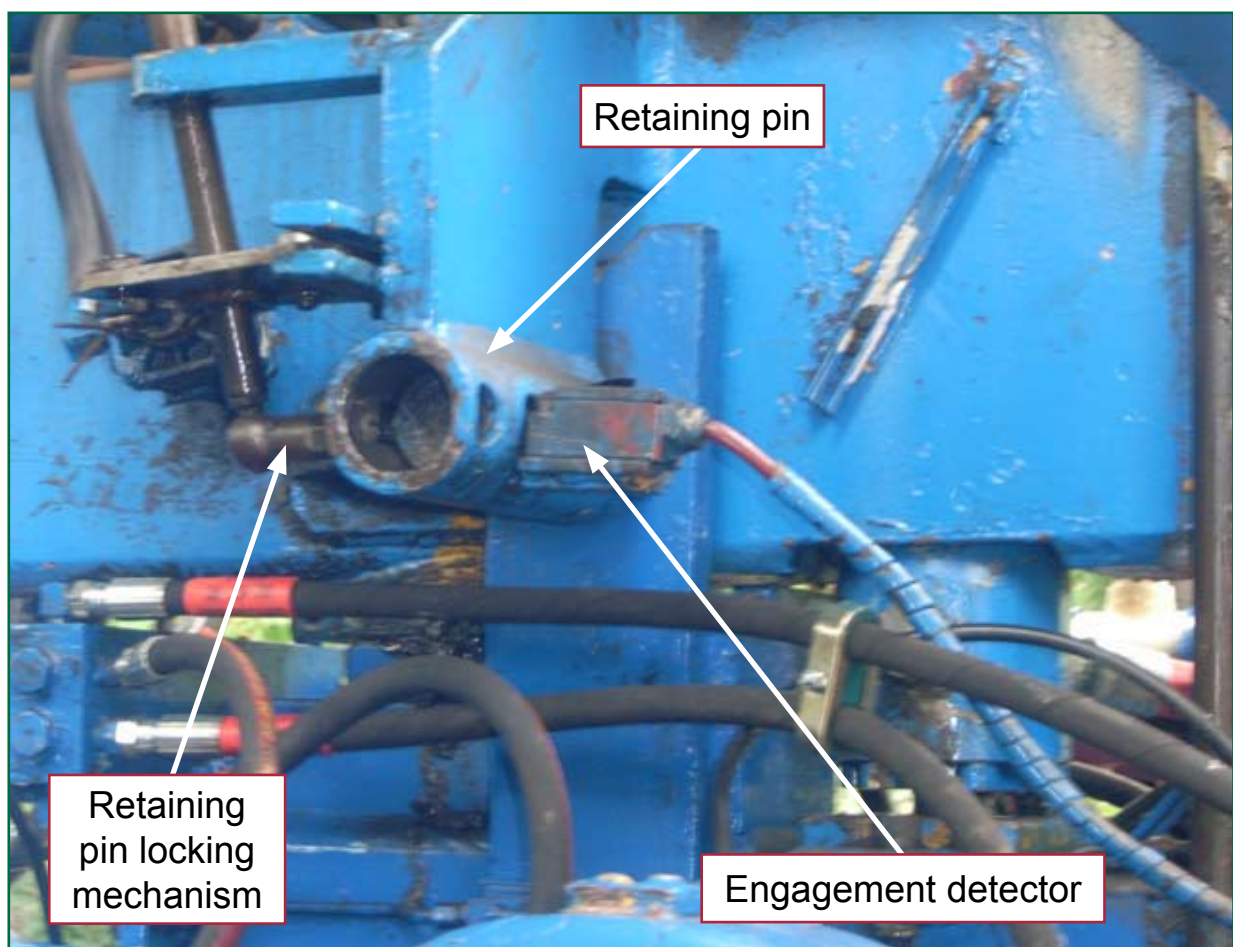
5. Apart from damage arising from the derailment, the tamping machine was found to be in good order.
6. The RAIB concluded that the left hand tamping bank retaining pin had not been fully engaged before the transit move from the stabling point. This resulted in the securing pin vibrating loose and the subsequent dropping of the bank.

7. Investigation showed that it was possible to locate the tamper bank retaining pins in such a way that, although they appeared to be fully engaged, they were not inserted far enough into the locating hole in the machine's frame to be locked in place. Observation of this condition, as part of the required preparation for moving the tamper from the depot to the worksite which took place at approximately 22:30 hrs, was made more difficult by the limited illumination of the pins and locking mechanism during hours of darkness.

8. Under these circumstances, when the tamping machine was stationary, the weight of the tamping bank kept each pin in position. As the tamping machine moved on its journey, and particularly through turnouts, the resulting vibration intermittently relieved the weight of the banks and the unlocked pin was able to move laterally until it released the tamper bank, allowing it to lower.

Figure 2: Tamper bank securing pin and locking mechanism

- The companies that own and operate Plasser 07 tampers should be aware of the difficulty of observing that the tamping banks are secure under low lighting conditions, and should train their maintaining and operating staff in the correct observation of the retaining pins.

- Those companies which anticipate retaining the Plasser 07 tamper in longer term use should consider the possibility of modifying the tampers to ensure that the main drive cannot be engaged unless the tamper banks are proved to be secured.
12. The RAIB has written to the company that owns and operates the tamping machine involved in the derailment, informing it of the RAIB's conclusions and decisions.
13. The findings of this bulletin are drawn to the attention of other owners and operators of Plasser 07 series tamping machines so that they can consider and take action to implement the learning points accordingly.

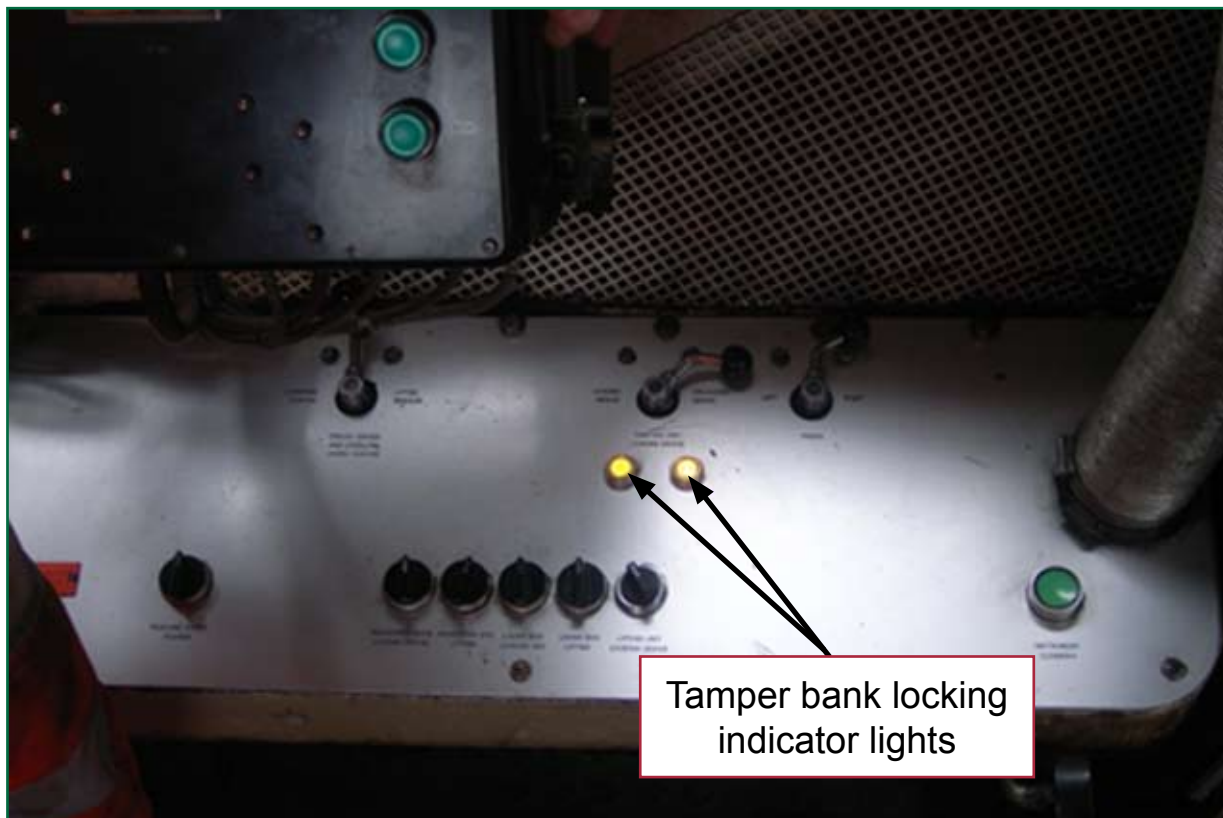
9. A light, activated by the locking mechanism, is fitted to the operating console, though not at either driving position, to indicate to the operator whether or not the tamping banks are securely retained for transit. The interpretation of the indication varies between machines (on some machines the lamp being illuminated indicates secure retention, whilst on others the lamp being extinguished indicates the same thing). This has led to a sense of uncertainty in the minds of the tamper operators. On the machine concerned, the lights were extinguished to indicate that the banks were securely retained.

Figure 3: Tamper bank locking indicator lights

11. These are:
- The indications given by the machine's systems to the operating personnel should be consistent and unambiguous, and also should be 'fail safe'. This would mean that illuminated lamps would indicate that the tamper banks are securely retained.
