Rail Accident Investigation Branch

Rail Accident Report

Near miss at Poplar Farm level crossing, Attleborough, Norfolk 1 July 2008

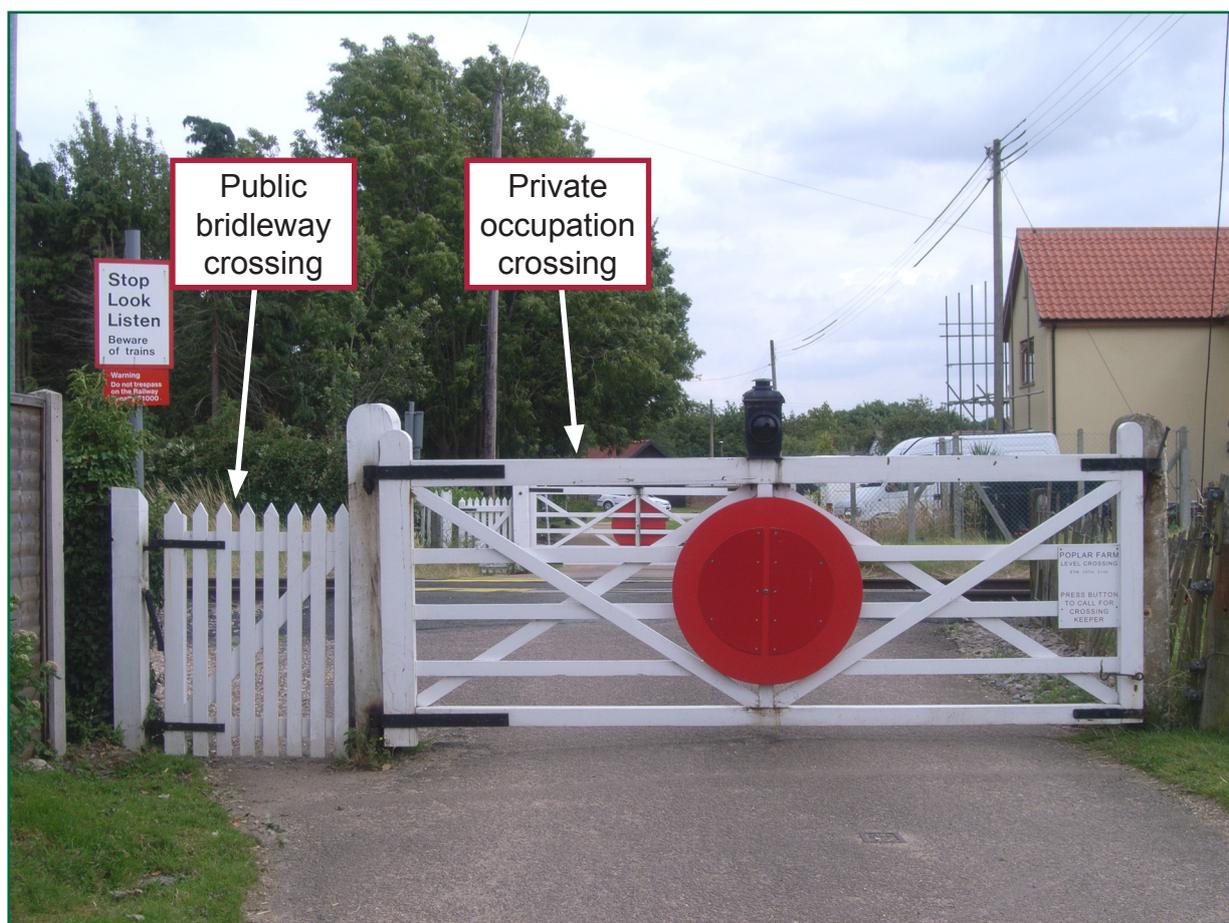
Figure 2: Poplar Farm level crossing from the down side of the railway (the direction approached by the mobility scooter)

- 9 The level crossing, although appearing to be one crossing, consists of two discrete parts (see Figure 2) with both having a boarded timber surface at rail level:

- a private *occupation crossing* giving vehicular access to 13 *authorised users* and others who have business with them, protected by outward opening gates on each side of the railway, which are normally closed across the road; and

- a public *bridleway crossing*, protected by outward opening self-closing *wicket gates* giving access across the railway to members of the public on foot, horse-riders and cyclists.

- 10 The person driving the mobility scooter involved in the incident was using the vehicular occupation crossing to cross from the down side of the railway to the up side.

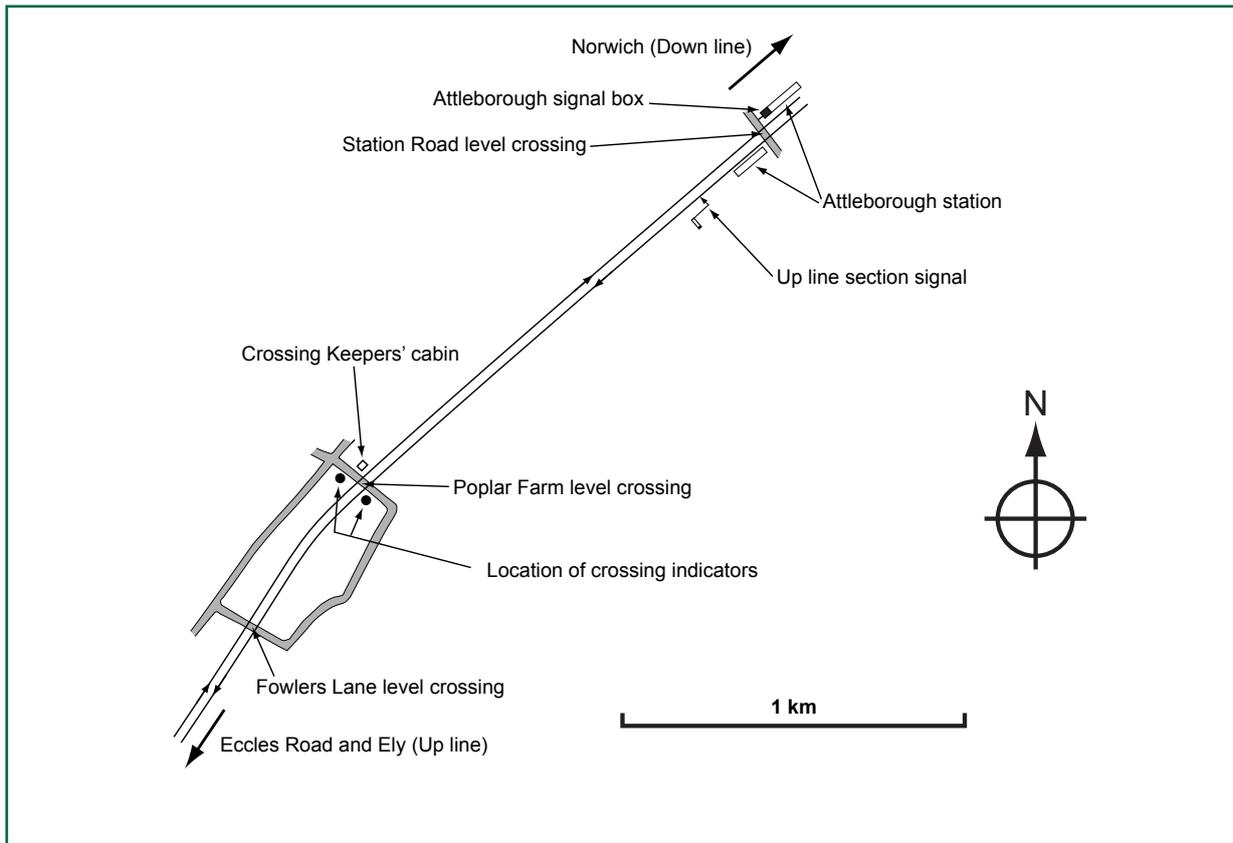
Figure 3: Location of Poplar Farm level crossing

- 11 A crossing keeper employed by Network Rail is provided at the crossing to open the vehicular occupation crossing gates when requested to do so, providing there is no train approaching the crossing. A person requiring vehicular access over the crossing is required to depress a button located on the approach to the crossing (see Figure 4). This rings a bell in the crossing keeper's cabin located on the down side of the railway on the Attleborough side of the crossing (Figure 3).

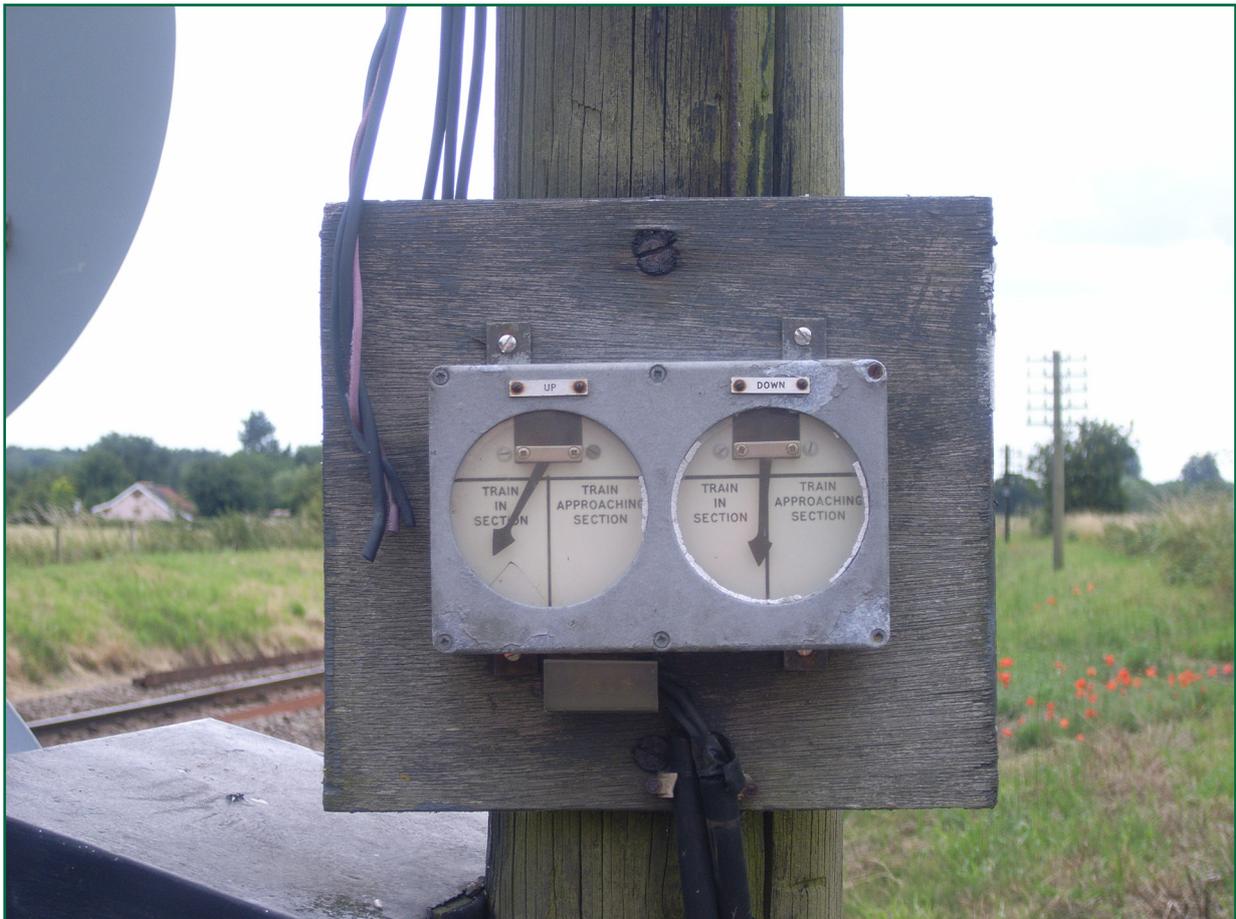
Figure 5: Poplar Farm level crossing indicators (note the up line indicator is showing 'train in section')

- 14 Indicators operated by the *block section circuit* between Attleborough and Eccles Road signal boxes are provided on both sides of the crossing on the Eccles Road side (Figure 3) to give guidance to the crossing keeper on whether it is safe to open the gates to allow vehicles to drive over the crossing. There is one indicator for each line and when energised through the block section circuit, the needle indicates either 'train in section' or 'train approaching section'. When the indicators are de-energised, they are referred to as being 'normal'. Figure 5 shows one of the sets of indicators.

- 16 The crossing keeper is not required by the crossing instructions to continuously monitor the position of the indicators; they are provided to inform the crossing keeper whether or not it is safe to open the vehicular crossing gates when a request to cross the railway from a user of the vehicular crossing is received.

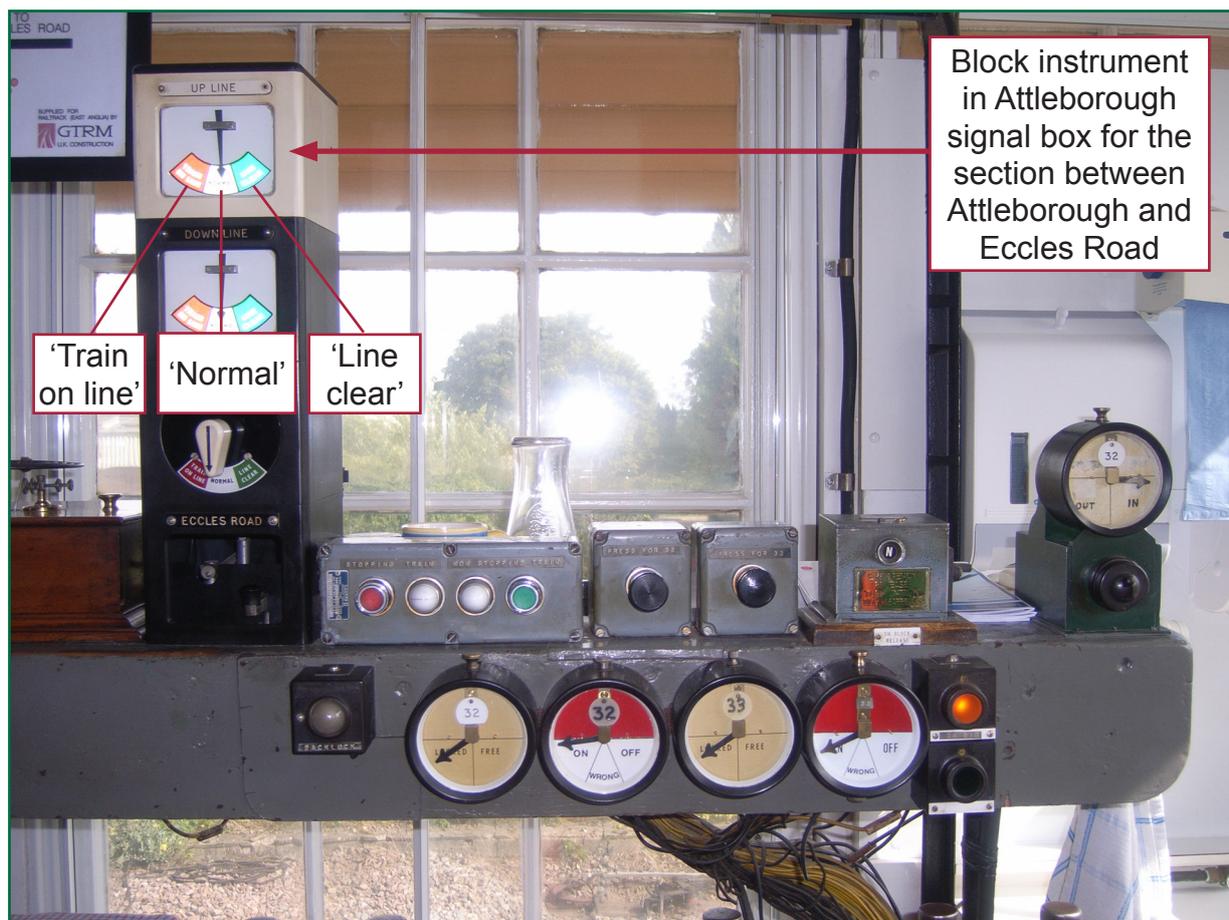
Figure 6: Block instrument in Attleborough signal box for the section to Eccles Road

Figure 6 shows the block instrument in Attleborough signal box for the block section to Eccles Road. The top indicator repeats the indications following the operation of the block instrument for up trains by the signaller at Eccles Road.

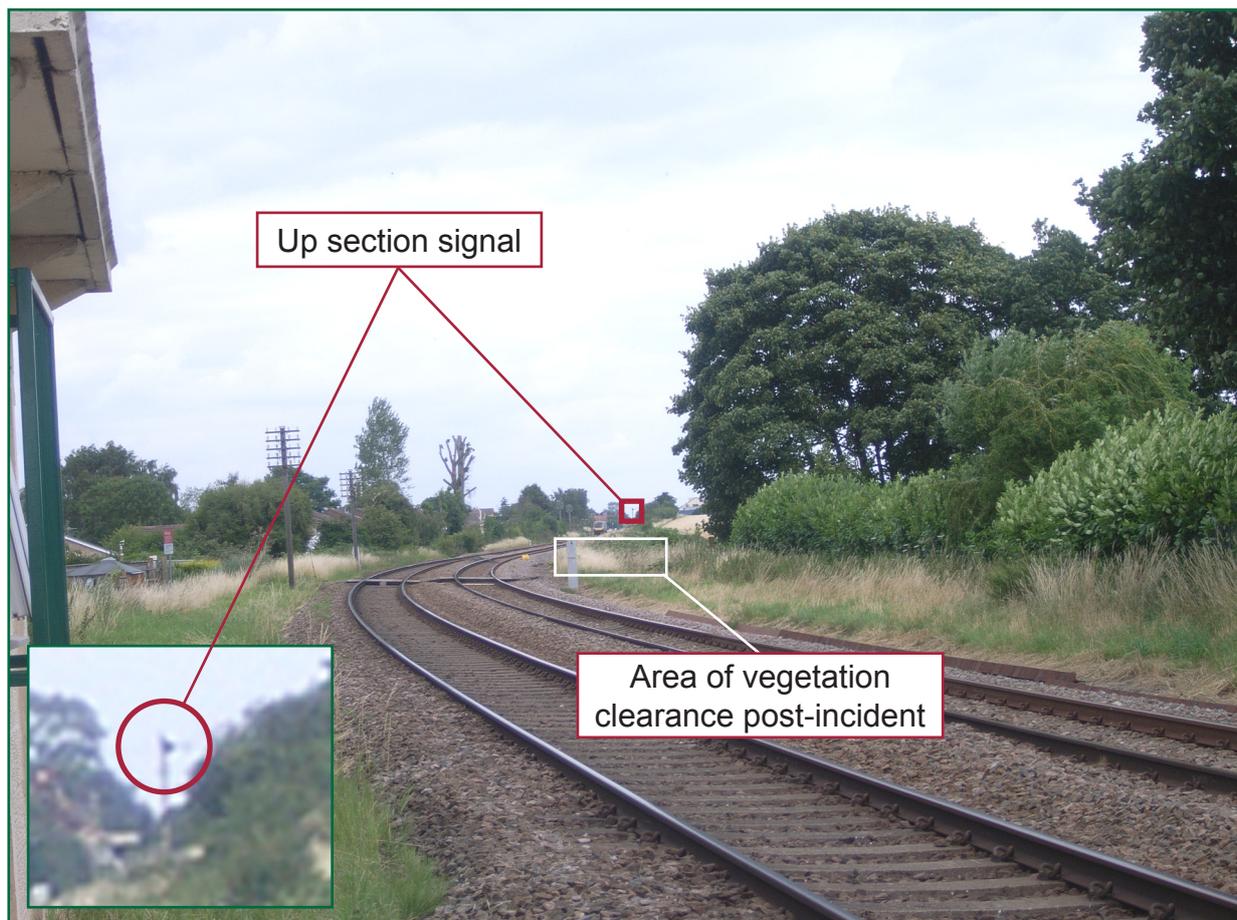
Figure 7: View from the down side of Poplar Farm level crossing to Attleborough station

- 17 Train 1M30 from Norwich departed from its booked stop at Attleborough station at 16:12 hrs on the up line and at about the same time, the bell sounded in the crossing keeper's cabin on the down side of the crossing to indicate that a person wished to cross over the level crossing. The crossing keeper looked at the indicators and saw that the up line indicator showed 'train in section' while nothing was indicated on the down line indicator. He looked along the railway towards Attleborough station and could see no train approaching the crossing on the up line. He also observed that the up *section signal* (Figures 3 and 7) was at danger.

- 18 From this, the crossing keeper concluded that the up line indicator was showing 'train in section' because the last up train over the crossing had not yet reached Eccles Road where it would clear the block section from Attleborough. He thought it was safe to open the level crossing gates because he believed that the train indicated as 'in section' had already passed the crossing. He did not realise that the train had not yet reached the crossing and was hidden from his view by the growth of lineside vegetation between Attleborough station and the crossing. Figure 7 shows the view towards Attleborough station from the down side of the crossing following the removal of lineside vegetation from the up side of the railway (paragraph 70).

- 49 The growth of lineside vegetation on the up side of the railway between Attleborough station and Poplar Farm level crossing did not allow a continuous view of trains approaching from Attleborough. The Attleborough signaller replaced his section signal to danger for the stopping train, 1M30, as soon as it had passed the signal. The train was then hidden from the view from Poplar Farm level crossing by the lineside vegetation.

- 58 In this incident, the crossing keeper looked along the railway towards Attleborough station, but the train concerned was hidden by vegetation. The maintenance of clear sight lines to help the crossing keeper to decide whether or not a train had already passed over the crossing was not appreciated by those who were carrying out the crossing inspections because the crossing was inspected as a manned gated crossing which did not require sighting to be checked (paragraph 40).

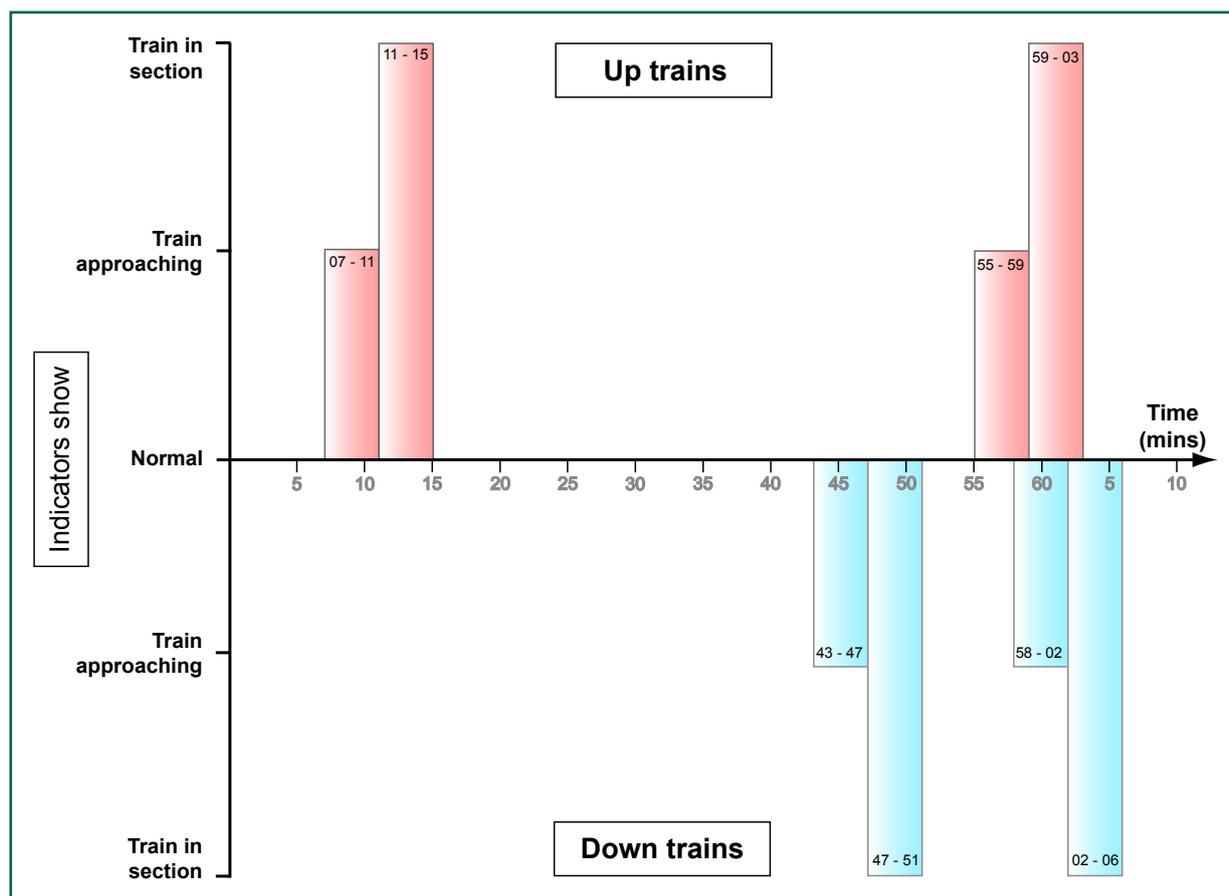
Figure 8: Operation of crossing indicators during any typical 60 minute period

- 29 The level of train service using the route causes the indicators at the crossing typically to display as shown in Table 1 during any 60 minute period. This information is also portrayed graphically in Figure 8.

- 30 In any one hour therefore, and providing trains are running according to the timetable, both indicators typically show 'normal' for 33 minutes, and at least one of the indicators shows 'train in section' for 15 minutes (for two minutes in every hour, both indicators show 'train in section'). During the period when an indicator shows 'train in section', the crossing keeper must ensure that any train concerned has passed over the crossing before opening the vehicular crossing gates in response to a user request.
