Rail Accident Investigation Branch

Rail Accident Report

Collision between a passenger train and two rail-mounted grinding machines at Acton West 24 June 2008

24 June 2008

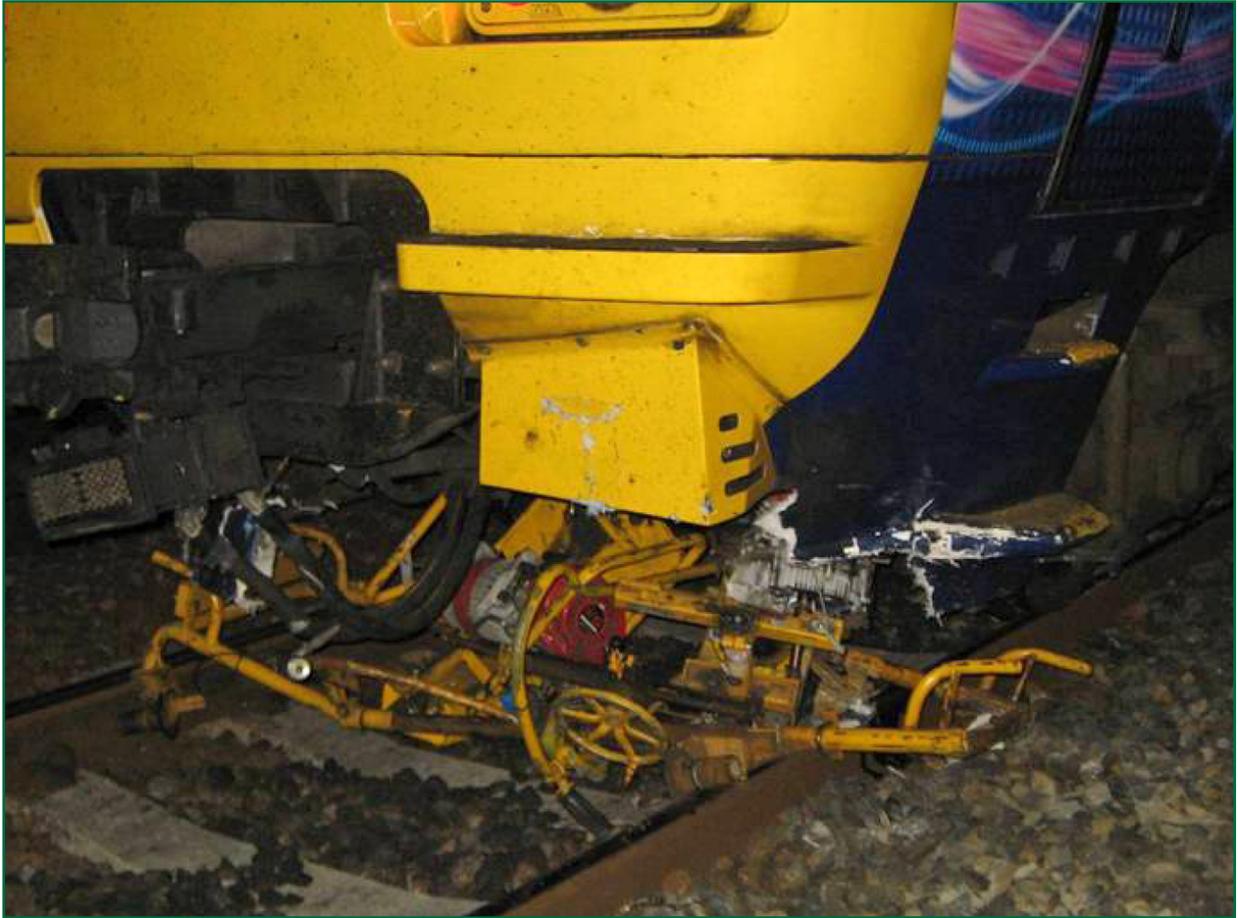
Figure 4: The train with the grinding equipment underneath (photograph courtesy of Network Rail)

- 48 Nobody suffered any physical injuries in the accident.
- 49 The grinding machines and equipment became wedged under the train and were carried to the point at which the train stopped, rupturing a fuel tank and causing damage to braking equipment on the leading vehicle. The grinding machines were destroyed.
- 50 A track-mounted *train protection and warning system* (TPWS) module was destroyed by the grinding equipment being carried underneath the train.

- 51 The train stopped approximately 250 metres from the point of impact (see Figure 4) and the driver made an emergency call to the signaller at Slough using the *Cab Secure Radio*. The signaller stopped traffic on all lines in the vicinity until the circumstances could be established. The driver checked that the 25 passengers on board the train were uninjured. Arrangements were made for them to be conveyed by road to their destinations. The passengers remained on the train until approximately 03:00 hrs before being evacuated by ladder to the track and up to Noel Road. The reason for the delay was confusion over the availability of a coach to take all the passengers. In the event, taxis were provided.

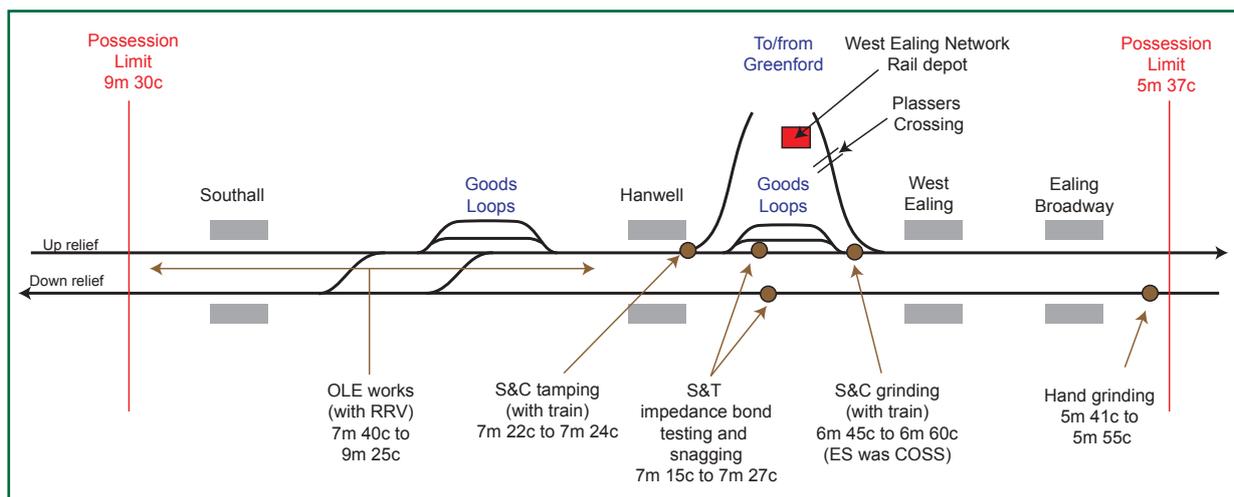
Figure 5: The possession and the tasks being carried out

- 58 See Figure 5 for details of the five tasks being carried out. Each of the tasks had a COSS allocated, whose principal job was to ensure the safety of the team working at that location.

- 59 An Engineering Supervisor was in charge of all work within the work site. He was also responsible for the movement of on-track machines into and through his work site. The Engineering Supervisor based himself at Network Rail's West Ealing depot initially, from where he arranged for two on-track machines (a *tamper*, and a rail grinding vehicle) and one item of on-track plant (a rail-mounted overhead line inspection platform) to enter his work site. He was then to become COSS for the staff working with the rail grinding vehicle at West Ealing (see Figure 5).

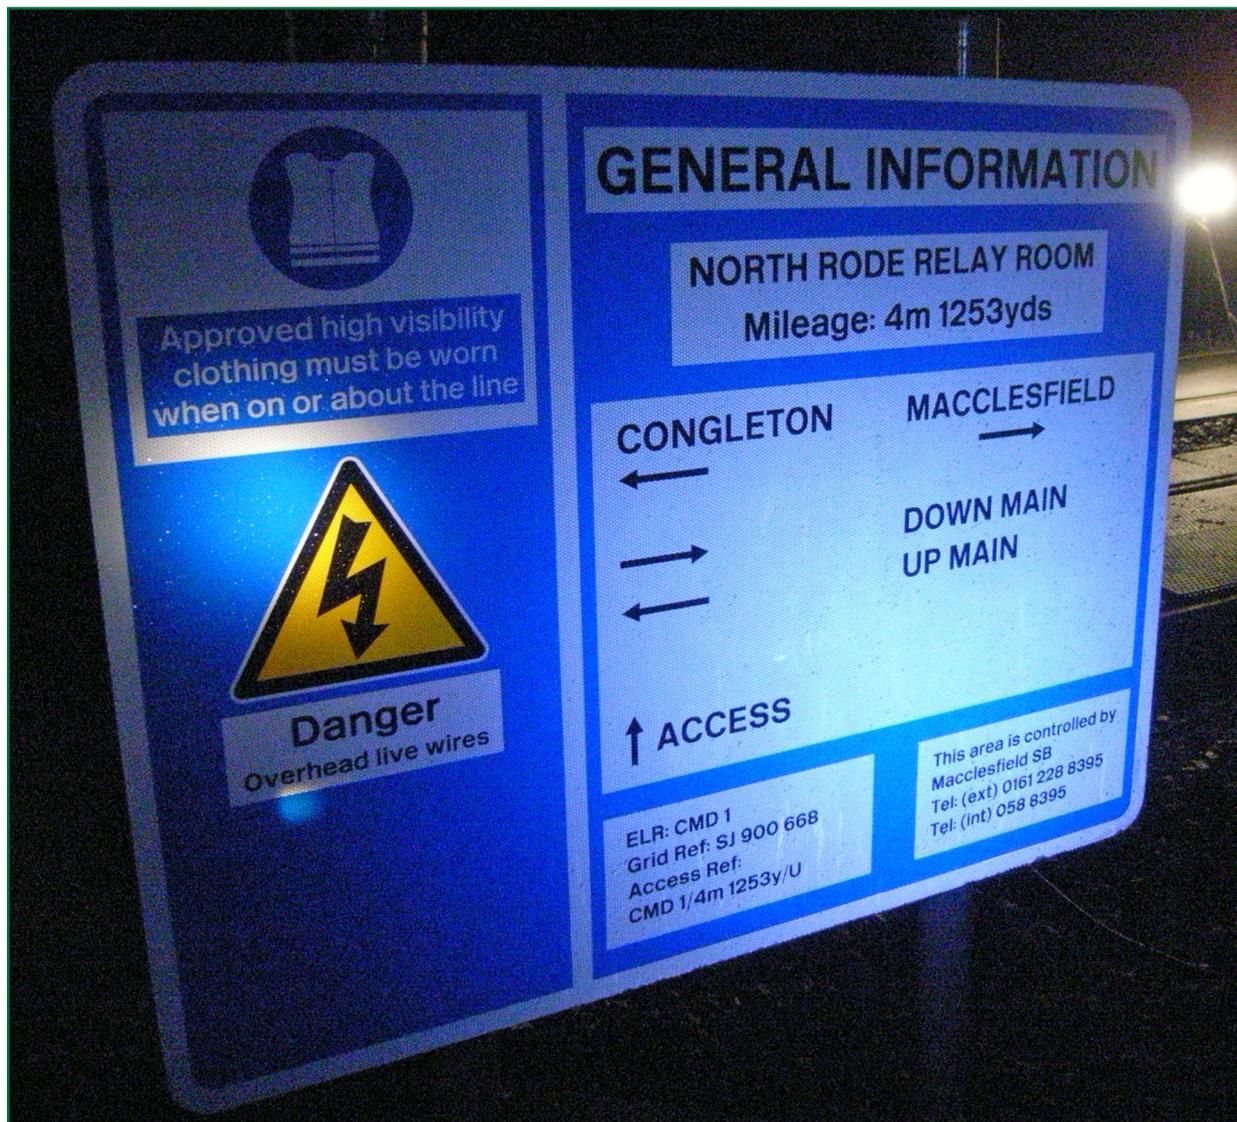
Figure 6: Lineside signage at North Rode access point

- 124 It would have been easier for the COSS to identify the location of the access point in relation to other railway features if there had been a track layout diagram provided at the access point. Such diagrams already exist at some locations on the railway (see Figure 6). The absence of a track layout diagram at the access point is a contributory factor to this accident.

- 3 The intention of this recommendation is to encourage Network Rail to expedite the provision of track layout signage at access points.
- Network Rail should develop and implement a programme for the provision of track layout information signage at all railway access points, showing mileages, line names and directions and other key items of local railway information, as appropriate (paragraph 167c).
