# Rail Accident Report

**Fatal accident at Moor Lane footpath crossing,  
Staines  
16 April 2008**

# Fatal accident at Moor Lane footpath crossing, Staines, 16 April 2008

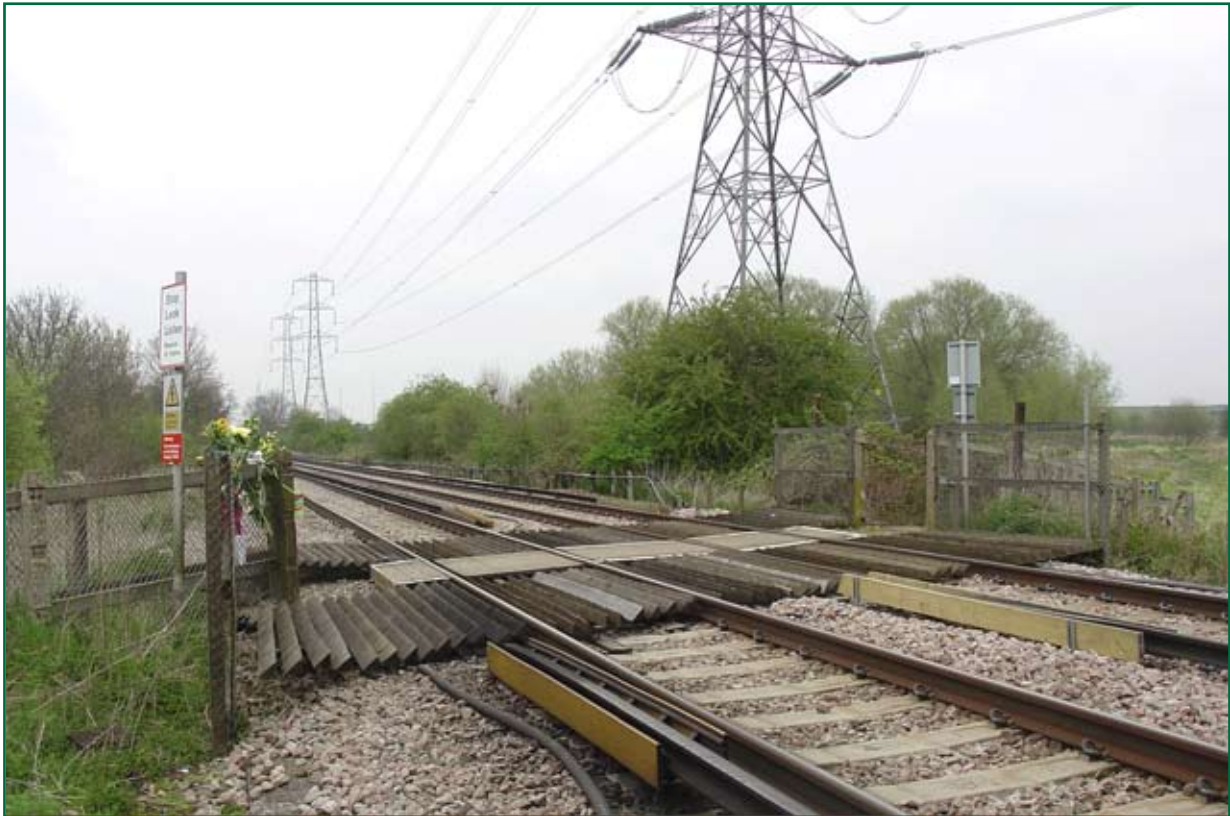
- 19 The crossing (Figure 2) carries a public footpath which runs from Moor Lane itself, about 50 m south-west of the railway, onto Staines Moor. It is used by people walking on the moor, and is part of the Colne Valley Way footpath.

Figure 2: Moor Lane crossing from the south-east

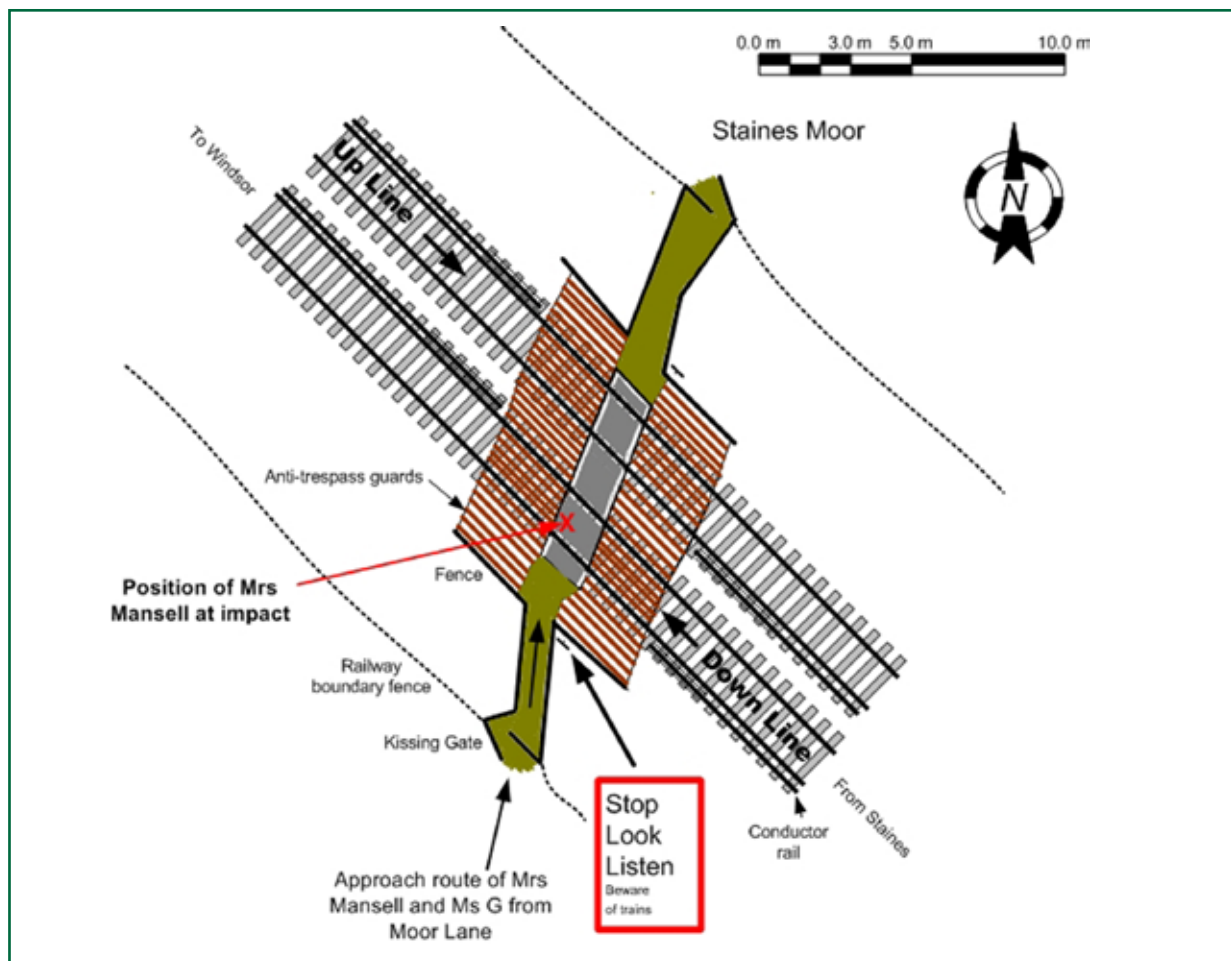
Figure 3: Plan of crossing

37 The approach to the crossing from Moor Lane is by two paths which converge immediately outside the railway boundary. There is a ‘kissing’ gate in the boundary fence, and beyond this the path runs between chain-link fences about 1m apart up to a point about 1.4 m from the nearest rail of the *down line*. The path is not at right angles to the railway, but approaches at about 45°. The path emerges from dense bushes close to the boundary fence, which stop about 3 m from the railway itself. There is a notice warning pedestrians to stop, look and listen, positioned on the right-hand side of the approach path about 2.5 m from the nearest rail (Figure 3). The crossing itself has a boarded timber surface, reached by a single step up from the approach path. It crosses the track at an angle of 66°. The boards of the crossing surface run parallel to the direction of the footpath, except for those on the outside (cess side) of the rails on both lines, which are parallel to the rails (Figure 4). There are 1.5 m high chain link fences extending from the end of the footpath for about 3 m, running parallel with the railway in both directions.

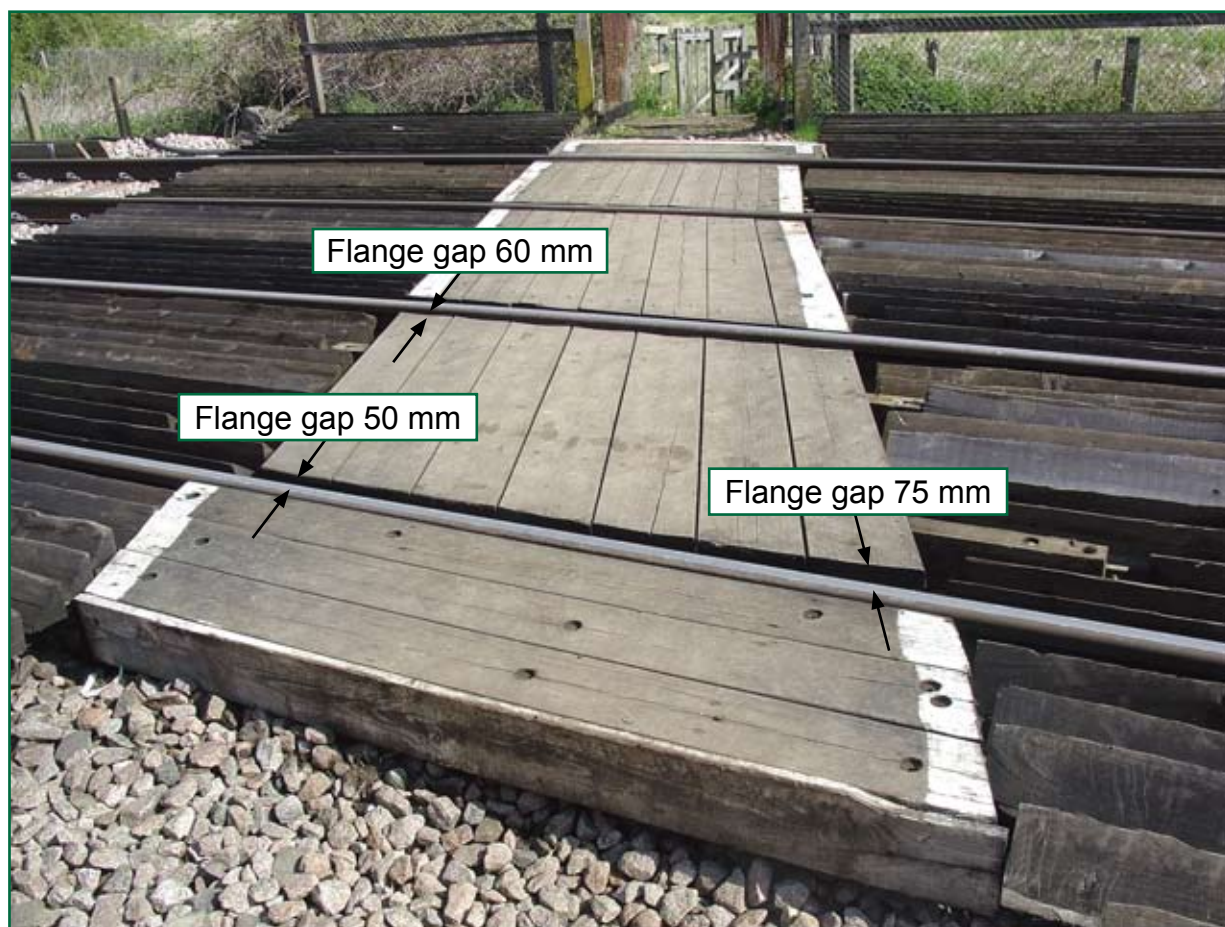
Figure 4: Moor Lane crossing surface, from the south side

- 40 There are white lines, about 50 mm wide, painted along both edges of the crossing. At the time of the accident these lines were missing from the timbers in the *four-foot* of the down line (Figure 4).

- 89 The surface of the crossing was of planed timber, neither painted nor varnished (Figure 4). The orientation of the crossing timbers parallel to the direction of the footpath was unusual. However, tests carried out by the RAIB, using walking shoe soles weighted with concrete blocks and pulled across the surface, found that the slip resistance was the same in both directions, along and across the crossing.

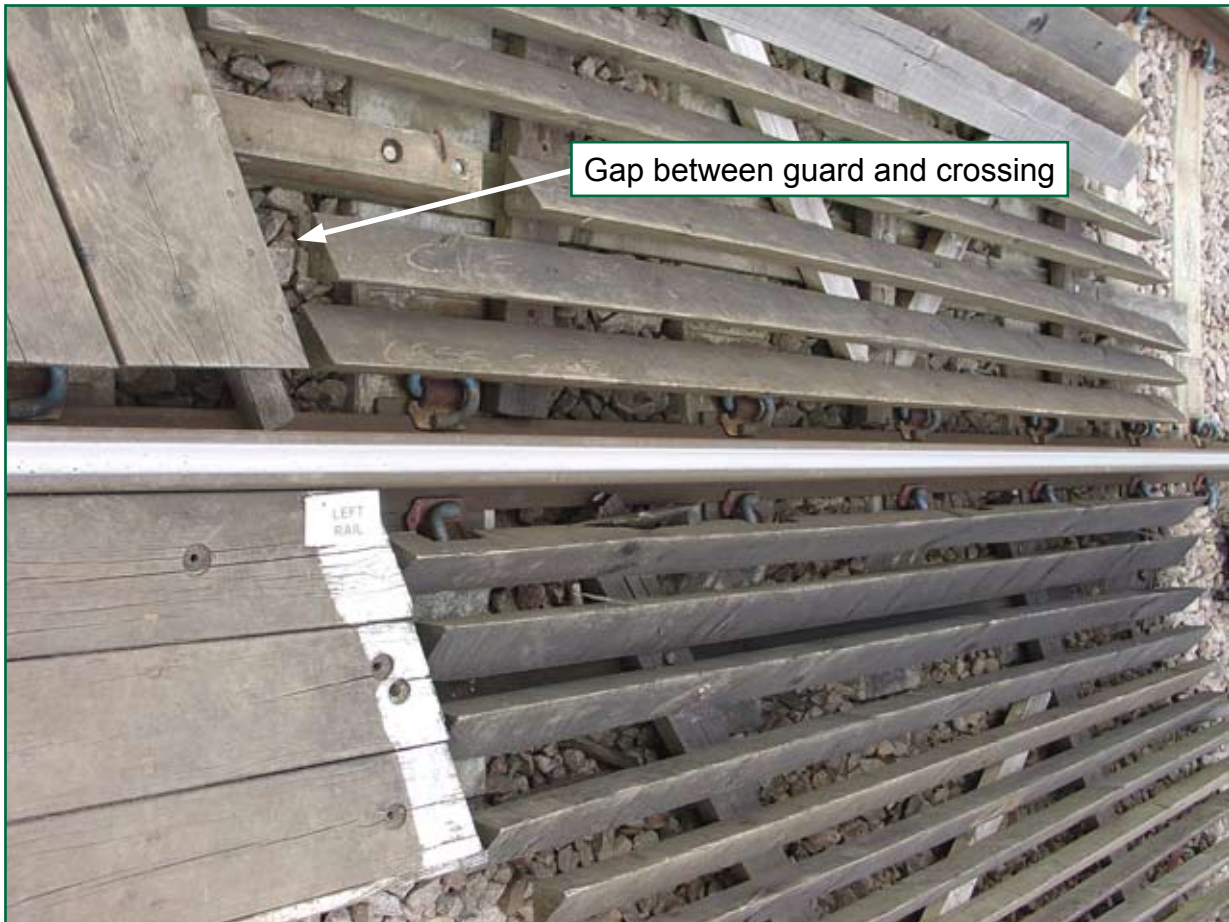
38 The conductor rails are interrupted at the crossing, and the gap extends over about 7 m. On either side of the crossing there are anti-trespass guards, consisting of triangular section timbers approximately 2.6 m long, fixed parallel to the rails at 80-100 mm intervals. These guards extend across the full width of the crossing between the fences on both sides. They are fixed close to the edge of the crossing surface, and terminated about 300 mm short of the ends of the conductor rails on both lines. There is in some cases a gap of up to 120 mm between the crossing surface and the end of the anti-trespass guard (Figure 5).

Figure 5: Anti-trespass guards

- 136 The guards are supposed to be fitted 'adjacent' (RSPG 2E paragraph 177) to the footway. In practice there may be a small gap between the footway and the end of the guard rails (Figure 5). This may create a hazard in which a person's foot can become trapped, should they stumble or slip off the footway itself. This hazard would be eliminated if there were a substantial gap (more than 300 mm) between the crossing and the anti-trespass guard, but this is not permitted in the current guidance.
