Rail Accident Investigation Branch

Rail Accident Report

Uncontrolled movement of a road vehicle in a Channel Tunnel passenger shuttle train in transit from the UK to France 4 April 2008

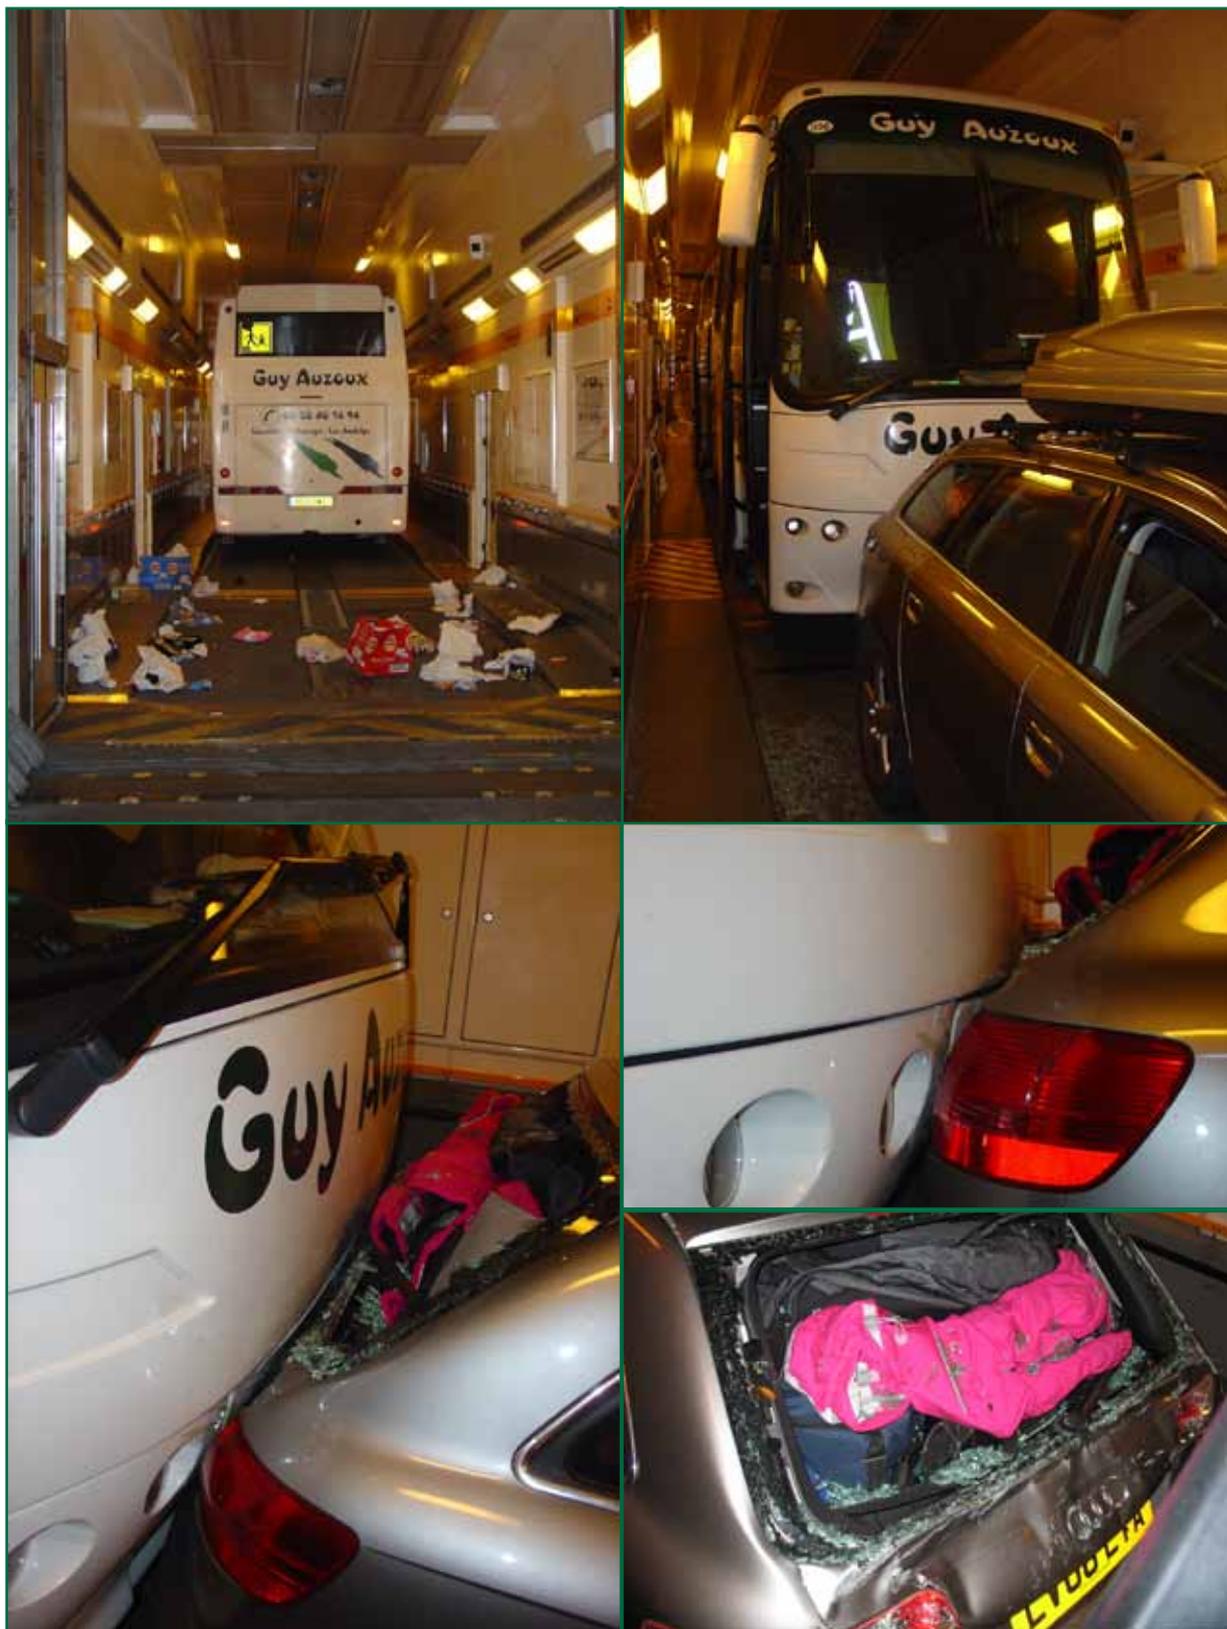
Figure 2: The road coach and private car immediately following the accident

- 20 *Mission 6608*, the 17:06 hrs Cheriton to Coquelles passenger shuttle started being loaded with road vehicles at 16:50 hrs. A mix of private cars and road coaches was loaded onto the single deck wagons forming the front section of the shuttle.

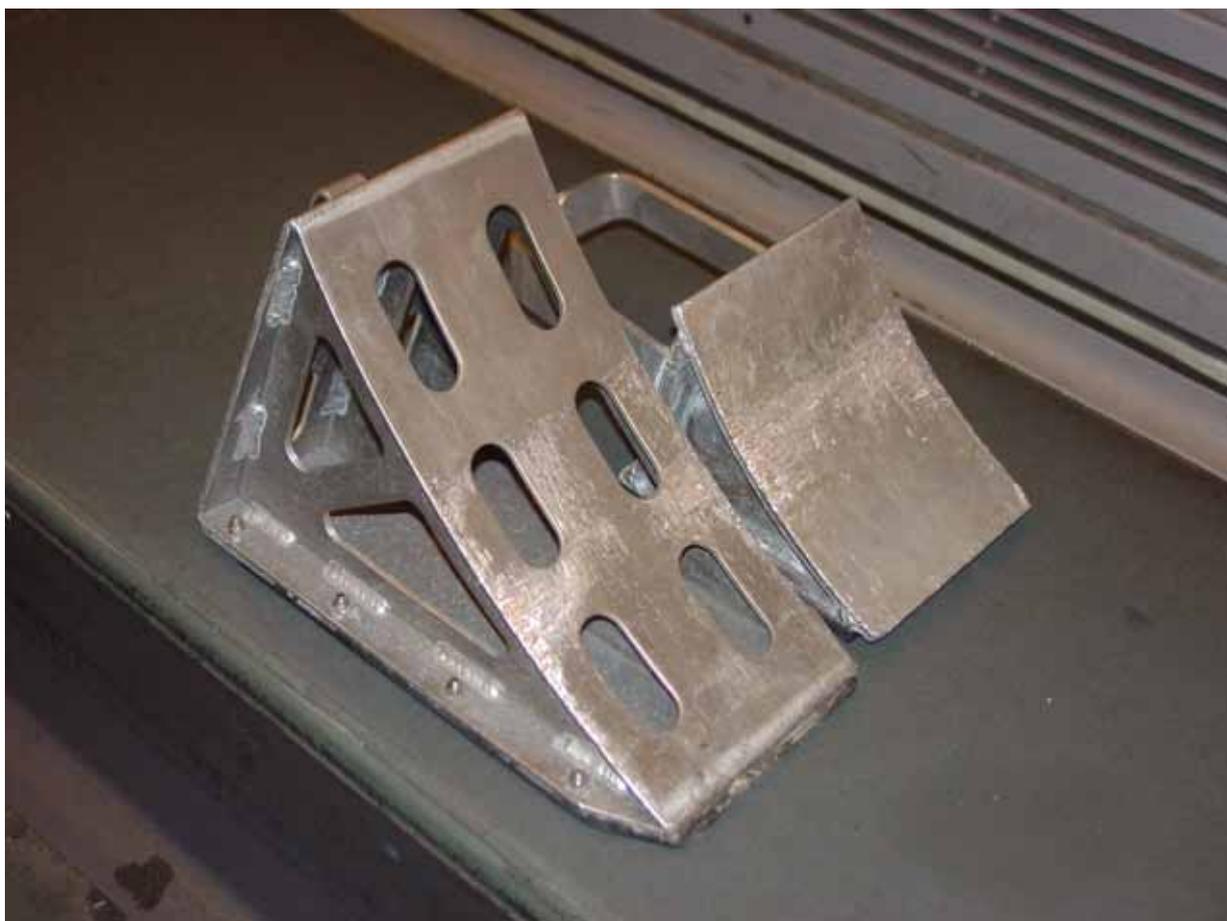
Figure 3: Large (left) and small (Right) chocks

- 23 On reaching the coach in wagon 6, a crew member found that there was no large chock available to be placed in front of the leading wheel of the coach, so he placed a small chock against that wheel, intending to complete the loading of the train and then return to wagon 6 with a spare large chock. However, he did not have the opportunity to return to wagon 6 before the accident occurred.

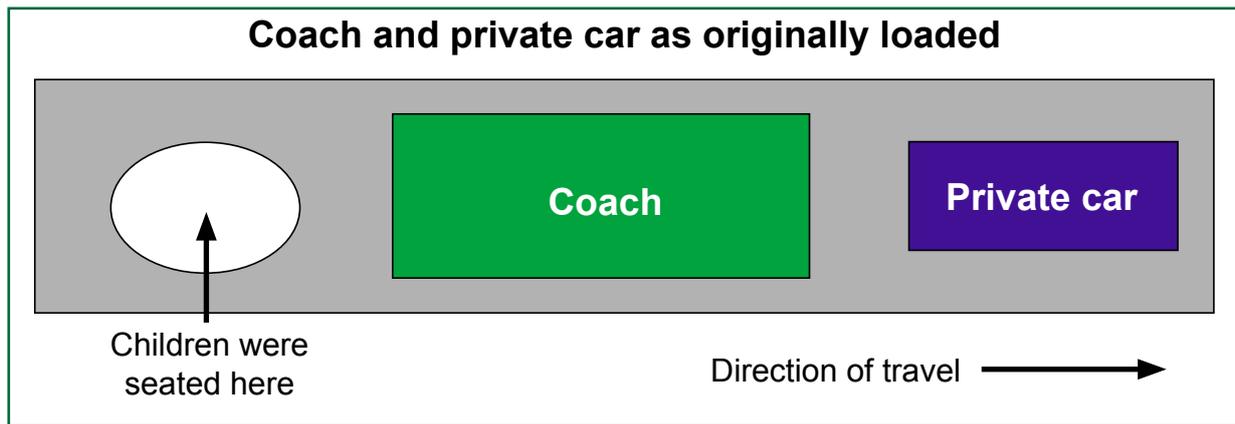
- 21 A private car was parked at the front of wagon 6 and a road coach immediately behind it. No vehicle was parked behind the road coach.
- 22 The loading crew passed along the shuttle chocking the vehicles and instructing the drivers of all vehicles to secure them with the handbrake on, the engine turned off and first gear engaged.

Figure 4: Coach and private car as loaded in Wagon 6

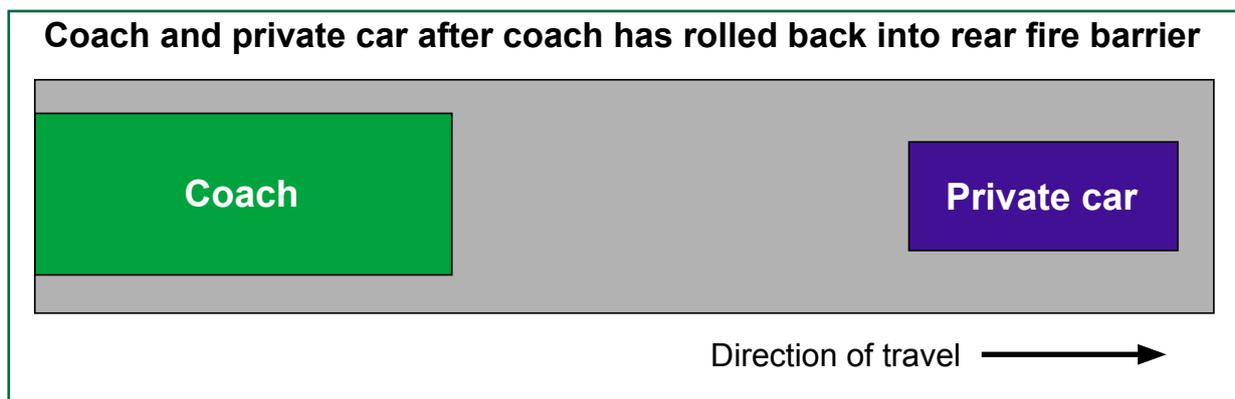
- 25 While the driver was next to the luggage compartment, the shuttle train began the journey to France.
- 26 The road coach then began to roll backwards towards the rear fire door of wagon 6.

Figure 5: Positions of coach and private car after departure but before braking

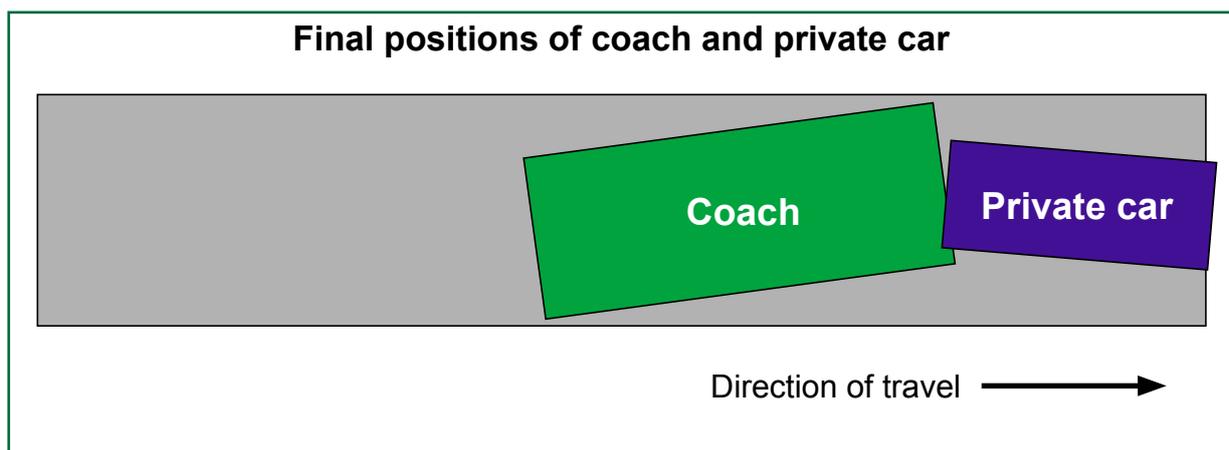
- 32 As the shuttle slowed down, the road coach moved forward, releasing the driver, who returned to the coach to attempt to stop its forward movement. Although he managed to enter the coach, he did not prevent it running into the car parked ahead of it. The coach and car moved onward into the fire barrier at the front of wagon 6. None of the occupants of the car was injured.

Figure 6: Positions of the coach and private car after the accident

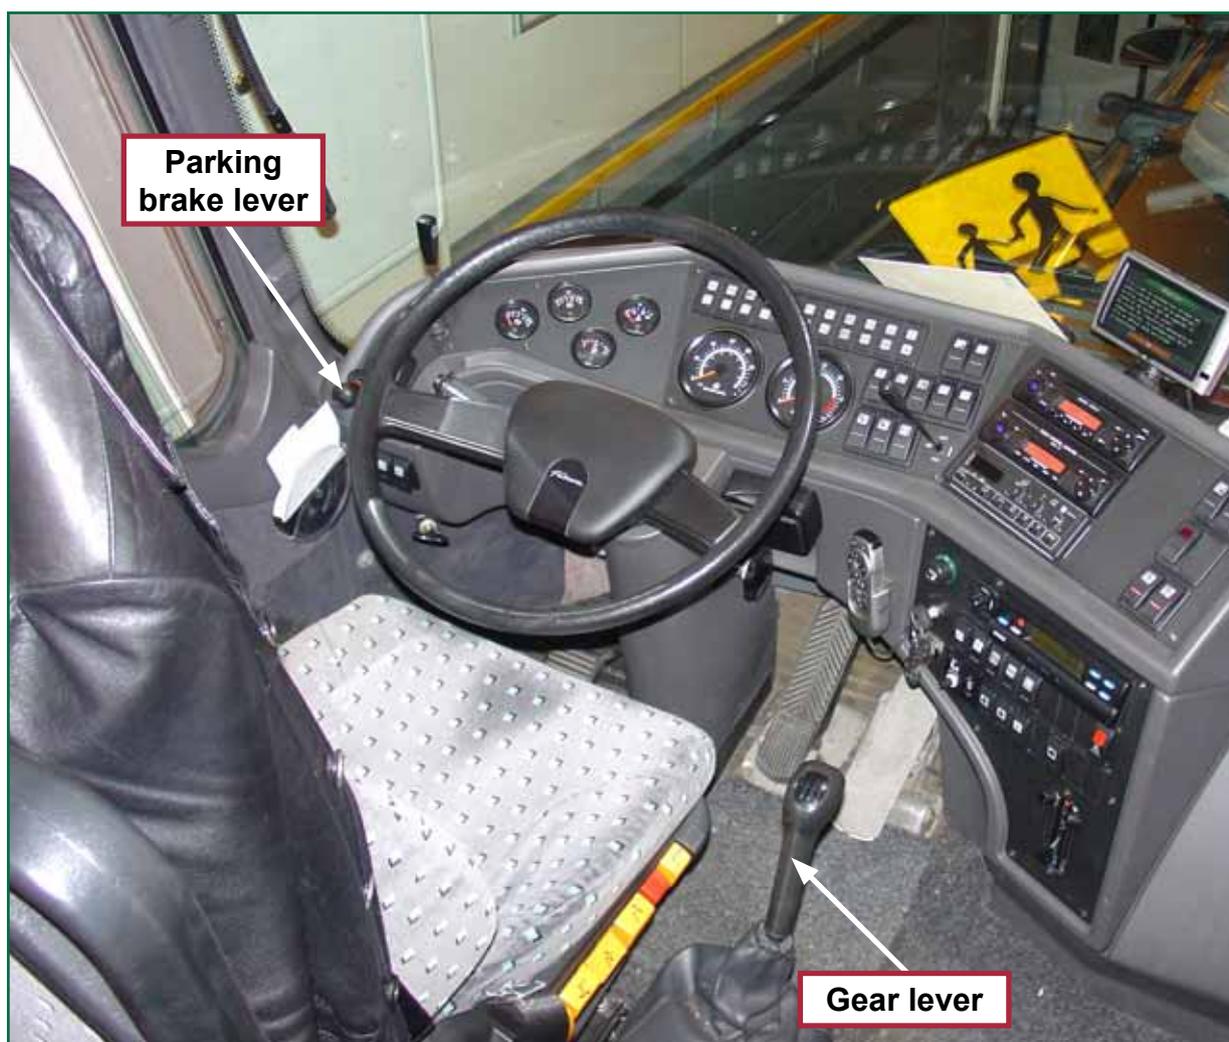
Figure 7: The layout of the Bova Futra's driving position showing parking brake and gear lever

- 75 The parking brake lever is under the steering wheel close to the corner formed by the windscreen and the side window as shown in Figure 7. It is also held in either applied or released position by a collar which fits into a recess when the lever is in either position, but not when it is between positions. It would be most unlikely that the brake would have been knocked away from the fully applied position because it is distant from the path which the driver would have taken when getting up, is protected by the steering wheel and is locked by the collar.

- 76 It is possible to lodge the parking brake lever away from applied or released positions and then to move it by knocking it. The protection provided by the steering wheel makes it unlikely that this happened.
