Rail Accident Report

**Fatal accident at Tackley station level crossing,
Oxfordshire
31 March 2008**

Report 09/2009
March 2009

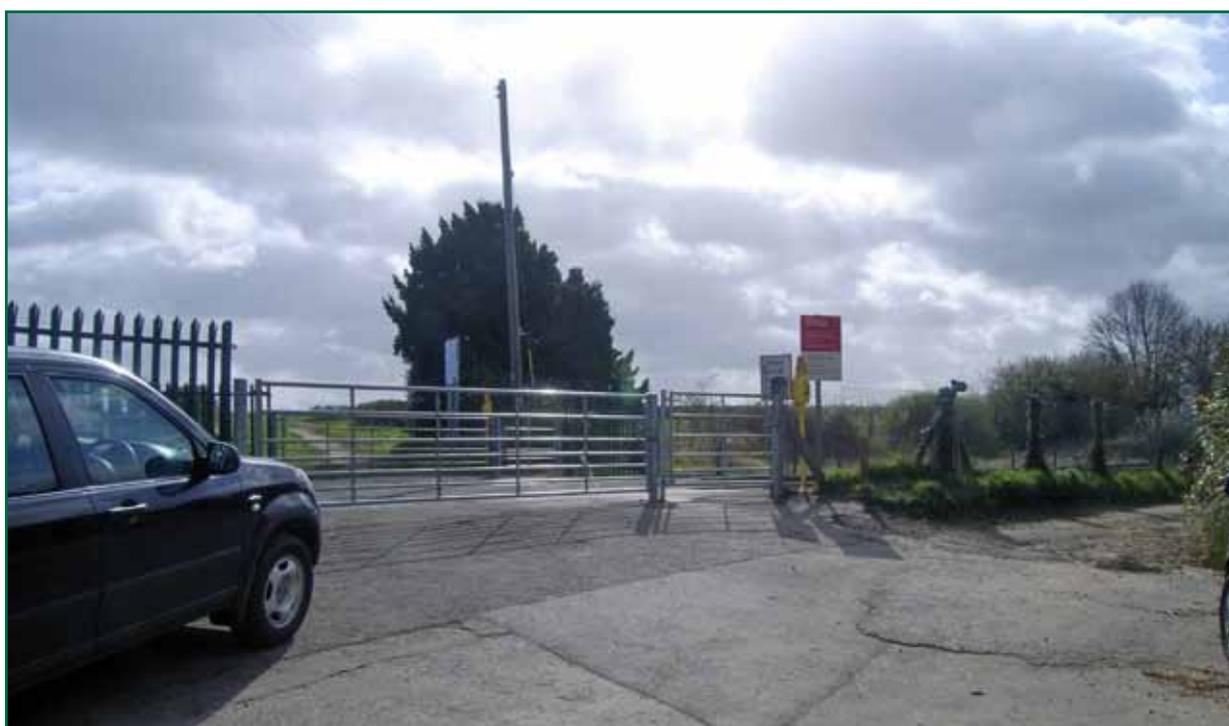
- 26 Tackley crossing is *user-worked* with separate vehicular and wicket gates, the vehicular gates normally being kept locked (Figure 2). The crossing provides three types of access:
- it is an *accommodation crossing* giving access for Tackley Estate, who are the only *authorised users*, and can use the crossing for farm vehicles in connection with managing and using the Estate;
 - it allows a footpath and bridleway to cross the railway, and forms part of an on-road cycle route promoted by the National Cycle Network; and
 - it is the only means of access to the up (London bound) platform of Tackley station from the village.

Figure 2: Approach to Tackley crossing from the down (ie village) side

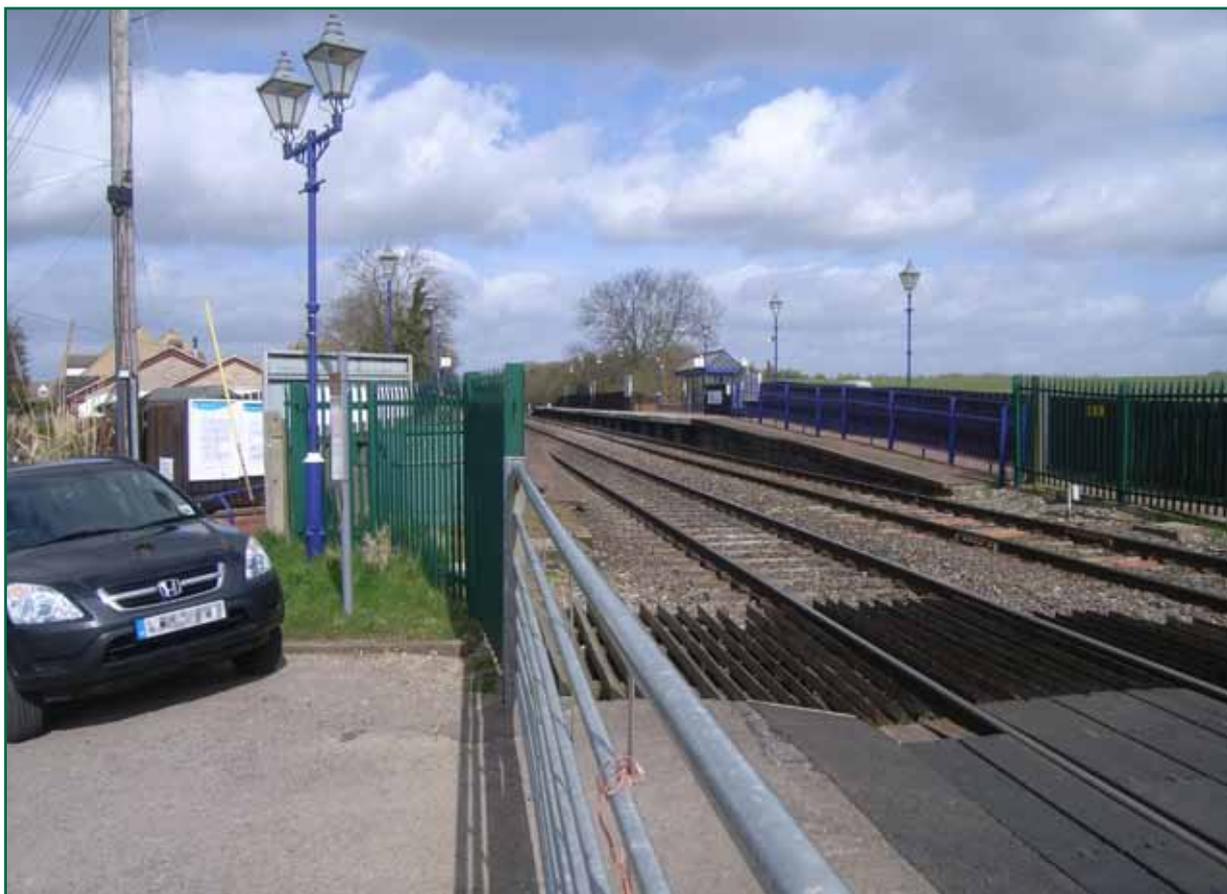
- 88 From the down side of the crossing, observing trains travelling on the up line (ie approaching from the north):
- a. Just outside of the railway boundary (ie wicket gate): 120 metres, equivalent to 3 seconds at 90 mph (145 km/h). The palisade fence at the north-west corner of the crossing obstructed visibility from this position (Figure 3).

Figure 3: Visibility from the down side of the crossing to the north, photographed from outside of the railway boundary

- 116 The palisade fence reduced the visibility of trains approaching on the up line to 120 metres from outside of the wicket gate. This represents three seconds travelling time for a train travelling at 90 mph (145 km/h) and was inadequate to assess whether it was safe to cross. Adequate sighting could be obtained from within the wicket gate (paragraph 88b).

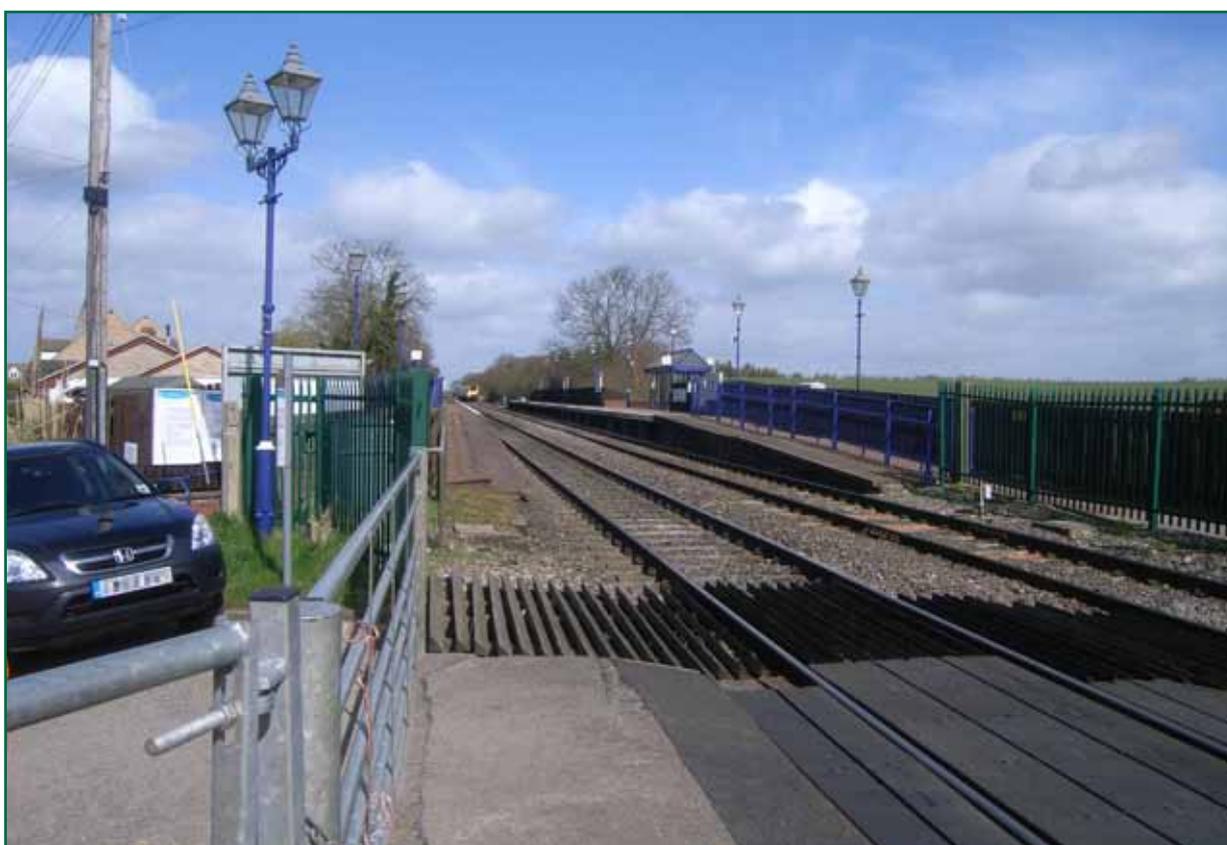
- b. Inside of wicket gate and approximately 2.2 metres from the running rail: 600 metres, equivalent to 15 seconds at 90 mph (145 km/h). This is the maximum possible distance due to curvature of the track and applies to sighting from both sides of the crossing (Figure 4).

Figure 4: Visibility from the down side of the crossing to the north from within the wicket gate

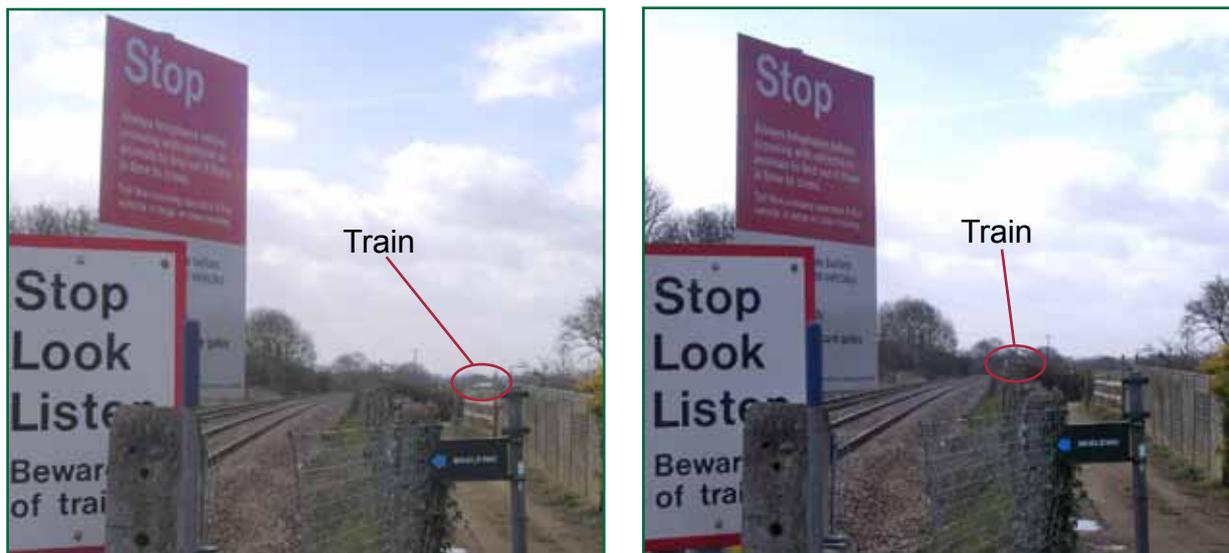
- 89 From the down side of the crossing observing trains approaching on the down line:
- Just outside of wicket gate: 925 metres, equivalent to 23 seconds at 90 mph (145 km/h). Approaching trains were visible across a field due to the curvature of the track.
 - Inside of wicket gate: 300 metres, equivalent to 7.6 seconds at 90 mph (145 km/h). Visibility from this position was restricted by vegetation on the inside of the curve growing on raised ballast, and by signs at the crossing. The roof of an approaching train was just visible above the vegetation as it passed the whistle board, 350 metres from the crossing (Figure 5) but this may not be apparent to all crossing users.

Figures 5 & 6: Train approaching on the down line, viewed from the down side of crossing outside of the wicket gate. The train is visible in the distance (Figure 5), but becomes hidden by vegetation as it approaches the crossing (Figure 6)

- 142 Sighting of trains approaching on the down line from the down side of the crossing was restricted by vegetation, some of which was growing on mounds of ballast deposited beside the track (paragraph 89, **Recommendation 6**).

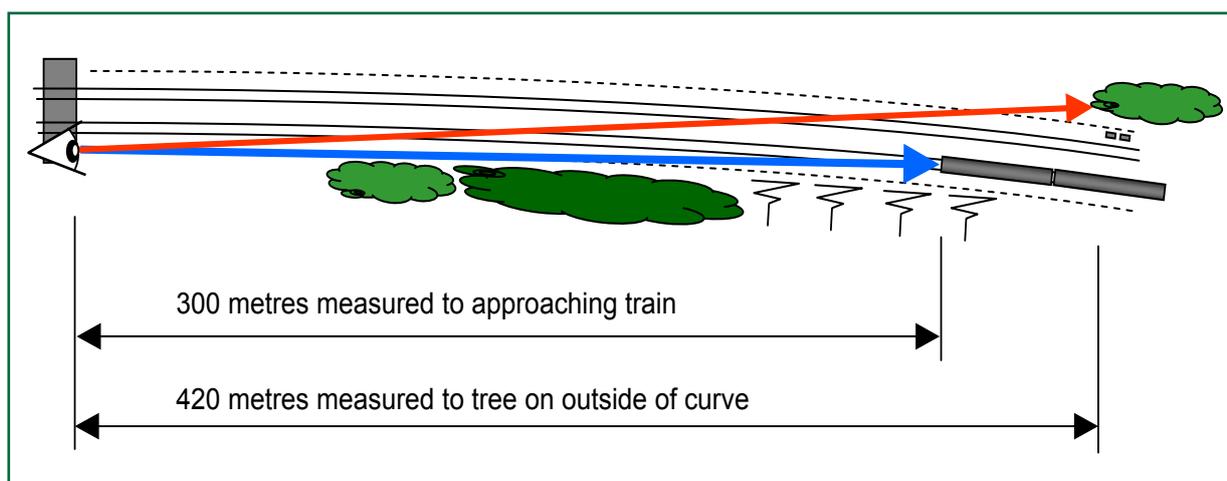
128 Network Rail provides training for staff responsible for inspecting level crossings and collecting data for ALCRM assessments. The training material identifies that both track curvature and vegetation can affect the sighting distance, but does not highlight the risk of error occurring if measuring to a non-specific point, or the effect of measuring to the outside of a curve (Figure 10). Range-finder equipment works by reflecting an infra-red beam off an object in its sightline. If there is no feature to reflect the beam at the required distance, the measurement will be incorrect.

Figure 10: Schematic diagram showing over-measurement of sighting distance on a curve

129 The difficulty in accurately assessing distances using range-finder equipment is evidenced by the April 2007 ALCRM assessment and December 2007 crossing inspection reports. Specifically, the ALCRM assessment used the distance to the outside of the curve, giving a sighting distance of 420 metres, 40 % greater than that calculated by the RAIB by observing approaching trains and using a stop-watch (paragraph 89b). The December 2007 level crossing inspection report gave a sighting distance from the up side of the crossing of over 800 metres, which is 30 % greater than that which is possible for trains approaching on the up line due to a curve in the track. The methods currently in use result in unacceptable variations in the measurement of sighting distances which could compromise the safety of crossing users.

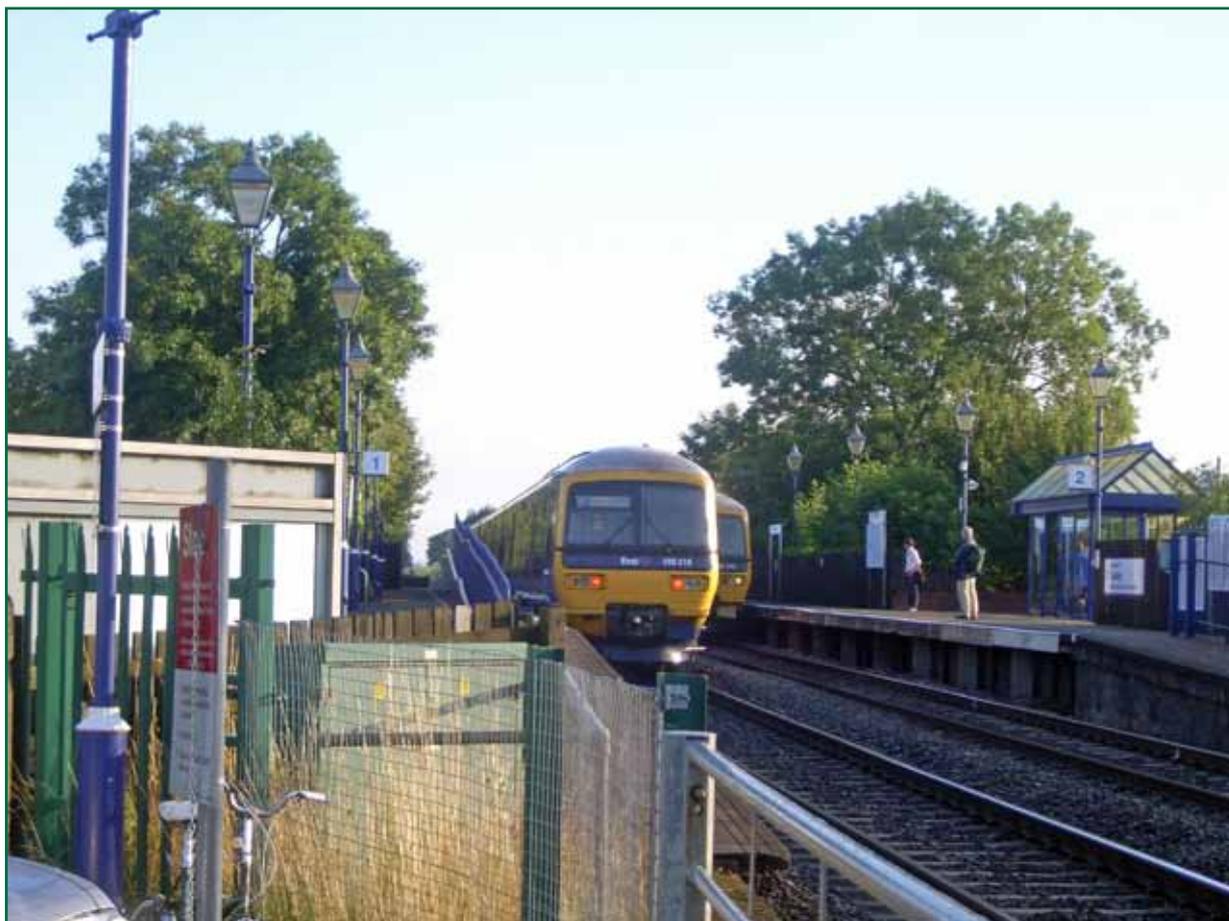
133 The visibility and audibility of trains approaching on the up line from the down side of the crossing is reduced when a train is stationary at the down platform. The respective layout of the station platforms and crossing means that a train travelling at 90 mph (145 km/h) becomes fully visible less than three seconds before it reaches the crossing. Network Rail refers to this phenomenon as a 'hidden train factor' (Figure 11).

Figure 11: Photograph of train in down platform, in August 2008, illustrating the 'hidden train factor'. Note that the green palisade fence has now been removed, but that sighting is still affected by fencing on the platform

- 144 Fast trains approaching on the up line are visible for less than three seconds before they reach the crossing when a second train is stationary in the down platform. This risk is not identified to crossing users (paragraph 134, **Recommendation 1**).
