# Rail Accident Report

## Network Rail's Management of Existing Earthworks

# Network Rail's Management of Existing Earthworks

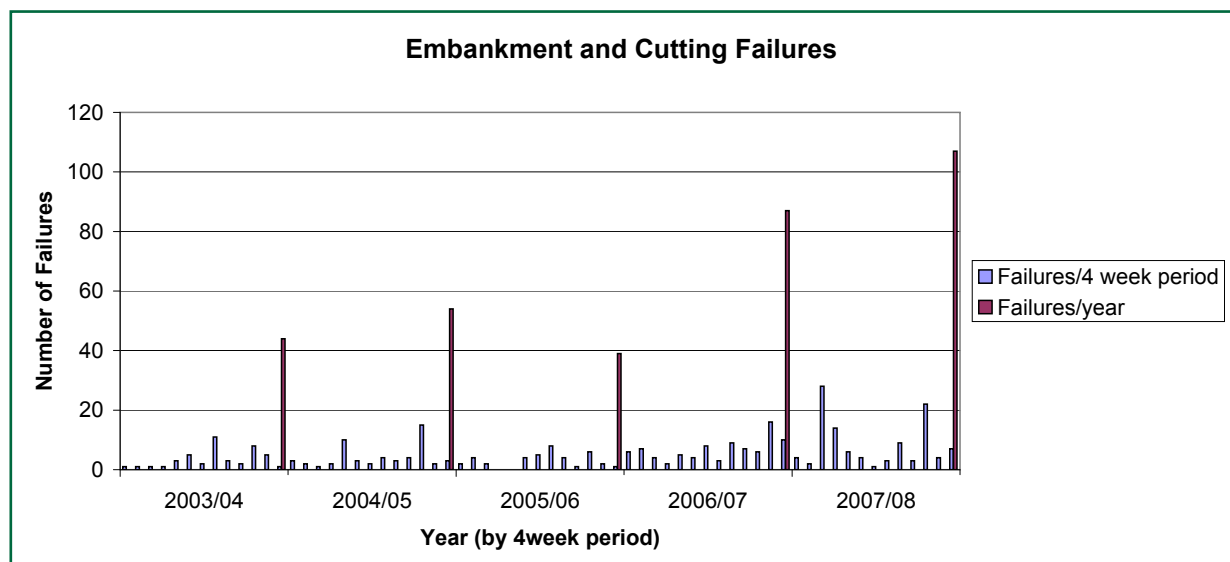
Figure 2: 2003 to 2008 Network Rail recorded earthworks failures

58 In the period covered by this data, train derailments attributed to earthwork failure were:

- 1 in 2003/4 – rock fall;
- 1 in 2004/5 – embankment slip;
- 2 in 2005/6 – 1 cutting slip and 1 cutting *washout*;
- 3 in 2006/7 – 1 cutting washout and 2 cutting slips; and
- 0 in 2007/8.

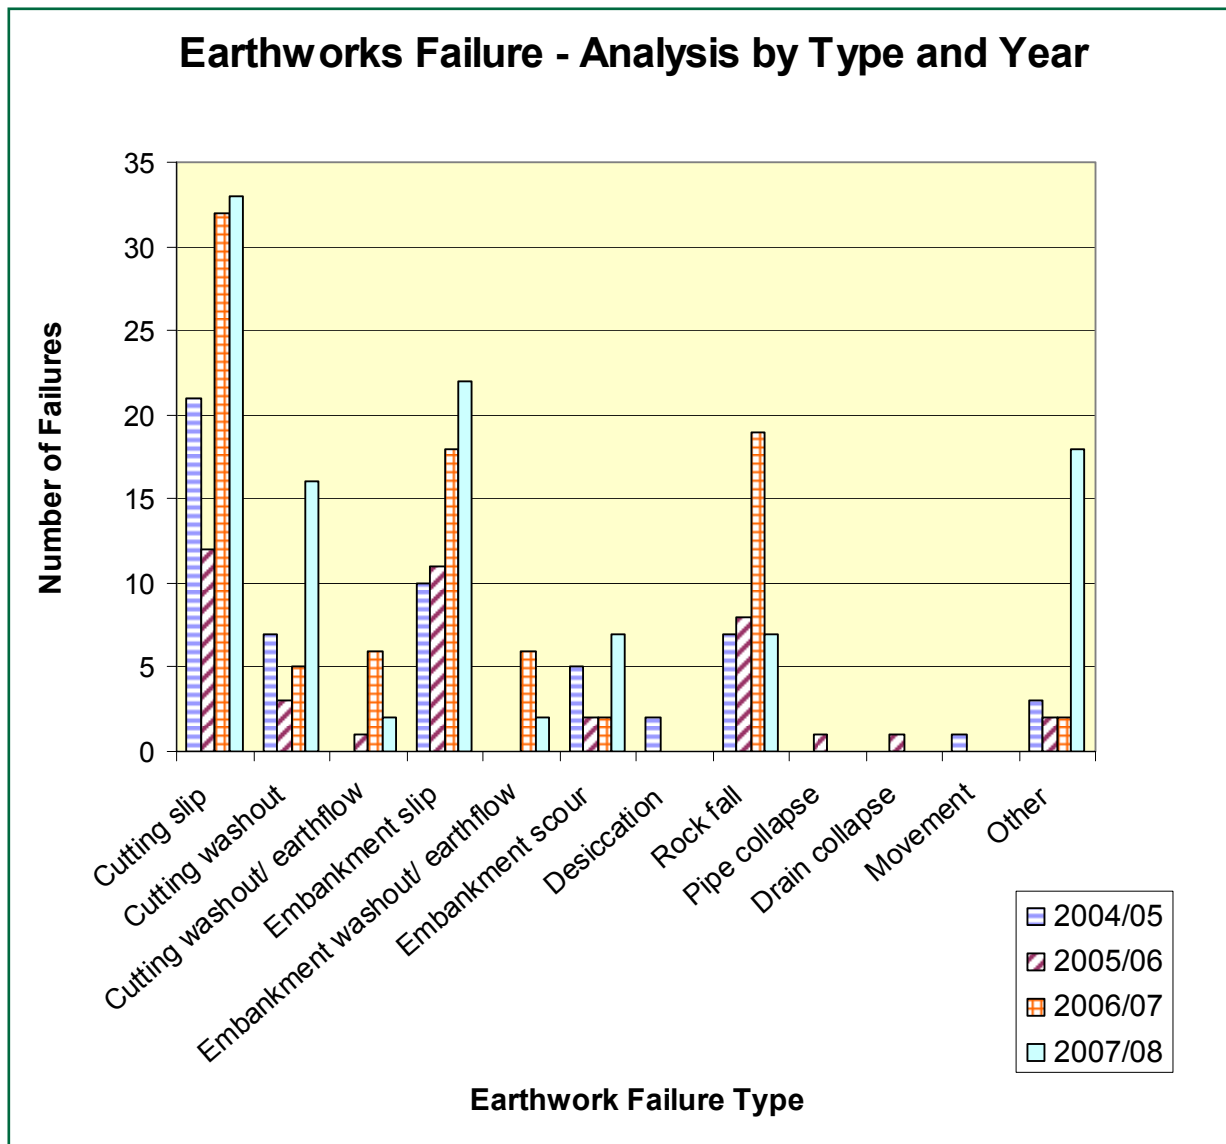
Figure 3: Network Rail recorded earthworks failures by type 2004 to 2008

- 60 Figure 3 indicates that the most prevalent earthworks failure mode in recent years was cutting slip followed by embankment slip.
- 61 Network Rail's Western Territory provided detailed earthworks data as part of the investigation into the failure at Kemble.
