Rail Accident Report

**Track worker struck by a train on Grosvenor
Bridge, London Victoria
13 November 2007**

Report 19/2009
July 2009

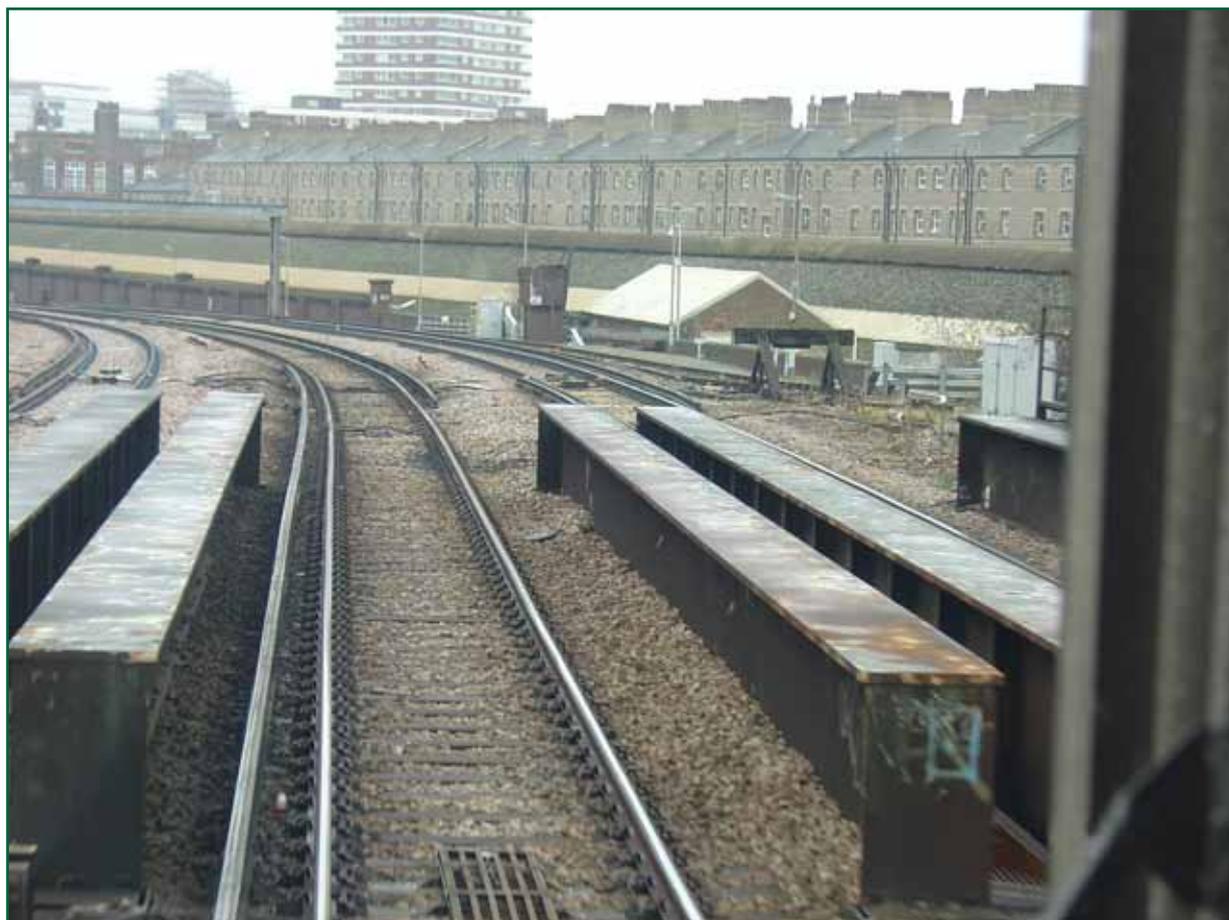
- 30 Between the Down Chatham Fast line and the eastern bridge parapet there is an area that formerly had a track laid on it, this now forms a cess wide enough to stand in, which is well clear of trains.
- 31 On the river bridge the four Chatham tracks are separated by *six-foot* areas which are *ballasted*.
- 32 On the Grosvenor Road Bridge there are raised parapets to a height of 1100 mm between the four tracks. There are two of these parapets between each track separated by a narrow gap of 450 mm. The parapets are 23.850 m in length (Figure 3).

Figure 3: View from class 375 unit of the Up Chatham Fast line immediately before Grosvenor Bridge, looking towards Victoria Station¹

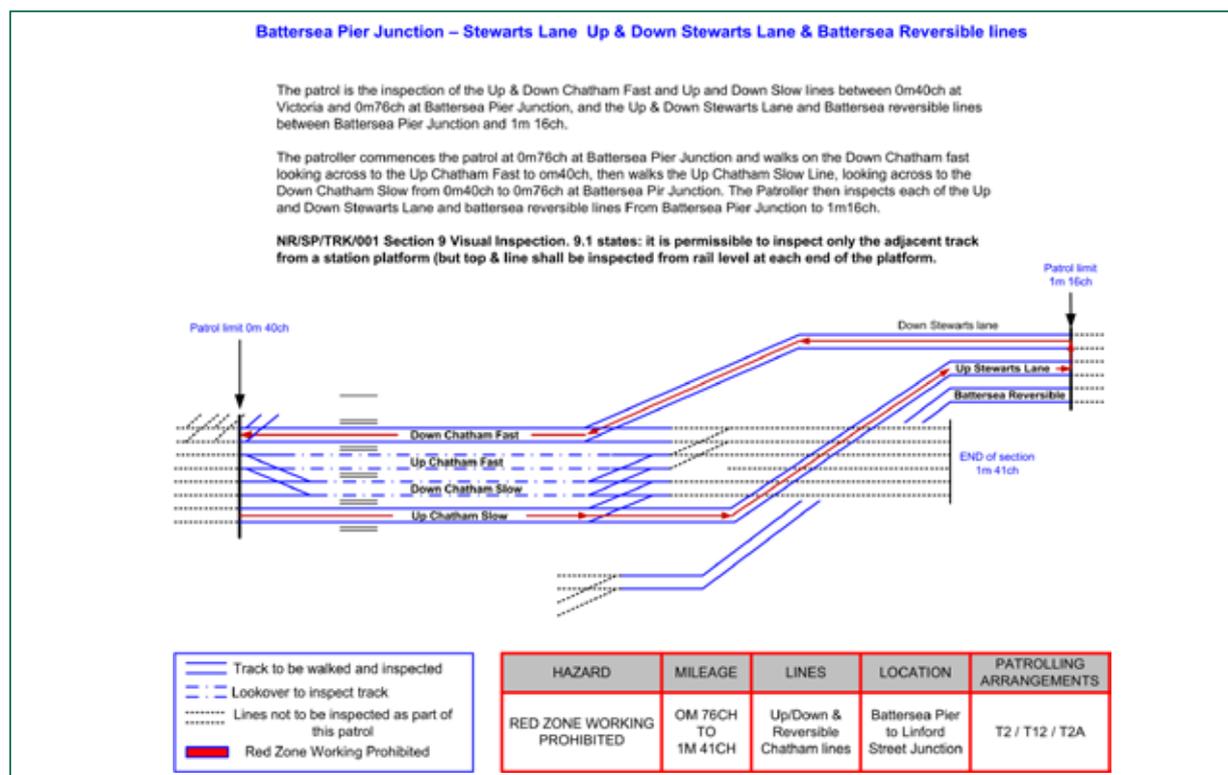
- 45 At around 13:00 hrs the two men began patrol 4A, which required them to walk out along the Up Chatham Slow line from Victoria (0 m 40 ch) to Battersea Pier Junction (0 m 72 ch), then along the Up Stewarts Lane line to 1 m 16 ch (Figure 4). There they would cross over and walk back to their starting point along the Down Stewarts Lane line and then onto the Down Chatham Fast line. See Figure 5 for a diagram of this patrol.

Figure 4: Route of Patrol 4A²

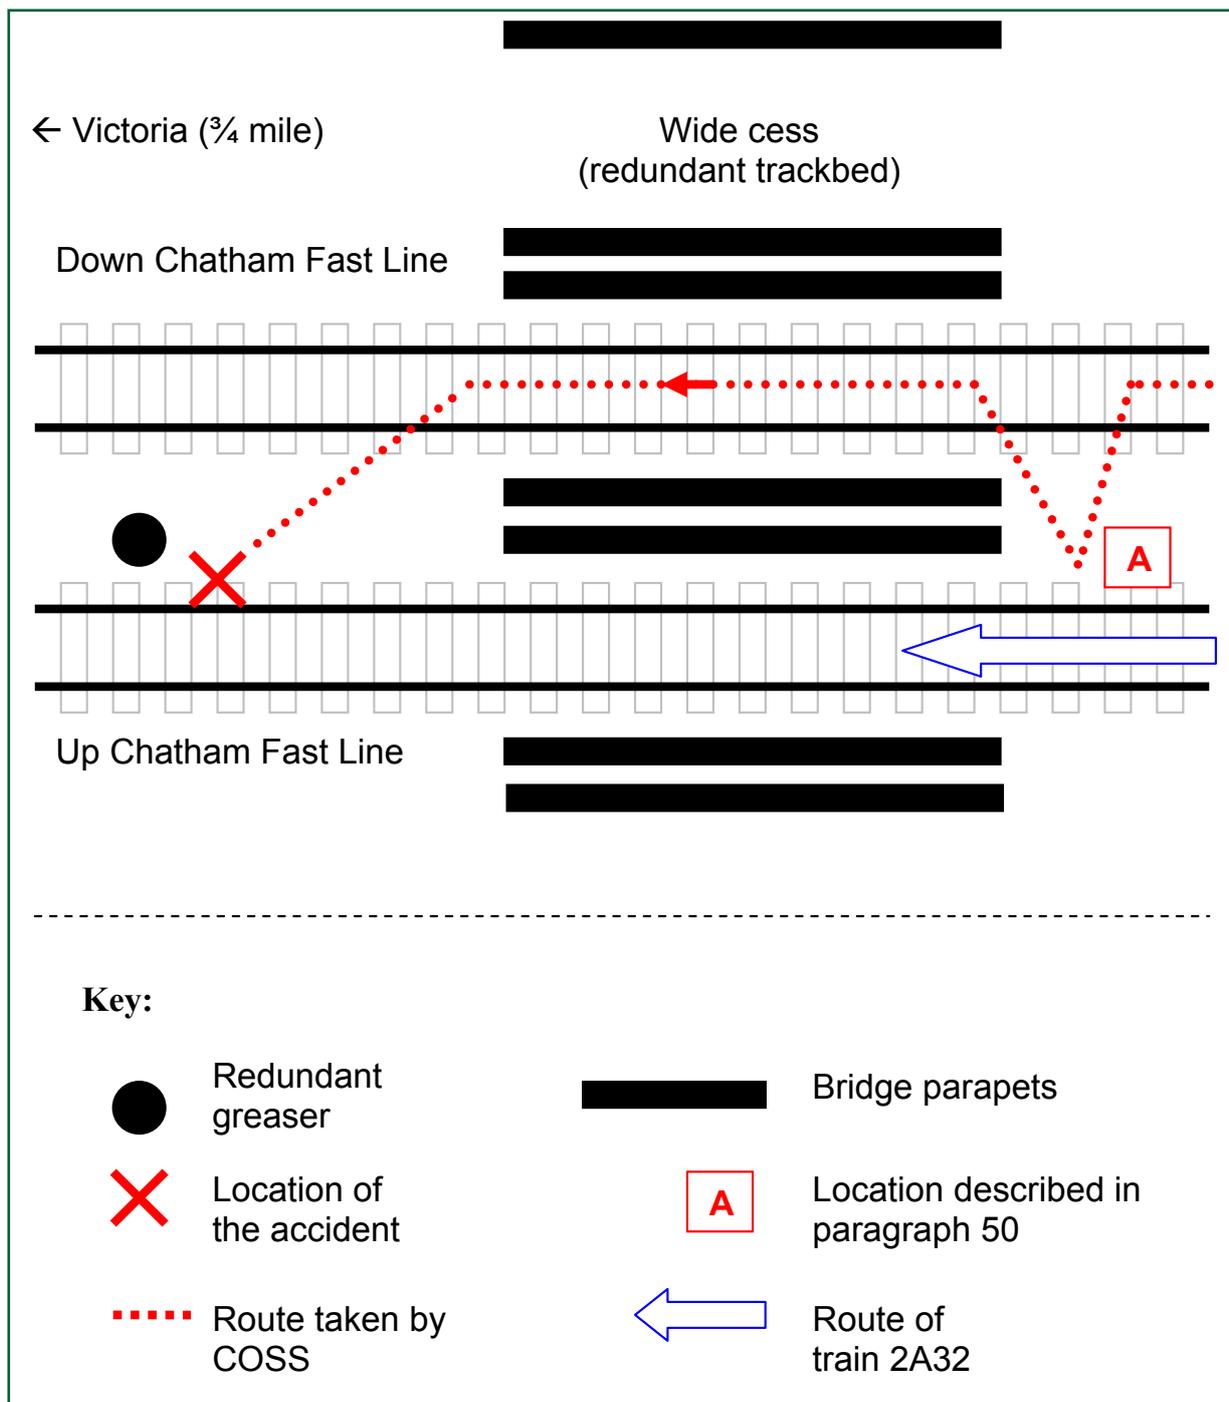
- 56 Six seconds later the COSS and his spanner were struck by train 2A32 which was travelling at just below 27 mph (43.2 km/h).
- 57 The train driver immediately stopped the train and made an emergency call to the signaller at Victoria Area Signalling Centre.

- 58 The lookout and trainee heard a "bang" and saw the train coming to a stand. Upon turning round, they saw their colleague lying in the six-foot between the Up Chatham Fast and Down Chatham Fast lines. He was lying on his back, parallel with the track, with his head towards the River Thames bridge and feet towards Victoria station. One of his boots was in contact with the *conductor rail* of the Up Chatham Fast line. The lookout and trainee pulled the COSS away from the conductor rail.

Figure 5: Route of COSS over Grosvenor Road Bridge

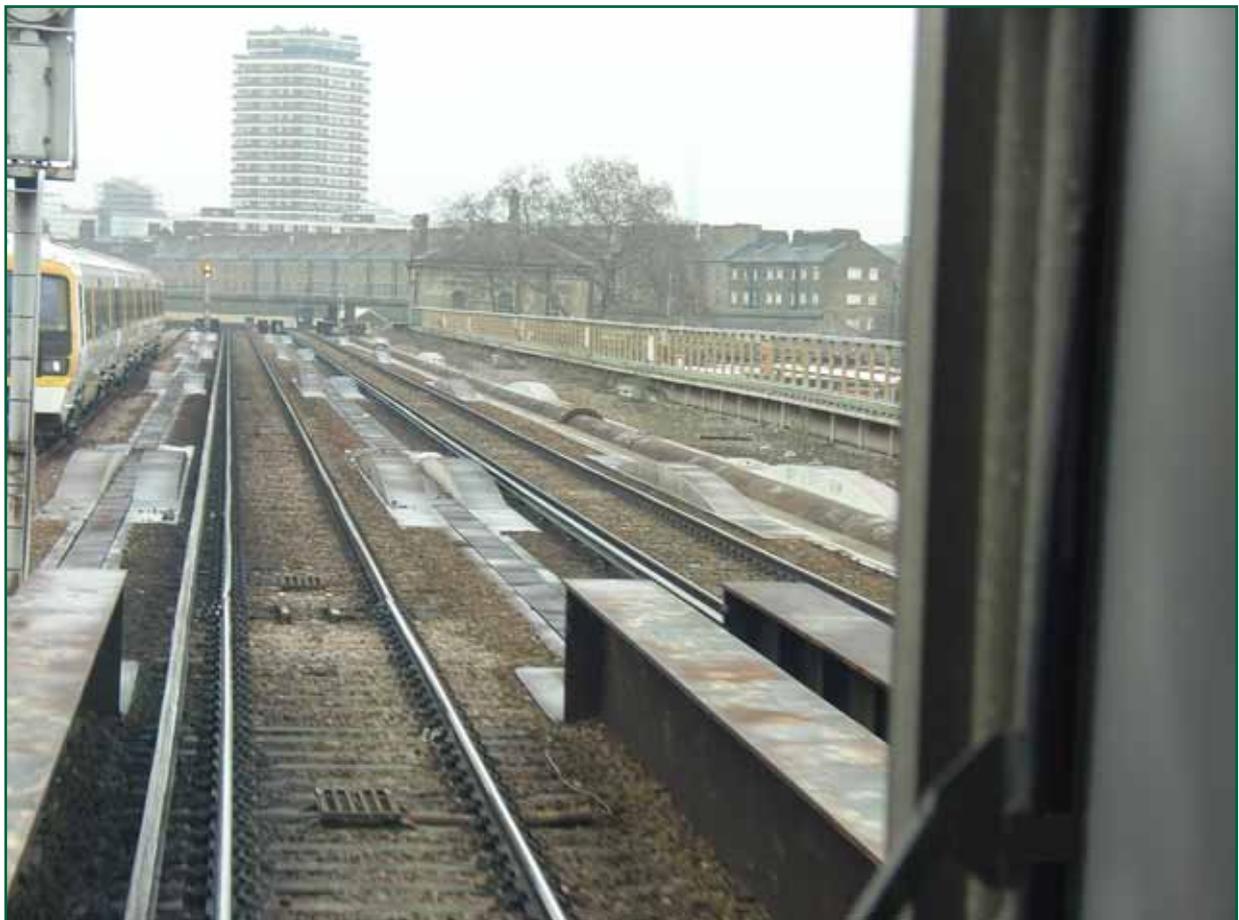
- 78 The class 375 type of electric multiple unit is capable of coupling to others of similar type. To allow through passage for passengers it has a corridor connection at the driving cab ends. The driving cab compartment is located to the left of the central gangway corridor connection which protrudes from the front of the cab. The driver has good vision of the line ahead; however the corridor connection only allows a restricted view of objects close to the right-hand side of the train. When driving on the main line this is not a limiting factor to a driver who is reliant on signals and observing that the line ahead is clear of obstructions. The corridor connection however does slightly restrict near visibility (Figure 6).

- 79 Between 12 m and 5 m from the accident site, the driver would have had restricted visibility of anyone close to the right-hand rail. From 5 m away the driver would have had no visibility at all of anyone in that location.

Figure 6: Drivers eye view from a class 375 train on the approach to Grosvenor Road Bridge which is beyond the signal displaying a double yellow aspect³

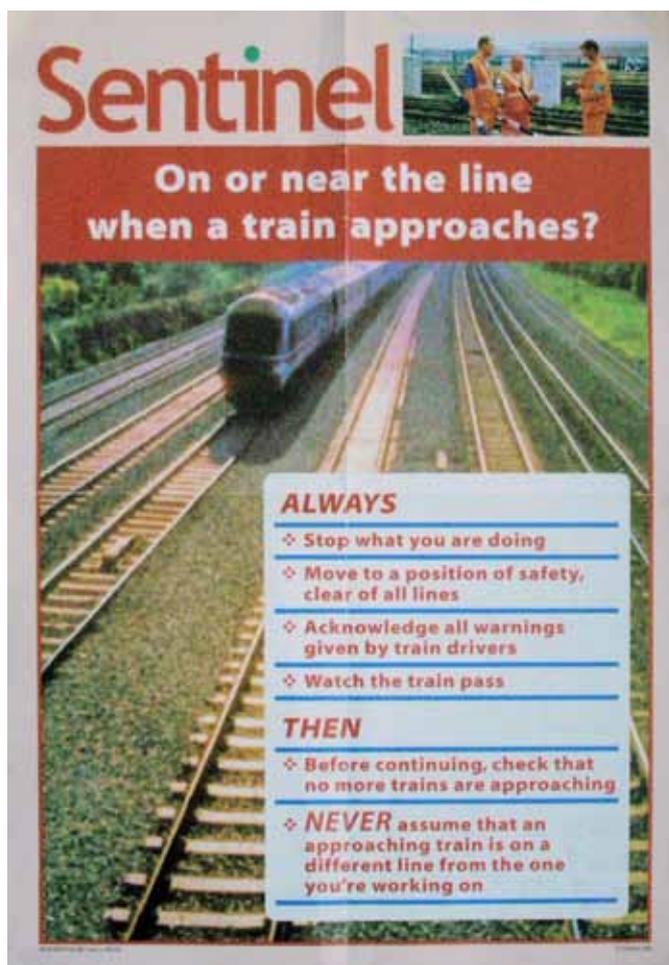
- 171 There is no clarity in the Rule Book, or in the COSS Handbook, as to the definition of an 'approaching train', and when a lookout might or might not sound a warning. Safety posters published by Sentinel in 2003 and distributed to Network Rail premises up until about 2007 are still displayed in some locations; they give the following instruction '*On or near the line when a train approaches? Move to a position of safety, clear of all lines*'; No definition of an 'approaching train' was given on the poster (see Figure 7).

Figure 7: Sentinel safety poster displayed in many Network Rail premises

213 There is a lack of clear guidance in the Rule Book, COSS Handbook and subsidiary publications about the definition of an 'approaching train' (paragraphs 171 to 177), and hence the criteria for setting up a Safe System of Work (**Recommendations 5 and 6**).
