Rail Accident Investigation Branch

Rail Accident Report

**Derailment near Exhibition Centre station,
Glasgow
3 September 2007**

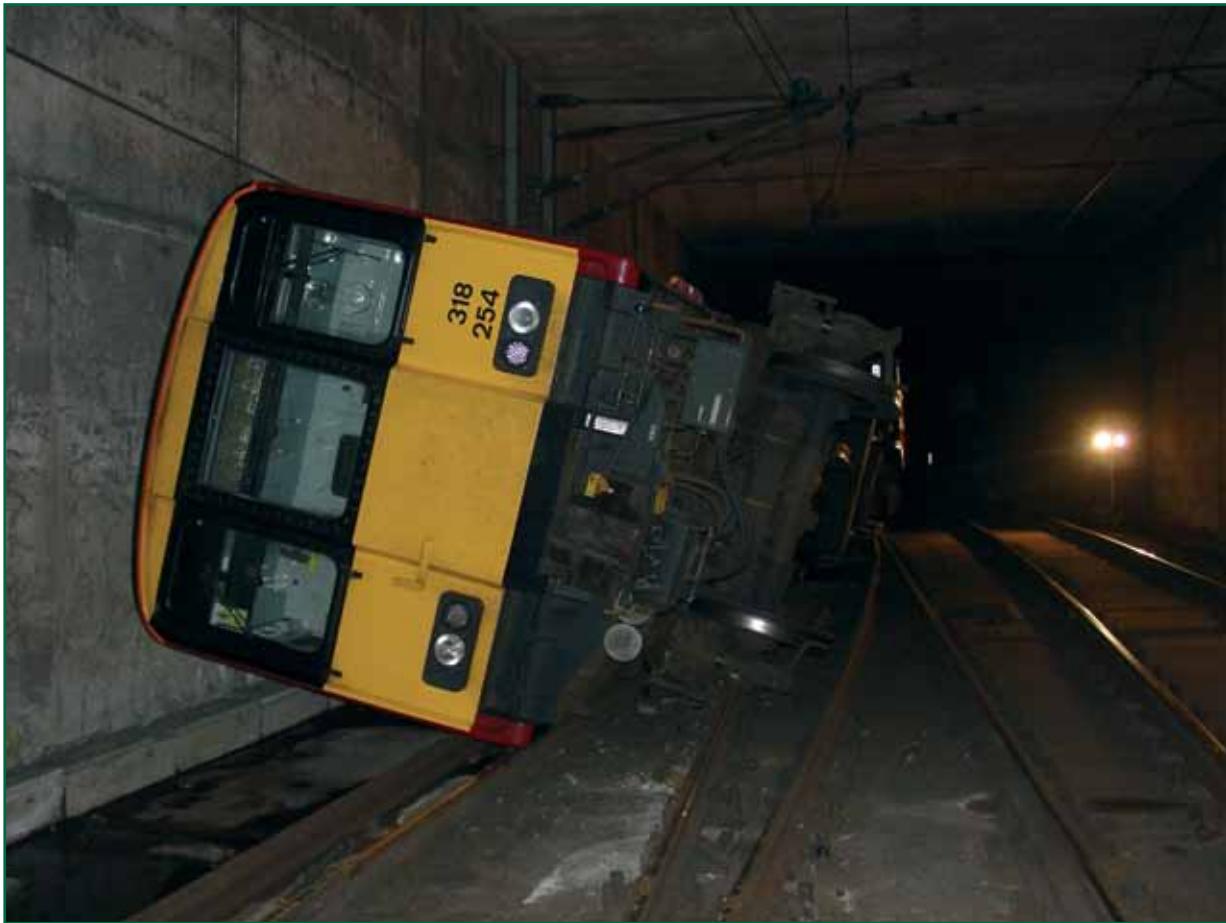
Figure 5: Photograph of the derailed carriage viewed from the Exhibition Centre end. This is shown as location **■ 5** on Figure 3

- 70 The third vehicle, 77244, sustained significant damage. The second vehicle, 62870, suffered damage, particularly in the *bar coupler* housing areas.

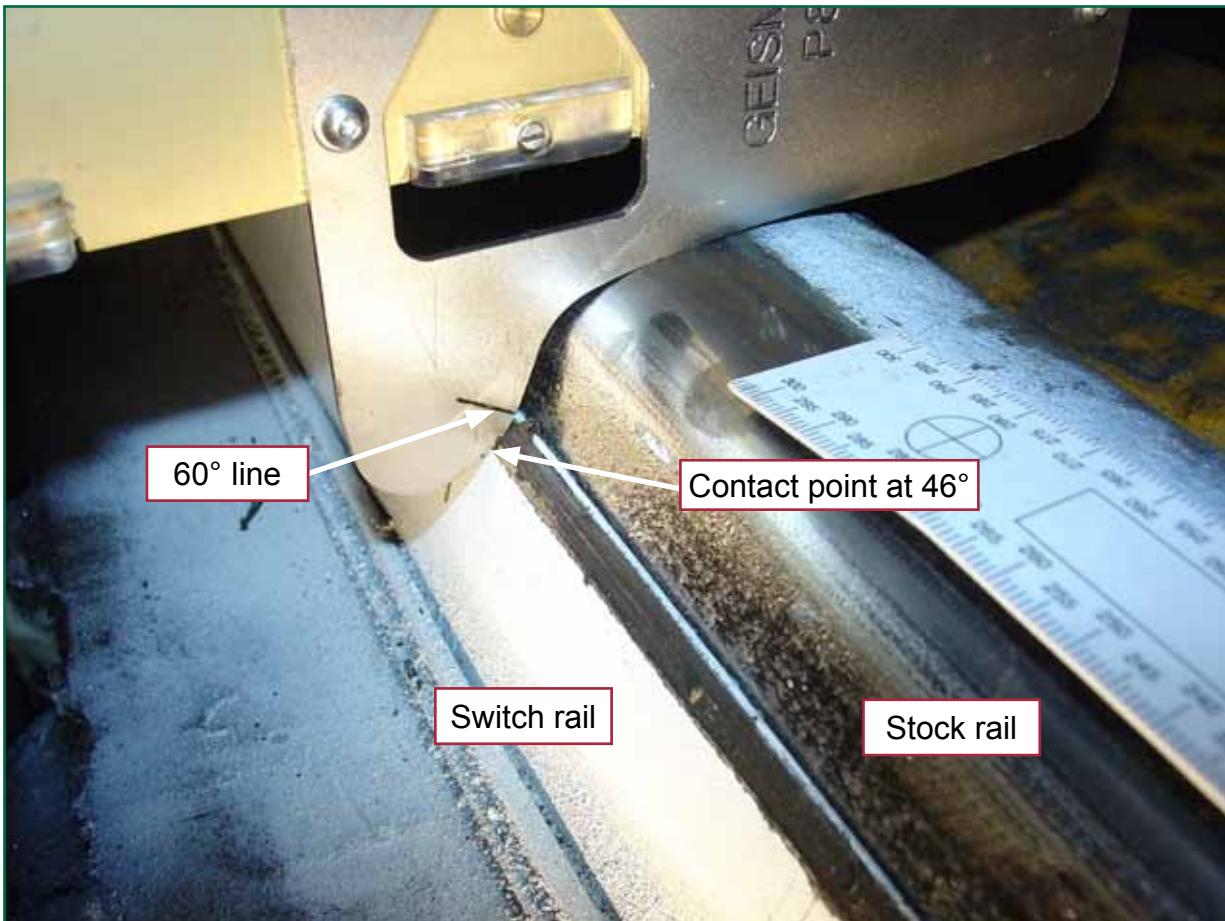
- 82 Following the derailment a track survey was undertaken in the vicinity of 201A points to check the gauge and whether track twist existed. The results of this indicated there was an area of tight gauge at the switch blades, 1429 mm at the worst point and with an average of 1430 mm. The minimum gauge permitted by *Railway Group Standard (RGS) GC/RT5021 'Track System Requirements'* at vertical points is 1430 mm with a maximum of 1438 mm. No track twist was present and apart from the defect identified in the next paragraph, there were no other factors present to initiate derailment.
- 83 There was a hazard 2 defect present on the right-hand switch rail from about 400 mm to about 710 mm from the toe. Presentation of the TGP8 gauge wheel profile clearly showed that the contact point was at 46°, significantly and noticeably below the 60° indicator line (Figure 11).

Figure 11: The TGP8 gauge used by the track inspection special examination team and 201A switch right-hand set, with the 60° indicator well above the switch rail contact point

- 95 The NR/SP/TRK/053 tests (paragraph 73 onwards) were not carried out correctly following the grinding repair. The two inspectors did not use the TGP8 gauge in the approved manner, and consequently did not see that the contact angle was less than 60°. Firstly, they did not use the gauge at sufficiently small distances along the switch rail to find the short area with the hazard 2 defect. When measured by the RAIB at the point of flange climb, the contact angle on the gauge was found to be 46° (Figure 11). Secondly, following their briefing, the inspectors pushed the gauge over the switch rail and towards the stock rail so that the profile above the 60° mark made contact with the stock rail. This lifted the tread profile of the dummy wheelset off the rail top by 8 mm, however the inspectors did not notice the potential for the flange, below the 60° mark, to run on to the top of the switch rail.

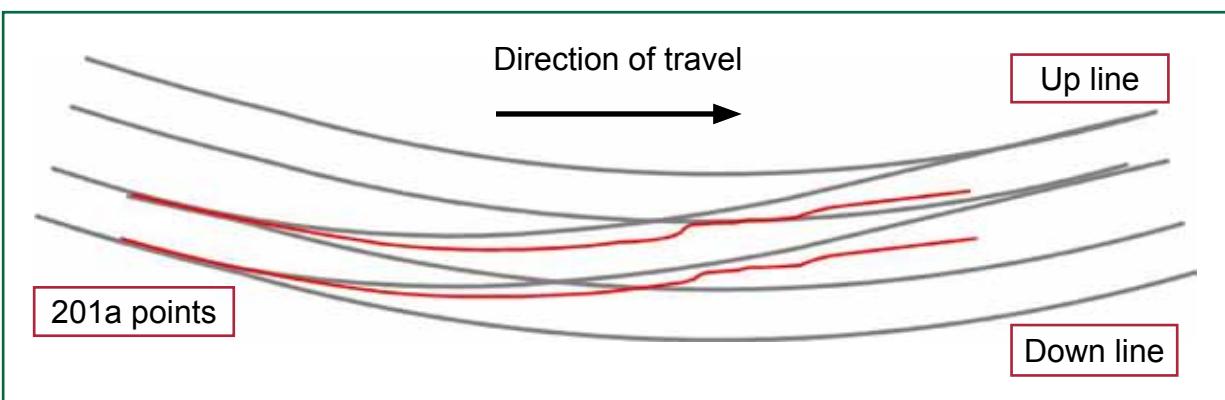
- 84 On the right-hand switch rail there was a fresh flange climb mark present from a point 410 mm from the toe, and this continued as a flange running mark across the rail head before dropping off the outside of the switch rail at the point where it diverged from the stock rail. A corresponding drop mark was noted on the left-hand stock rail where the left-hand wheel tread had been pulled off the rail.
- 85 The route of the derailed wheelset was visible by score marks in the concrete slab and broken fastenings until the left-hand wheel was 1000 mm short of the crossing. At this point there was evidence that the wheels on the second axle had derailed to the right, and had steered the third vehicle, 77244, towards the six-foot side of the track (Figure 12).

Figure 12: Illustration of the trajectory taken by the derailed wheelsets

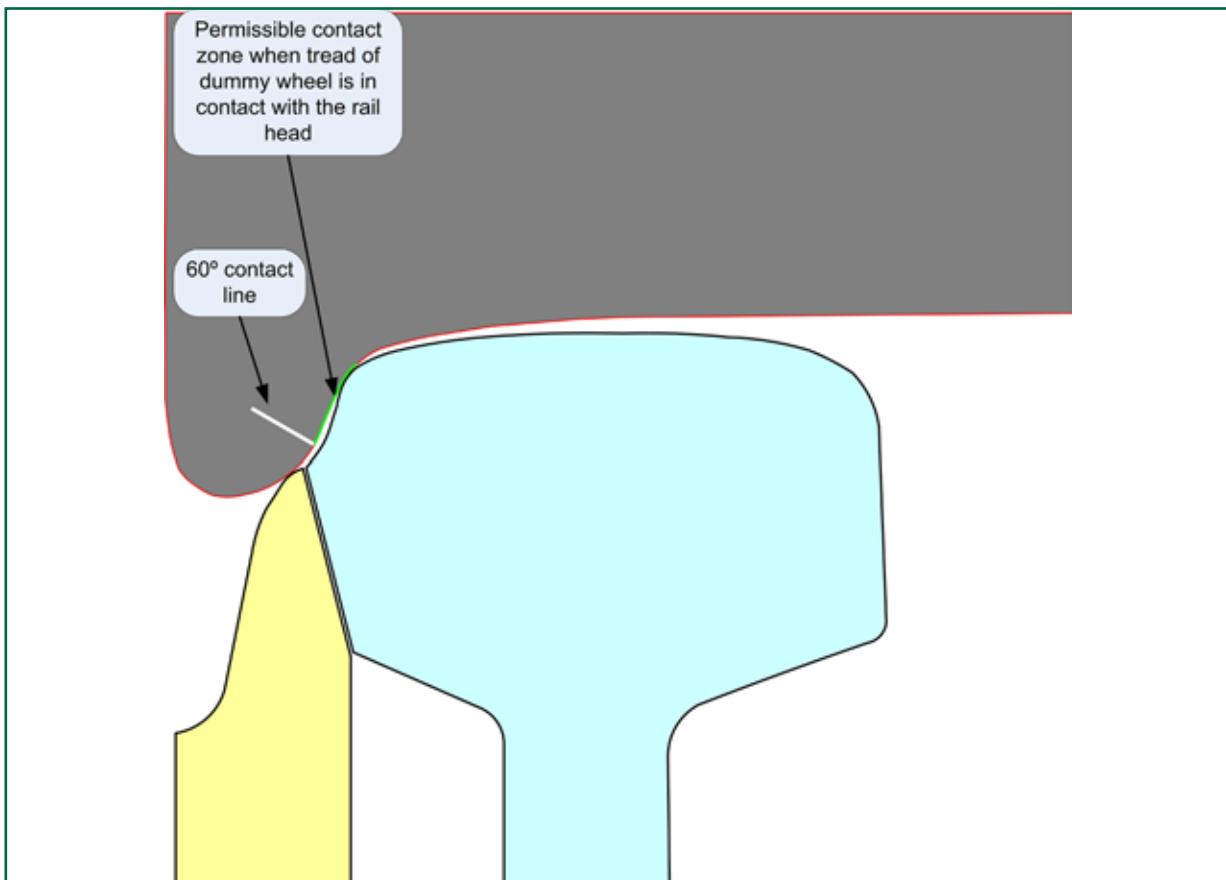
Figure 14: Diagram showing how the TGP8 gauge was used on 31 August 2007 (not to scale)

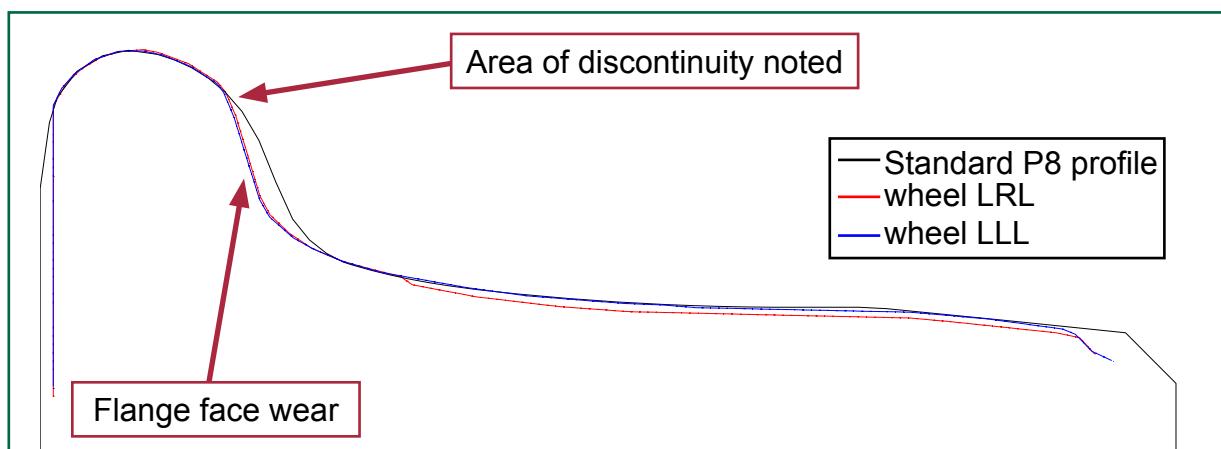
- 102 The RAIB measured the wheel profiles on coach 77244, the vehicle that derailed. These were compared to the standard P8 profile as described in GM/RT 2466 (Figure 15).

Figure 15: Overlay of wheel profiles recorded on 77244 leading axle

- 103 There was some damage sustained by all the wheels as a result of the derailment.
- 104 Certain wheel profiles on coach 77244 showed flange face wear and a discontinuity where the thinning of the flange met the normal profile of the flange tip. Figure 16 shows the nomenclature used for wheelset identification. The discontinuities were found on the wheels in positions LRL, LLL, LRT, LLT and TRT wheels.

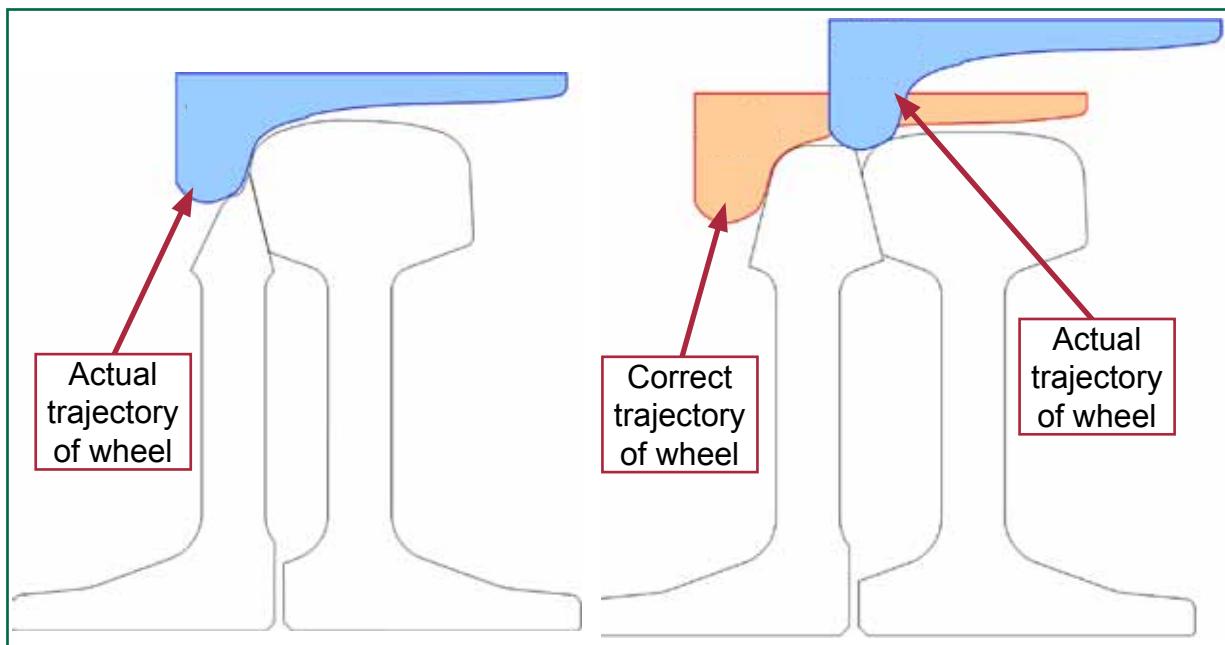
- 141 Detailed analysis of the LRL wheel of coach 77244 at the right-hand switchblade of 201A points indicates that the discontinuity described in paragraph 104 would not have initiated wheel flange climb. The discontinuity may have been caused by roll-over of material from the flange thinning however the RAIB found no firm evidence to confirm or discount this hypothesis. Once the wheel climb had started, the profile may have actively assisted further flange climb leading to the subsequent derailment. This was a possible contributory factor to the derailment.

Figure 17: 77244 LRL wheel profile overlaid on 201A switch profile

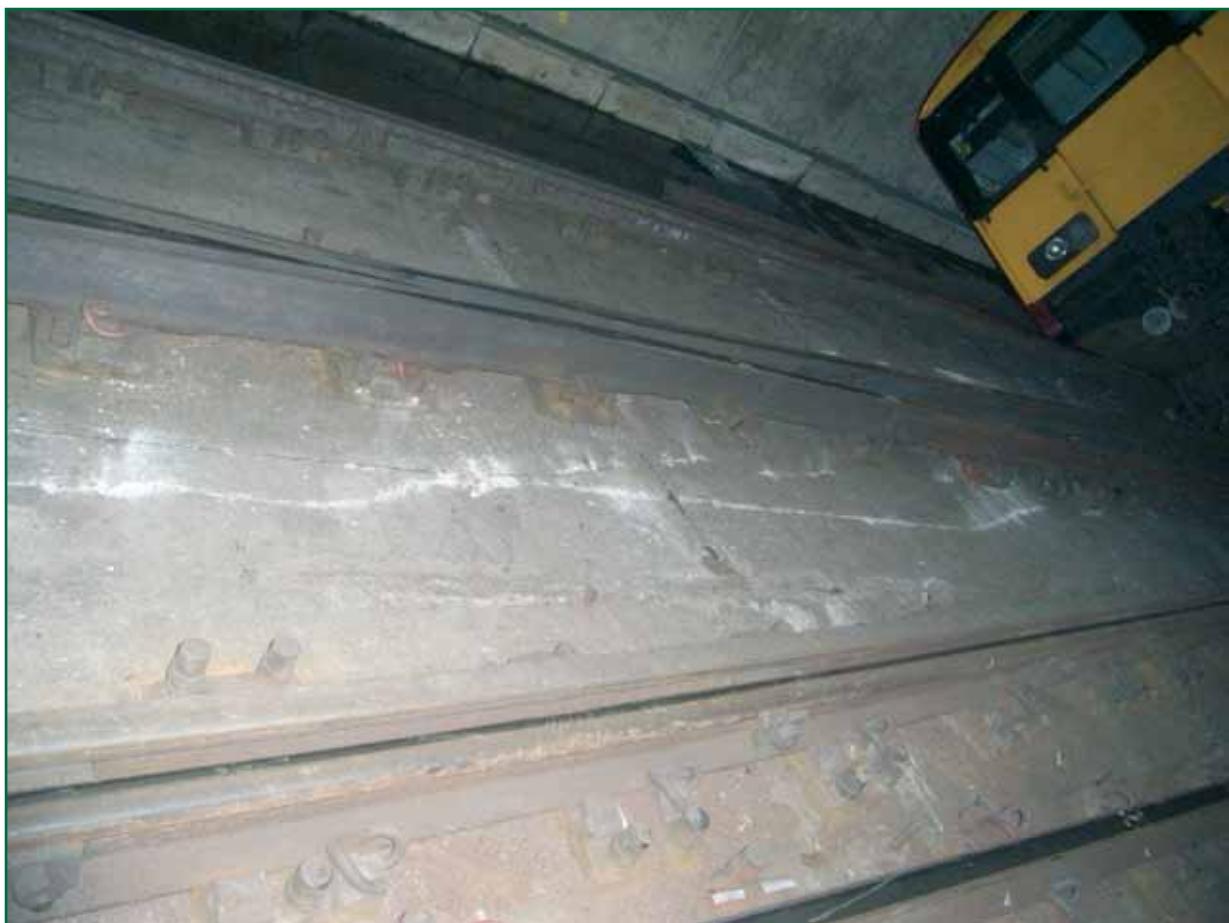
147 The extent to which vehicle 77244 rotated and toppled over was unusual in such a slow speed and short distance derailment. That may be due to the fact that the derailment occurred on slab track (paragraph 143).

Figure 18: Slab track with fixtures connected directly to the base concrete. Also scores made by the flanges of the derailed wheels.
