Rail Accident Investigation Branch

# Rail Accident Report

**Derailment near Exhibition Centre station,  
Glasgow  
3 September 2007**

Report 04/2009  
February 2009

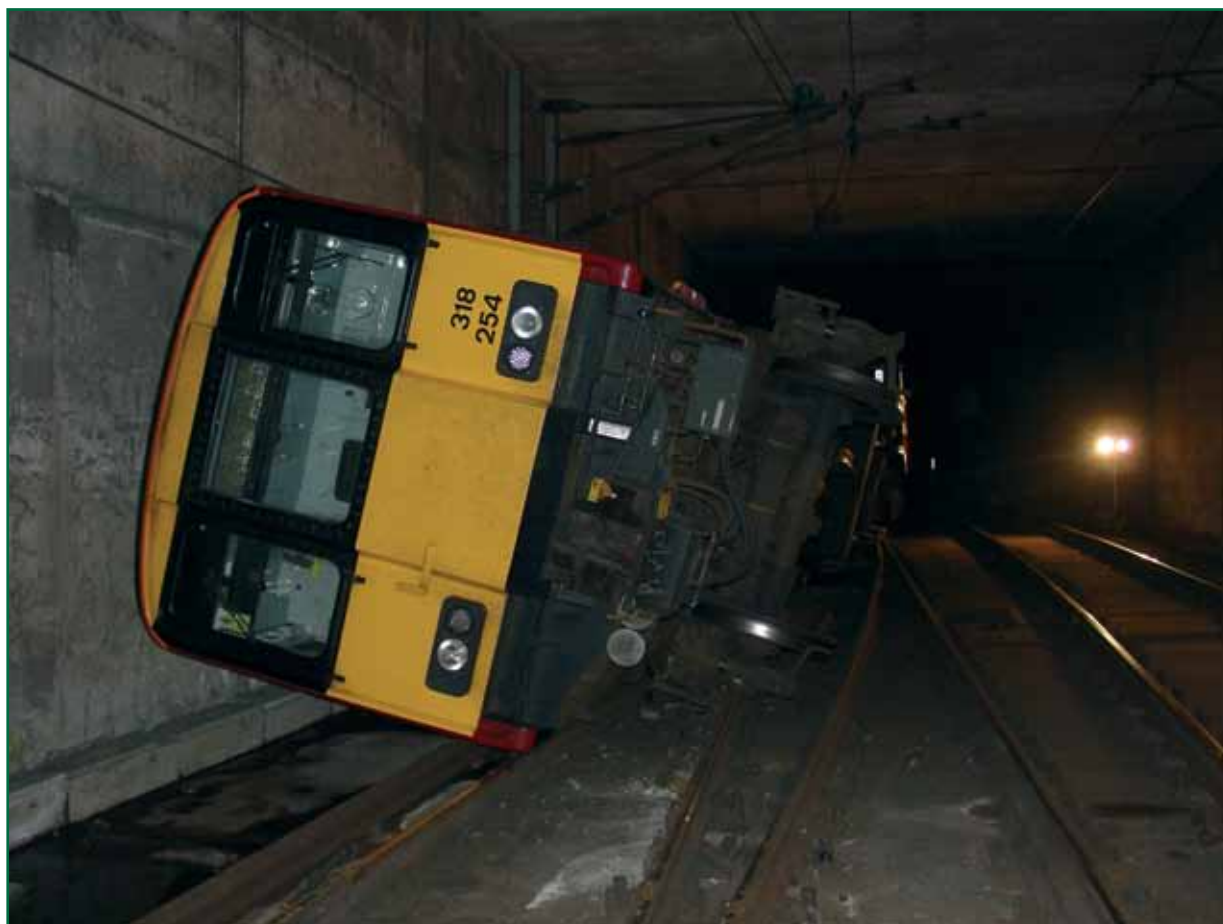
Figure 5: Photograph of the derailed carriage viewed from the Exhibition Centre end. This is shown as location 5 on Figure 3

- 70 The third vehicle, 77244, sustained significant damage. The second vehicle, 62870, suffered damage, particularly in the *bar coupler* housing areas.

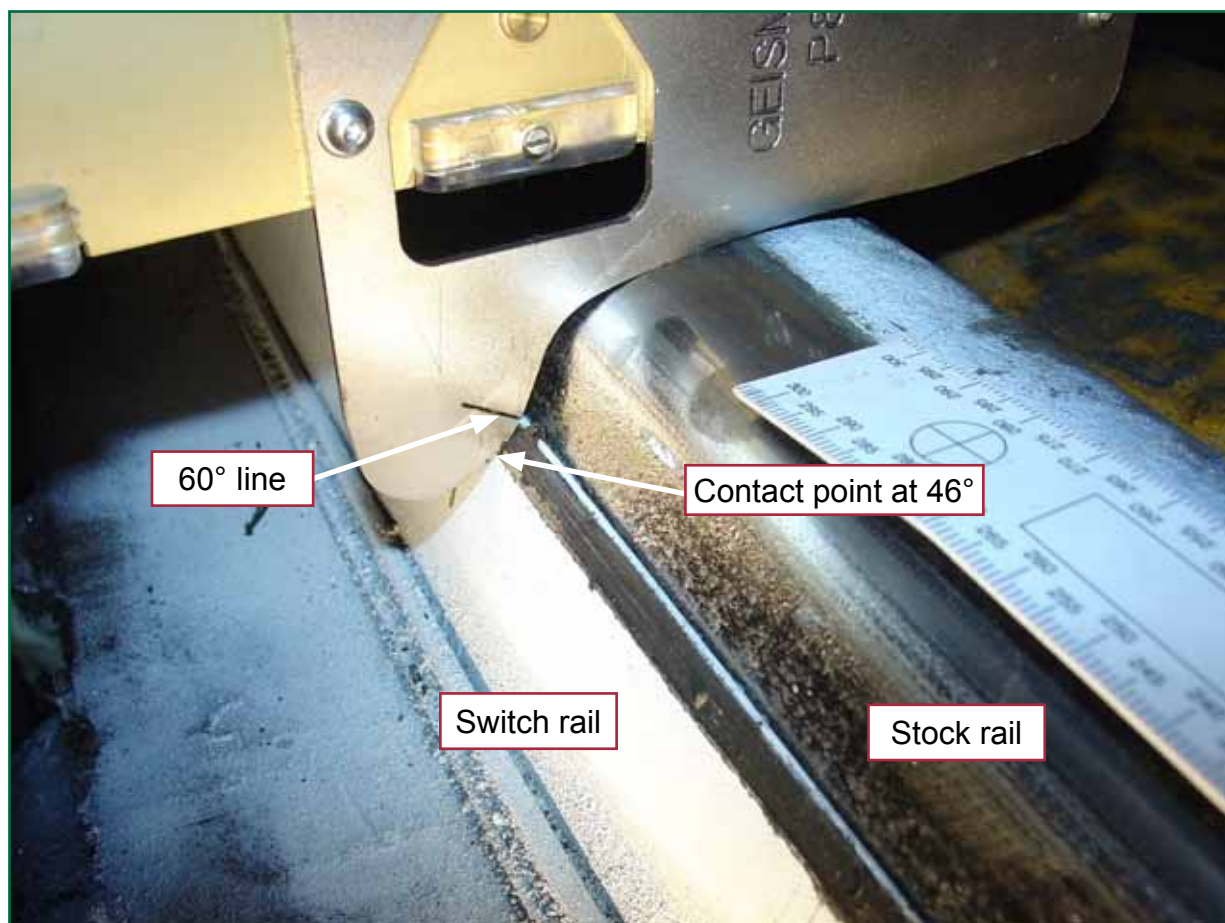
Figure 11: The TGP8 gauge used by the track inspection special examination team and 201A switch right-hand half set, with the 60° indicator well above the switch rail contact point

- 95 The NR/SP/TRK/053 tests (paragraph 73 onwards) were not carried out correctly following the grinding repair. The two inspectors did not use the TGP8 gauge in the approved manner, and consequently did not see that the contact angle was less than 60°. Firstly, they did not use the gauge at sufficiently small distances along the switch rail to find the short area with the hazard 2 defect. When measured by the RAIB at the point of flange climb, the contact angle on the gauge was found to be 46° (Figure 11). Secondly, following their briefing, the inspectors pushed the gauge over the switch rail and towards the stock rail so that the profile above the 60° mark made contact with the stock rail. This lifted the tread profile of the dummy wheelset off the rail top by 8 mm, however the inspectors did not notice the potential for the flange, below the 60° mark, to run on to the top of the switch rail.

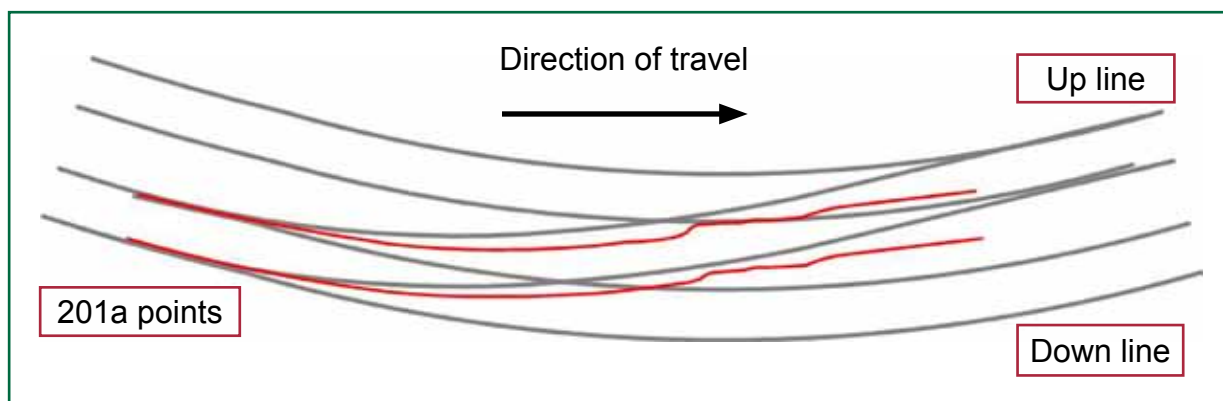
- 84 On the right-hand switch rail there was a fresh flange climb mark present from a point 410 mm from the toe, and this continued as a flange running mark across the rail head before dropping off the outside of the switch rail at the point where it diverged from the stock rail. A corresponding drop mark was noted on the left-hand stock rail where the left-hand wheel tread had been pulled off the rail.
- 85 The route of the derailed wheelset was visible by score marks in the concrete slab and broken fastenings until the left-hand wheel was 1000 mm short of the crossing. At this point there was evidence that the wheels on the second axle had derailed to the right, and had steered the third vehicle, 77244, towards the six-foot side of the track (Figure 12).

Figure 12: Illustration of the trajectory taken by the derailed wheelsets

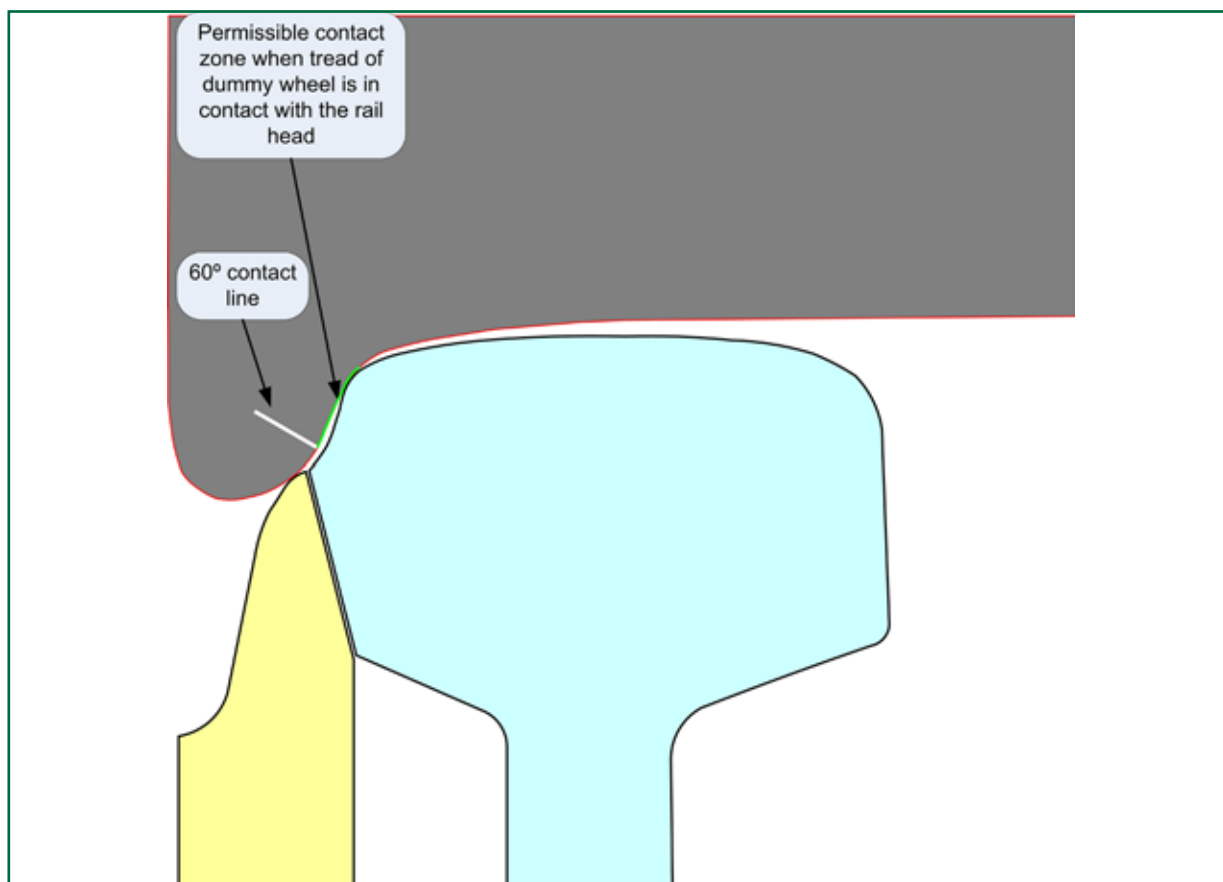
- 91 Although the training was delivered the inspectors later misinterpreted how the TGP8 gauge should be used (paragraph 95).
- 92 The national introduction date for the TGP8 gauges was in the spring of 2006; its use was made mandatory by Letter of Instruction NR/BS/LI/063 from 20 December 2006. It reached the Area Track Engineer – Scotland West on 21 December 2006 and was briefed out on 26 January 2007.

Figure 14: Diagram showing how the TGP8 gauge was used on 31 August 2007 (not to scale)

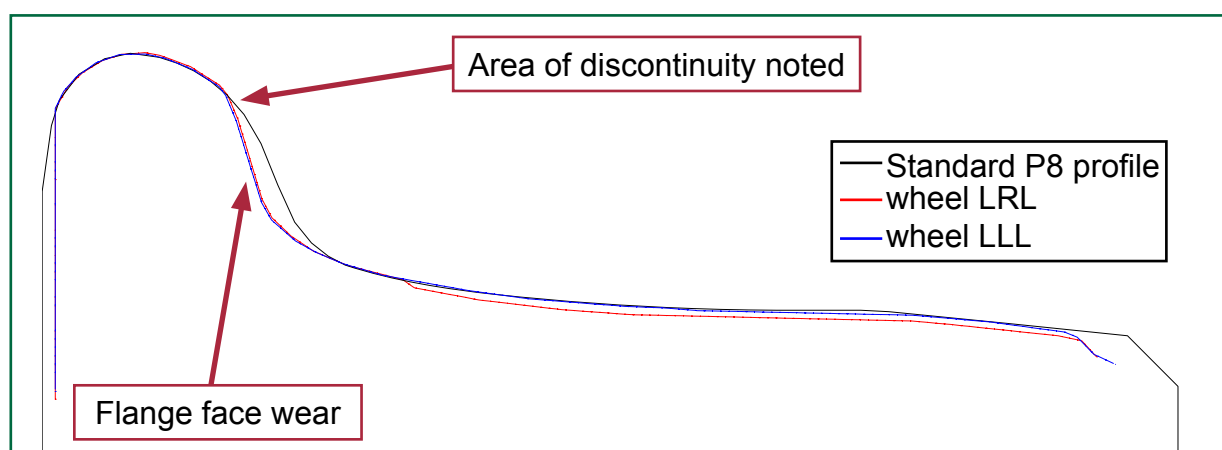
Figure 15: Overlay of wheel profiles recorded on 77244 leading axle

- 103 There was some damage sustained by all the wheels as a result of the derailment.
- 104 Certain wheel profiles on coach 77244 showed flange face wear and a discontinuity where the thinning of the flange met the normal profile of the flange tip. Figure 16 shows the nomenclature used for wheelset identification. The discontinuities were found on the wheels in positions LRL, LLL, LRT, LLT and TRT wheels.

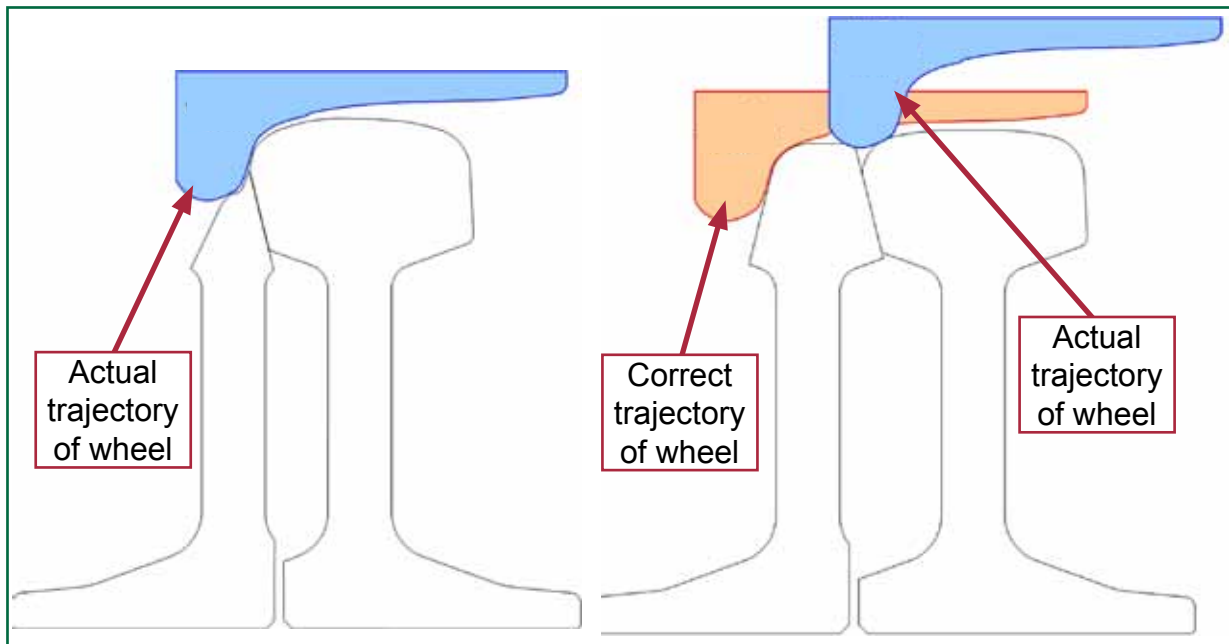
- 141 Detailed analysis of the LRL wheel of coach 77244 at the right-hand switchblade of 201A points indicates that the discontinuity described in paragraph 104 would not have initiated wheel flange climb. The discontinuity may have been caused by roll-over of material from the flange thinning however the RAIB found no firm evidence to confirm or discount this hypothesis. Once the wheel climb had started, the profile may have actively assisted further flange climb leading to the subsequent derailment. This was a possible contributory factor to the derailment.

Figure 17: 77244 LRL wheel profile overlaid on 201A switch profile

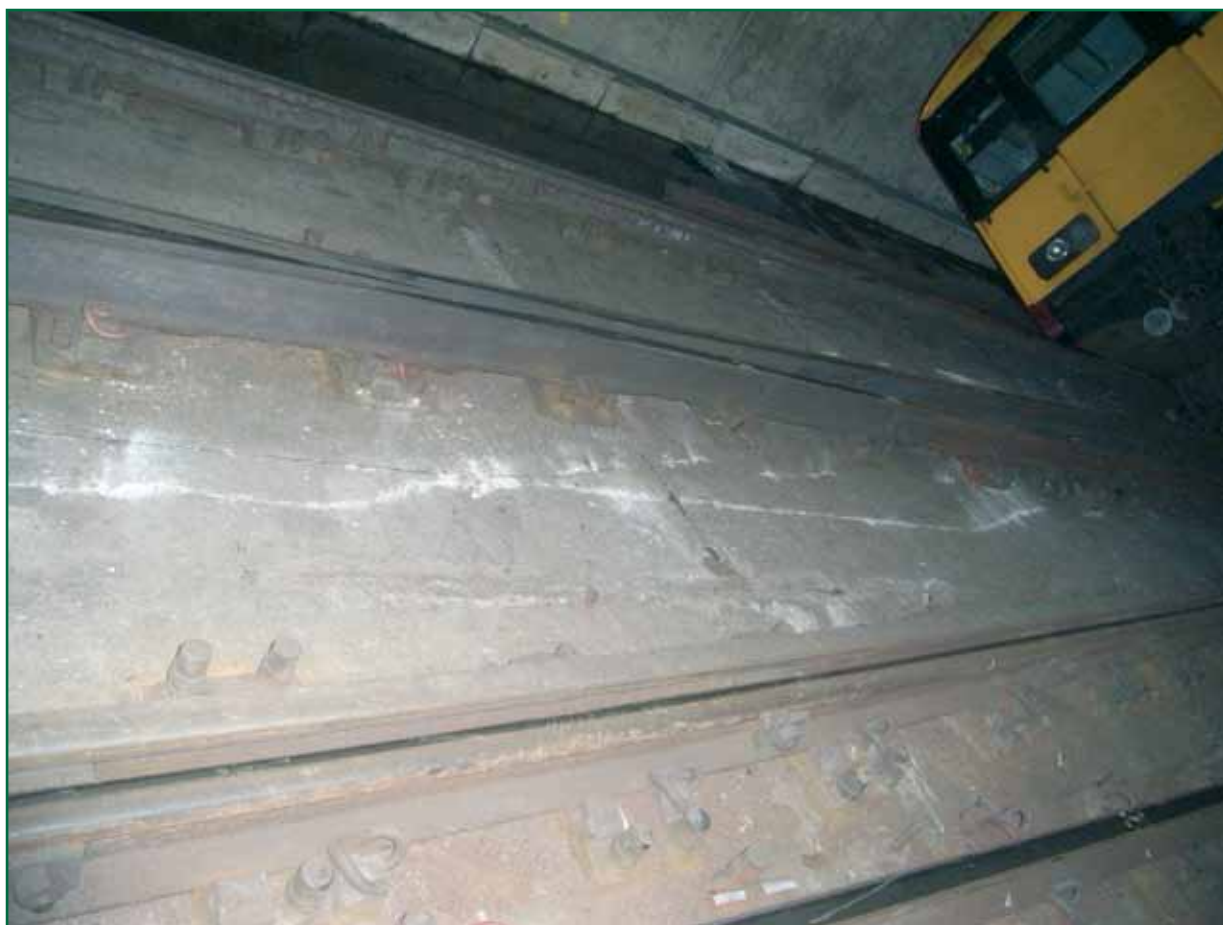
147 The extent to which vehicle 77244 rotated and toppled over was unusual in such a slow speed and short distance derailment. That may be due to the fact that the derailment occurred on slab track (paragraph 143).

*Figure 18: Slab track with fixtures connected directly to the base concrete. Also scores made by the flanges of the derailed wheels.*
