Rail Accident Investigation Branch

Rail Accident Report

Train overspeeding through an emergency speed restriction at Ty Mawr Farm Crossing on 29 August 2007

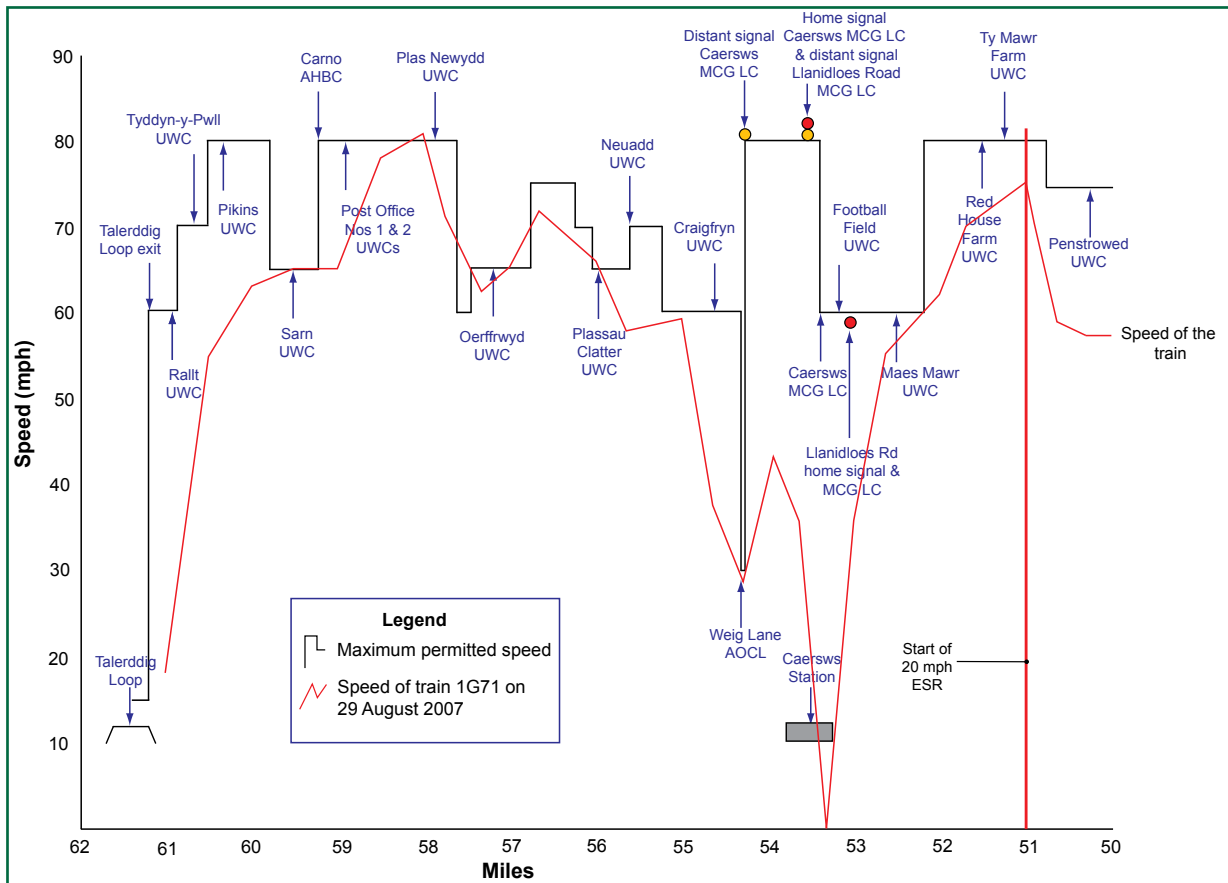
Figure 2: Variations in maximum permitted speed, location of level crossings and signals between Talerddig and Ty Mawr and speed of train 1G71 on 29 August 2007

67 The working timetable allows eight minutes for a train to run from Talerddig to Caersws (start to stop). Train 1G71 exceeded the sectional running time by approximately two minutes. Figure 2 shows the location of the speed restrictions over this section of route, the locations of level crossings and signals and the speed achieved by train 1G71 through this section on 29 August 2007.

- 90 The section of route between Talerddig and Caersws was modelled using the route driveability tool. One feature that is highlighted by the tool is the number of speed changes. Although this did not necessarily create conflicts for the driver (i.e. there were few examples of overload through simultaneous driver inputs and actions), the Network Rail human factors specialist observed that it did add a level of complexity to the driving task that increases the potential for the driver to forget other items of information.

- 3 Network Rail should review the range of speed restrictions and the timings for trains between Talerddig and Caersws to determine whether rationalisation of the number of such restrictions and/or relaxation of timings could enhance the driveability of the route and reduce the potential for distraction and misunderstanding by train drivers under degraded operating conditions (paragraph 122b).
