Rail Accident Investigation Branch

Rail Accident Report

**Collision between a train and a road vehicle on
the Leighton Buzzard narrow gauge railway
25 August 2007**

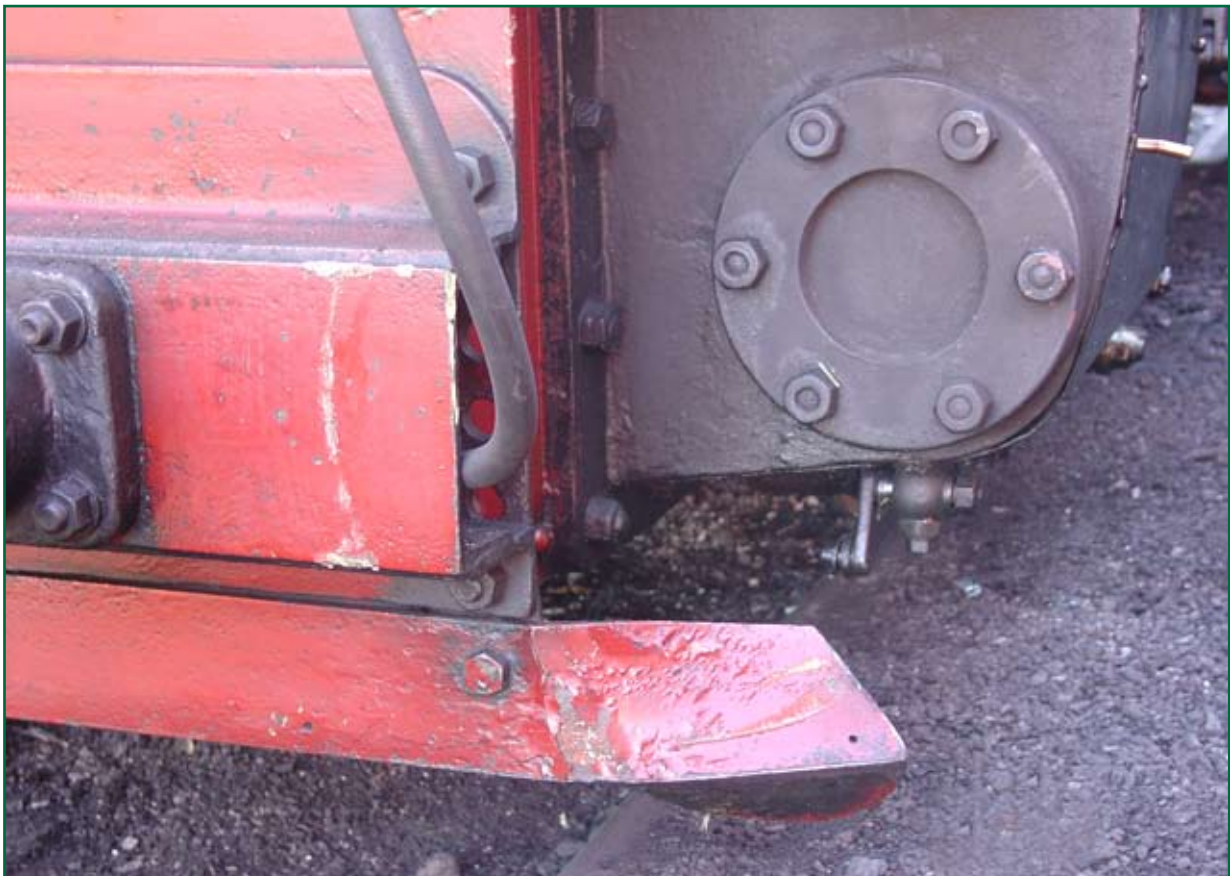
20 The locomotive's front end was slightly damaged (Figure 4). The tractor's front wheels and steering were more substantially damaged.

Figure 4: Damage to locomotive
