# Rail Accident Report

**Collision between a train and a road vehicle on  
the Leighton Buzzard narrow gauge railway  
25 August 2007**

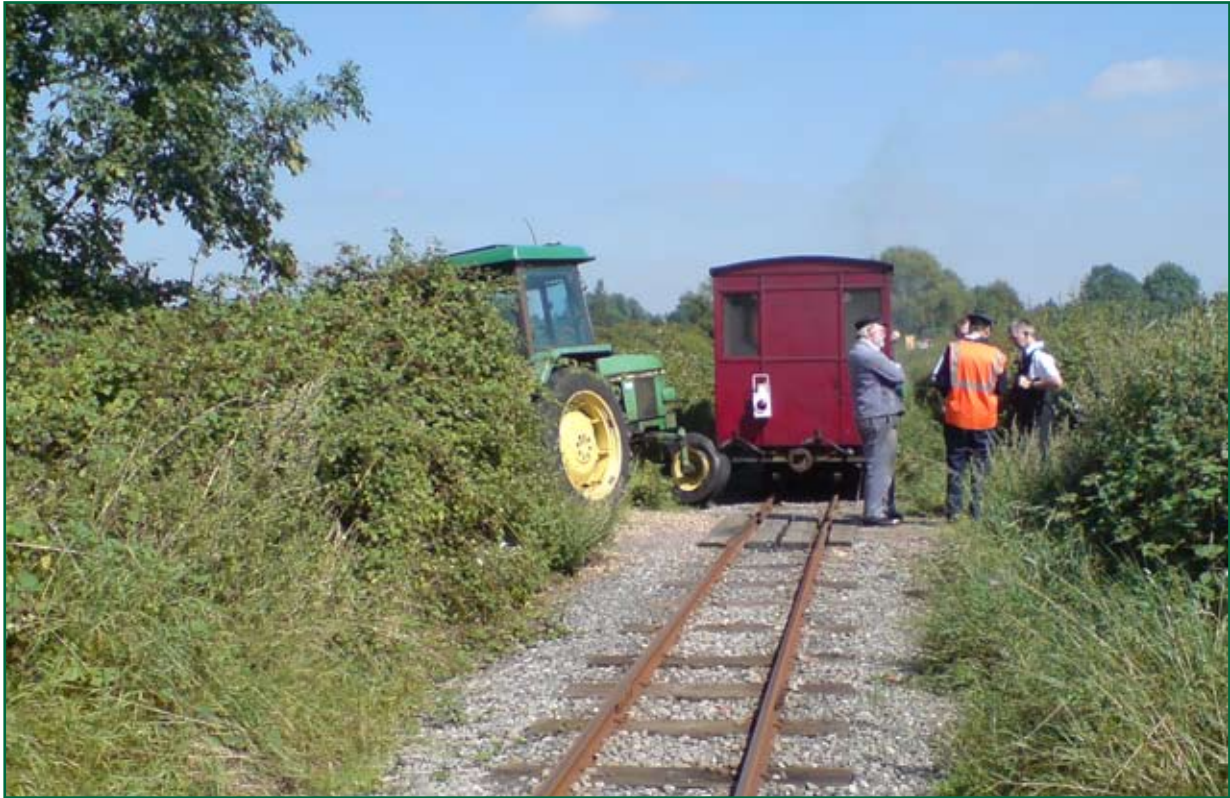
- 15 At approximately 12:20 hrs, steam locomotive, number 11, hauling three carriages, departed Pages Park station, en route to Stonehenge Works station. There were thirty seven passengers and four staff on board.
- 16 The train driver was accompanied by a *fireman* on the locomotive.
- 17 The locomotive was running chimney first. The driver was positioned on the right-hand side in the direction of travel (the south-eastern side of the locomotive).
- 18 Approximately 5 m short of the crossing the driver saw a tractor appear onto the crossing from his left hand side. He immediately applied the brakes, but was unable to prevent a collision. The tractor was pushed to one side by the locomotive, which stopped with its last carriage on the crossing and still in contact with the tractor (Figure 3).

Figure 3: Position of train and tractor after collision (courtesy Leighton Buzzard Railway)
