Rail Accident Investigation Branch

# Rail Accident Report

**Collision between a train and tractor on  
crossing XL202 near Limavady Junction,  
Northern Ireland  
2 August 2007**

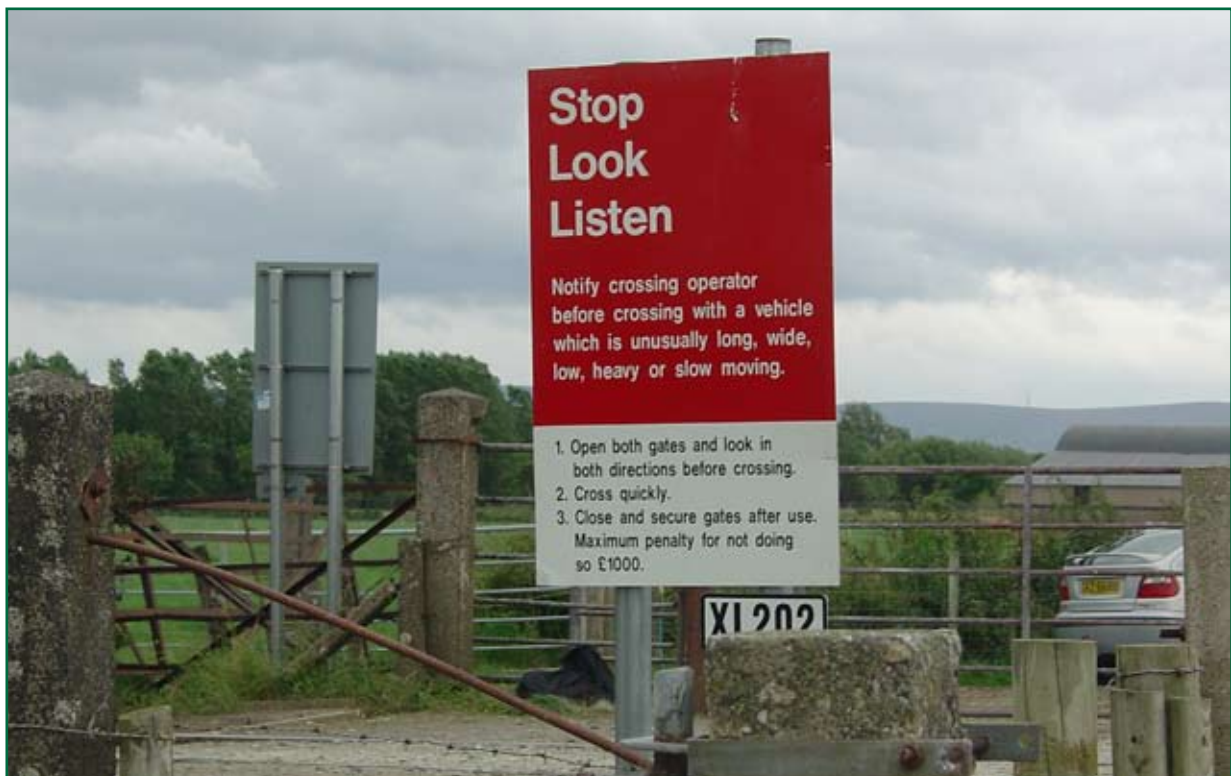
Figure 2: Signage at crossing XL202 (3 August 2007)

- 25 The users of the crossing are responsible for ensuring that it is safe to cross before they do so. Gates are provided to segregate the railway from the farm track (paragraph 24) and these must be maintained closed across the roadway. Failure to close gates after use is an offence under the Railway Safety Act (Northern Ireland) 2002.

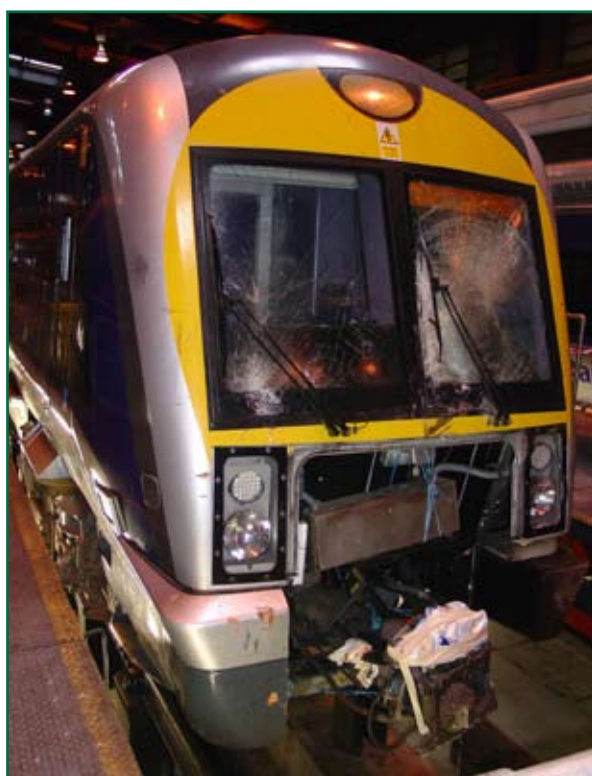
*Figure 3: Damage to the front of unit 3014 (3 August 2007)*

41 Following repair, the train returned to traffic on 7 September 2007.

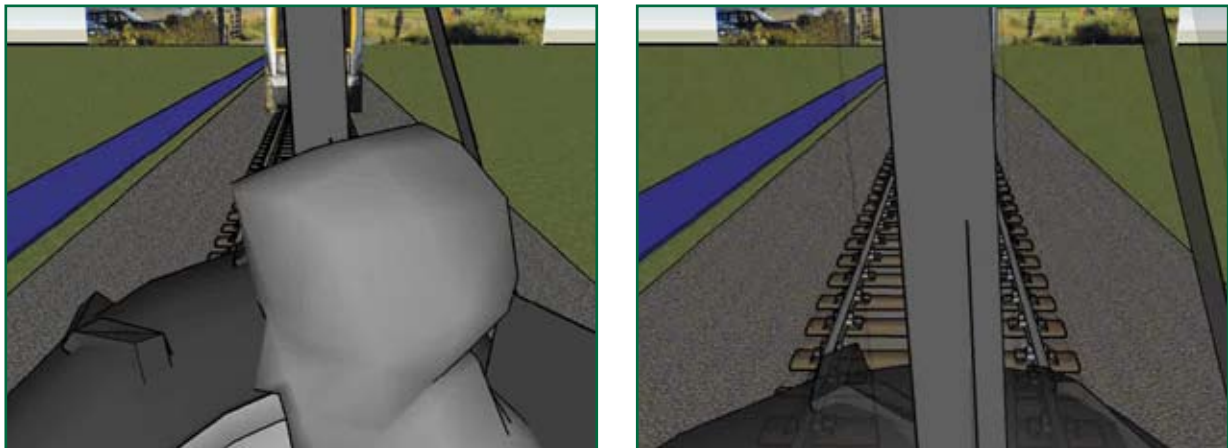
- 89 When crossing at an angle, the tractor driver's view to the railway on the right could have been affected by the tractor's roof support pillar when the tractor driver was sitting upright in the seat. This would have started to occur just as the tractor was approaching the railway (approximately three seconds before it reached the point where conflict with the train was inevitable and approximately six seconds before the time when impact occurred) and continued until the time of impact. The presence of the roof support pillar may have impeded the tractor driver's peripheral vision, preventing him becoming aware of the train until it was too late. Even if he had glanced quickly to his right, the presence of the pillar and the bright sunlight coming in through the tractor's right-hand window may have combined to make seeing the approaching train difficult.

90 Figure 6 illustrates the possible problem caused by the roof support pillar when the train is 19 m from the crossing and is based on the design and dimensions of the model of tractor involved in the accident and the dimensions of the Class 3000 DMU. The left-hand graphic shows the position of the tractor driver sitting upright in his seat with the train located 19 m from the crossing, while the right-hand graphic provides an indication of the peripheral vision available to the tractor driver in equivalent circumstances, and shows the roof support pillar obstructing the view of the approaching train. The skewed nature of the crossing, in conjunction with the position of the roof support pillar on the off side of the tractor are possible contributory factors for this accident.

Figure 6: Graphic showing the possible effect of the roof support pillar on a tractor driver's vision at Crossing XL202
