Rail Accident Investigation Branch

Rail Accident Report

Runaway of two wagons from Camden Road Tunnel 19 July 2007

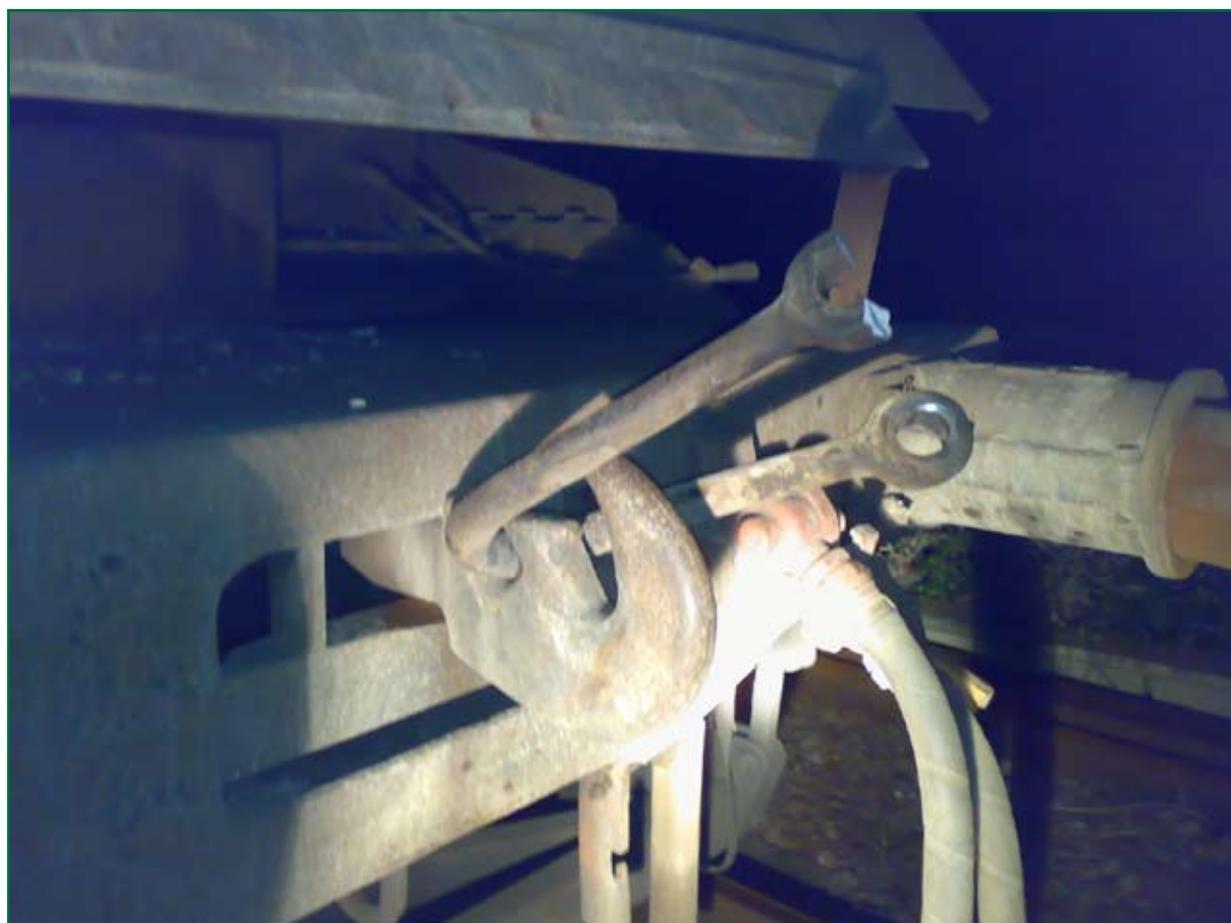
Figure 8: Remains of screw coupling, south end of MAR17712 (by courtesy of Network Rail)

- 36 With the permission of the signaller, the locomotive from train 7M59 was used to retrieve the two wagons and haul them to Churchyard Sidings.
- 37 The shunter and the driver found that the screw coupling at the south end of MAR17712 had broken with only part of it still attached to the wagon's *drawhook* (see Figure 8).

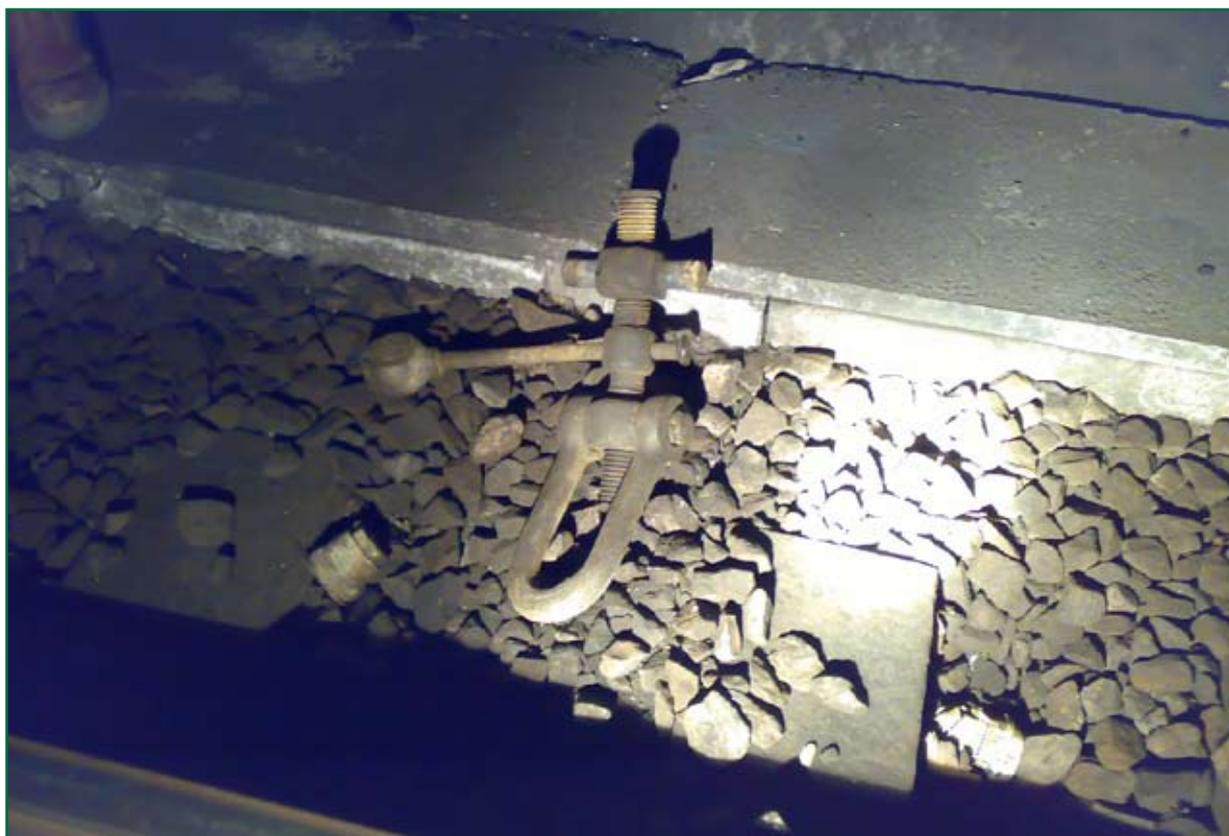
Figure 9: Other portion of coupler from south end of MAR17712 in the location where it was found (by courtesy of Network Rail)

- 38 Network Rail staff found the other portion of the broken coupling inside Camden Road Tunnel, 40 metres from the south portal (see Figure 9). The portion of broken coupling was retrieved for metallurgical examination to determine the cause of failure before trains re-commenced running.
- 39 The driver was subjected to the standard railway industry tests for drugs and alcohol and the results were negative.

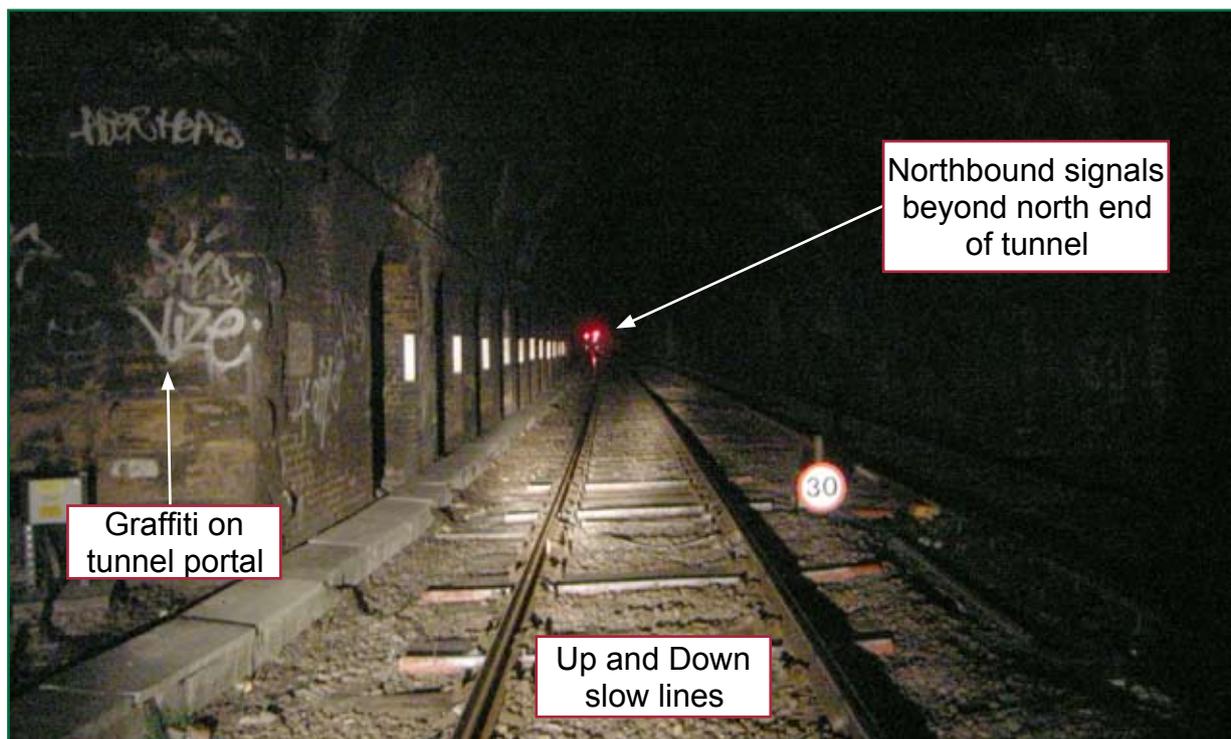
Figure 11: View looking north through Camden Road Tunnel

- 46 Camden Road Tunnel is straight, and northbound signals WH223 and WH429 beyond the north portal can be clearly seen from outside the south portal. Figure 11 shows the view through the tunnel looking north.

- 90 Despite the two detached wagons being only about 24 metres away from the rear of the front portion of the train (paragraph 83), the driver did not see them standing there in the darkness of Camden Road Tunnel, even though they might have been visible, given the ambient light conditions (Figure 11 and paragraph 46). This is a contributory factor.

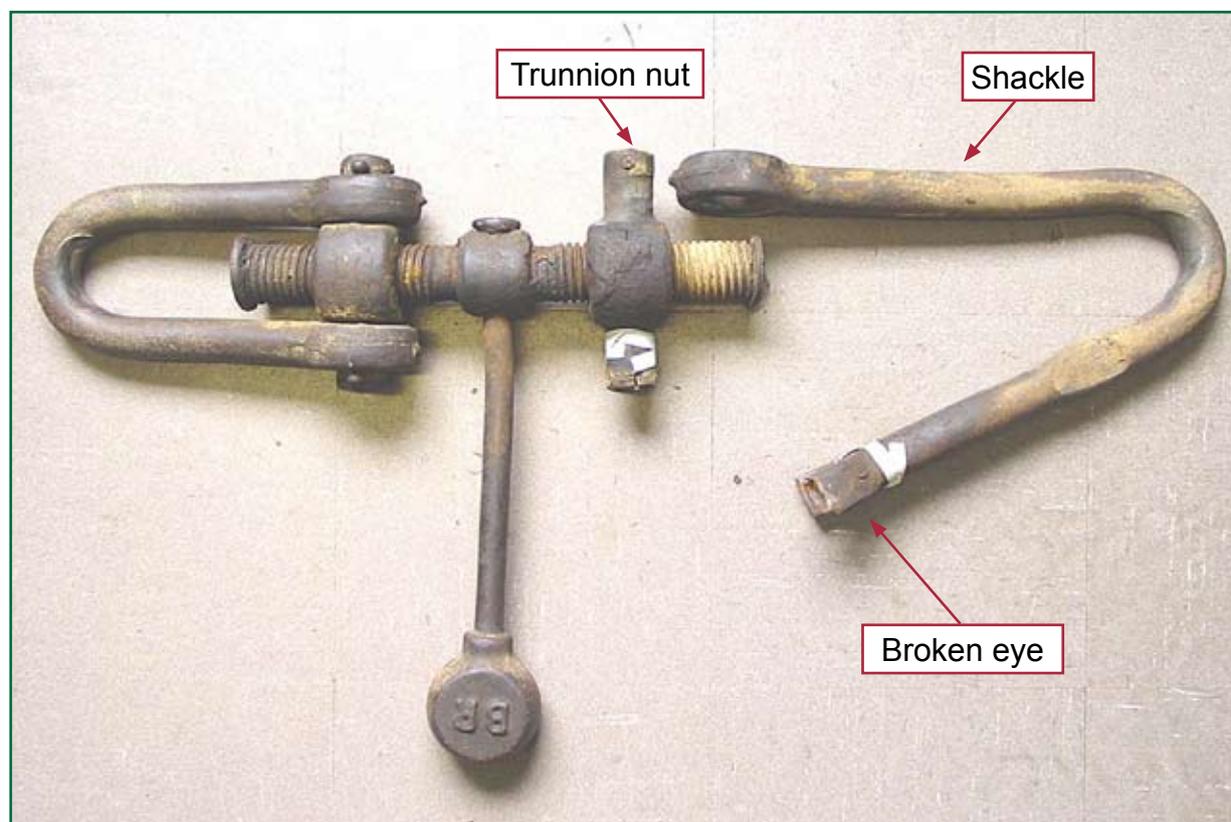
Figure 12: General view of the coupling (by courtesy of Serco Technical and Assurance Services)

47 Figure 12 shows a general view of the coupling and the eye which broke. The eye breaking caused the shackle to detach from the trunnion nut and deform.

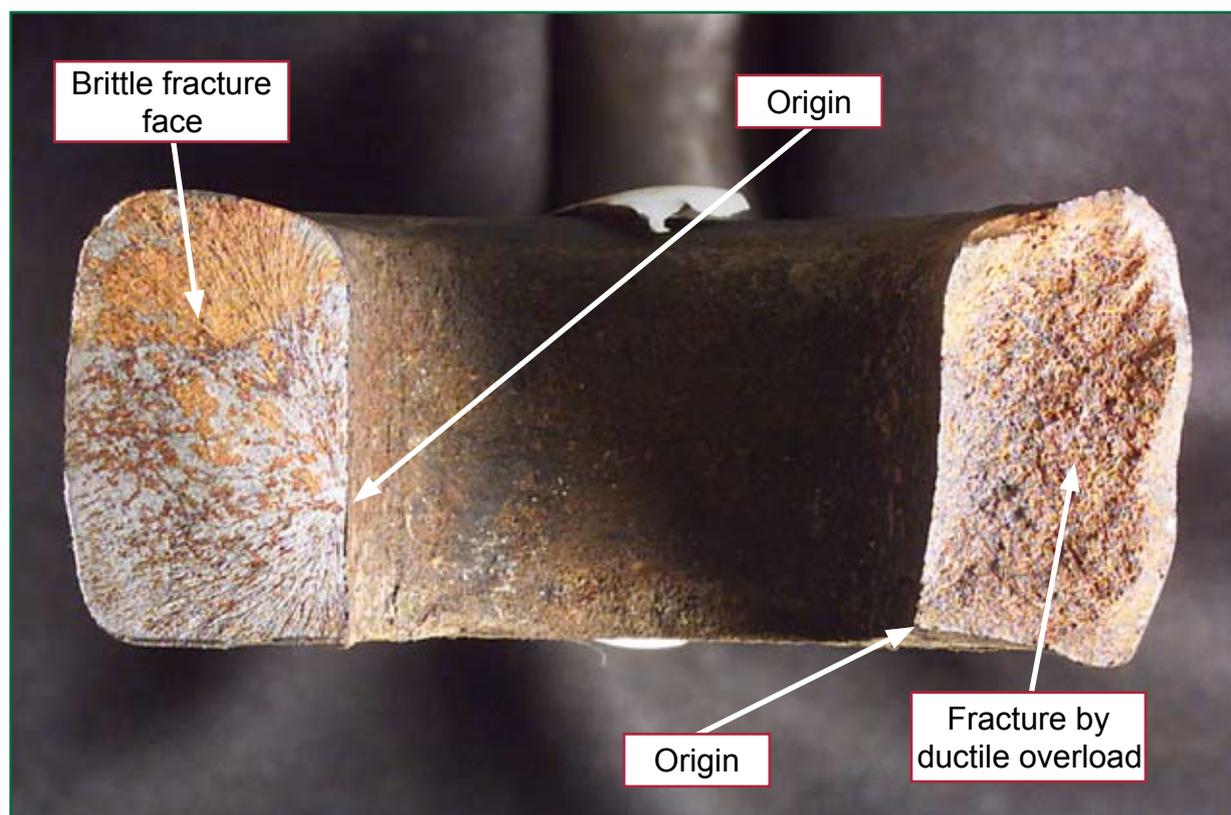
Figure 13: Eye end fracture faces (by courtesy of Serco Technical and Assurance Services)

48 Examination of the broken eye revealed that the two fracture faces had different material properties (Figure 13). One of the fractures had occurred rapidly with the break being through material that was predominantly brittle while the other fracture was a rapid ductile failure. No evidence of fatigue was found. The brittle fracture suggested that the material in that part of the eye had been subjected to localised heating and cooling some time after manufacture. The hardness measured (more than 600HV30¹) was greatly in excess of that specified for the coupling (255 – 305HV). The hardness of the ductile fracture was found to be within the specification for the type of steel used in the manufacture of the coupling (BS970 945M38).

- 49 From the results of the metallurgical examination, the RAIB believes that the brittle fracture occurred first, followed by the more ductile portion of the eye, which was in the correct condition.
- 50 Based on the amount of wear exhibited, it appeared that the coupling had been in service for some time, although the maintenance records showed that both couplings fitted to MAR17712 were renewed on 2 June 2004. Examination of the records thereafter (which were incomplete) showed no clear indication that heat might have been applied to the failed coupling as part of a repair carried out to the wagon.
- 51 It was not possible therefore to determine when or why the localised heating had occurred.

- 99 The metallurgical examination of the failed coupling concluded that the failure occurred where the hardness was much greater than that specified in BS970 945M38 (paragraph 48). The metallurgist thought this could have occurred due to localised heating and cooling of the coupling in the area where the failure occurred, although it has not been possible to determine why such heating and cooling might have occurred. The failure of the coupling is a causal factor of the runaway and the hardness of the coupling material in the area where the coupling failed is a contributory factor.

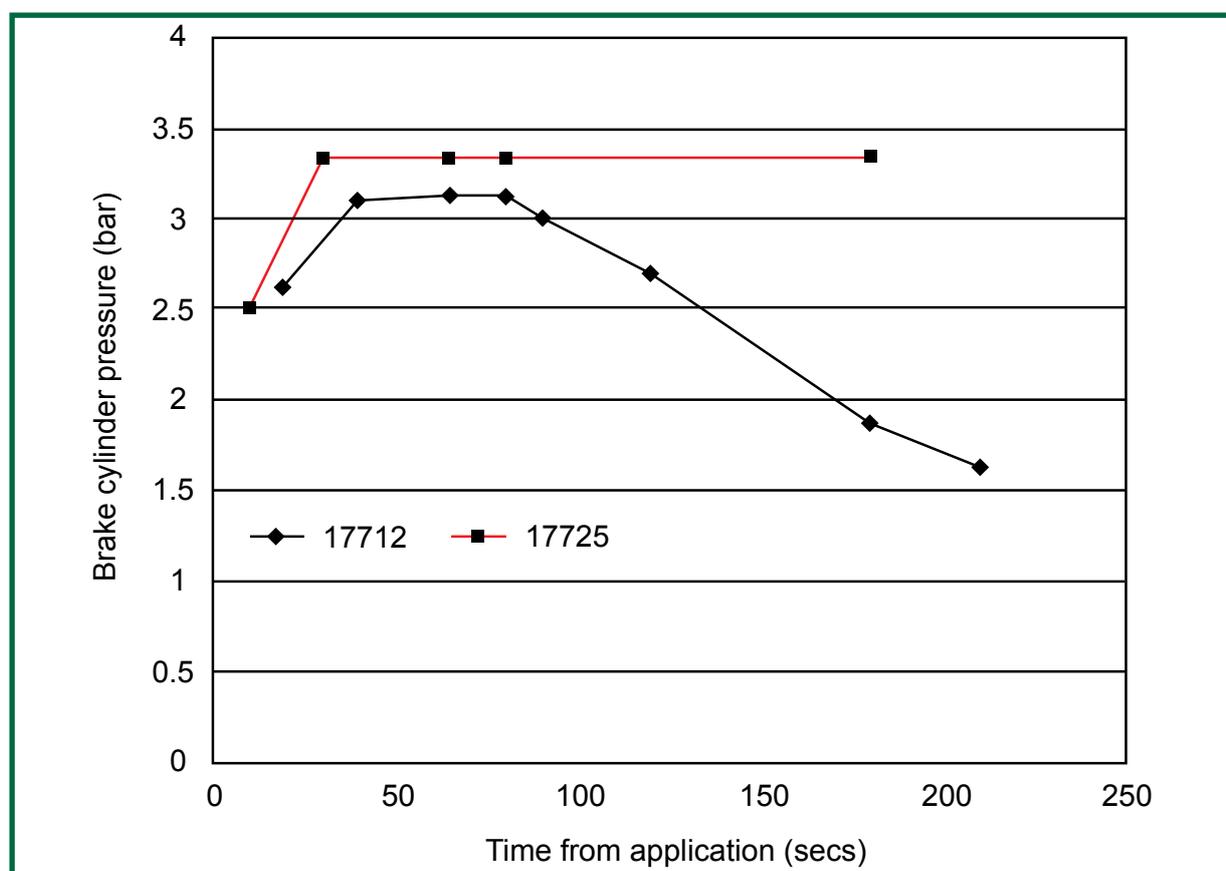
Figure 16: Results of brake cylinder leakage tests for wagons MAR17712 and MAR17725

- MAR17712 did not meet EWS/ES/0097 for brake cylinder leakage (maximum 0.2 bar over 5 minutes). The results suggest that the brakes would lose half their pressure within a matter of minutes (Figure 16), although the rate of leakage would not be linear and would reduce as the brake cylinder pressure reduced. However, EWS's tests revealed no obvious air leaks.
- The 'A' Gaps for the two slack adjusters fitted to MAR17725 were found to be 80 mm and 82 mm which is more than twice the design value of 32 mm. This would probably have reduced the amount of brake force for a given brake cylinder pressure, although this was not measured during the tests.
