Rail Accident Investigation Branch

Rail Accident Report

Derailment of a London Underground Central Line train near Mile End station 5 July 2007

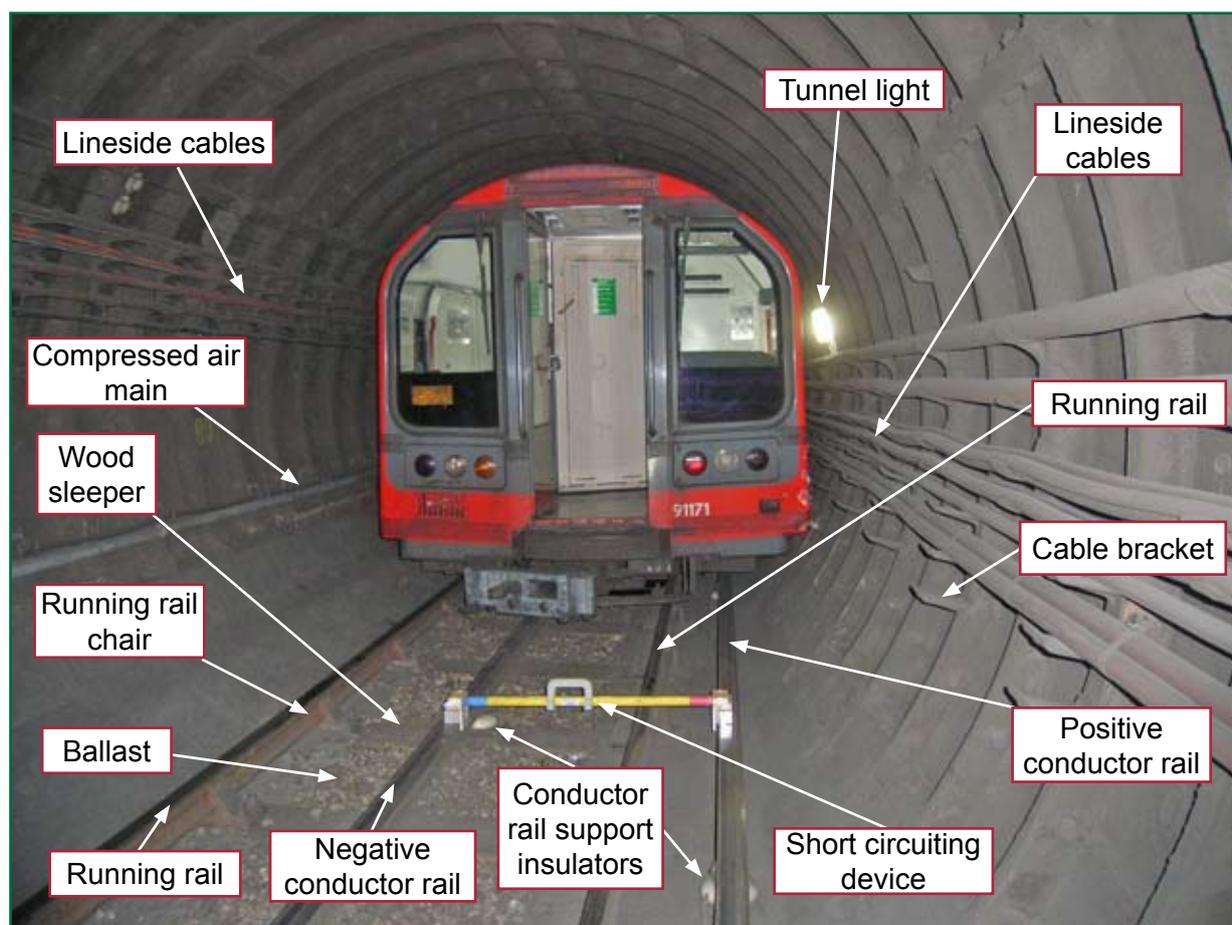
Figure 3: The derailed train viewed from the front

- 131 Upon hitting the roll of fire-resistant blanket the train derailed to the left by five of the six leading wheelsets. For a considerable distance the train was supported by some of the motor *gear pans* which ran along the left-hand running rail. The train wheels were then guided by the conductor rail which prevented it from hitting the wall of the tunnel. Had the train hit the tunnel wall, damage to the two leading cars would have been substantially greater, with the likelihood of severe damage to the driver's cab and with broken windows and object incursions into the passenger space.

- 132 Two windows were broken however shards of glass were largely retained by the protective plastic film. Only a few small pieces of glass from the end window, and no objects from outside the train entered the passenger space.

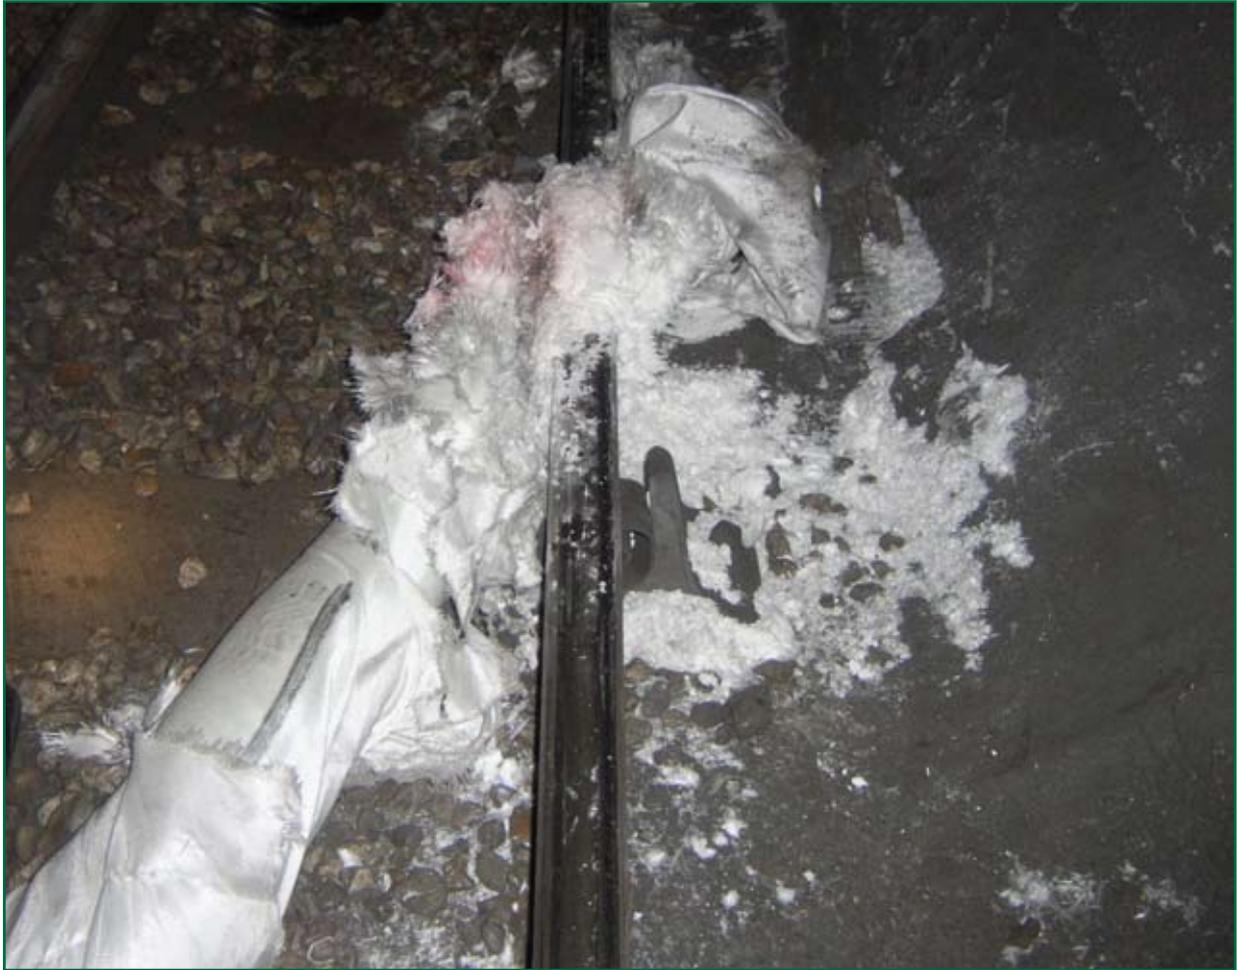
Figure 4: The remains of the fire-blanket after train 117 had passed over it

92 During the evacuation of passengers following the incident BTP officers ensured that no evidence was disturbed. The squashed remains of the roll of fire-resistant blanket was lying at approximately 30° to the right-hand running rail and 6.6 m from the entrance to the cross passage. The roll was separated from an unrolled length that stretched from about 2.4 m away from the roll, back along the running tunnel and thence along the cross passage (Figures 5 and 9).

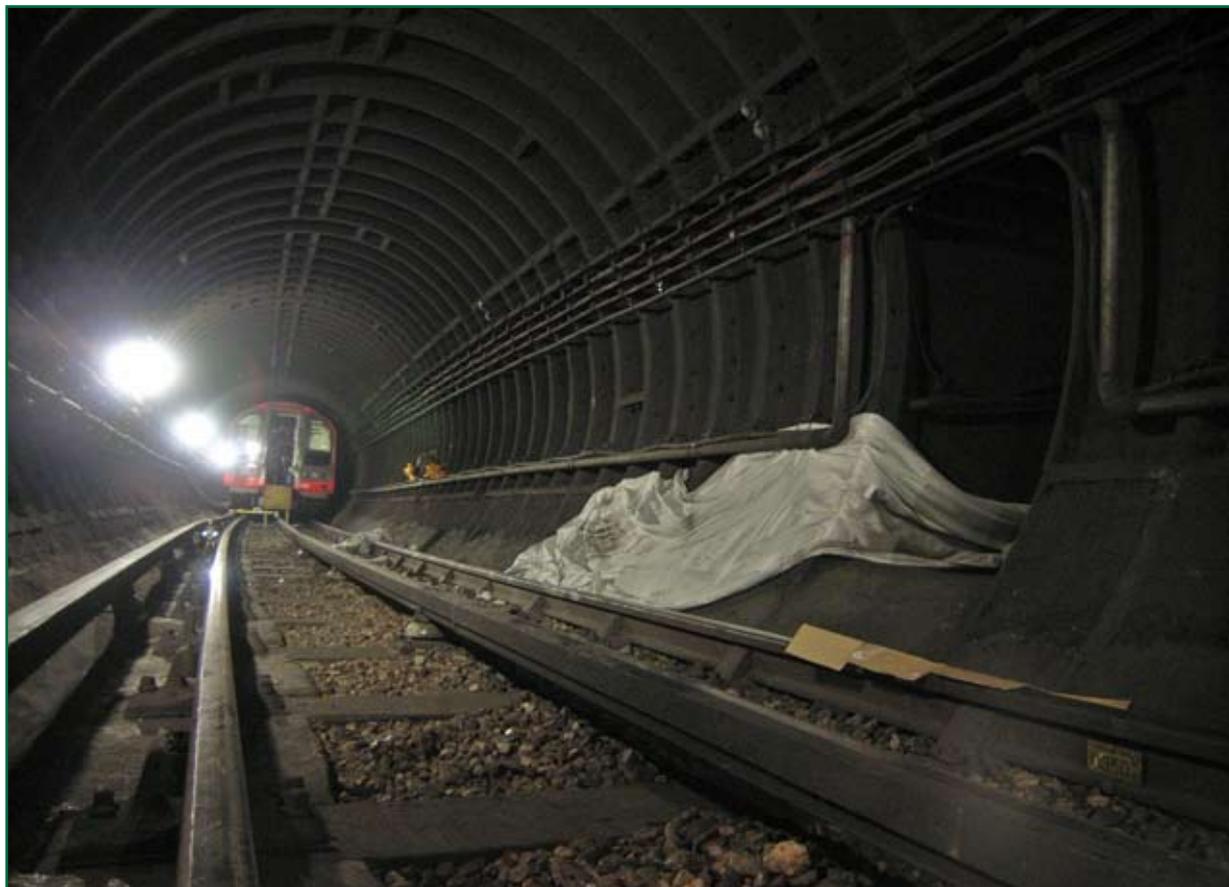
Figure 5: The tunnel and rear of train 117

- 83 The train operator then moved to the back of the train and was assisted by a British Transport Police (BTP) officer to deploy the detrainment ramp (this can be seen forming a ramp from the cab door in Figure 5). The train operator then tried to report this to the service controller from the rear cab but failed to get a response over the radio system; contact was eventually made from the front of the train.

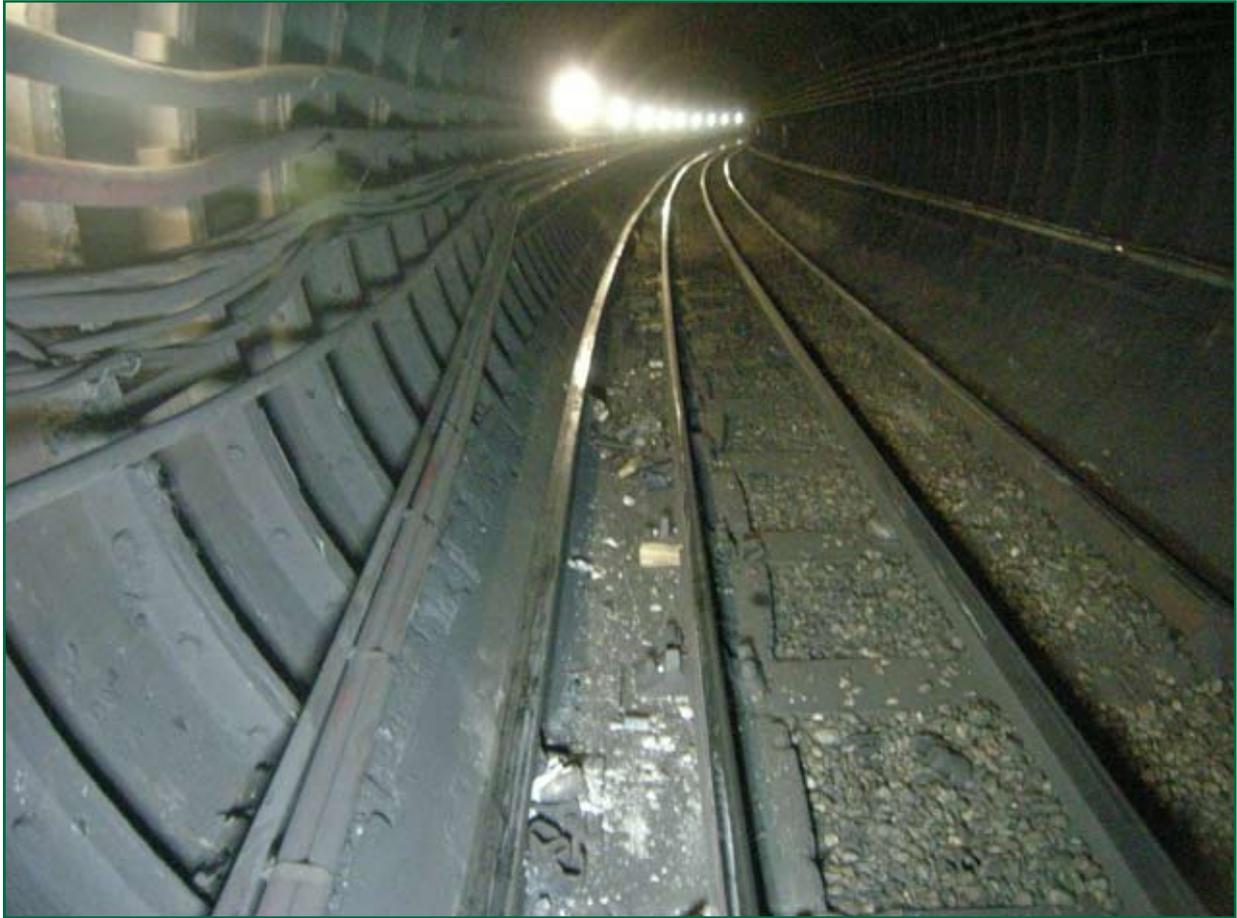
Figure 6: Track damaged by the derailment after the train had been removed

- 75 During the time that the train ran in a derailed condition it caused considerable damage to the infrastructure; one signal head, several cable brackets, a number of track bonds, one length of 22 kV cable and many rail chairs and conductor rail insulators were damaged beyond repair. One length of high voltage cable was damaged but repaired in situ. The positive conductor rail was bent and displaced to the left.

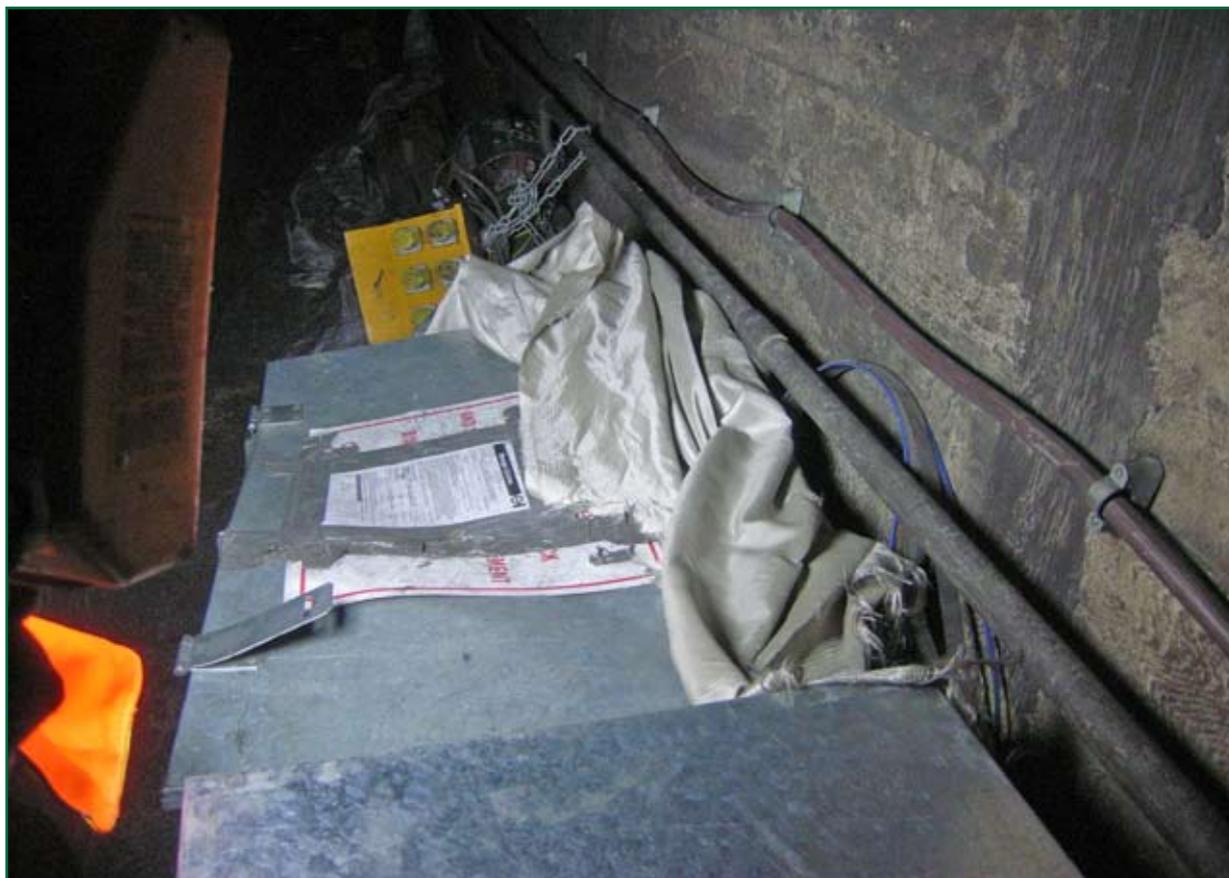
Figure 7: The storage licence and storage bins located in the cross passage as seen facing the westbound tunnel

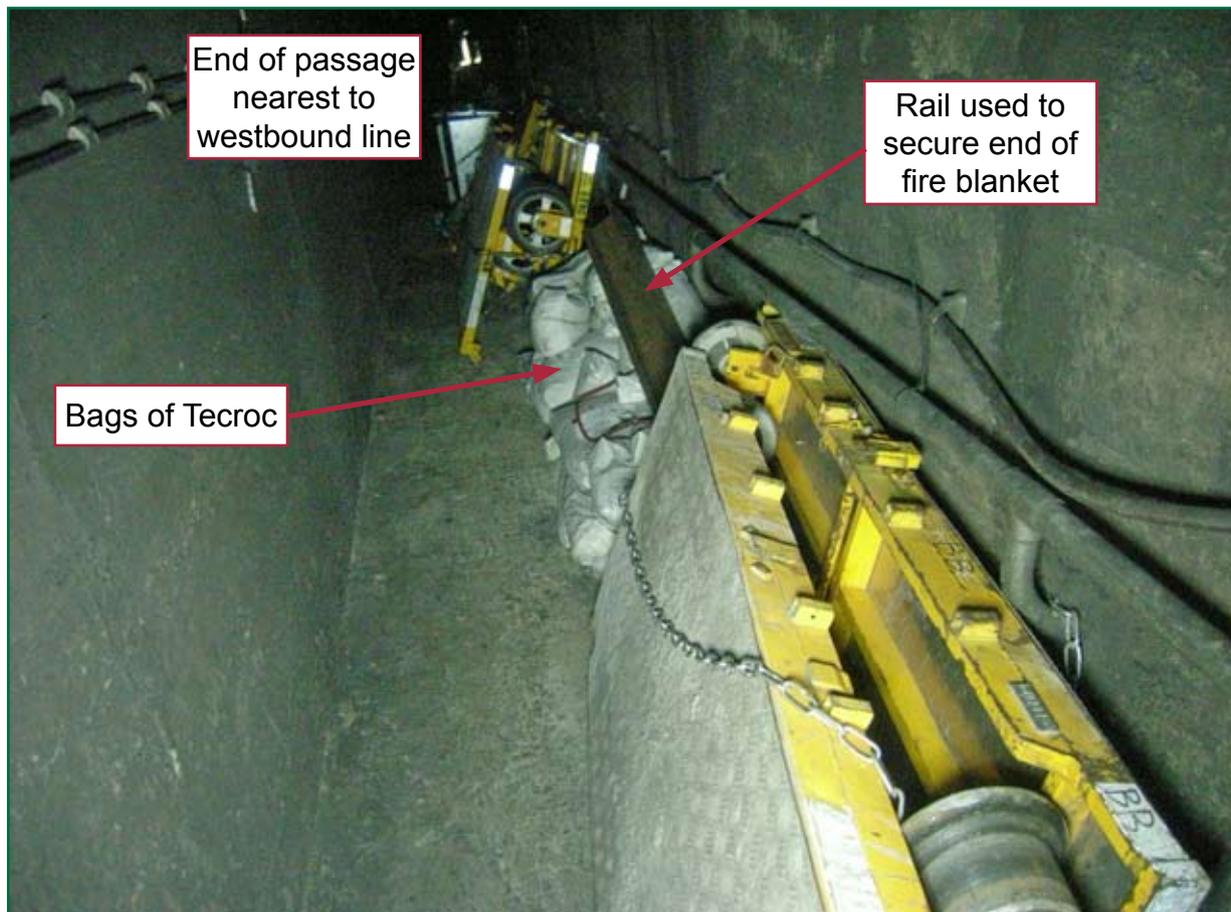
Figure 8: Equipment stored in the cross passage as found immediately following the derailment and viewed from end closest to the eastbound track

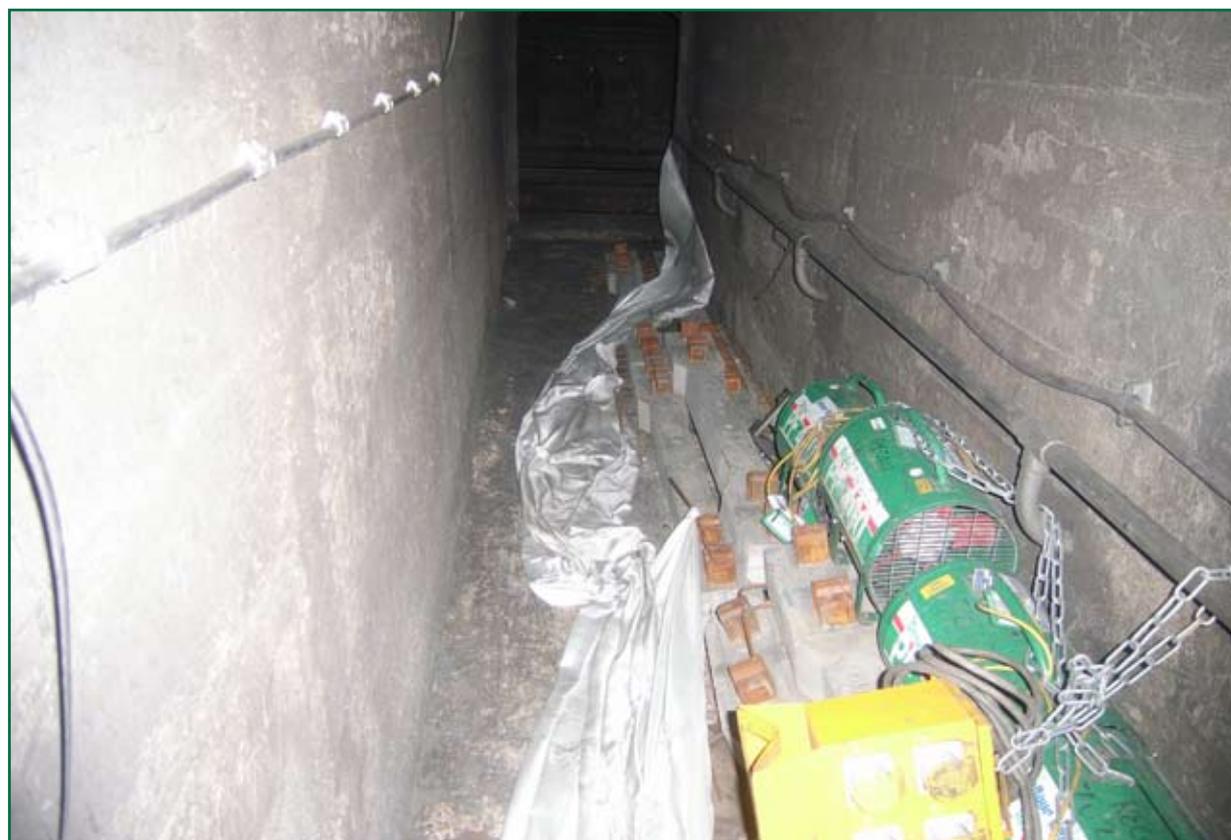
Figure 9: Equipment stored in the cross passage as found immediately following the derailment and viewed looking towards the westbound track

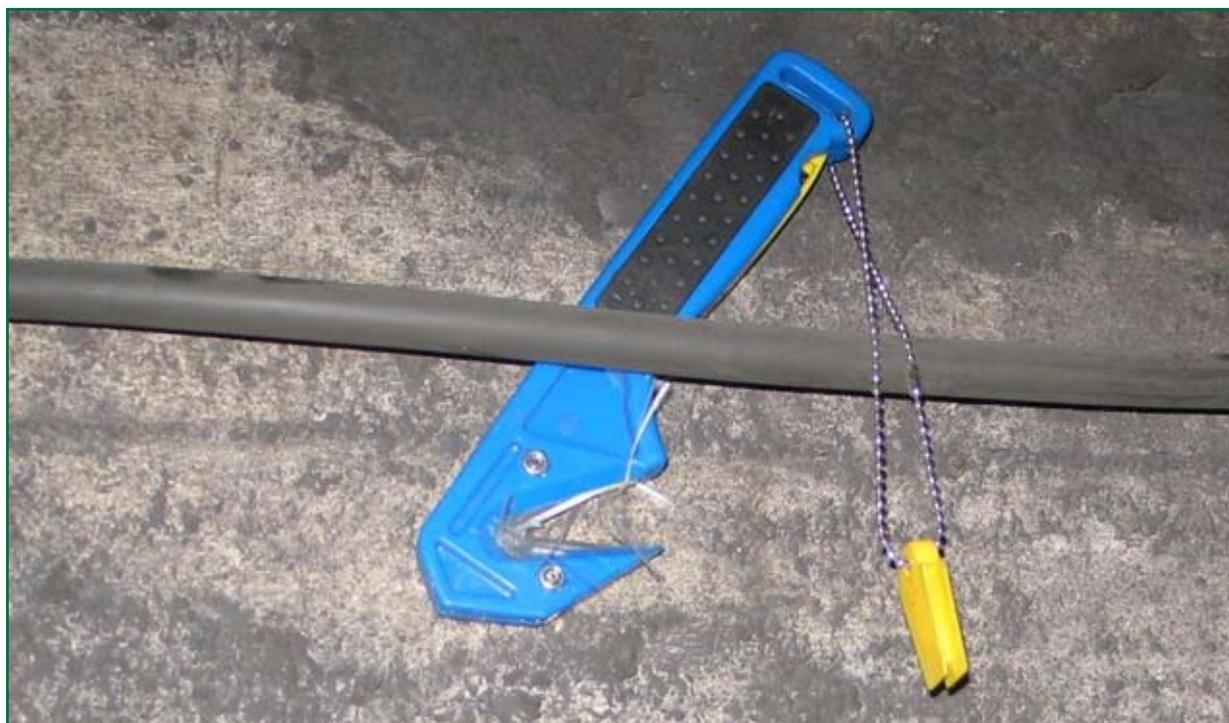
Figure 10: Safety cutter

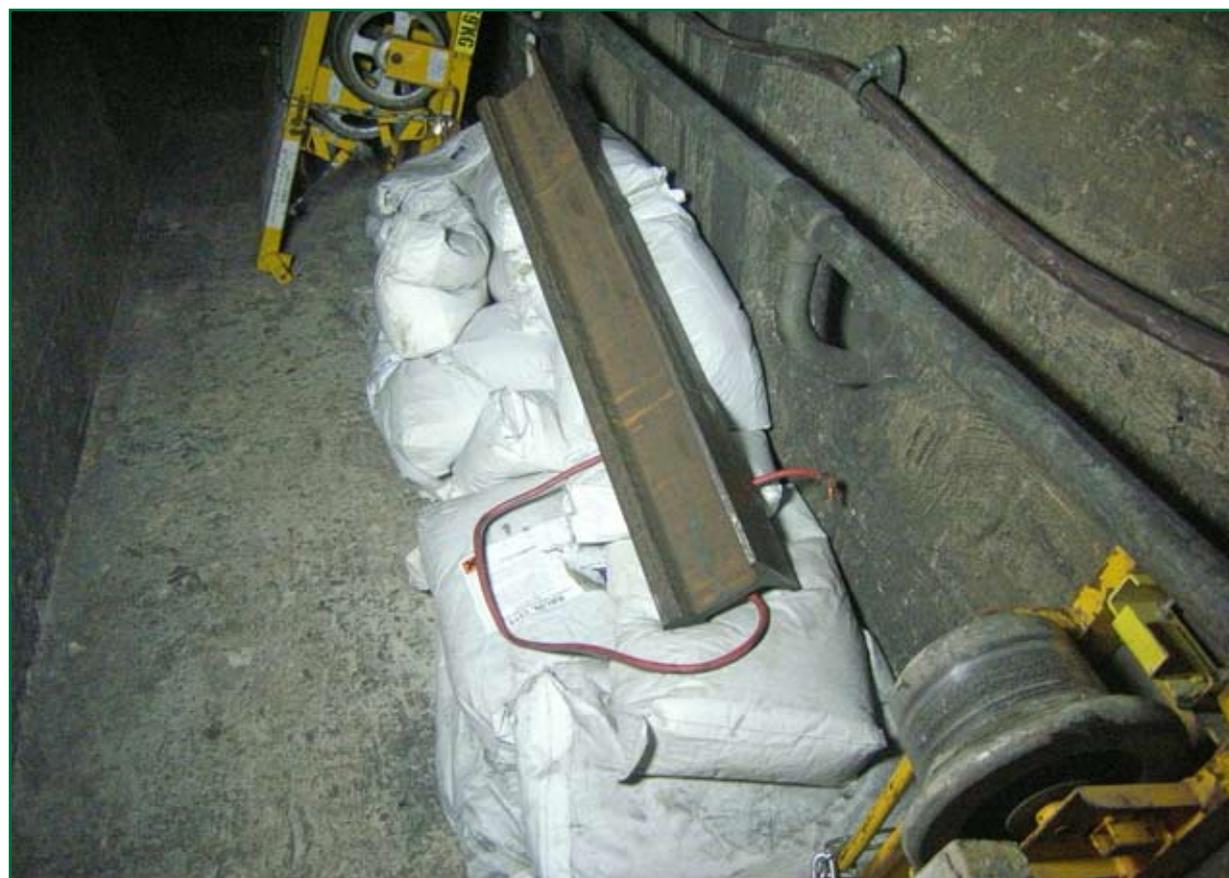
Figure 11: Cross passage showing rail and Tecroc bags

- 63 The blanket was unrolled and the free end secured under a piece of flat bottom rail just over 900 mm in length and weighing in excess of 50 kg. Figure 11 shows how the rail and Tecroc were left at the end of the gang's shift. The fire-resistant blanket is a fire retardant woven fibre material and is difficult to cut with an ordinary knife; it is even more difficult to cut with the narrow vee-shaped blade of the safety cutter (Figure 10) which tends to clog as it is drawn through the material. The unrolled length of fire-resistant blanket was left attached to the roll. The orientation of the roll was such that it was free to roll across the floor of the cross passage; it was not being prevented from doing so by the unrolled length of fire-resistant blanket.

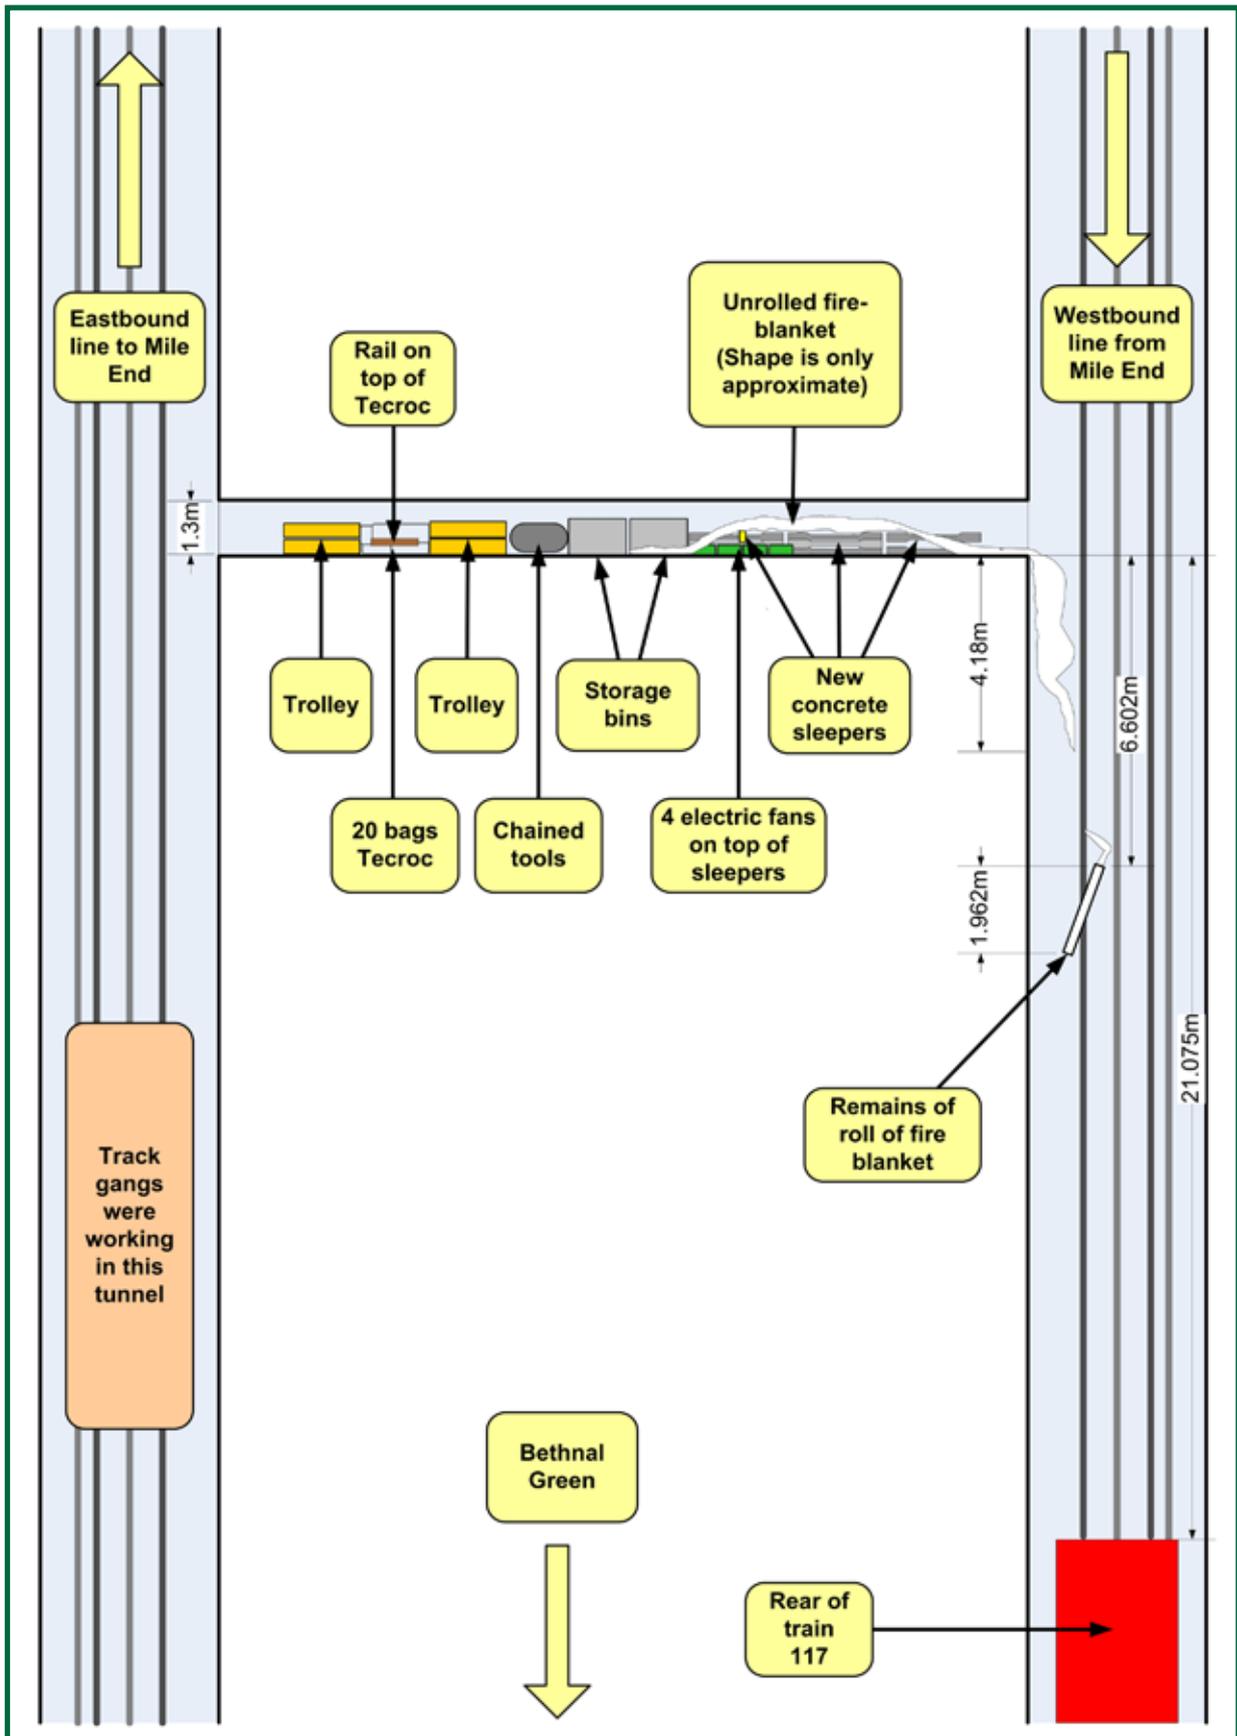
Figure 12: Diagram of cross passage and running tunnels

- 93 The unrolled length was snagged at various places, particularly behind the air pipe in the running tunnel immediately adjacent to the cross passage entrance and on the reinforcing bars protruding from the sides of some stored concrete sleepers. The further end was at the junction between the two storage boxes and lying on the top of the one closest to the westbound line.

- 94 Within the cross passage a length of rail slightly in excess of 3 ft (912 mm) long was found lying on top of bags of Tecroc.
- 95 Short fibres of material were found snagged on various clamps retaining electrical cables and conduit in place, these fittings being half way up the wall on both sides of the passage. Fibres were also found snagged on a cable bracket above the westbound line entrance to the cross passage.

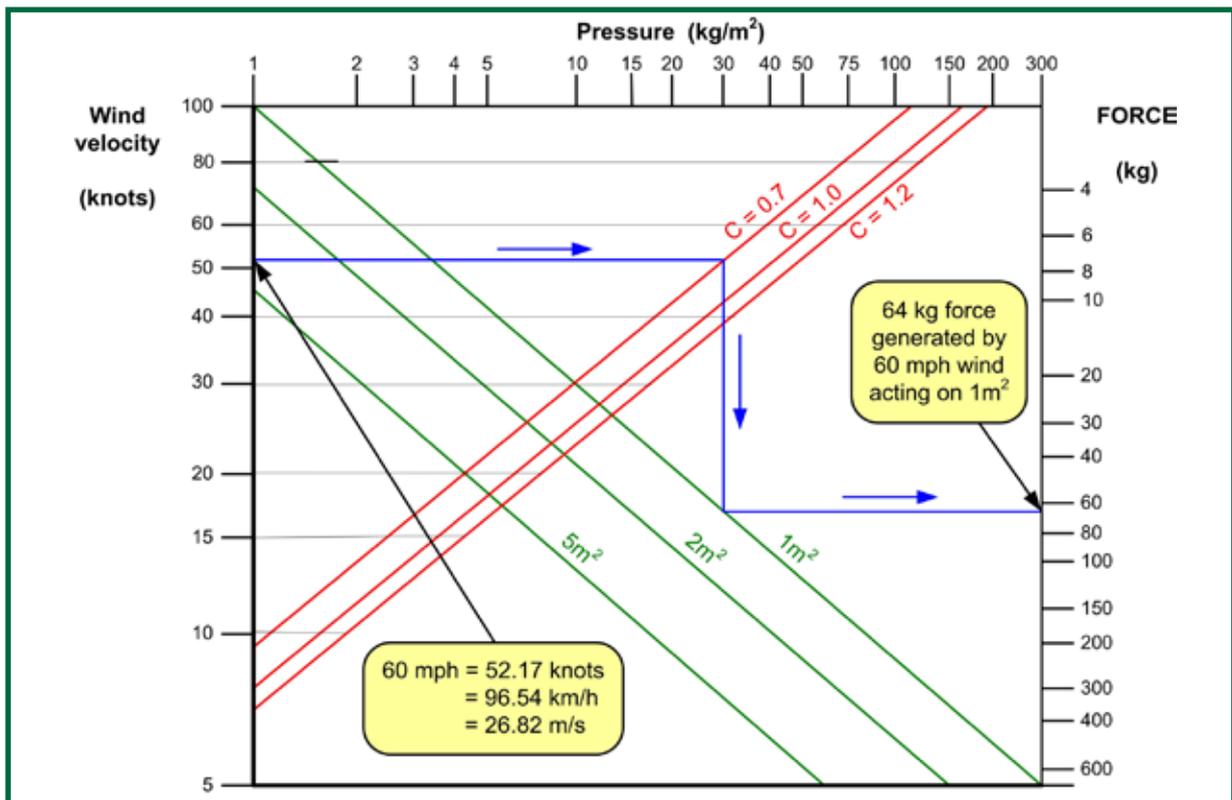
107 The wind tests undertaken for Metronet (paragraph 99) allowed an estimation of the forces acting on the roll of fire-resistant blanket. Data from standard tables (see Figure 13) indicates that with a drag coefficient of 0.7, a force of approximately 64 kg could be generated by a wind speed of 60 mph (96 km/h) acting perpendicularly on a sail area of 1 m². (A conservative value for drag coefficient has been used for these calculations. This type of data has been derived by empirical means; typically 1.28 for a flat plate, 0.8 to 1.5 for billowing sails and 0.75 or greater for parachutes).

Figure 13: Wind speed and force diagram [Reference 5]

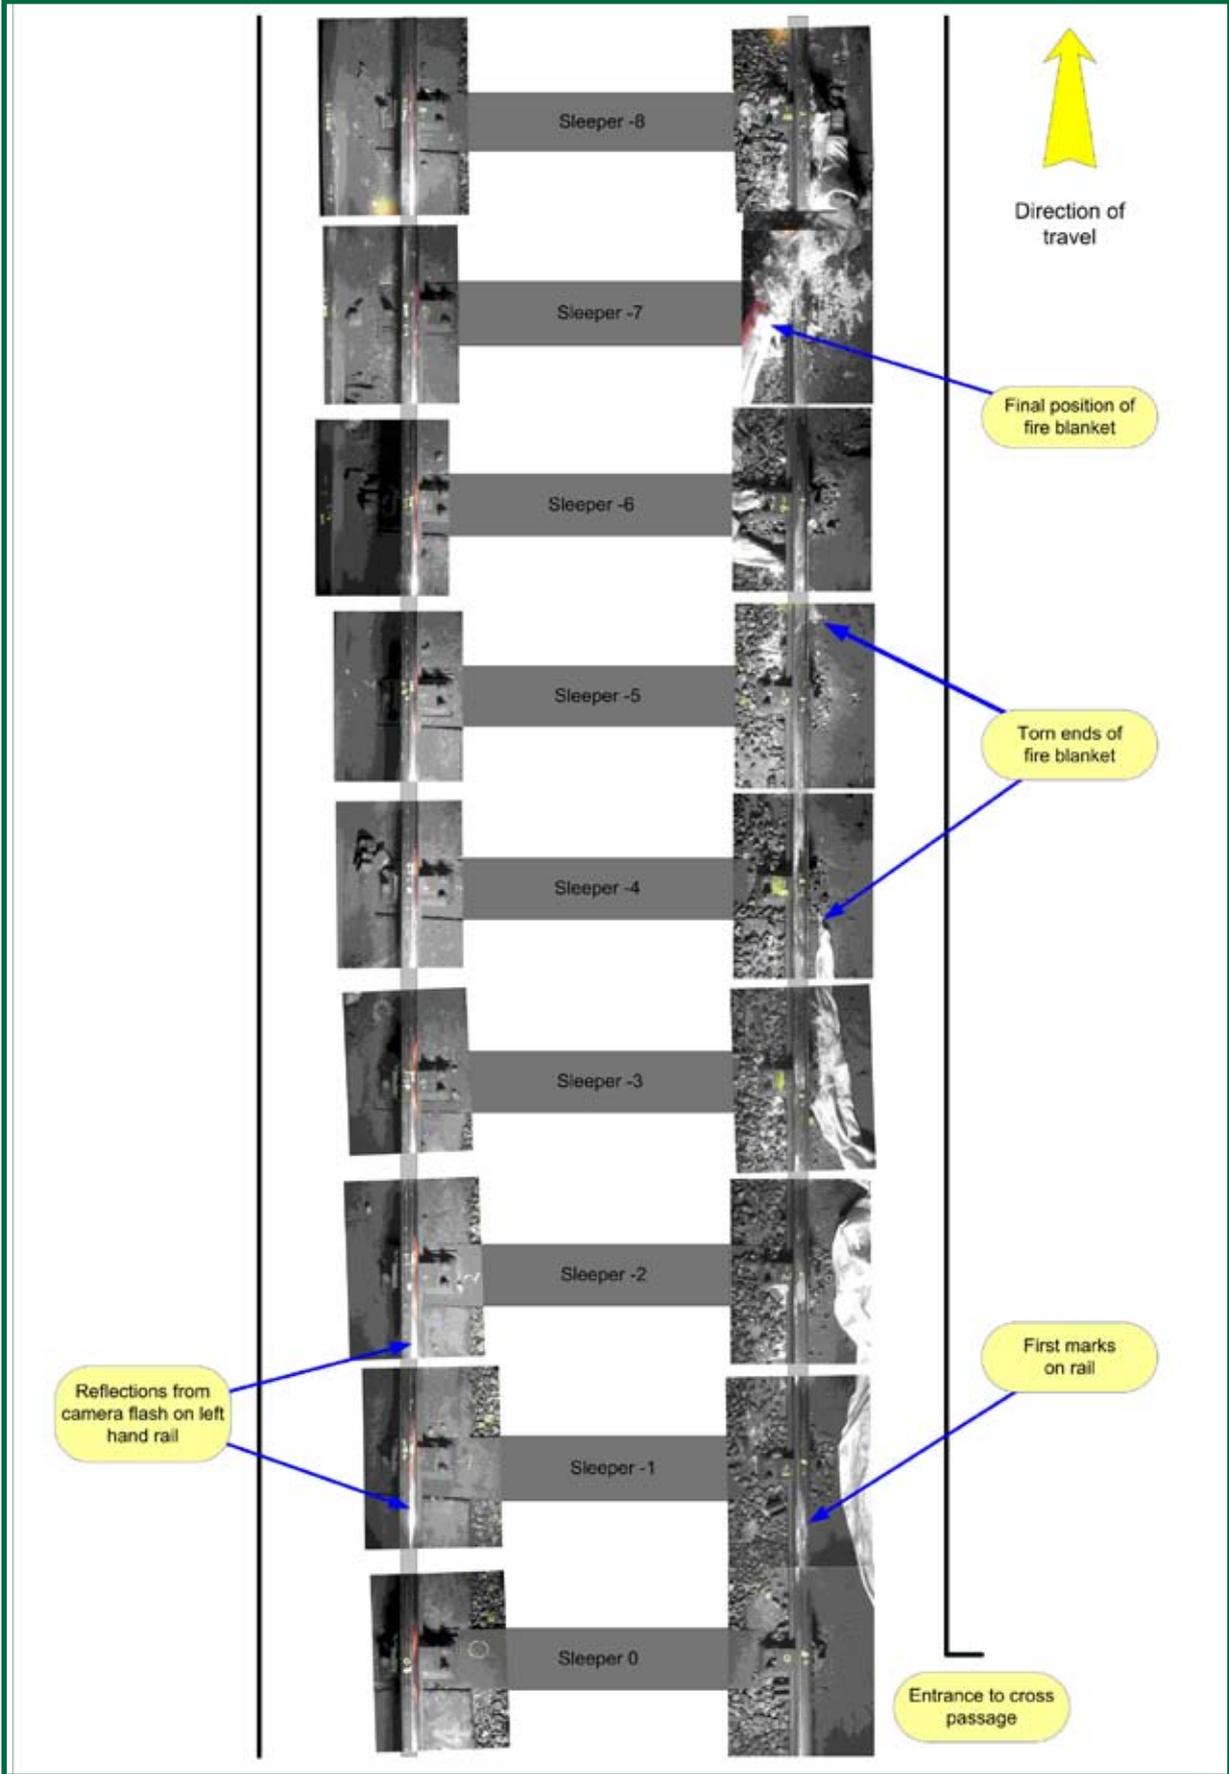
Figure 14: Composite photo diagram showing the rails between the initial point of impact and the final position of the roll of fire-resistant blanket

- 112 When the leading wheel set hit the roll of fire-resistant blanket located midway between sleepers -3 and -4 (Figure 14) it caused the leading right-hand wheel to lift (all sleepers have been numbered negative after the point of derailment). This in turn caused the flange of the left-hand wheel to lose contact with the running rail. The transverse vertical skew of the axle caused the wheelset to be deflected to the left. When the axle dropped after passing over the obstruction, the left wheel flange followed a path along the head of the rail, dropping to the outside of the rail after about 2 m (midway between sleepers -3 and -4 and smashing the cast iron rail chair on sleeper -4. The roll of fire-resistant blanket remained in its initial position whilst the wheel rolled over it but it was subsequently dragged forward by the current collector shoe on the right-hand side of the train until it was stopped by the next rail chair on sleeper -2.

- 113 The roll of fire-resistant blanket was subsequently run over by the second wheelset which also lifted and derailed to the left at sleeper -5 (Figure 14). The third wheelset was not found in a derailed condition. It is possible that this wheelset ran along the rail head and then dropped back into the correct position but the rail head marks do not allow any definite conclusion to be drawn from them. The fourth wheelset of the first car and the first wheelset of the second car derailed at sleepers -6 and -7. Wheelset two of the second car derailed at sleeper -9. The derailment marks on the rail head became much more complex after sleeper -7, however there are clear signs that between sleepers -7 and -10 three wheelsets ran with their flanges on the top of the left-hand rail; however they all dropped back to their correct, underailed, position. It is possible that wheelset three was one of these however there is no definite evidence for this.

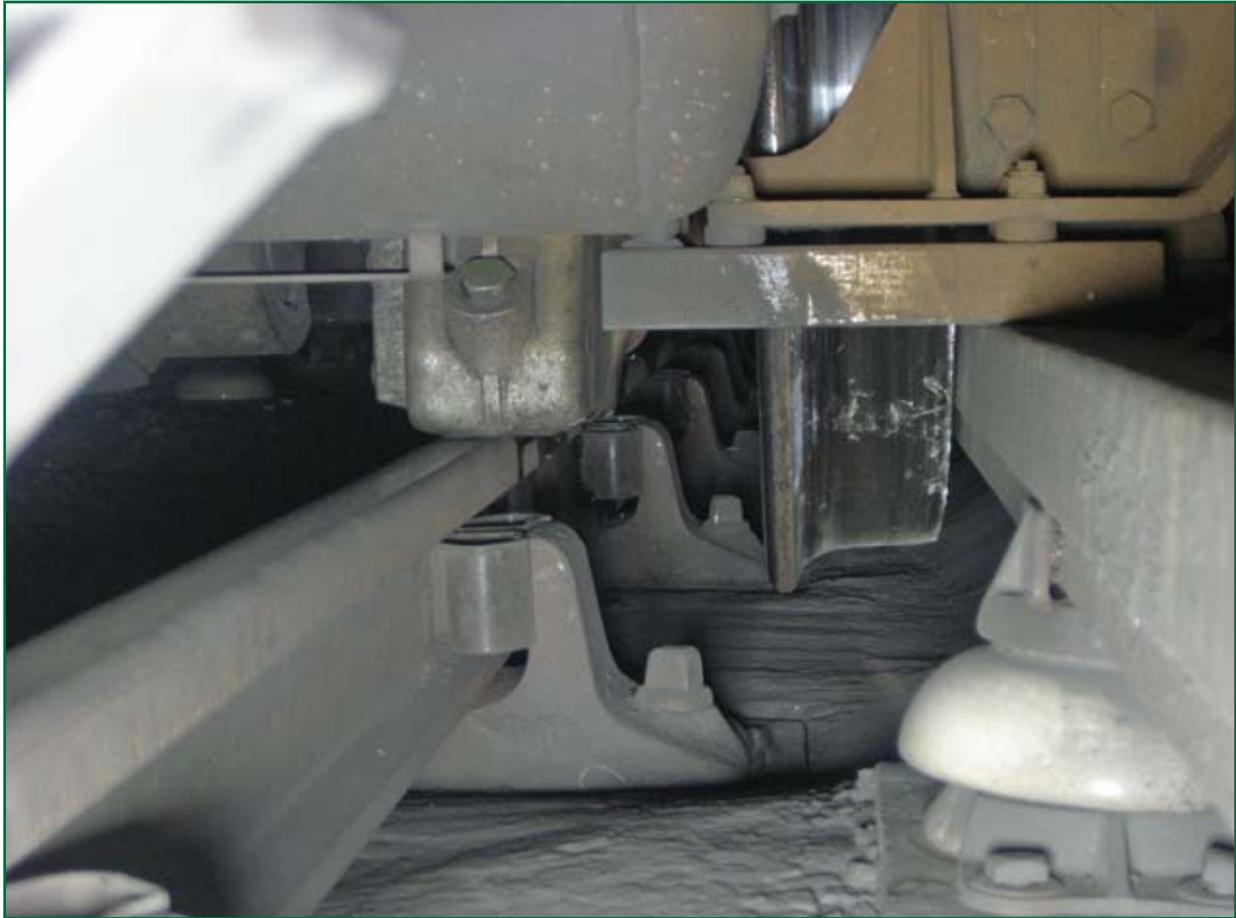
- 116 The white deposits on the rail and wheels (paragraph 97) were caused by the crushing of the fibre glass fire-resistant blanket.
- 117 During the onward motion of the train some of the weight of the cars was taken by the leading motor gear cases. These are located on alternate sides of the bogie for each of its two axles. The wheels on the other side of the axle bumped along the approximately level surface of the sleepers and concrete infill next to the rail chairs. The bogie frames displaced the conductor rail to the left which then assisted in constraining the trajectory of the train so that the leading gear cases on the leading ends of the first and second cars remained on the rail head. This prevented the car bodies from further displacement and collision with the tunnel wall (Figures 3 and 15).

Figure 15: Photograph showing how the conductor rail has helped to guide the bogie
