Rail Accident Investigation Branch

Rail Accident Report

Incident at Wellesley Road on Croydon Tramlink 15 June 2007

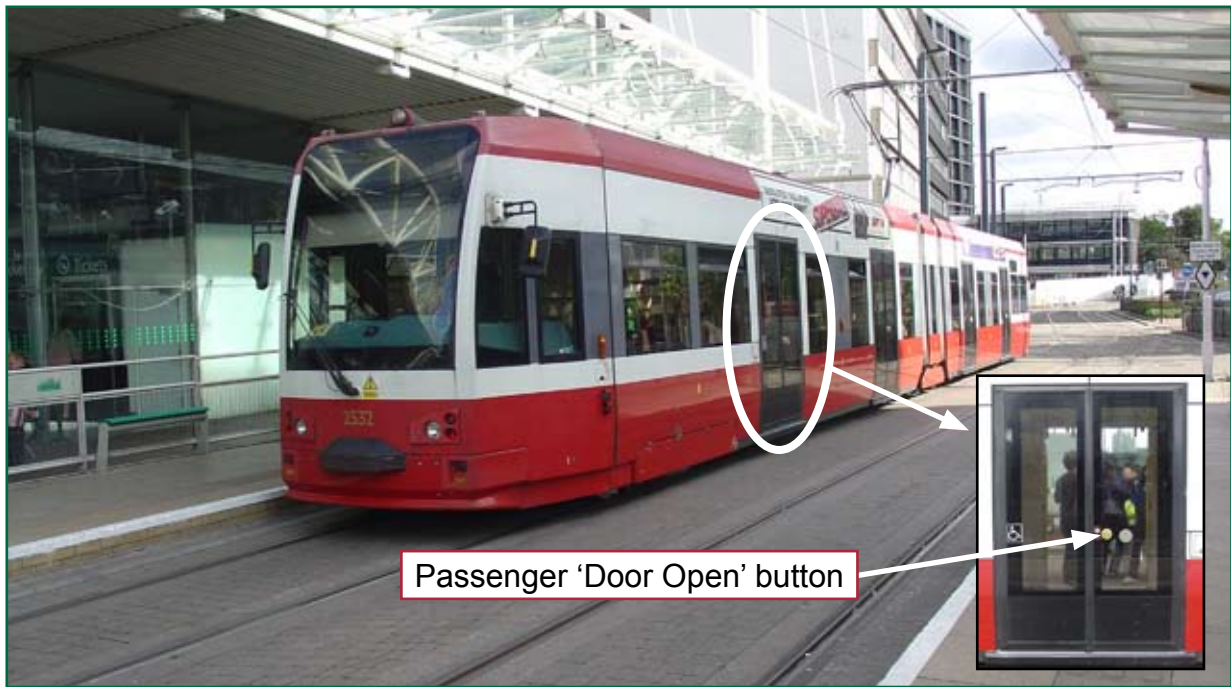
Figure 3: Croydon tram, showing doors and push button (inset)

- 12 The vehicle involved was tram 2542, one of the 24 units that make up the Tramlink fleet. It was built by Bombardier Transportation in Austria in 1998. There are four sets of *sliding plug* double doors on each side of the tram, all of which have 'doors open' buttons on the right-hand door (as seen from the outside).
