Rail Accident Report

**Tube train driven in the wrong direction,
Camden Town, Northern Line
10 June 2007**

Tube train driven in the wrong direction, Camden Town, Northern Line, 10 June 2007

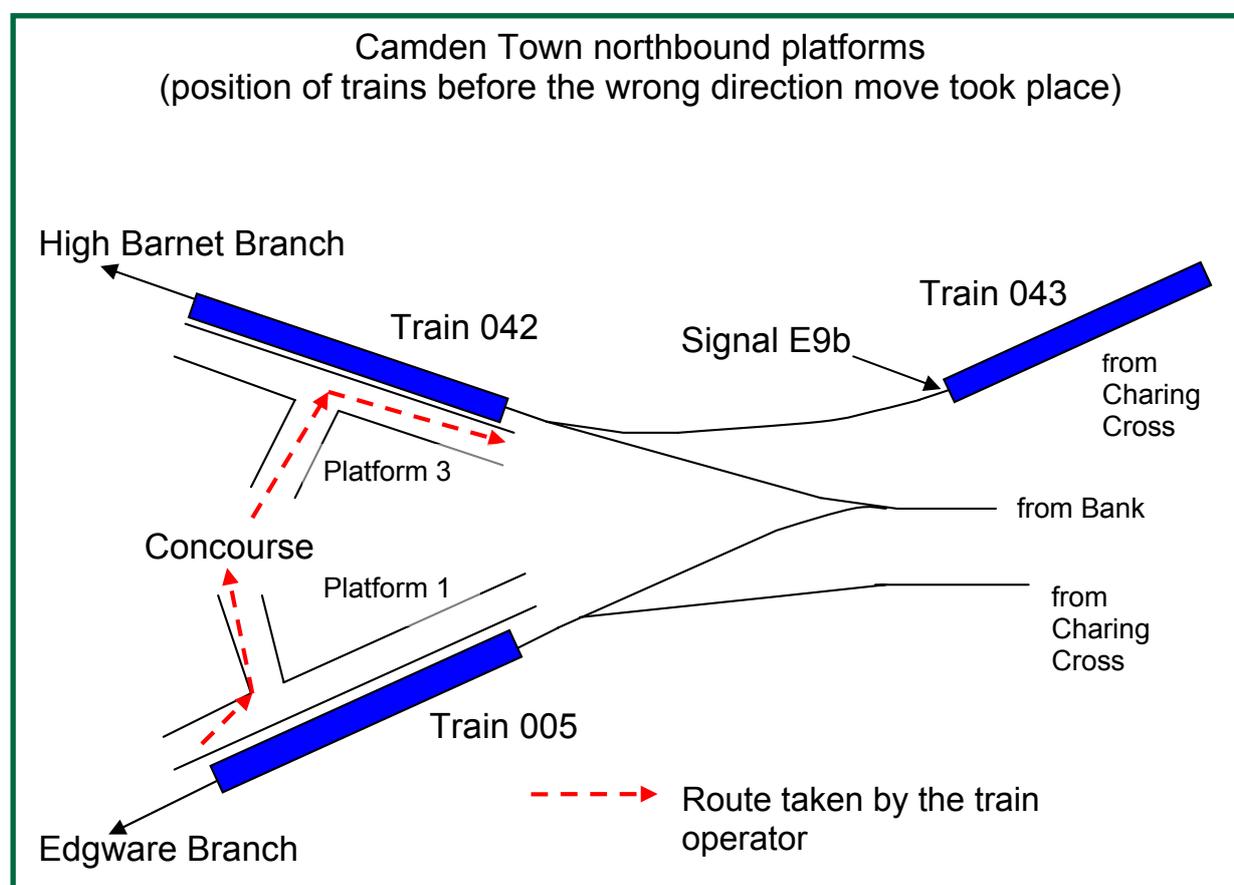
Figure 2: Camden Town northbound platforms, junctions and the positions of the trains immediately before train 042 was driven in the wrong direction

- 15 After his train entered the tunnel, the train operator of train 042 became aware of a train (043) standing on the track ahead and brought his train to a stand some 108 metres south of the platform *headwall* and 20 metres away from the approaching train.

- 16 There were no injuries and no damage to infrastructure or rolling stock.
- 17 The route taken by the train operator from the Edgware platform to the High Barnet platform and the relative positions of the trains immediately before the wrong direction move occurred are shown in Figure 2.

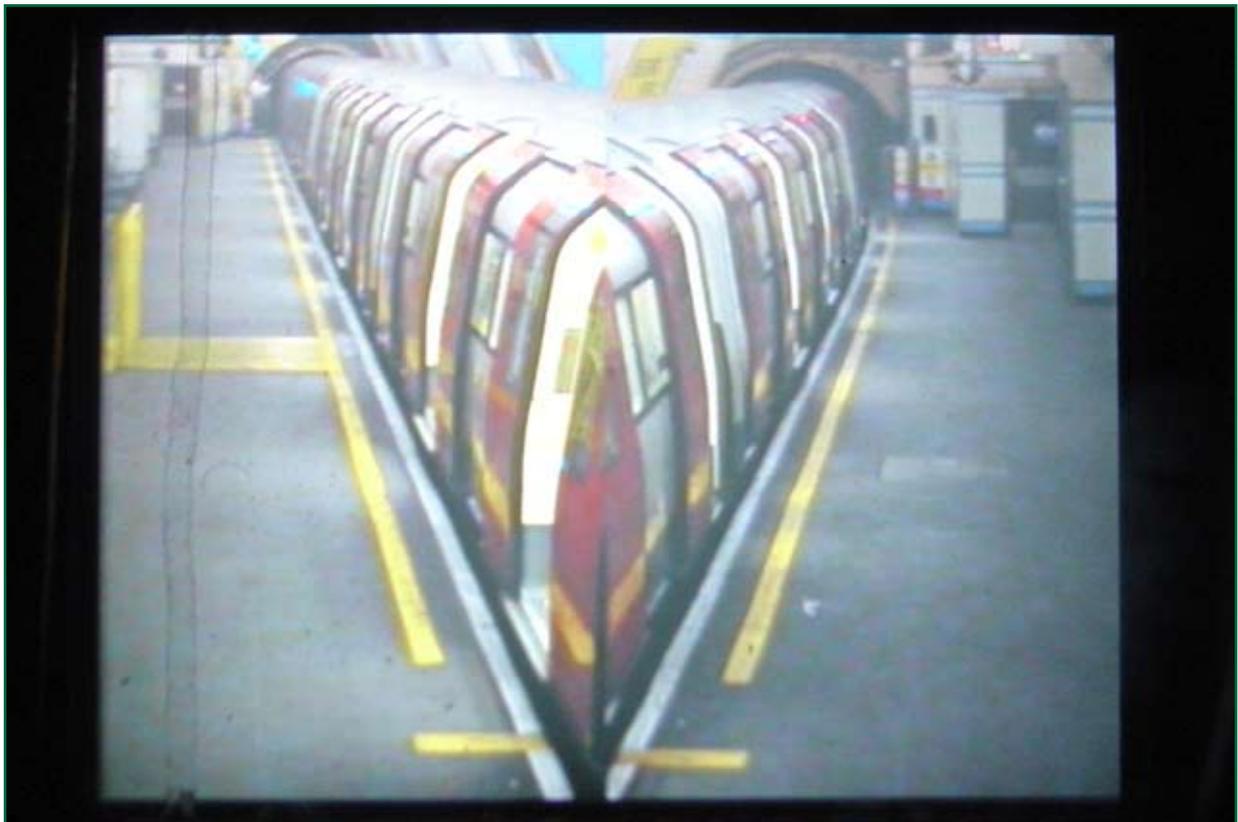
Figure 3: The image displayed by the CCTV

- 52 One of the images included the headwall at the front end of the platform. The repeater signal appeared in that image and was, correctly, exhibiting a 'proceed' aspect. The train operator noted this and took it as confirmation that he was authorised to proceed.

- 106 Since the repeater signal exhibits an aspect to indicate that shown by the station starter signal itself, the train operator observed the repeater in the CCTV image and used it to establish that the starting signal was exhibiting a clear aspect. This may explain why the train operator did not also look for the station starting signal which would have been clearly visible to him had he been at the correct end of the train. This was a factor contributory to the incident.

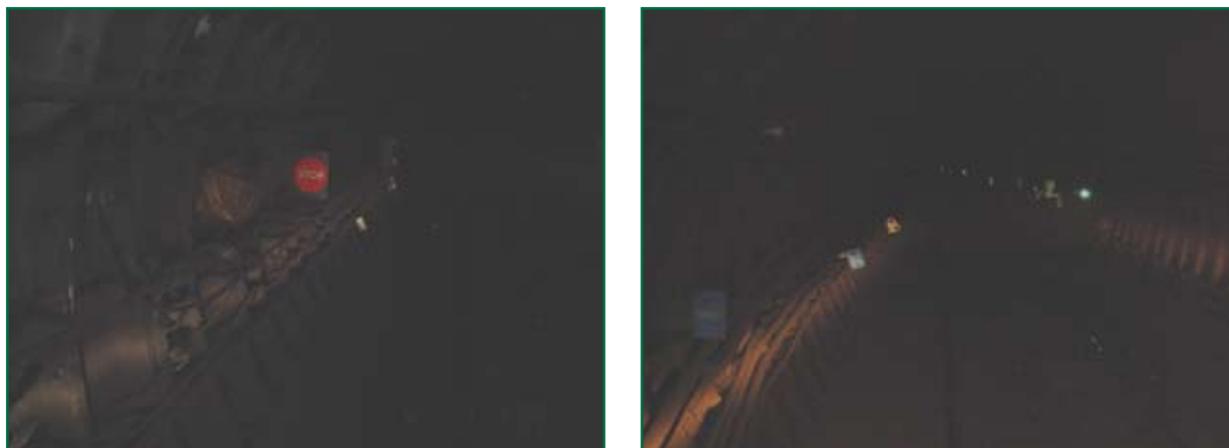
Figure 4: The forward view from the cab at the south end (left) and the north end (right) of a train standing at the Barnet Branch platform at Camden Town

- 55 A red board with the word 'stop' in white letters is exhibited on the left of the tunnel wall a short distance into the tunnel at the south end of the platform. It is not specifically illuminated, but it would be reflected in the train's headlights and be visible to a person seated in the train operator's seat by the train's headlights when the train is ready to be moved as shown in Figure 4.

- 107 There is no evidence that the train operator was aware of the 'stop' board. Had he observed the board, it is unlikely that he would have driven past it without taking other factors into account which would probably have caused him to realise that he had entered the wrong cab. This was a factor contributory to the incident.
