Rail Accident Investigation Branch

Rail Accident Report

Passenger train derailment near Fisherground on the Ravenglass & Eskdale Railway 12 May 2007

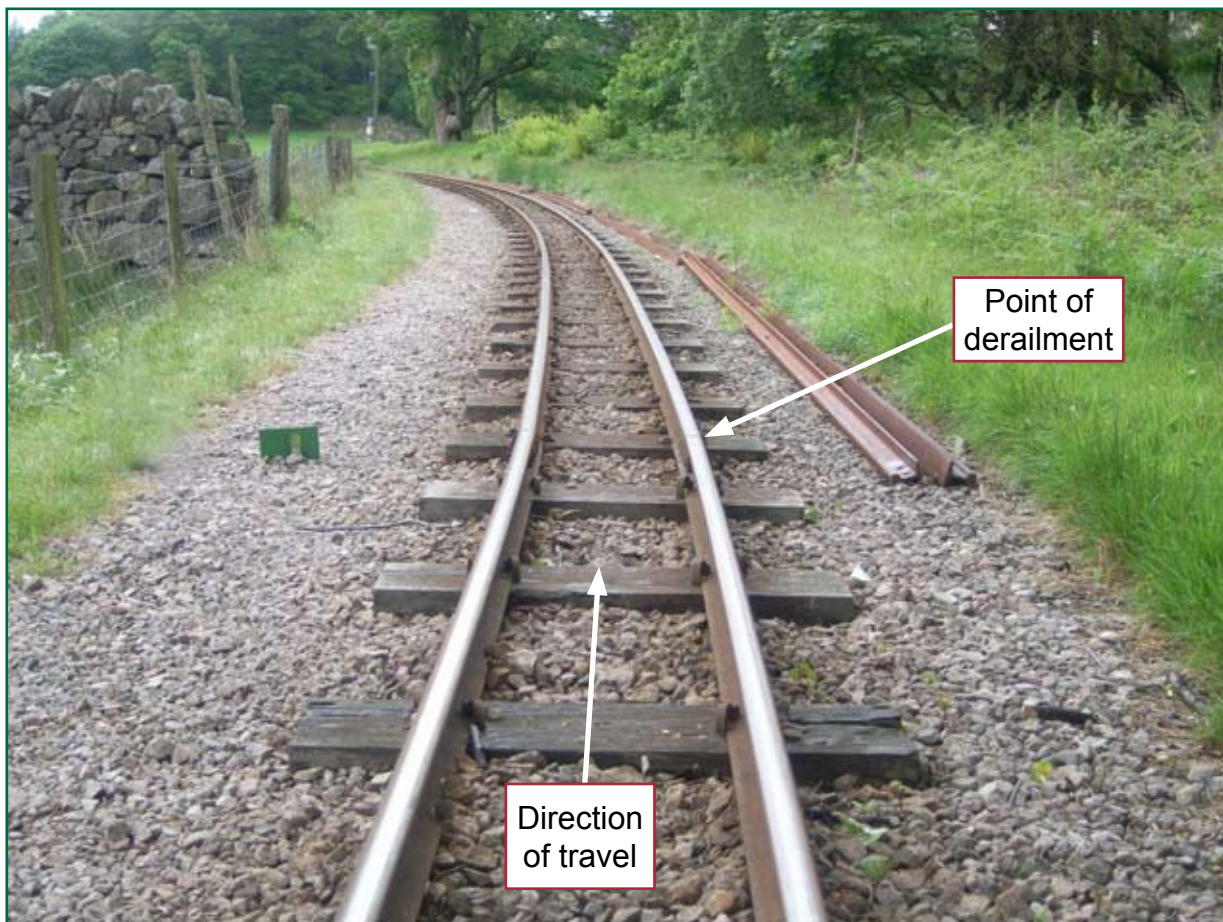
Figure 2: Site of derailment at Hollin How

- 26 Although the POD was at the start of a stretch of track which was awaiting renewal, there was no evidence of track vertical or lateral alignment problems nor voiding in the immediate vicinity of the POD, which could have directly caused or contributed to the derailment.

27 There was a rail joint in the sleeper bay just before the POD which had a dip of 4-5 mm on the right hand rail and 2-3 mm on the left hand rail causing a slight track twist at this point. A right rail dip of 4-5 mm is considered by R&ER to be at the upper range of acceptability given that the track was approaching relaying and already had a temporary speed restriction. Although the track twist at the rail joint was insufficient to have caused the derailment, it would have exacerbated any wheel unloading arising from a suspension collapse (paragraph 35).

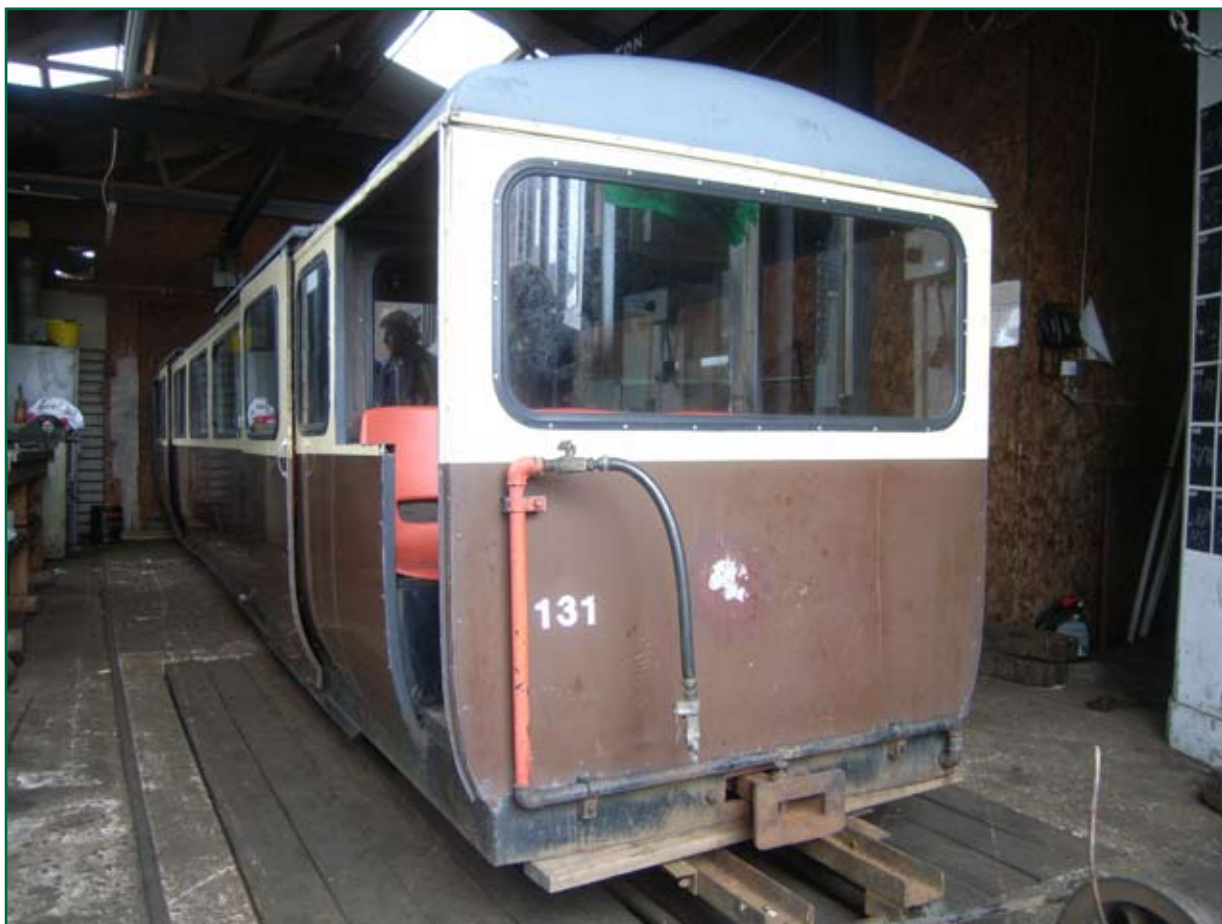
Figure 3: Maxi coach 131 with leading end (nearest) on skidder unit

- 19 The derailed coach was detached from the trailing coaches and the leading bogie was placed on a skidder unit (Figure 3). The trailing bogie was rerailed. The five remaining vehicles on site, including coach 131, were recovered back to Ravenglass later that evening.

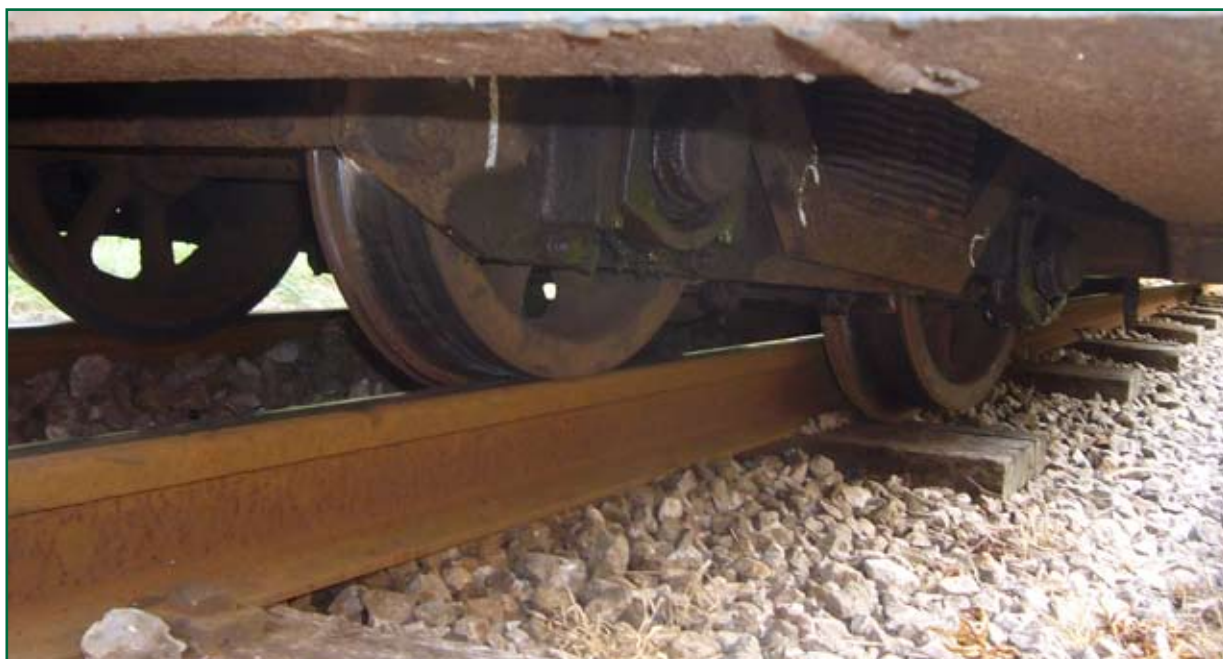
Figure 4: Derailed leading wheelset on trailing bogie of Maxi coach 131 on site at Hollin How (courtesy of R&ER)

- 25 Track marks found shortly after the derailment showed that the leading right hand wheel of the trailing bogie on Maxi coach 131 had derailed by flange climb toward the outside of the curve (Figure 4), possibly aided by the prevailing dry wheel/rail conditions. The trailing wheelset of this bogie did not derail.

- 38 The immediate cause of the derailment was flange climb of the leading right hand wheel of the trailing bogie on Maxi coach 131 as it unloaded whilst negotiating the left hand curve at Hollin How. The unloading resulted directly from the prior collapse of the suspension on the left hand side of the leading bogie as confirmed by tests (paragraph 35).

- 39 A very low vertical wheel load in the presence of normal lateral curving forces would have induced the wheel flange to climb. Additionally the slight twist at the rail joint just before the POD (paragraph 27), would have contributed to the wheel unloading and explains why the bogie derailed at that particular location. The dry rail head conditions may also have contributed to the derailment.

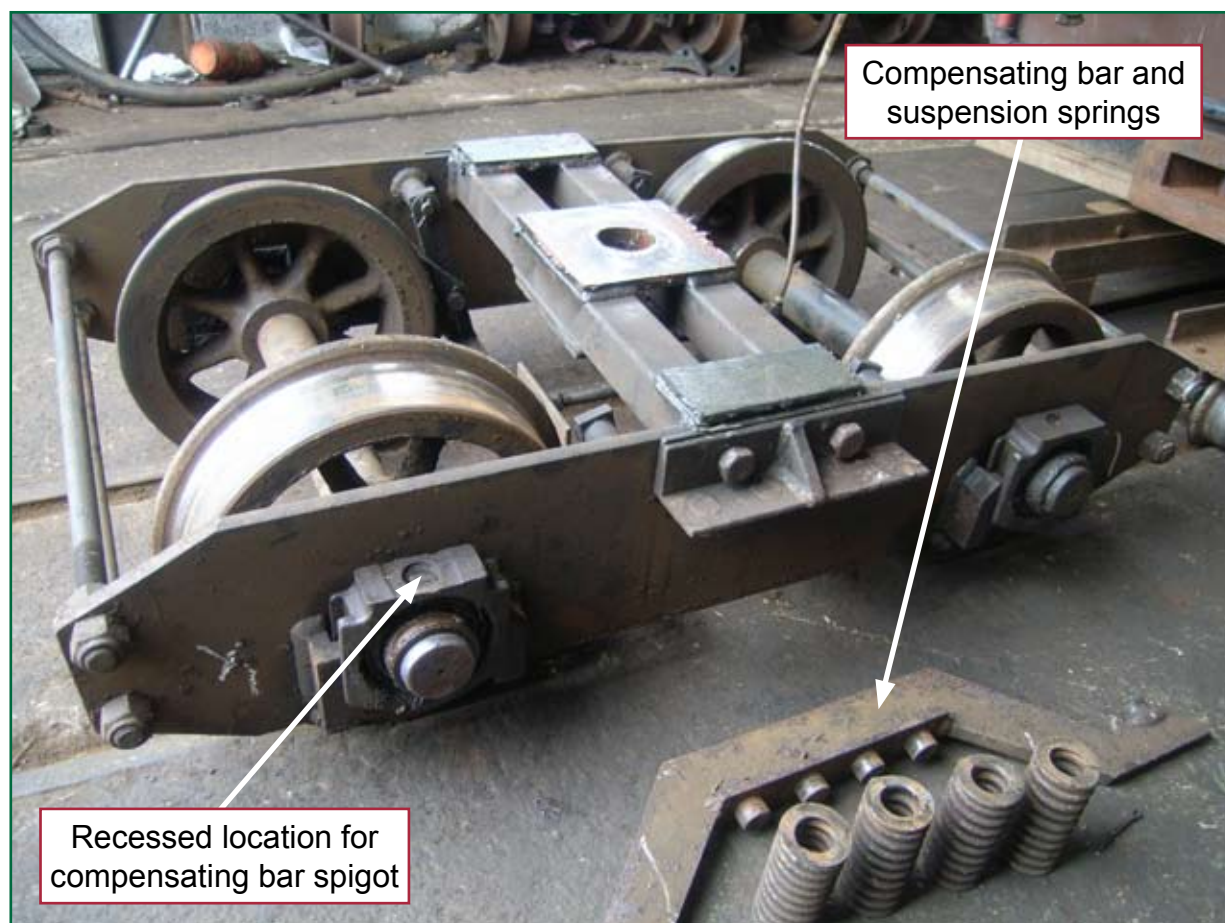
Figure 5: Derailed leading bogie from Maxi coach 131 with compensating bar detached from left-hand side

28 The compensating bar and the four coil springs on the left side of the leading bogie had fallen off 14 sleepers before the POD, causing the suspension on that side to collapse but without causing derailment of the leading bogie.

29 Each end of the compensating bar has a spigot which normally sits in a shallow locating recess on the top of the *axlebox* (Figure 5). The spigot at the leading end of the left hand compensating bar was severely scored with signs of overheating where it had been rubbing on the adjacent axle. The top of the axlebox also had signs of wear indicating that the spigot had been riding outside its recessed seat. The axle end showed corresponding signs of heavy wear confirming that the detachment of the bar and the subsequent drop onto the track was the initiating event rather than consequential.

- 32 Interview evidence indicated that the most likely cause of the compensating bar coming adrift at Hollin How was that it had not been properly seated in its axlebox locating recess when the bogie was reassembled. The work had been carried out under some time pressure due to the high workload at the time and the R&ER maintainer, who had over 20 years experience on this type of work, had not spotted the problem when the bogie was fitted to coach 131. The task sheet for the inspection contained only the result tables to be filled in as measurements were taken. There was no checklist for reassembly or any requirement for an independent check to be done following reassembly of the bogie.

- 33 Even with the spigot of the compensating bar sitting on the outer edge of the axlebox, the bogie can still be reassembled and will appear to run normally. However, in this condition the bar can shuffle along and fall off onto the axle end where it could ride for some time before falling off completely. This sequence of events appears to have been what happened in the lead up to the derailment and was confirmed by testing the bogie on coach 134 which was also found to have a displaced compensating bar. When suspension movements were induced by swaying the coach body from side to side, the compensating bar moved toward the outboard edge of the axlebox and had it been tested further, would have fallen onto the axle end.

- 40 The reason that the suspension collapsed on the leading bogie was that the left hand compensating bar fell off, probably because it had not been fitted correctly when the bogie was reassembled on 26 April 2007. Testing of the coaches (paragraphs 34 and 35) and previous service experience on the R&ER confirm that correctly fitted compensating bars do not work themselves out of their recessed housing on the axleboxes. The incorrect assembly of the compensating bar was therefore a causal factor. Time pressure due to the high workload at the time may have been a contributory factor (paragraph 32).

- 41 R&ER did not, at the time of the derailment, have a requirement for an internal independent check to be carried out on each bogie following reassembly and the incorrect installation of the compensating bar went unnoticed. Additionally, once the bogie is installed under the vehicle, the top of the bogie is not visible. The lack of a correctly implemented independent check following bogie reassembly was therefore also a causal factor (Recommendation 1).

- 43 R&ER have carried out the following actions since the derailment:
- Modified their bogie maintenance procedure to include an independent safety check by a competent person following bogie reassembly.

- Commenced fitting of retaining brackets to Maxi coach bogies and other bogie designs which feature compensating bars. The brackets are designed to keep the bars in place if they become dislodged from their axlebox housing for any reason.

1. Review and identify safety critical elements of engineering work on their bogies, including the re-fitting of compensating bars, and implement work procedures which include:
 - a primary check by the person undertaking the work; and
 - a secondary independent check signed off by a competent R&ER person to ensure that any problems are detected before entering service (paragraph 41).
2. Review their safety management system and operational procedures to identify if there are other areas where safety critical maintenance or design work is undertaken, or decisions are made, which should be subject to independent checking, and implement appropriate changes to procedures (paragraph 42).
