Rail Accident Report

Collision at Pickering station North Yorkshire Moors Railway 5 May 2007

Investigation into collision at Pickering station North Yorkshire Moors Railway, 5 May 2007

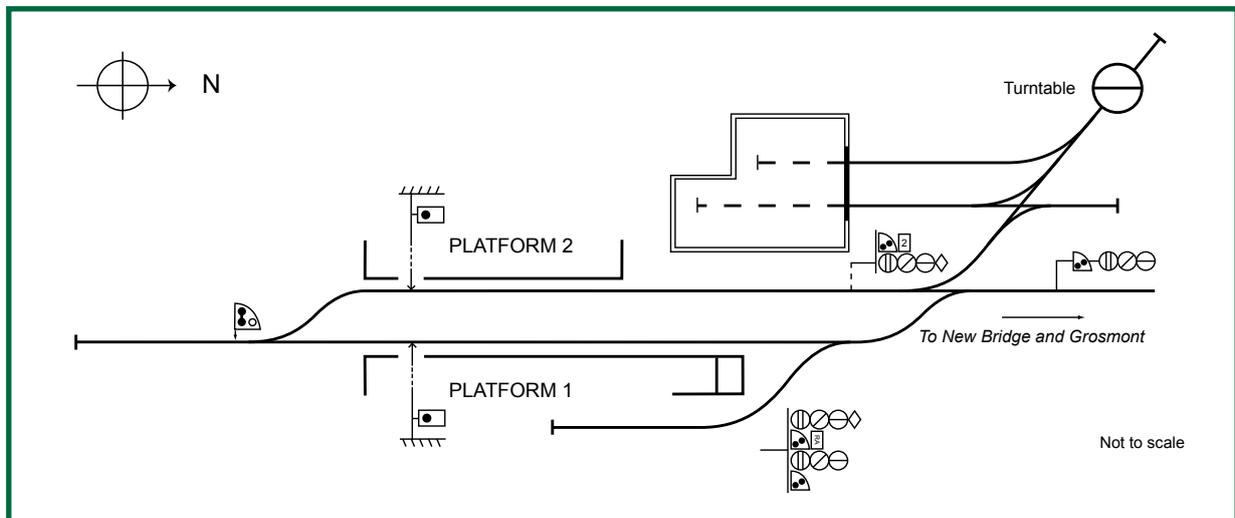
Figure 2: Track layout at Pickering

- 10 Pickering station is the southern terminus of the line. There are two running lines passing between the two platforms. At the southern end of the station is a single pair of points, leading from both lines into a headshunt (Figure 2).

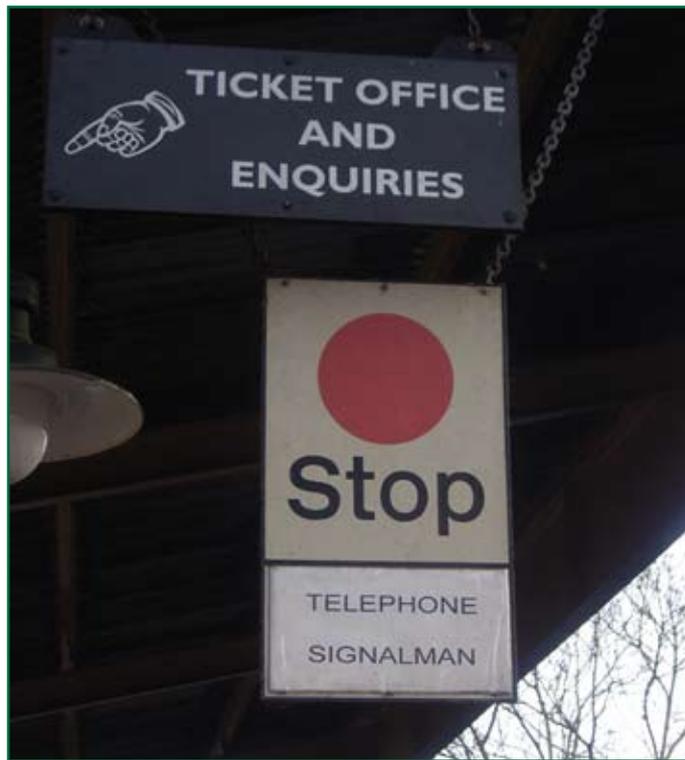
Figure 3: Stop board at the south end of Pickering station

- 12 At the south end of platforms one and two running lines are *stop boards* (Figure 3). A train arriving at Pickering that is short enough to fit in the platform line with its engine has to stop before reaching these boards, which are effectively signals. The locomotive is then uncoupled from the train, and moved into the headshunt, before returning through the other platform to run round. If a train is longer than normal it can be given a written permit by the signaller at New Bridge to pass the stop board, drawing forward to a position where the locomotive can still run round its train, but preventing the risk of the carriages fouling the other line.

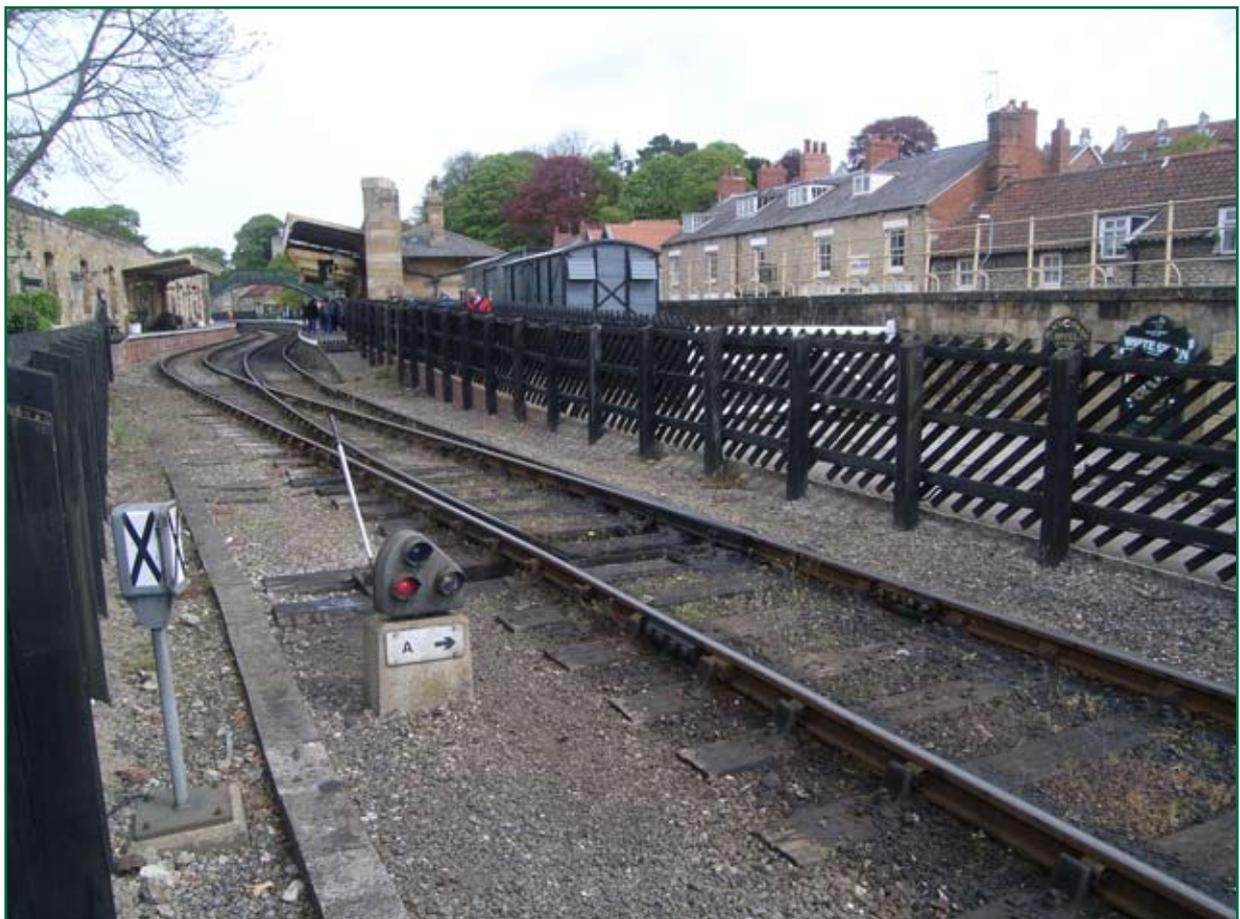
Figure 4: Points lever and ground signal at Pickering south

- 13 The points at the south end of the station are not traversed by any passenger trains, and are operated by a hand lever. A single *ground signal* (Figure 4) is provided, which can be *cleared* by the signaller at New Bridge when there is no train detected by a *track circuit* as standing on the south end points. The ground signal can only be cleared two minutes after the track circuit has itself cleared and is intended to ensure that a locomotive only runs round when the signaller wishes it to. This is to avoid the risk of a collision being caused by a locomotive running round one train at the same time as another train enters the second platform.

- 14 The ground signal gives no indication as to which direction the points are set in, only permission to enter the platform loop area. Discussion with Network Rail indicates that this arrangement of signals is not used on the national network.

- 39 A further contributory factor was that the ground signal only indicated that the locomotive could enter the station, but did not indicate the lie of the points.

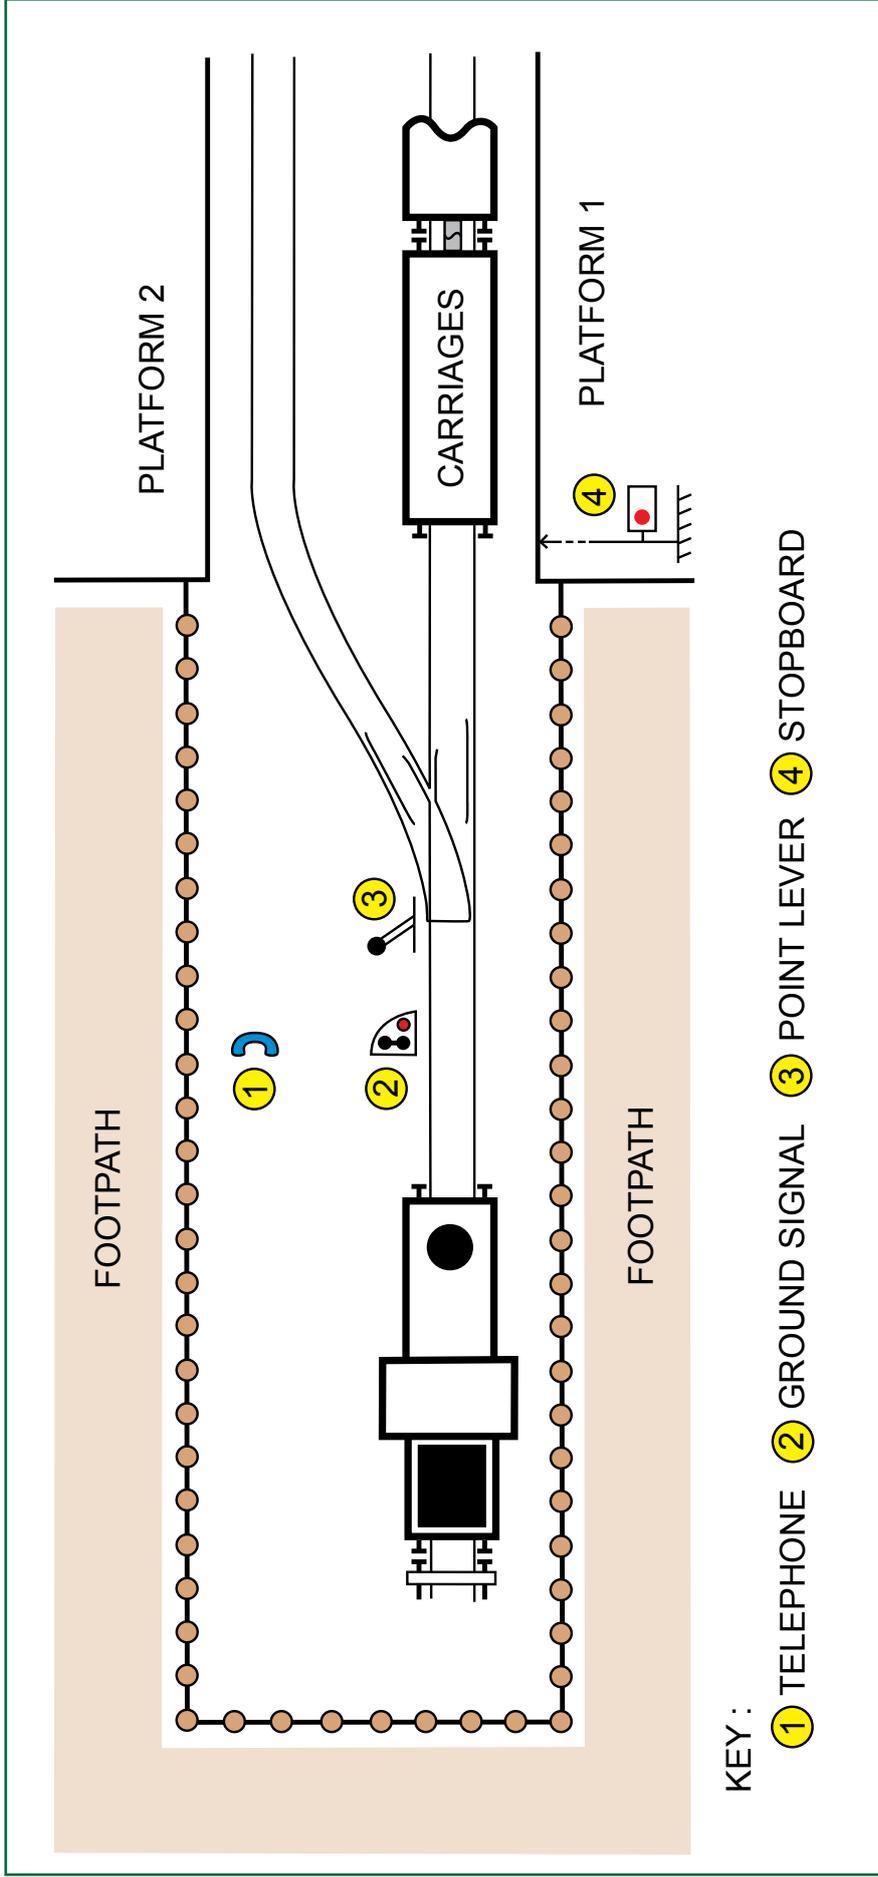
Figure 5: Key features of the headshunt at Pickering south at 15:23 hrs, 5 May 2007

- 15 The headshunt is separated from the surrounding area by a wooden fence. The public have access to the outside of the fence, on both sides of the railway, and gather in this area to observe locomotives running round from close by (Figure 5).

- 29 The driver then descended from the locomotive and went to change the points. He spoke to the signaller using the signal post telephone next to the ground signal, but then became engaged in conversation with members of the public outside the boundary fence who were asking about the operation of the railway. The driver was concerned about time pressure before the train's departure (scheduled for 15:40 hrs), and broke off the conversation to return to the cab. In doing so he overlooked that he had not changed the points.

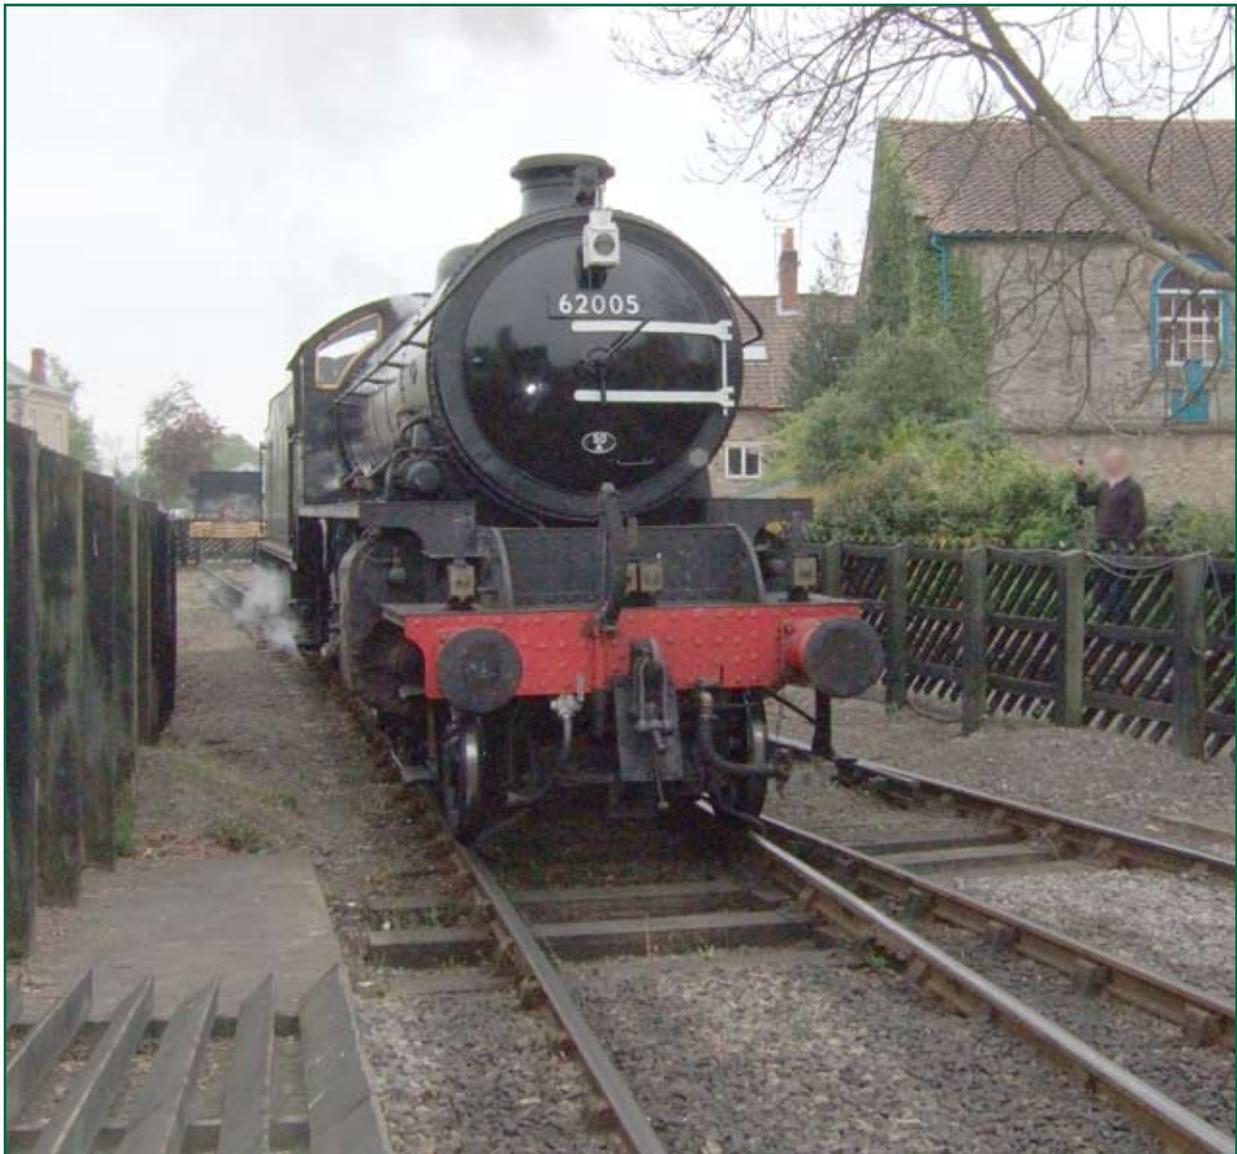
Figure 6: Train re-entering platform one at Pickering (photograph courtesy of site witness)

- 31 At 15:24 hrs the locomotive re-entered platform one and the crew realised that they were on the wrong line; the driver immediately applied the brakes (Figure 6). However, it was too late for the locomotive to stop and it collided at slow speed with the carriages it had hauled, moving the train northwards by about 0.5 m.
- 32 There were four passengers in the observation saloon of the General Manager's saloon at the time of the collision. Some of them saw the locomotive approaching, and realising that a collision was imminent, attempted to leave the carriage. A number of passengers were knocked over by the collision; none were seriously injured, and first aid was provided by NYMR staff. One of these passengers was taken to hospital as a precaution, but was discharged the same evening.

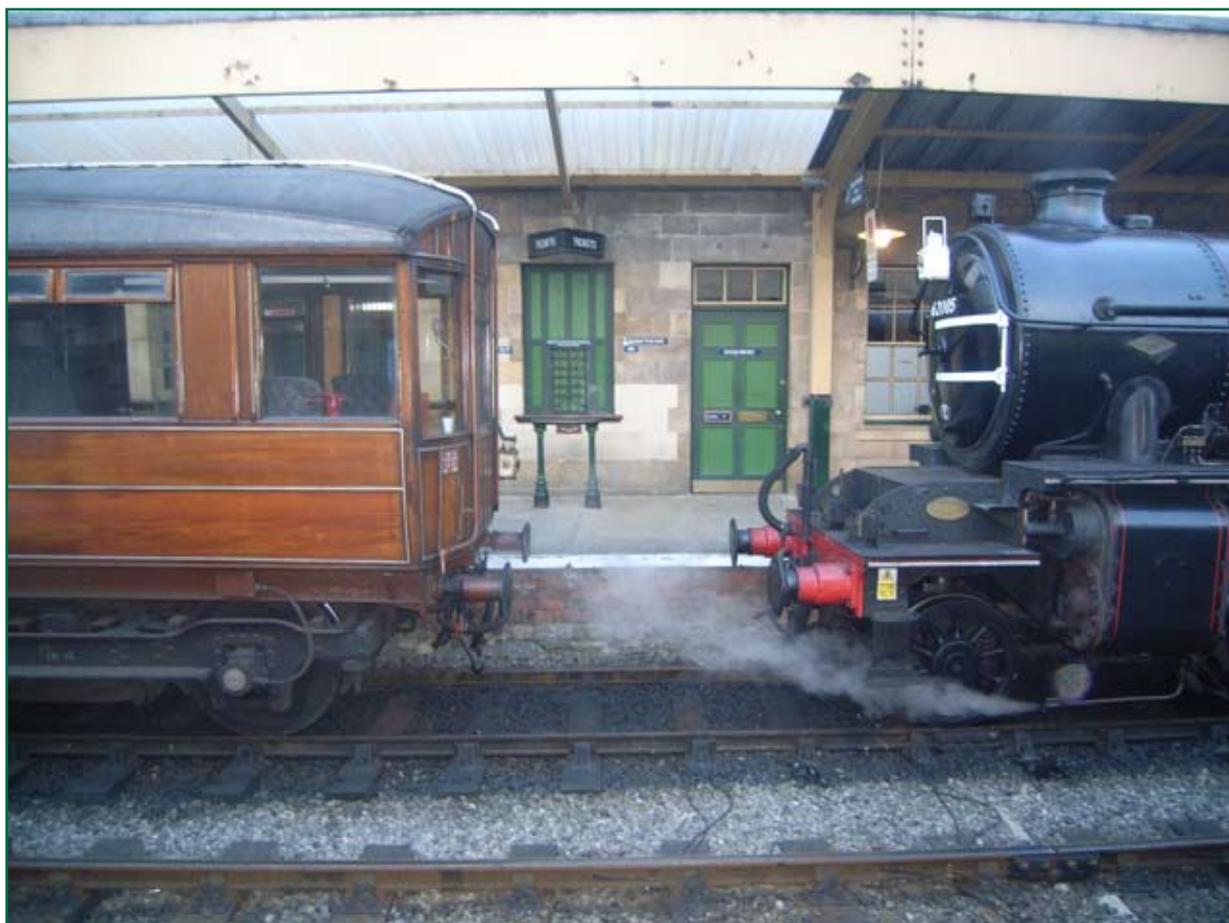
Figure 7: Locomotive and saloon after locomotive had been moved clear

33 The collision had lifted the body of the General Manager's saloon a small amount (probably less than 25 mm) off its south end bogie. The collision also resulted in compression of the buffers between the two vehicles. Shortly after the collision occurred the driver eased off the locomotive steam brake in order to then apply the handbrake. The buffer springs expanded and moved the locomotive back, and the driver let it roll back to a natural stop and re-applied the brakes about a metre away from the carriages. In doing this he considered he was making the train safer. However, as a result the saloon dropped back onto its bogie; the shock and noise of this caused further distress to those passengers who were still inside. Moving the locomotive in this way also disturbed evidence without the agreement of the RAIB, contrary to the Rail Accident (Investigation and Reporting) Regulations, 2005 (Figure 7).

- 42 Releasing the locomotive brakes to allow it to move away from the train after the collision without ensuring that those involved were aware of the imminent movement caused further distress to the passengers and in addition disturbed evidence of the accident without permission from the RAIB.

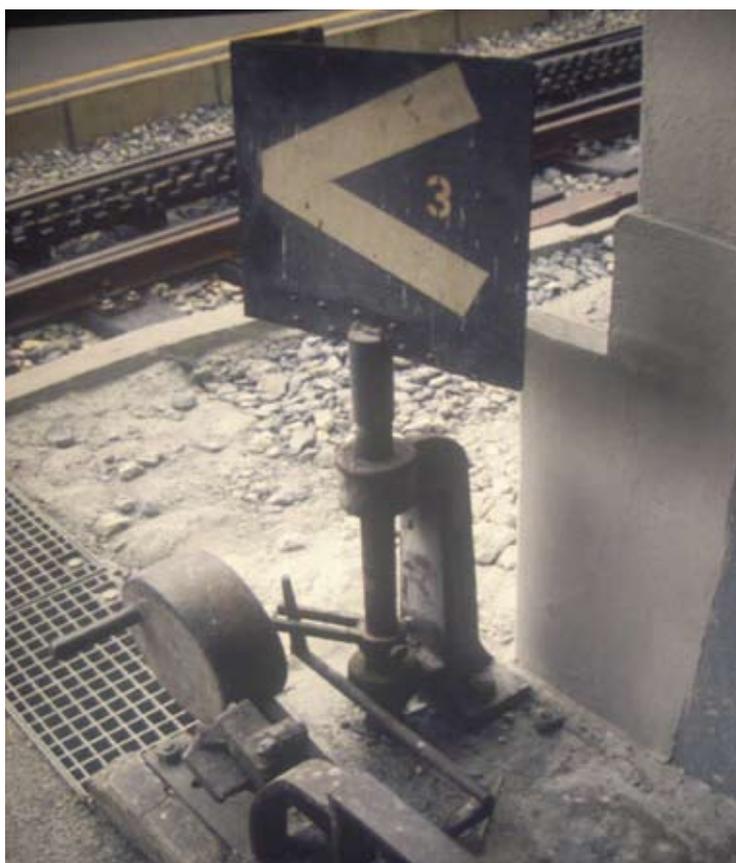
Figure 8: Point lever and indicator combined (photograph courtesy of private collection)

- 41 Either a person standing by the points, observing their lie, and calling the train forward or a suitably designed hand worked lever mechanically linked to an indicator (Figure 8) would have adequately mitigated the risk identified at Pickering from this incident.

1. The NYMR should immediately mandate that the person who operates the hand points at Pickering south should remain at the points after operating them, and should only call a locomotive past them when the ground signal clears, after again checking the lie of the points (paragraphs 41 and 43); or
The NYMR should install a system at Pickering south that provides an indication to the train crew in the cab as to the lie of the points (paragraph 41).
2. The NYMR should introduce procedures to ensure that after an accident no rolling stock or other evidence is moved without considering the effect on people involved, and only in compliance with the Rail Accident (Investigation and Reporting) Regulations, 2005.
