Rail Accident Investigation Branch

# Rail Accident Report

## **Collision at Pickering station North Yorkshire Moors Railway 5 May 2007**

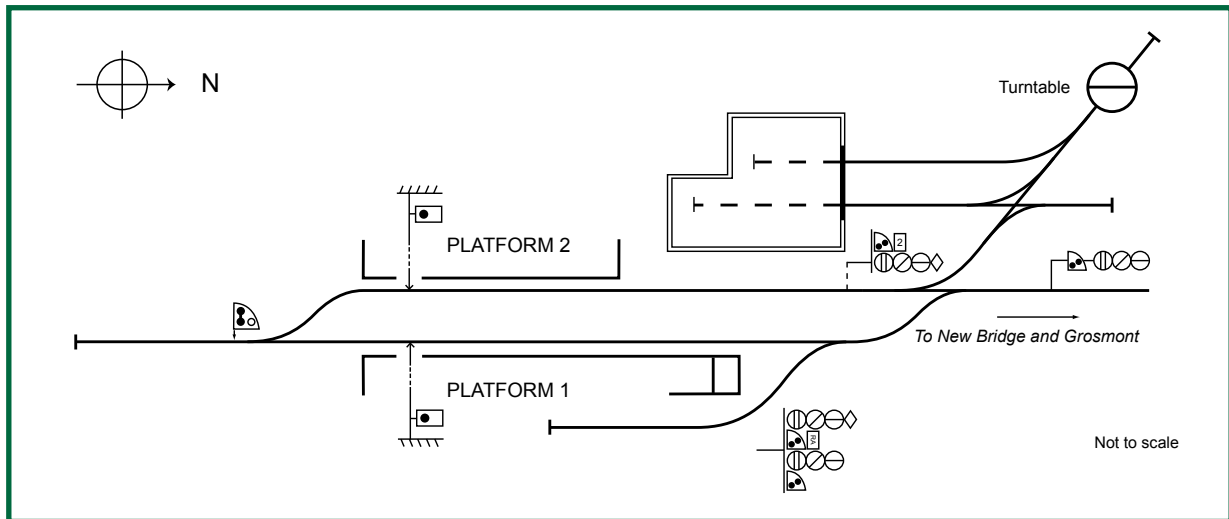
- 10 Pickering station is the southern terminus of the line. There are two running lines passing between the two platforms. At the southern end of the station is a single pair of points, leading from both lines into a headshunt (Figure 2).

Figure 2: Track layout at Pickering

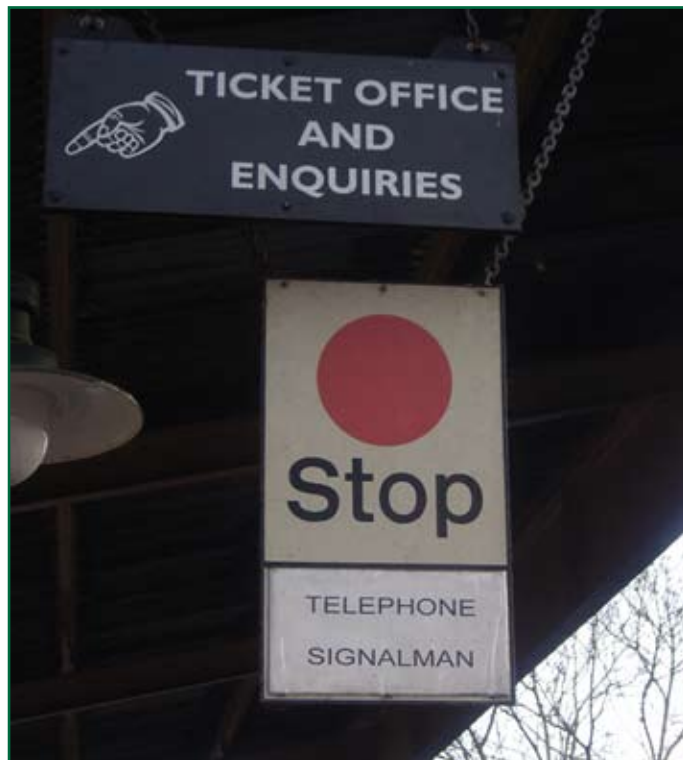
- 12 At the south end of platforms one and two running lines are *stop boards* (Figure 3). A train arriving at Pickering that is short enough to fit in the platform line with its engine has to stop before reaching these boards, which are effectively signals. The locomotive is then uncoupled from the train, and moved into the headshunt, before returning through the other platform to run round. If a train is longer than normal it can be given a written permit by the signaller at New Bridge to pass the stop board, drawing forward to a position where the locomotive can still run round its train, but preventing the risk of the carriages fouling the other line.

*Figure 3: Stop board at the south end of Pickering station*

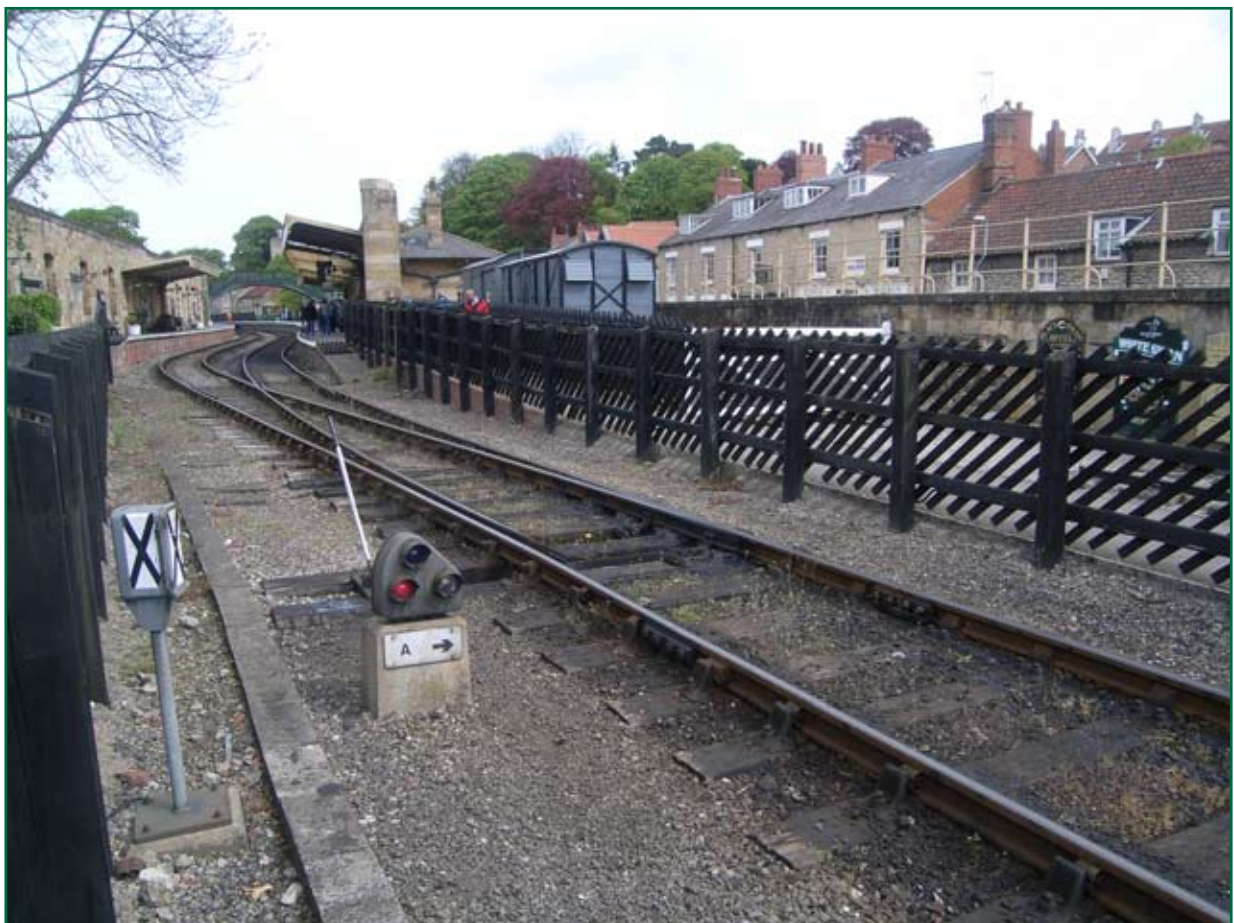
*Figure 4: Points lever and ground signal at Pickering south*

- 13 The points at the south end of the station are not traversed by any passenger trains, and are operated by a hand lever. A single *ground signal* (Figure 4) is provided, which can be *cleared* by the signaller at New Bridge when there is no train detected by a *track circuit* as standing on the south end points. The ground signal can only be cleared two minutes after the track circuit has itself cleared and is intended to ensure that a locomotive only runs round when the signaller wishes it to. This is to avoid the risk of a collision being caused by a locomotive running round one train at the same time as another train enters the second platform.

- 14 The ground signal gives no indication as to which direction the points are set in, only permission to enter the platform loop area. Discussion with Network Rail indicates that this arrangement of signals is not used on the national network.

- 39 A further contributory factor was that the ground signal only indicated that the locomotive could enter the station, but did not indicate the lie of the points.

- 43 The NYMR have instructed that any person who operates the hand points at Pickering south must remain at the points after operating them, and only call a locomotive past them when the ground signal clears, after again checking the lie of the points.

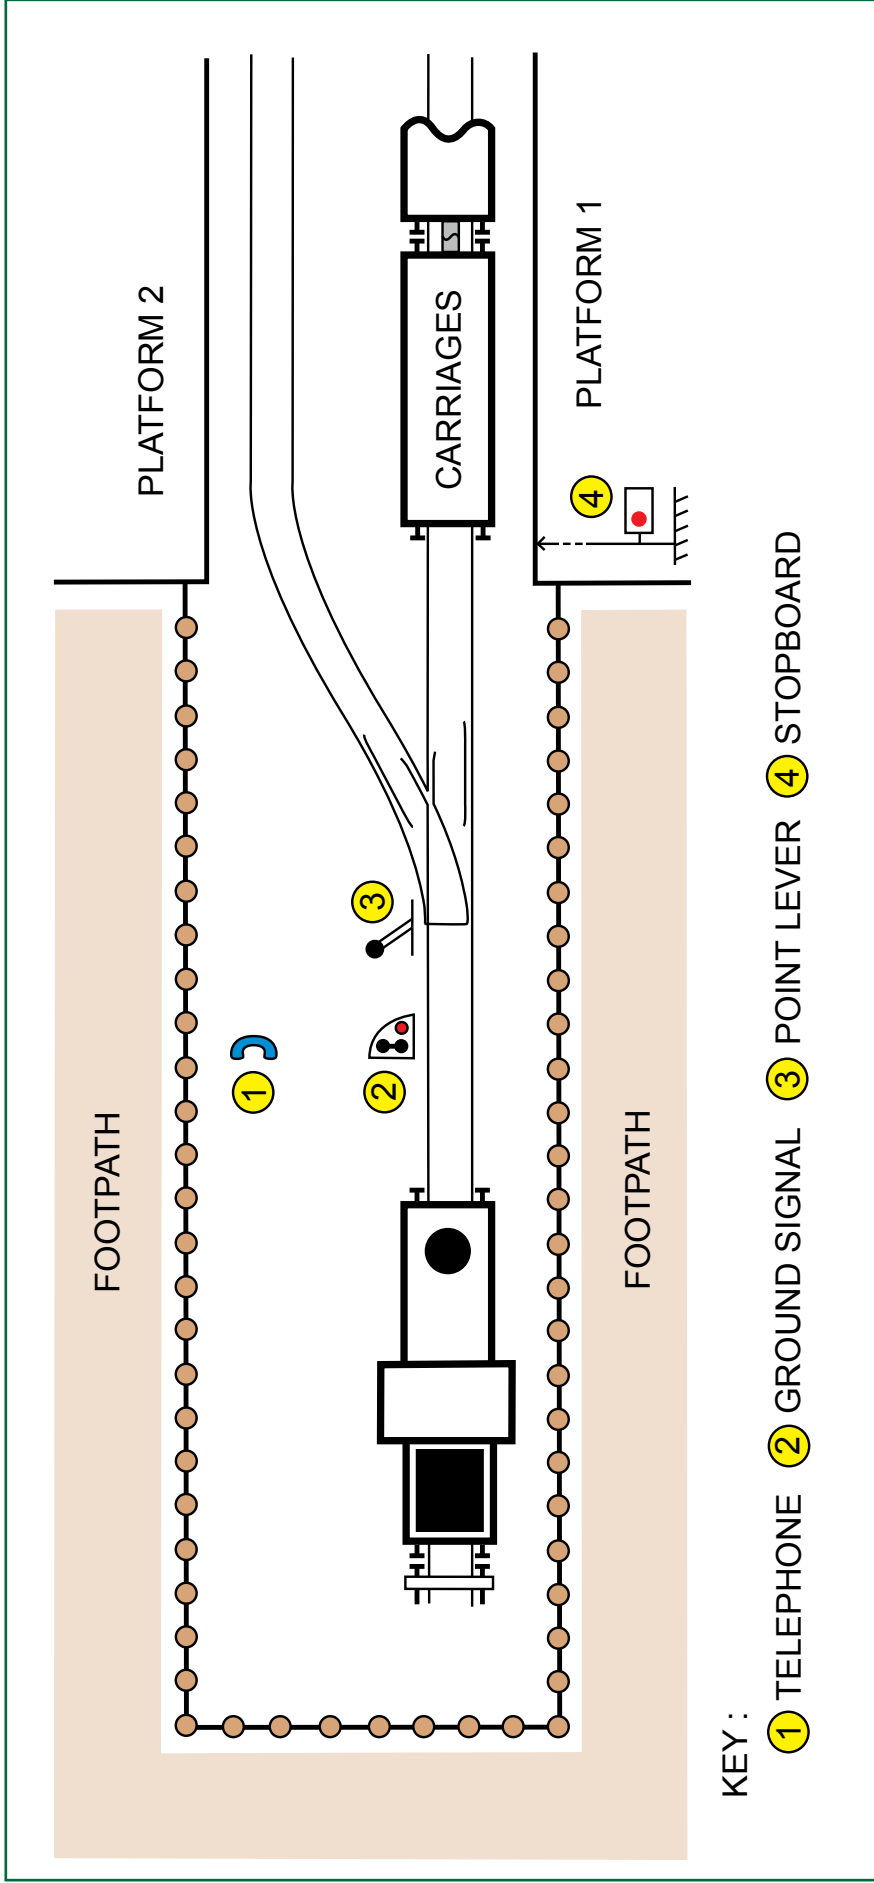
- 15 The headshunt is separated from the surrounding area by a wooden fence. The public have access to the outside of the fence, on both sides of the railway, and gather in this area to observe locomotives running round from close by (Figure 5).

Figure 5: Key features of the headshunt at Pickering south at 15:23 hrs, 5 May 2007

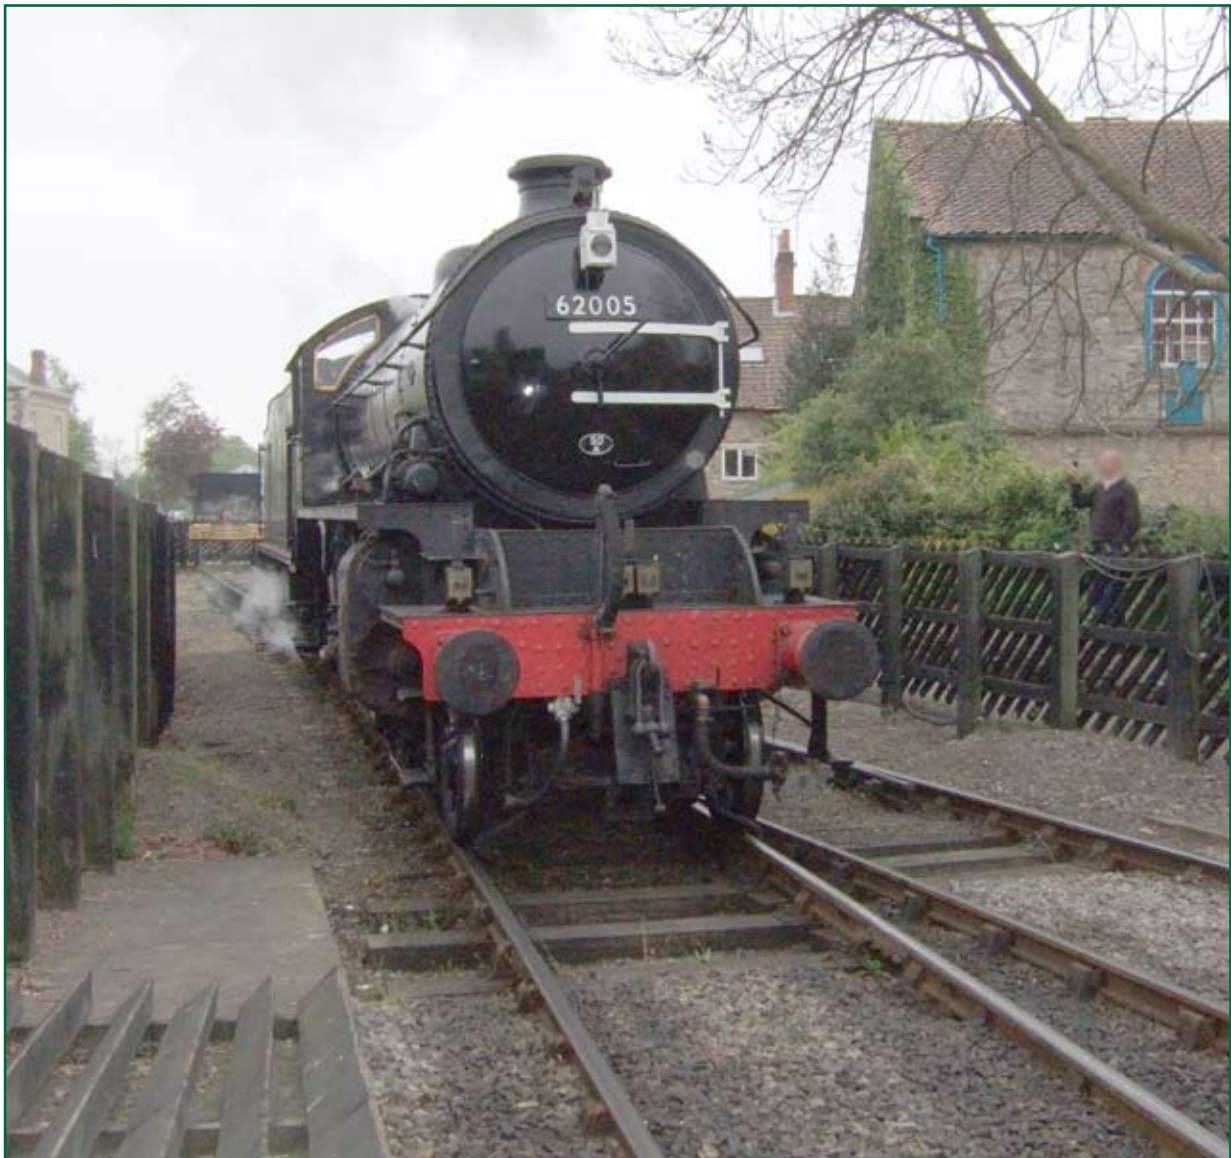
*Figure 6: Train re-entering platform one at Pickering (photograph courtesy of site witness)*

- 31 At 15:24 hrs the locomotive re-entered platform one and the crew realised that they were on the wrong line; the driver immediately applied the brakes (Figure 6). However, it was too late for the locomotive to stop and it collided at slow speed with the carriages it had hauled, moving the train northwards by about 0.5 m.
- 32 There were four passengers in the observation saloon of the General Manager's saloon at the time of the collision. Some of them saw the locomotive approaching, and realising that a collision was imminent, attempted to leave the carriage. A number of passengers were knocked over by the collision; none were seriously injured, and first aid was provided by NYMR staff. One of these passengers was taken to hospital as a precaution, but was discharged the same evening.

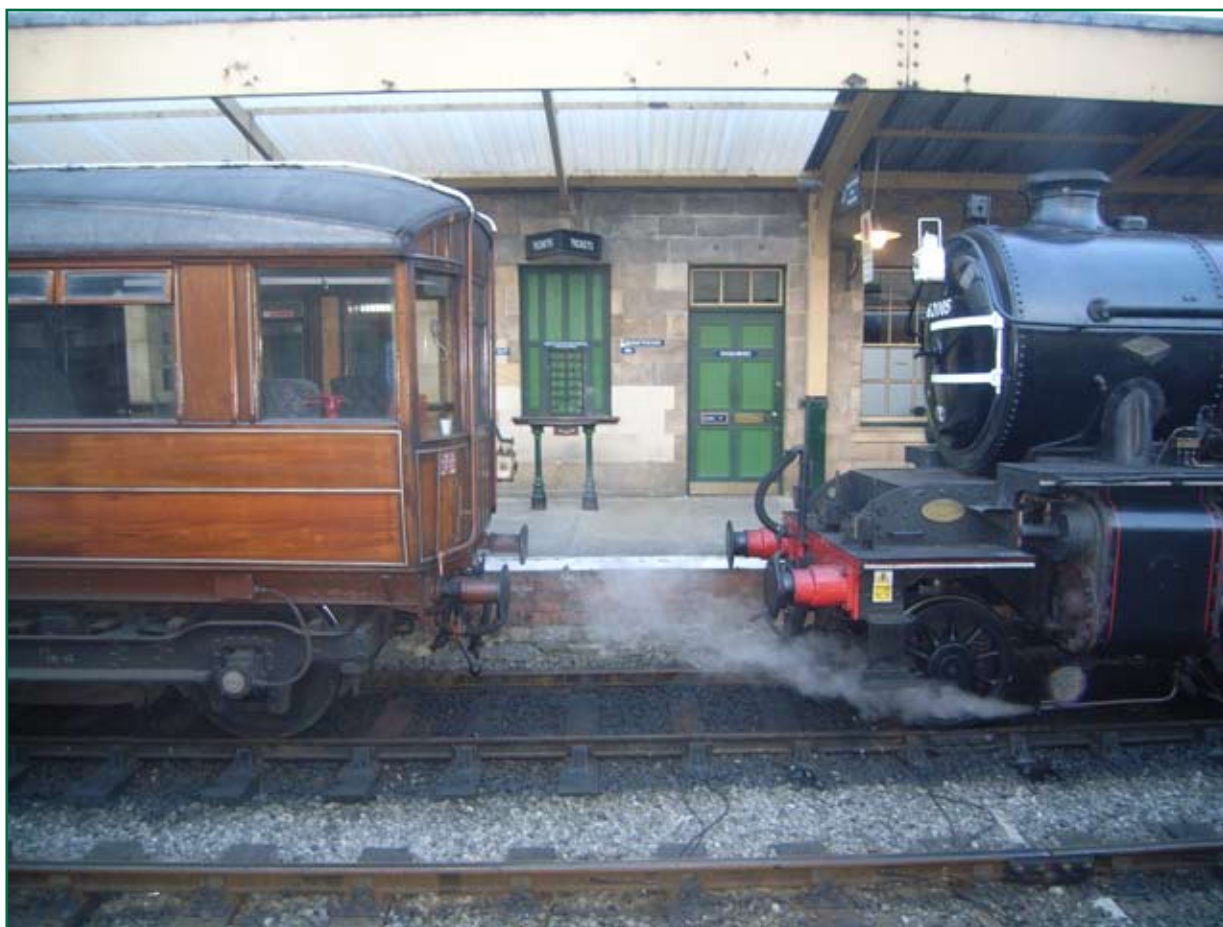
33 The collision had lifted the body of the General Manager's saloon a small amount (probably less than 25 mm) off its south end bogie. The collision also resulted in compression of the buffers between the two vehicles. Shortly after the collision occurred the driver eased off the locomotive steam brake in order to then apply the handbrake. The buffer springs expanded and moved the locomotive back, and the driver let it roll back to a natural stop and re-applied the brakes about a metre away from the carriages. In doing this he considered he was making the train safer. However, as a result the saloon dropped back onto its bogie; the shock and noise of this caused further distress to those passengers who were still inside. Moving the locomotive in this way also disturbed evidence without the agreement of the RAIB, contrary to the Rail Accident (Investigation and Reporting) Regulations, 2005 (Figure 7).

*Figure 7: Locomotive and saloon after locomotive had been moved clear*

- 42 Releasing the locomotive brakes to allow it to move away from the train after the collision without ensuring that those involved were aware of the imminent movement caused further distress to the passengers and in addition disturbed evidence of the accident without permission from the RAIB.

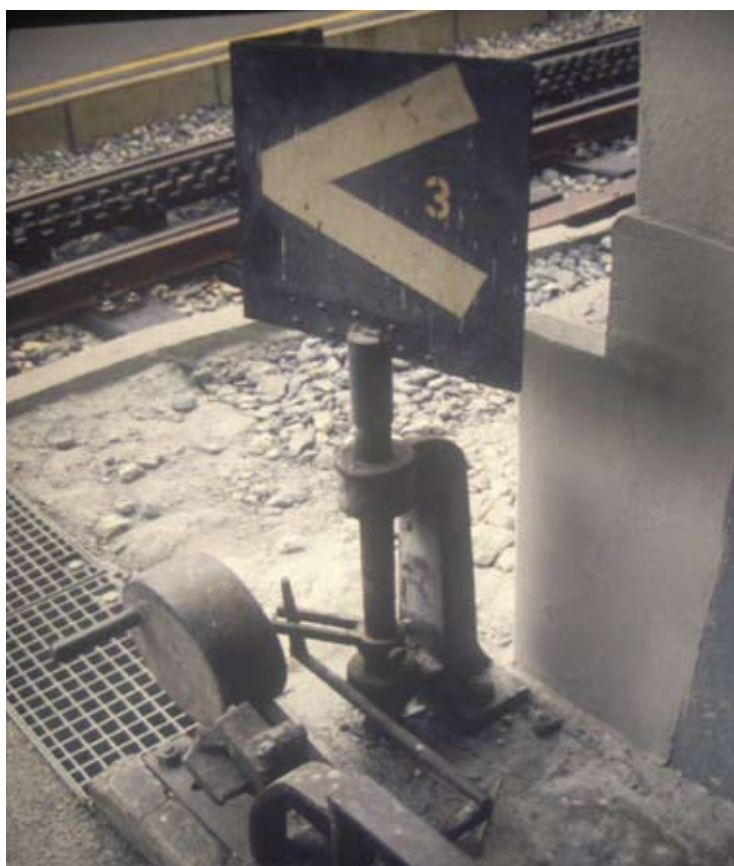
- 41 Either a person standing by the points, observing their lie, and calling the train forward or a suitably designed hand worked lever mechanically linked to an indicator (Figure 8) would have adequately mitigated the risk identified at Pickering from this incident.

*Figure 8: Point lever and indicator combined (photograph courtesy of private collection)*

1. The NYMR should immediately mandate that the person who operates the hand points at Pickering south should remain at the points after operating them, and should only call a locomotive past them when the ground signal clears, after again checking the lie of the points (paragraphs 41 and 43); or  
The NYMR should install a system at Pickering south that provides an indication to the train crew in the cab as to the lie of the points (paragraph 41).
2. The NYMR should introduce procedures to ensure that after an accident no rolling stock or other evidence is moved without considering the effect on people involved, and only in compliance with the Rail Accident (Investigation and Reporting) Regulations, 2005.
