Rail Accident Investigation Branch

Rail Accident Report

Track worker fatality at Ruscombe Junction 29 April 2007

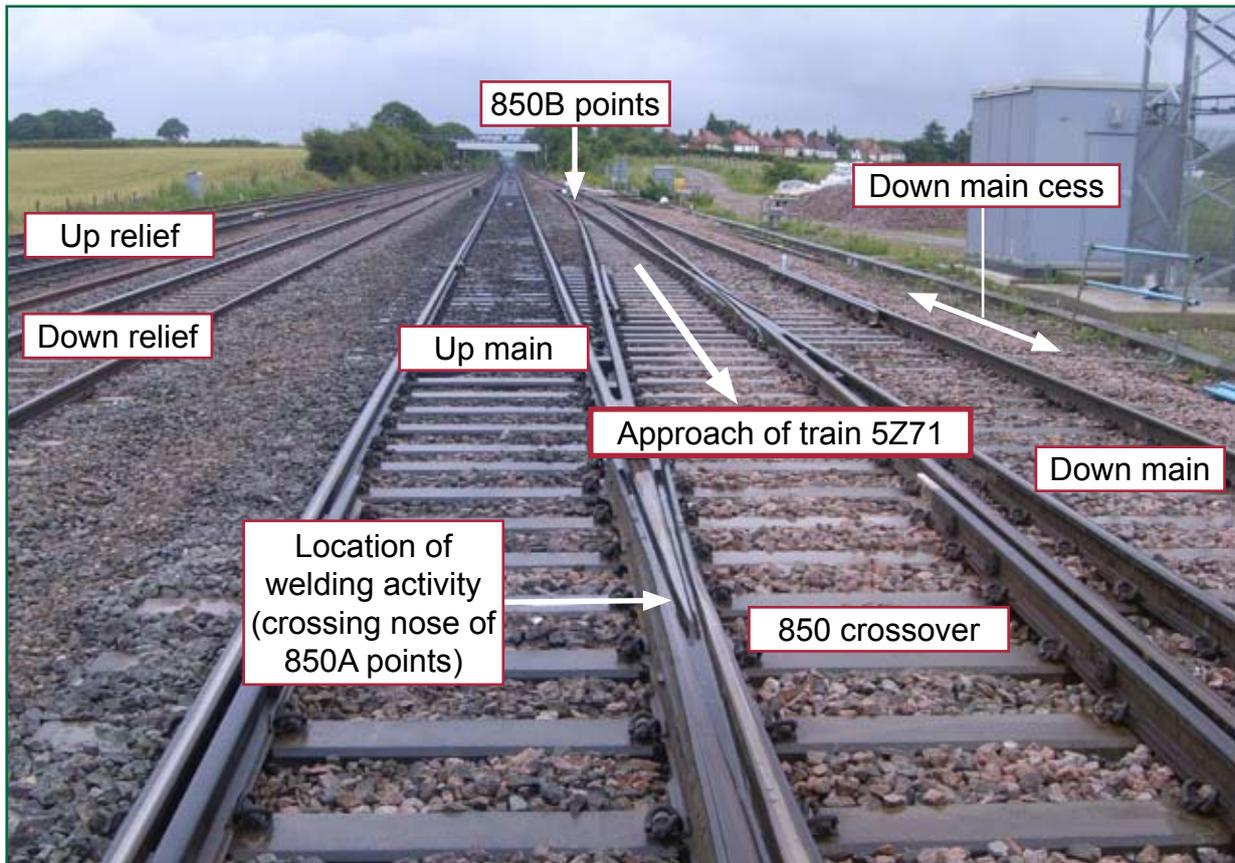
Figure 3: Ruscombe Junction (looking east at the crossing nose of 850A points)

- 36 Crossovers and especially the crossing nose of a high speed crossover are subject to heavy loading from the regular passage of trains through them and consequently wear rapidly.

- 37 Damage to the crossing nose is repaired by arc welding. This involves the crossing nose being cut back to sound metal by grinding and weld material being built up in layers. The finished repair is ground to its final profile.
