Rail Accident Report

Train/vehicle collision on the Leighton Buzzard Narrow Gauge Railway 25 March 2007

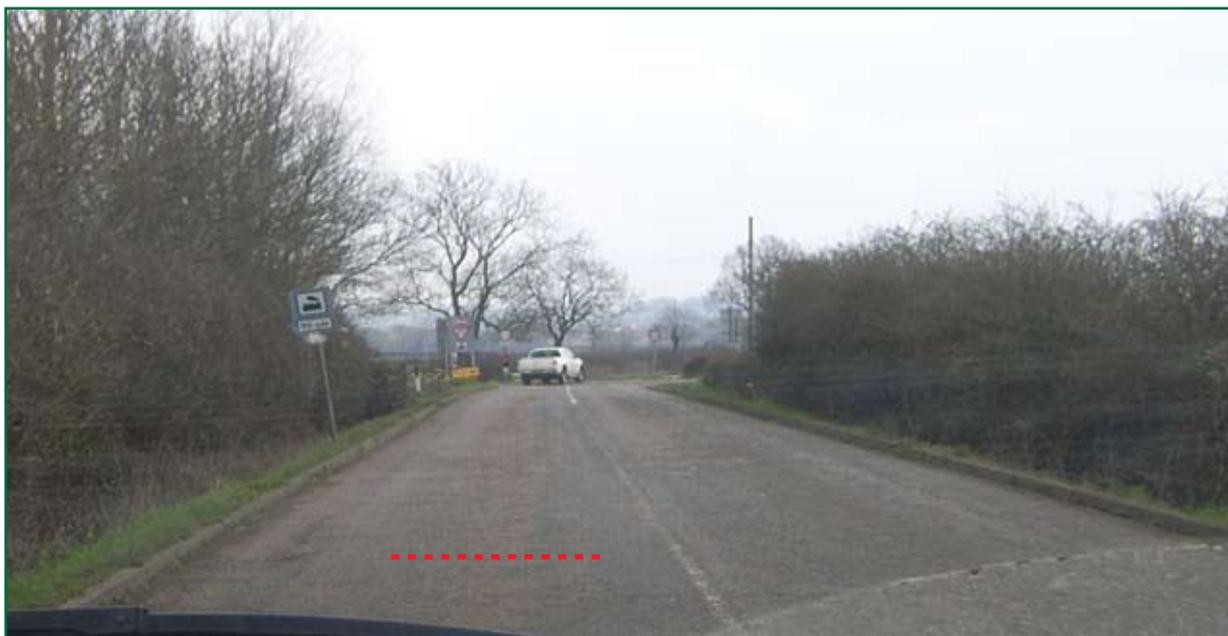
- 13 There is one advance sign on Shenley Hill Road indicating the level crossing, albeit not compliant to Diagram 771, and this is followed by two signs warning motor vehicles to give way, one for the crossing and one for the road junction. Both give way signs are accompanied by white stop lines painted on the road. The road markings are not clear and are in need of repair (see Figures 2 and 3).

Figure 2: View approaching Shenley Hill Road level crossing from North to South. A vehicle can be seen in space between the two give way areas waiting to turn right onto Mile Tree Road. The red line indicates the location, 40 m from the junction when the train can be partially seen from the left-hand side (LHS) in the direction of travel

- 14 There is space to allow a car to safely pass over the level crossing, stop and wait at the second give way signs, whilst still allowing a LBR train to safely pass behind the road vehicle (see Figure 2).

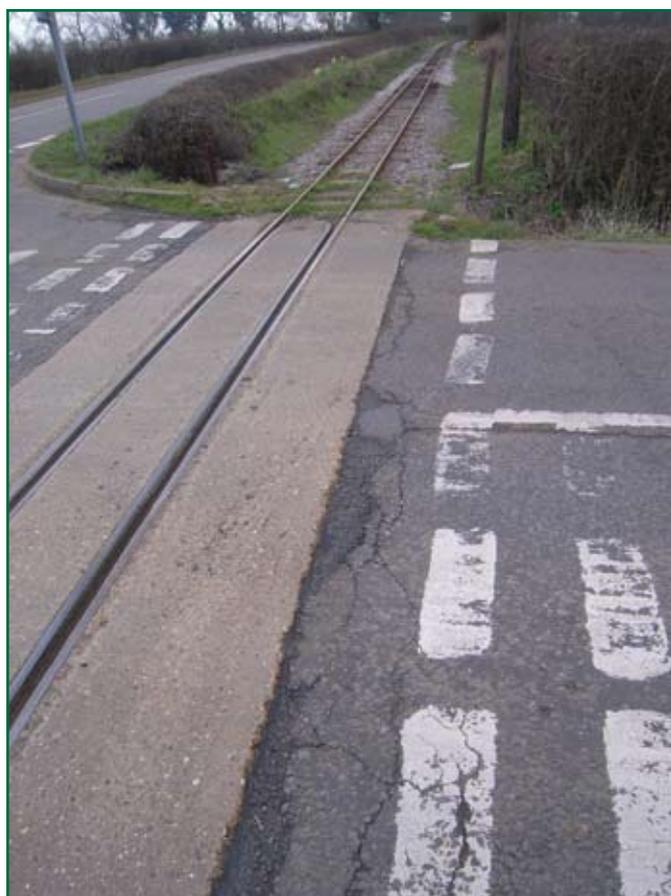
Figure 3: View from east to west of Shenley Hill crossing

- 9 Shenley Hill Road railway crossing is located to the north side of a road junction between Shenley Hill Road and Mile Tree Road (see Figures 2 and 3). Shenley Hill Road runs north to south, and is to the north of Mile Tree Road. The rail crossing has been the location of five near misses in 2006 and one near miss incident in 2007. Two separate fatal road traffic accidents occurred at the road junction in 2001 and 2004 respectively. All of these road traffic incidents and accidents were reported to and dealt with by Bedfordshire Police.

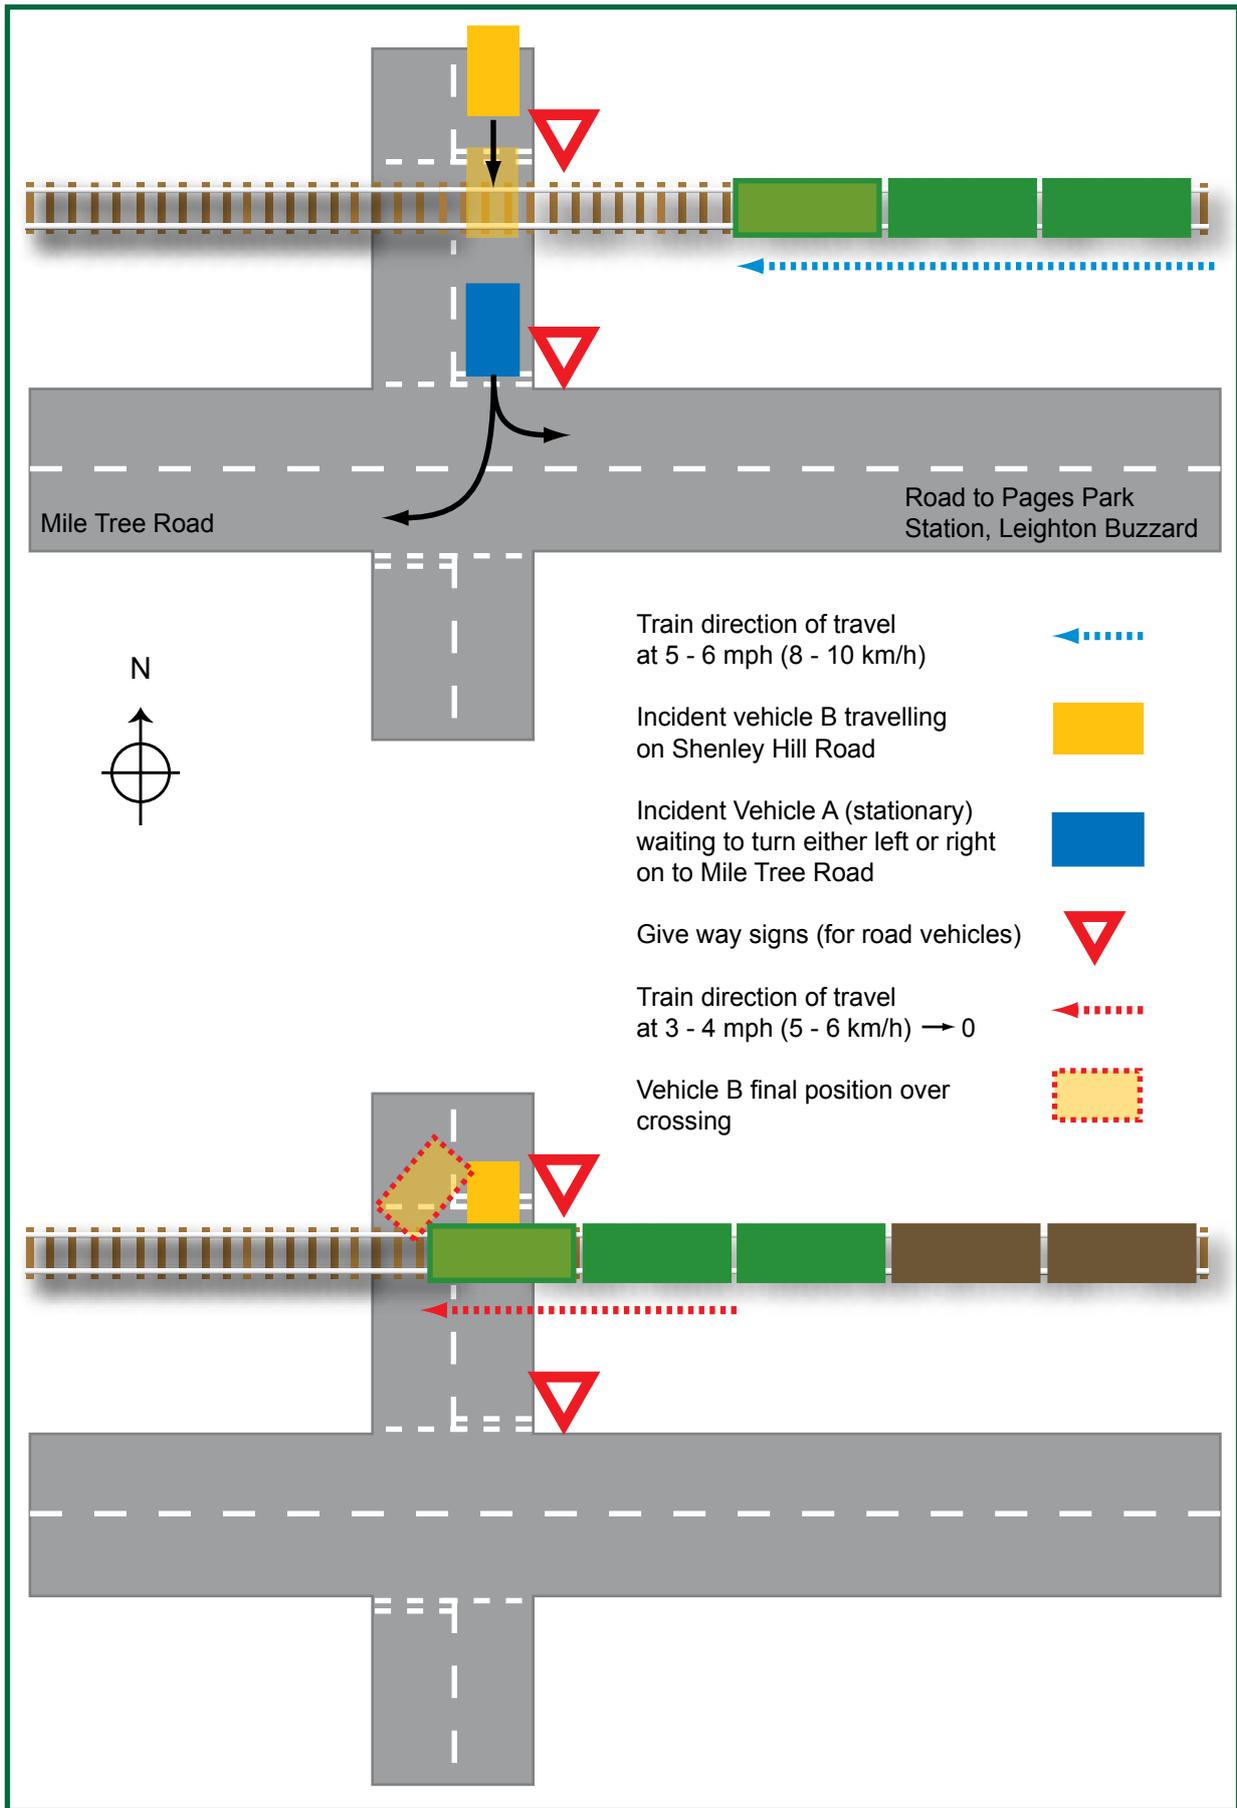
Figure 4: Plan view showing train and motor vehicle (a) and (b) positions before and at the point of collision

- 20 A Mercedes 4x4 motor vehicle was travelling along Shenley Hill Road en route from Leighton Buzzard to Luton at a reported speed of 30 mph (48 km/h) as it approached the level crossing (see Figure 4).

- 23 Both the train driver and the driver's assistant observed two road vehicles on Shenley Hill Road, approaching the crossing from the right to left in the direction of the trains travel (see Figure 4).

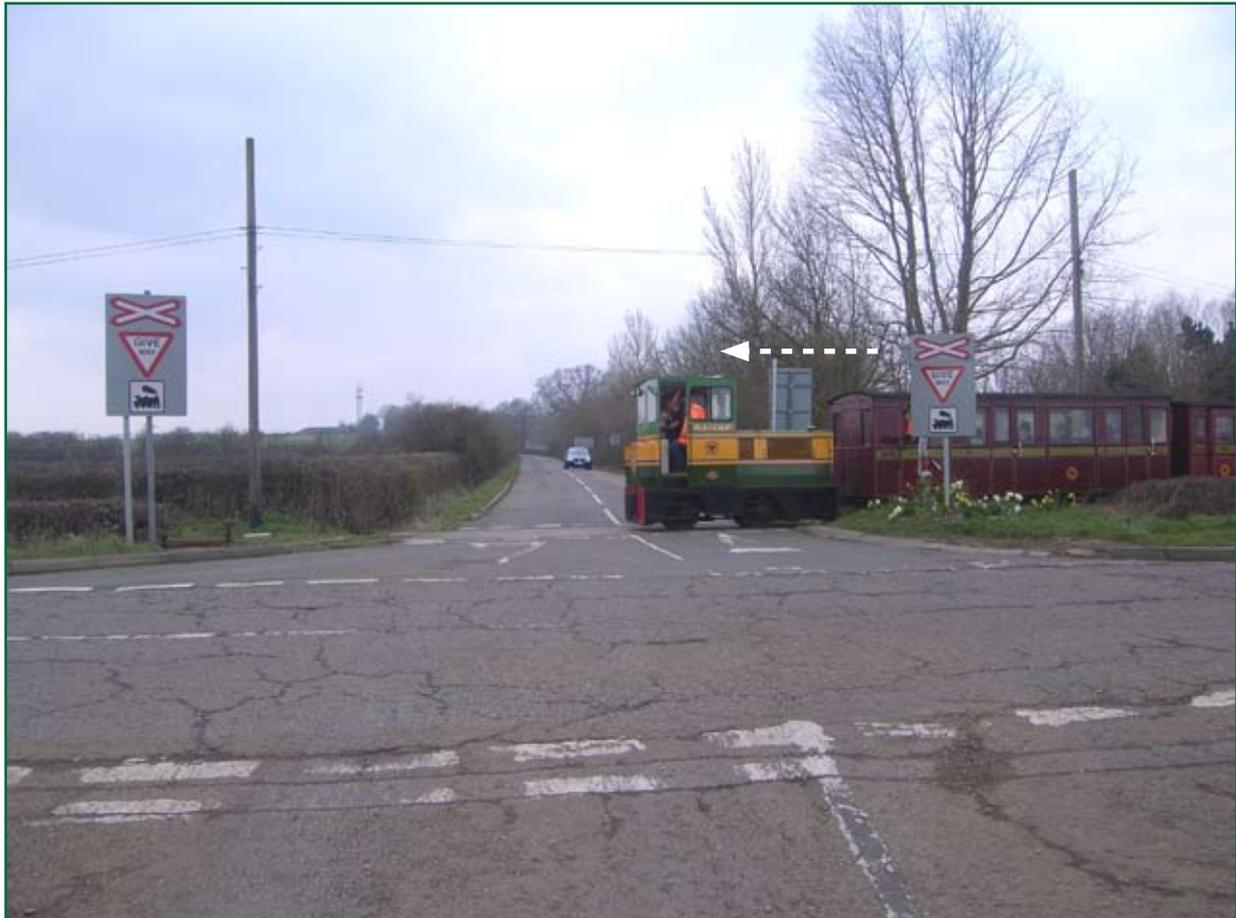
- 28 The passenger carriages had not entered the road area and all passengers remained safely in them (see Figure 5).
- 29 The only witnesses to the accident were the train driver, the driver's assistant, the Mercedes vehicle driver and the passengers in the car. No other staff or passengers on the train were aware anything was amiss until the collision.

Figure 5: South view looking at incident train and position of incident vehicle. A vehicle can be seen on Shenley Hill Road approaching the level crossing

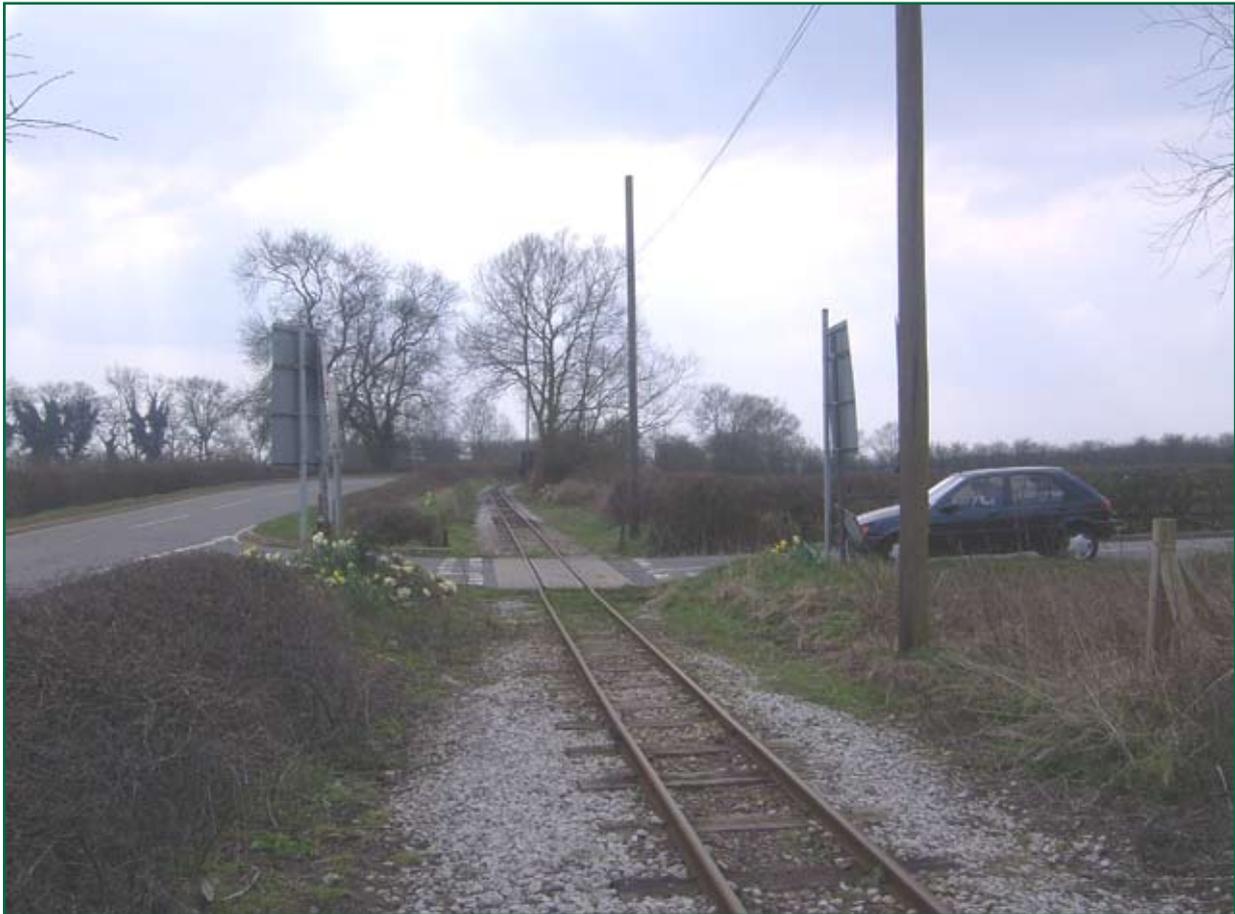
Figure 6: View from the east travelling towards Shenley Hill Road crossing

- 25 When the train driver saw the Mercedes come to a stop on the level crossing, the locomotive was approximately 6 m from the vehicle and he applied the emergency brake. However, the train driver was unable to stop the locomotive and avoid a collision. The train pushed the Mercedes vehicle at low speed sideways onto the right hand carriageway (see Figures 6 and 7).

- 39 The motor vehicle driver was a local man and had a good knowledge of the Leighton Buzzard area, and in particular the town. He was aware of the LBR but assumed that all crossings were protected by a flagman. At the time of the incident he was travelling with young passengers.
- 40 As the motor vehicle driver approached Shenley Hill open level crossing he observed a vehicle waiting at the crossing to turn onto Mile Tree Road. He did not see a train and assumed that, as there was no flagman and a motor vehicle waiting to turn onto the main road, there was no train present. For this reason, he did not see a need to anticipate or brake for the first give way road marking; he drove his vehicle over the give way line without stopping and drew up to the rear of the motor vehicle waiting to turn (see Figures 6 and 7).

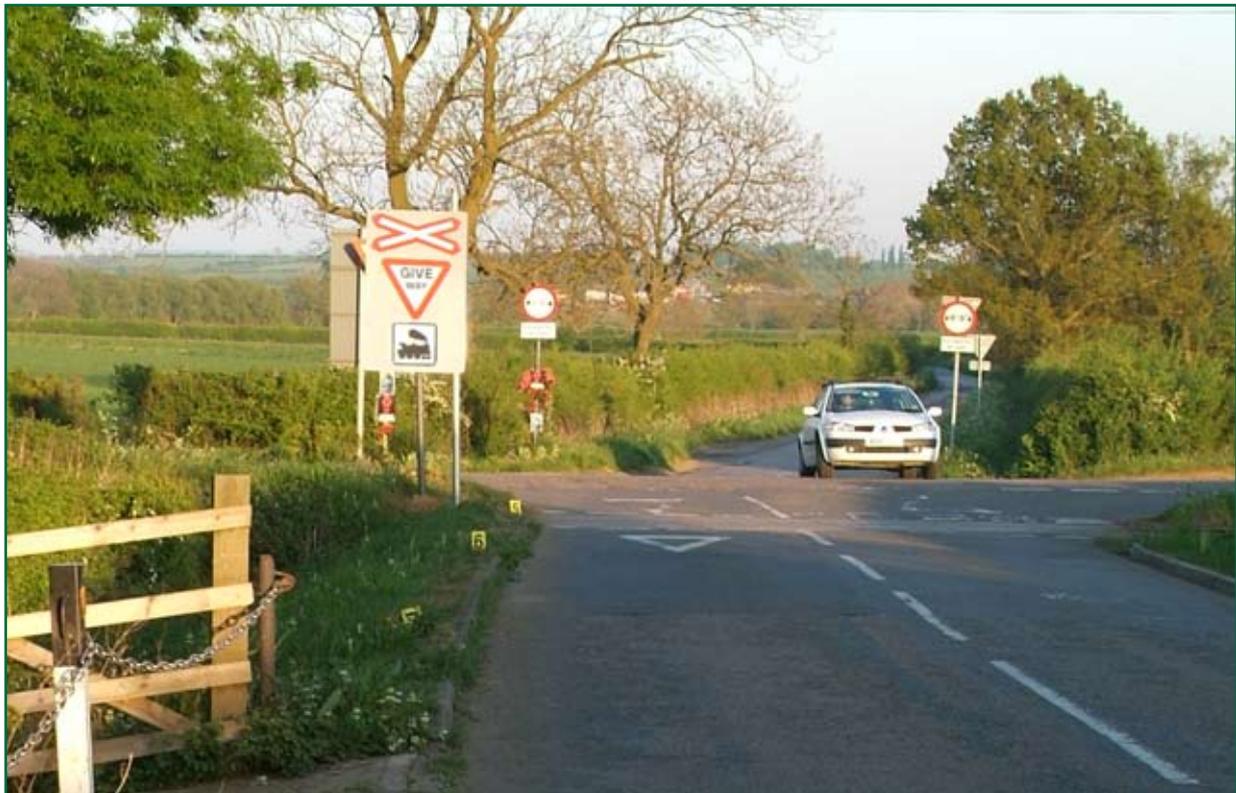
Figure 7: View on approach to Shenley Hill Road crossing (incident locomotive approached crossing from left of image)

- 50 As part of the investigation the LBR operated a test train over the Shenley Hill Road level crossing so that it came to a stand two metres away from the highway. On each occasion that the train was brought to a stand, road vehicle traffic, having observed the locomotive stationary at the crossing, stopped behind the northern give way sign, and in Mile Tree Road (see Figures 7, 8 and 9).

- 74 The RAIB evaluated the use of 'box junction' markings from the northern give way line until clear of the crossing on Shenley Hill Road (Diagram 1045 Traffic Signs Regulations and General Directions 1994). The layout of the crossing and dimension of vehicles that use the crossing preclude this from being an effective solution, because the distance between the two give way lines and a box marking road layout would cause a long vehicle such as an articulated lorry to disobey the law by default (see Figure 7).

- 78 Observations conducted during an RAIB visit concluded that bringing the train to a stationary position before crossing the highway ensures that road vehicle drivers are fully aware of the presence of the train and its driver's intention to pass over the crossing (see Figure 7).

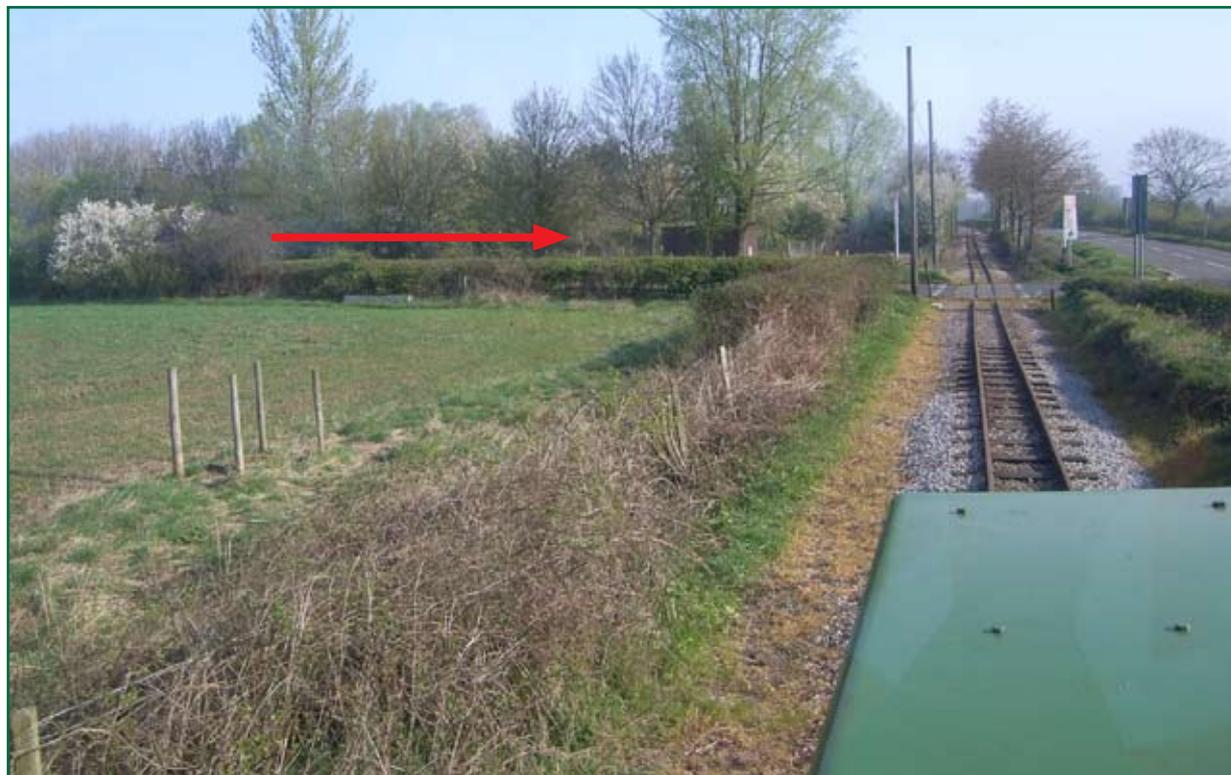
Figure 8: Train driver's view 40 m from crossing as viewed from the west

59 The viewing zones are not dependent on the speeds of trains, which are limited as in paragraph 55, or of road vehicles, but on the distances when the driver of the train observes the motor vehicle. Actual views from a road vehicle approaching from Shenley Hill Road, and trains approaching in both directions, are given in Figures 8 – 11.

- 60 Vegetation and trees obstruct the visibility for motor vehicles 20 - 40 m from the crossing on Shenley Hill Road and subsequently give intermittent visibility of the train approaching from Stonehenge Works Station.
- 61 Much of the vegetation that obstructs the visibility of approaching trains is outside the boundaries of both the railway and highway.
- 62 This limited visibility means that Shenley Hill Road crossing would not comply with requirements of RSPG Part 2E for viewing zone distances for motor vehicles and trains (see Appendix D and Figures 10 and 11). This lack of visibility may have contributed to the accident.
