TRAIN DERAILMENT AT
GRAYRIGG, CUMBRIA
23 FEBRUARY 2007

RAIB INTERIM REPORT

ISSUE DATE : 26 FEBRUARY 2007

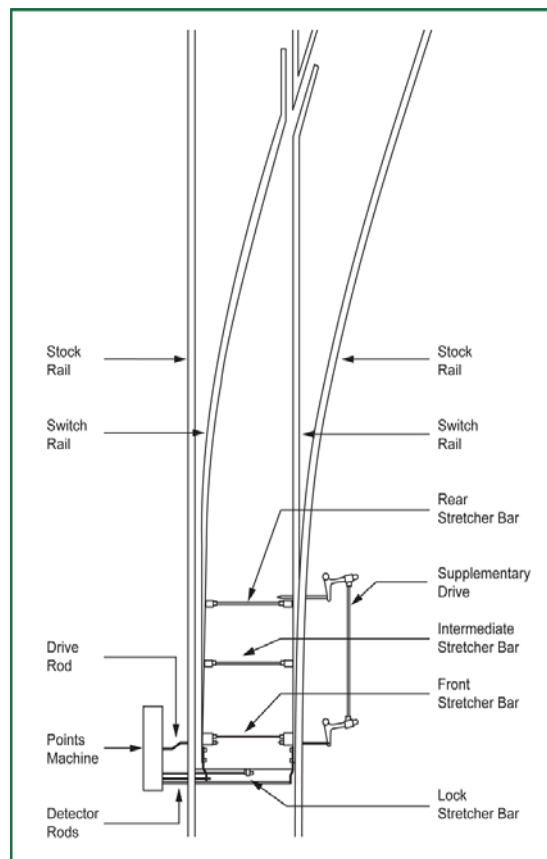
Figure 2: Diagram of switch and stock rails and stretcher bar

27. Investigation of the lock and stretcher bars in the facing points at Lambrigg crossover showed that one of three stretcher bars was missing, and bolts that secured the lock bar and another stretcher bar were not in place – some of these bolts and the associated nuts and washers were found in the ballast, but others were not. However, the RAIB search of the area has not been completed. There is no evidence that the bolts had been wrenched free. Two of the stretcher bars were fractured; in one case the nature of the fracture surface indicates that it may have been consequential to the derailment. In the other case, the fracture surface indicates that it may have predated the derailment. The latter will be confirmed by further analysis.

28. There was therefore no complete stretcher bar in place between the switch rails immediately before the derailment. The left hand switch rail was free to move across close to the left hand stock rail whilst the right hand switch rail remained, correctly, against the right hand stock rail.

29. The marks on the crossover at Lambrigg indicate that at the time of the derailment both switch blades were in contact or very close to their respective stock rail. The train wheels were thus set on a course where the gauge was narrowing as the train moved forward. The train wheels, (which are rigidly mounted on an axle a fixed distance apart), could not follow the narrowing route and climbed over both switch rails, and then ran in a derailed state.
