Rail Accident Investigation Branch

Rail Accident Report

Derailment of a tram at Pomona, Manchester 17 January 2007

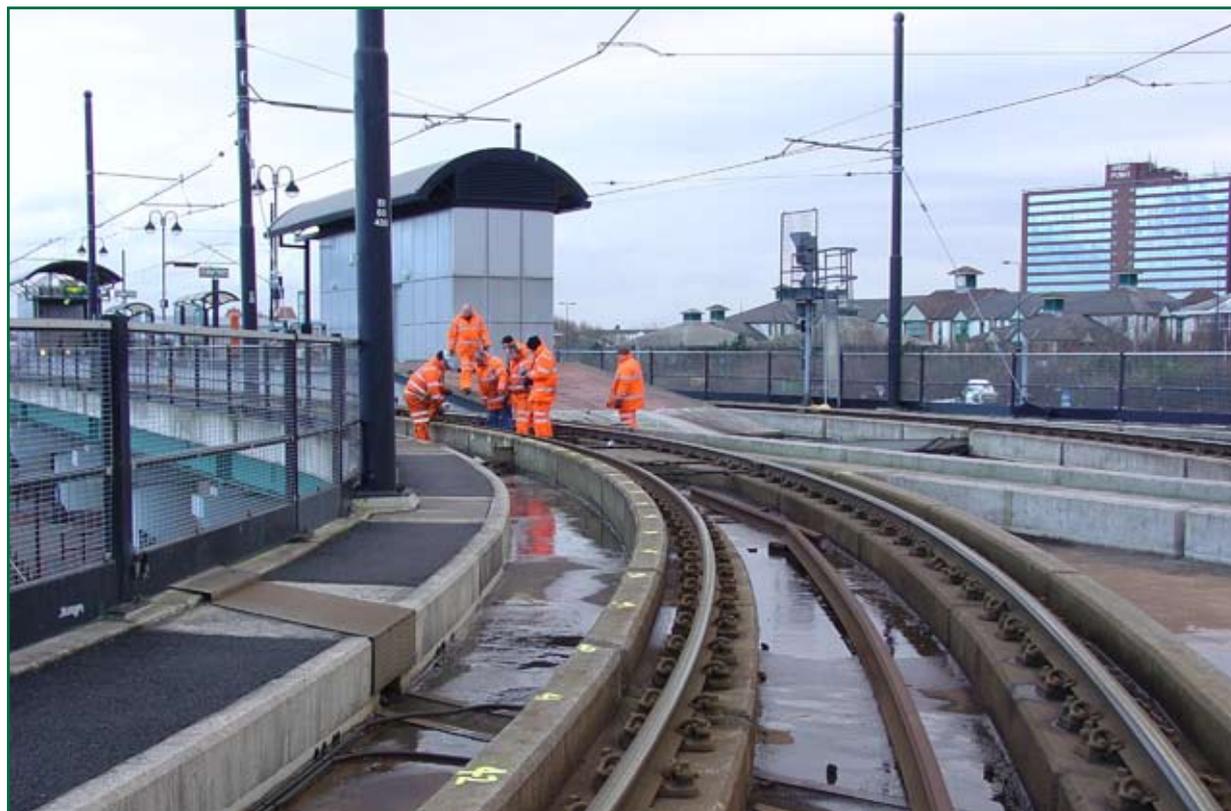
Figure 2: The track on which the tram derailed, looking towards Pomona station

15 The *wheelset* was able to drop into the four-foot as the track gauge was wider than allowed in the specification and the rails were able to be forced further apart relatively easily. The wheelset ran with the left wheel in the four-foot and the right wheel on the rail for 17 m, forcing the rails apart, until it encountered an *expansion joint* in the rails. The rails here were more securely held to gauge than in the curve and the right-hand side wheel was forced over the rail head and into derailment by the narrowing gauge of the more securely fixed rails (Figure 3).

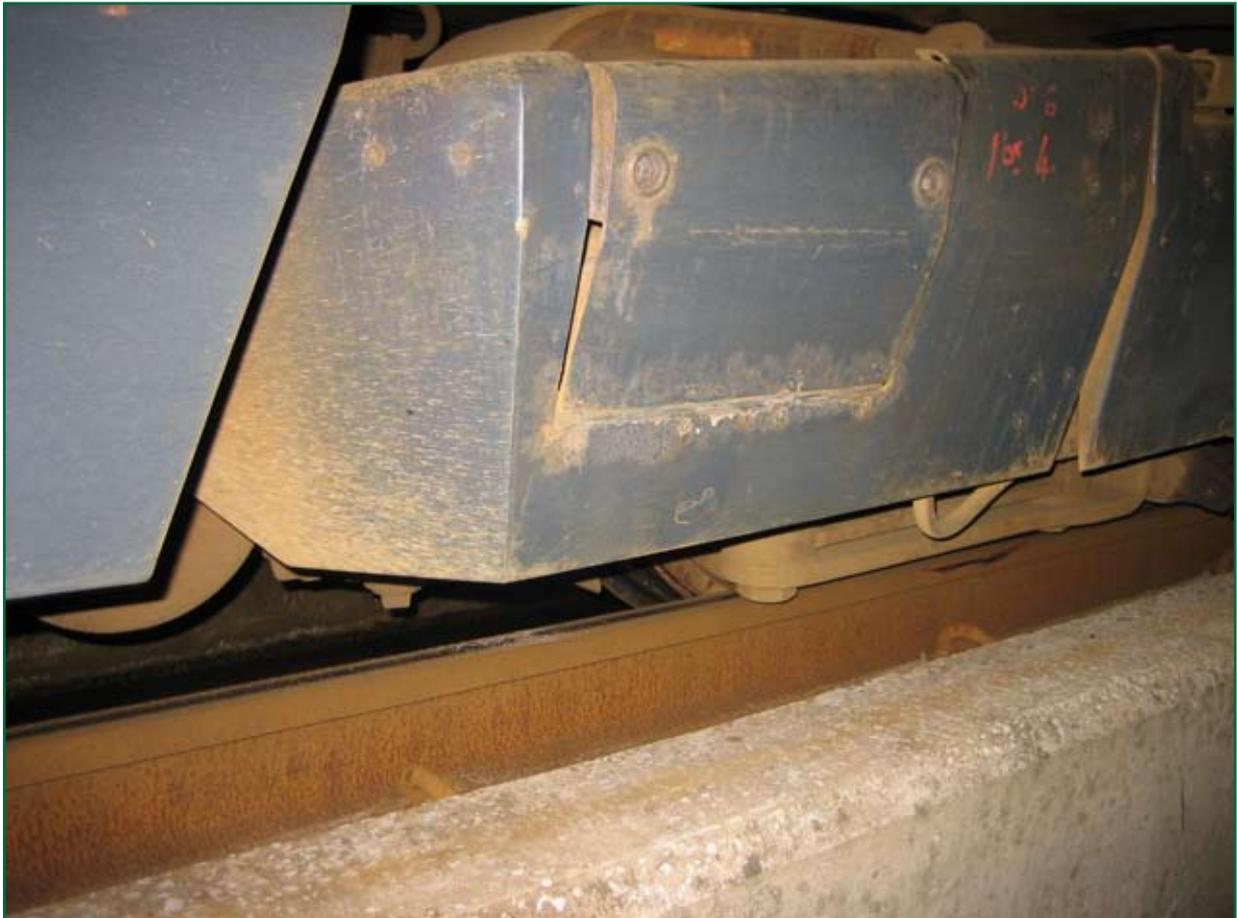
Figure 3: Derailed wheel at front left-hand side of tram

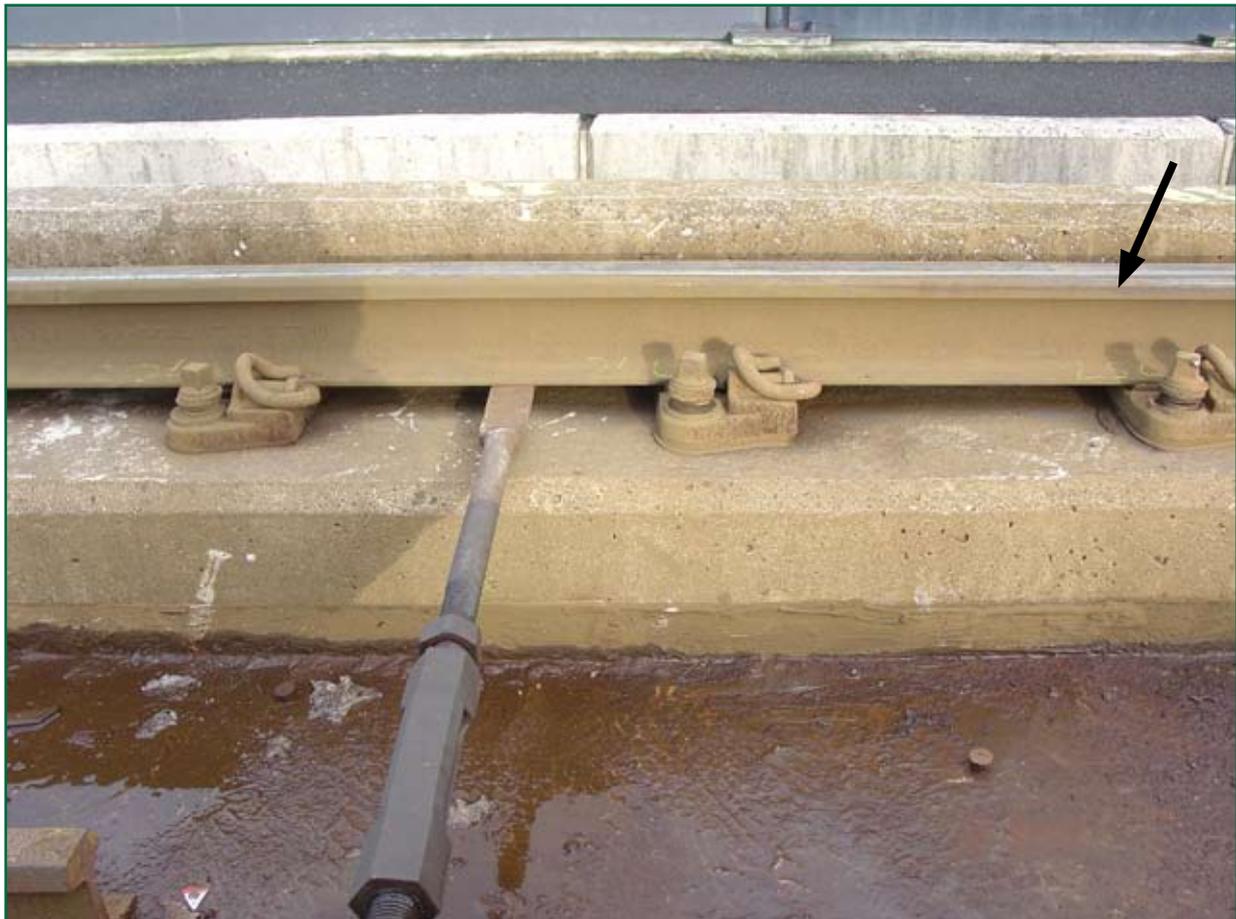
Events during the accident

- 26 The tram was heavily loaded with passengers as it formed an evening peak service through the commercial area around Salford Quays.
- 27 The tram driver was joined in the cab by his supervisor at Harbour City tram stop. This was a routine observation of the driver by his supervisor.
- 28 As the tram approached Pomona station the driver allowed the gradient to slow the tram for the curve. Whilst the tram was negotiating the curve the driver and his supervisor felt the tram jolt then they heard an unusual sound from beneath the tram. The driver applied full service brake and the tram stopped 17 m from the point of derailment.
- 29 The supervisor asked the driver to contact the Metrolink control room by radio to report the incident and got down to examine the tram. He found that the leading wheelset had derailed.

Figure 4: (left) side rail, showing wheel drop-in mark (arrowed)

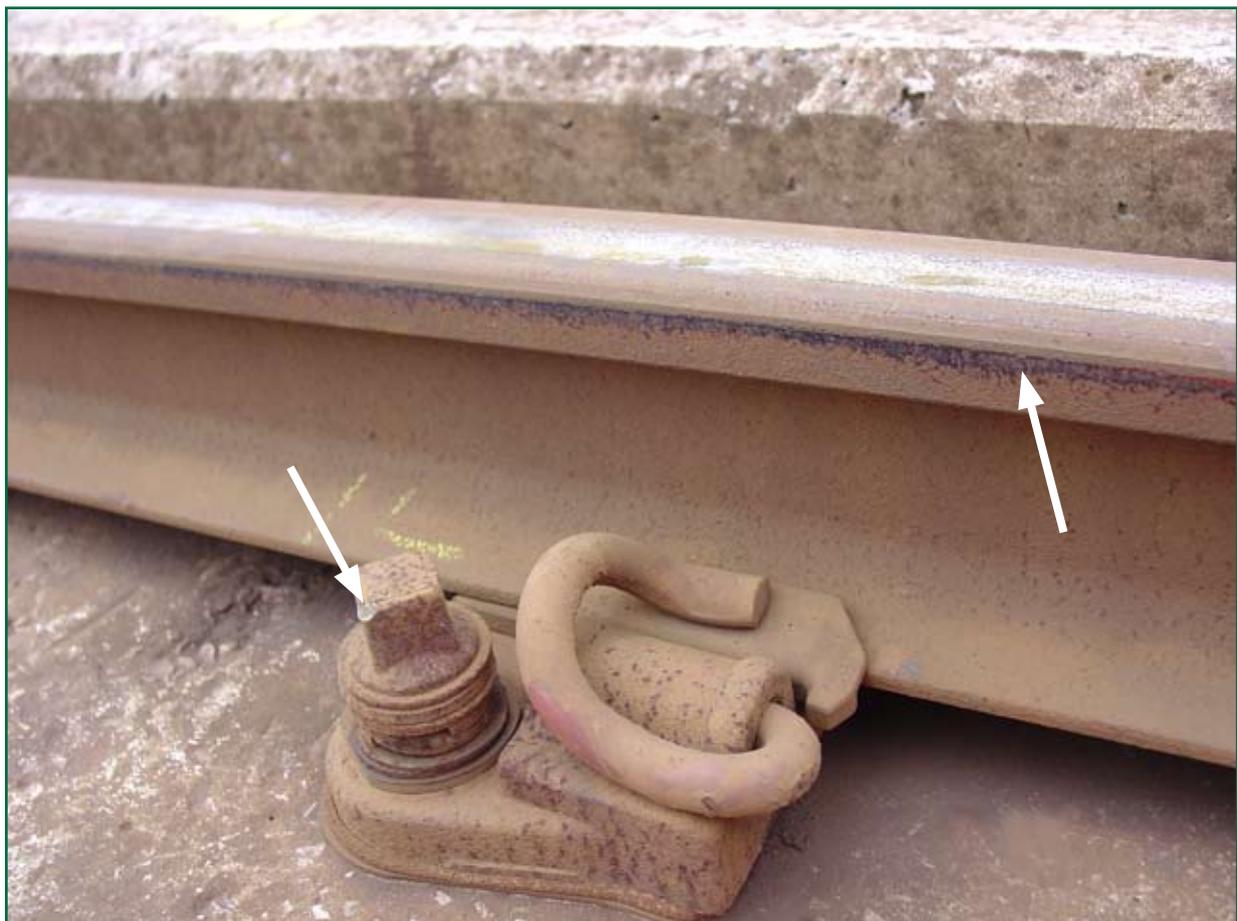
- 44 The Railways (Accident Investigation and Reporting) Regulations 2005 require that evidence at the site of a railway accident is preserved until the RAIB has concluded its investigation or no longer requires the evidence. The installation of the tie bar was thus contrary to these regulations.
- 45 The derailed wheelset ran with the left wheel rubbing on the *cess* rail leaving a mark on the side (Figure 5) and the right wheel running normally on the six-foot rail, but pressing hard against it, forcing the rail outwards and widening the gauge.

Figure 5: Cess side rail showing marks left by wheel (arrowed)

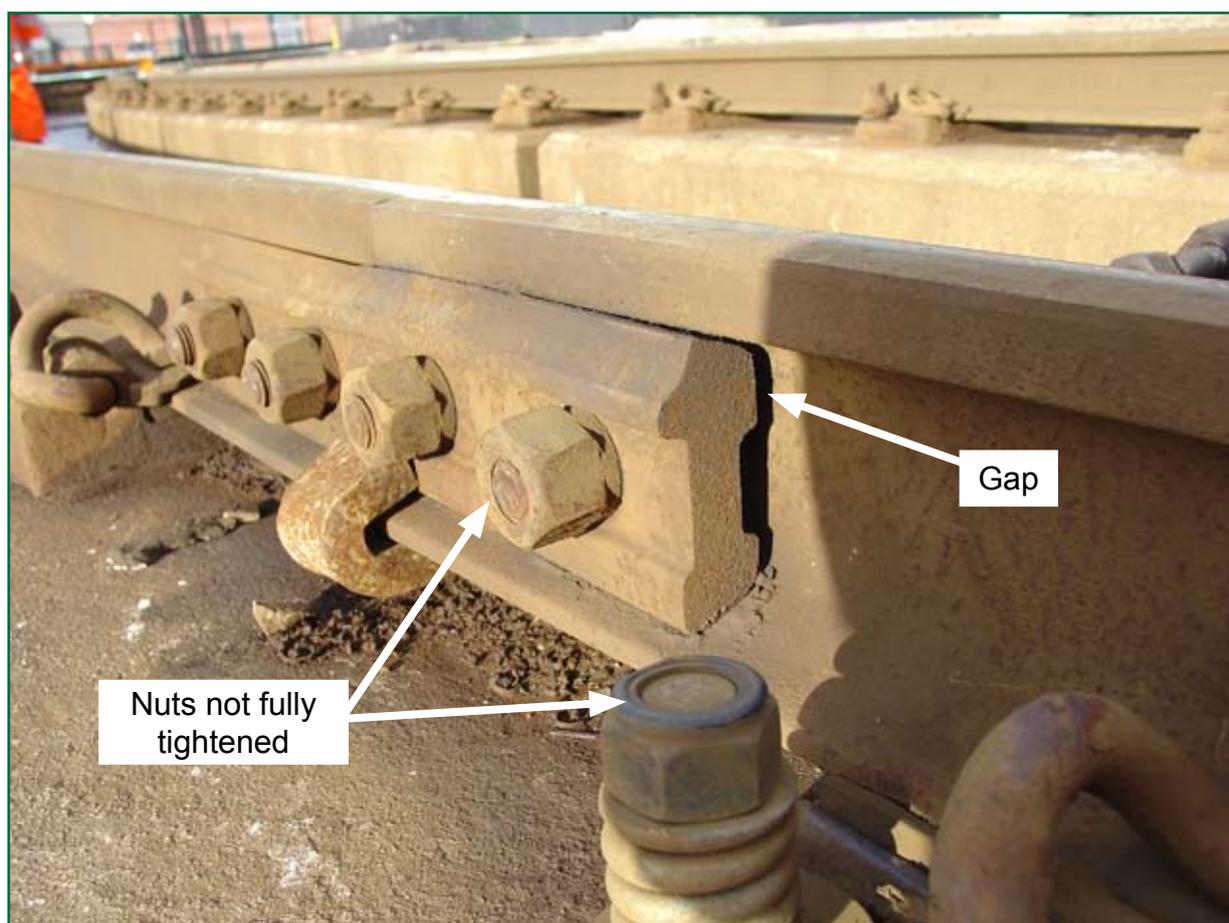
65 The rail baseplates were bolted to the reinforced concrete upstands on the bridge deck by means of two holding down bolts per baseplate. These holding down bolts had been found to be prone to failure in shear and Serco Metrolink had been replacing them with a revised design. The revised design involves a larger diameter bolt with a spring bearing down on the baseplate. One of these bolts can be seen in Figure 6, but appears not to be tightened down fully.

Figure 6: Rail joint in six-foot rail at point of derailment

- 74 The joints at each end of the replacement rail were made with straight fishplates and normal fishplate bolts. The tight curvature meant that it was not possible for the outer bolts to be tightened sufficiently to bring the outer ends of the fishplates into contact with the rails (Figure 6). The effectiveness of the joint was therefore compromised and this provided a weak spot in the six-foot rail where the gauge could widen further under the lateral load from tram wheels.

- 75 The initial 'drop in' derailment of the left side wheel occurred opposite one of these joints. At this point the concrete upstand was not present and the rail was only restrained by its *fastenings*. The fishplated joint at the other end of the replacement rail was propped from the adjacent upstand by a piece of timber (Figure 7). The design of the track at this location called for continuous welded rail (CWR) and there should not have been any fishplated joints here.

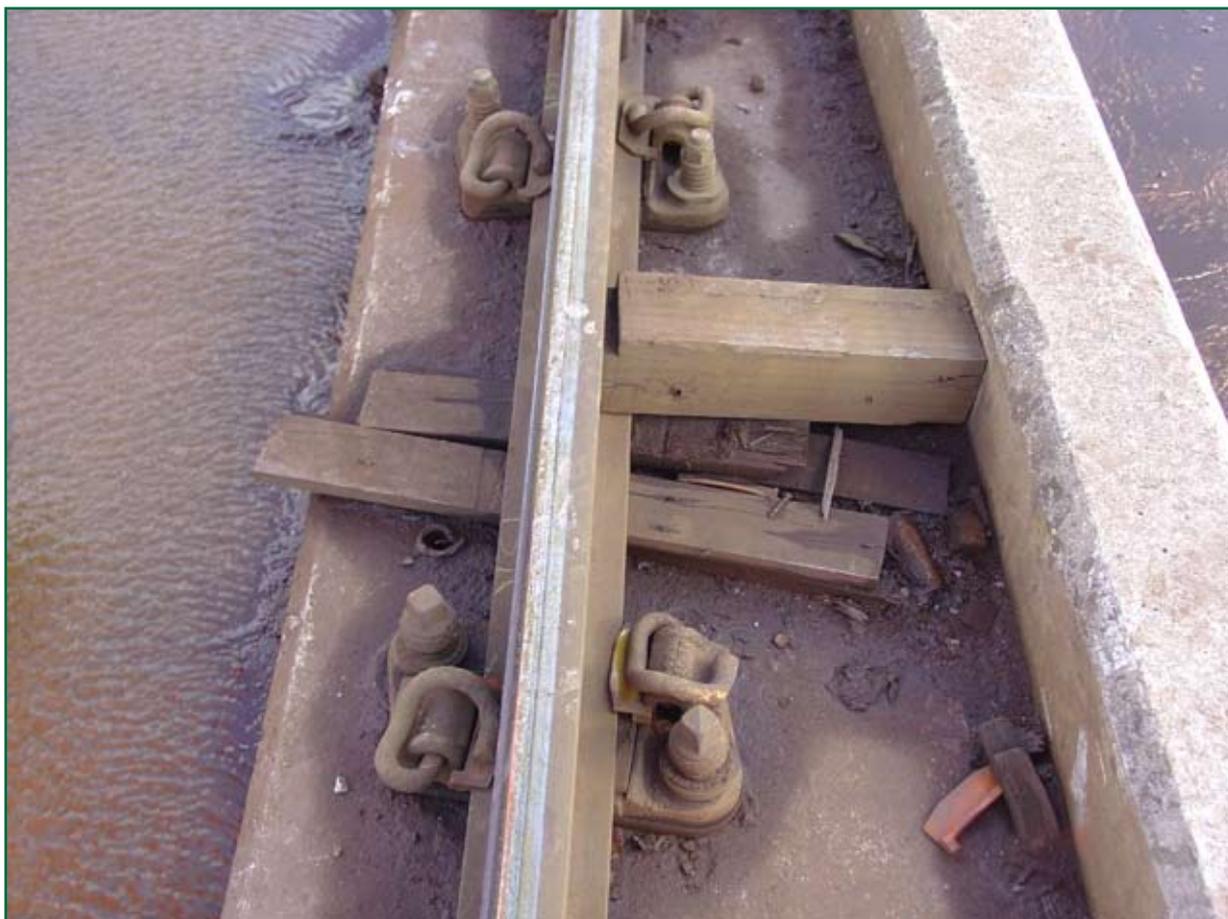
66 The track slab on the bridge deck includes concrete upstands for derailment protection purposes. One of these upstands limited the movement of the derailed bogie and was damaged in the process. These upstands are situated just outside the running rails and have been used to provide additional lateral restraint to the six-foot rail in at least one location by means of timber wedged between them (Figure 7).

67 The bolt failures, gauge tie bars and use of timber props are evidence that the track is unable to sustain the gauge spreading forces at this location. It is concluded that the holding down arrangements of the baseplates did not provide sufficient restraint to maintain track gauge on the curve.

Figure 7: Timber propping six-foot rail against concrete upstand

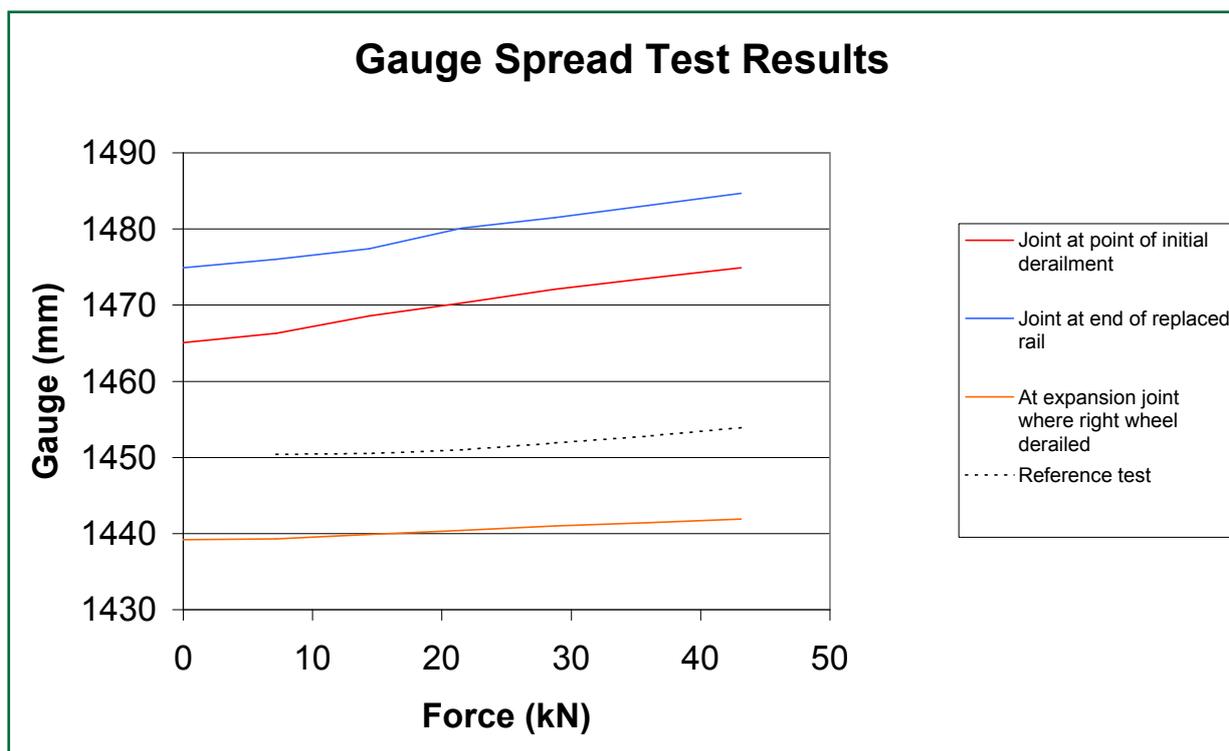
- 89 The ability of the track to resist gauge spreading forces was measured by means of gauge spread tests conducted by the RAIB the day after the derailment. These tests consisted of forcing the rails apart using a calibrated hydraulic jack and measuring the resulting track gauge. The tests were carried out at the point of the initial derailment of the left wheel, the point of the final derailment of the right wheel, the location of a second fishplated joint in the six-foot rail and at a section of good track clear of the derailment area. The last location was included as a control. The results of the gauge spread bar tests are shown in Figure 8 as load/deflection curves.

Figure 8: Gauge spread bar tests

- 90 The gauge spread test carried out at the initial point of derailment of the left wheel (Figure 8) shows that the gauge could be spread to 1475 mm by a 44 kN force. The gauge spread test carried out on the joint at the other end of the replaced rail, where there was no tie bar, showed that the gauge could be spread to 1485 mm by the same 44 kN force. By comparison, the control test on track away from the site of the derailment only spread to 1454 mm with the 44 kN force.
