Rail Accident Investigation Branch

Rail Accident Report

Fire on prototype tram 611 at Blackpool 24 January 2007

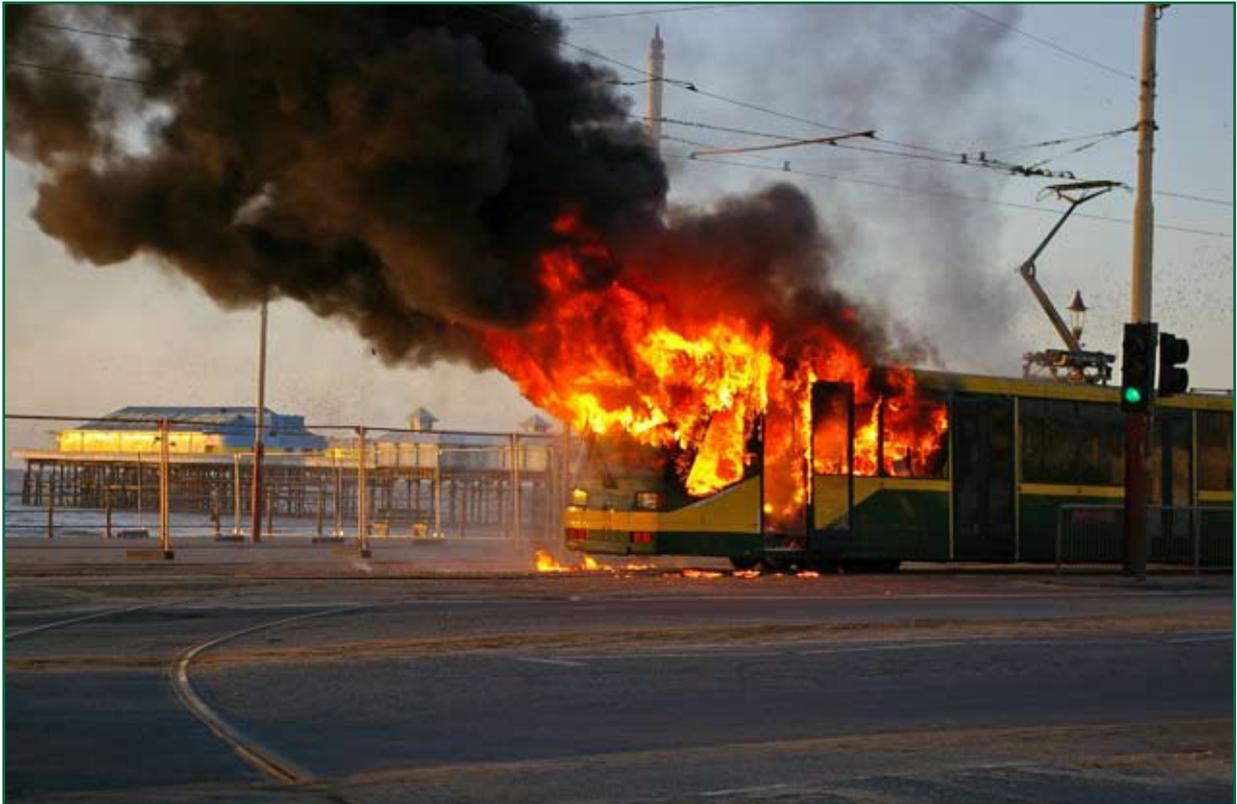
- 12 Once outside the vehicle, the driver realised that he had not lowered the pantograph as required in an emergency. The driver then went to the rear of the tram and opened the A end driver's door. He realised that he would not be able to lower the pantograph from this position as the control panel could not be enabled without the use of the driver's key. He could not retrieve the key as the fire at the B end was by then too intense. The driver was unable to enter the passenger saloon from the A end and lower the pantograph manually, due the presence of smoke. Figure 3 shows the tram during the fire.

Figure 3: Tram 611 during the fire (courtesy of Blackpool Transport Services Ltd)

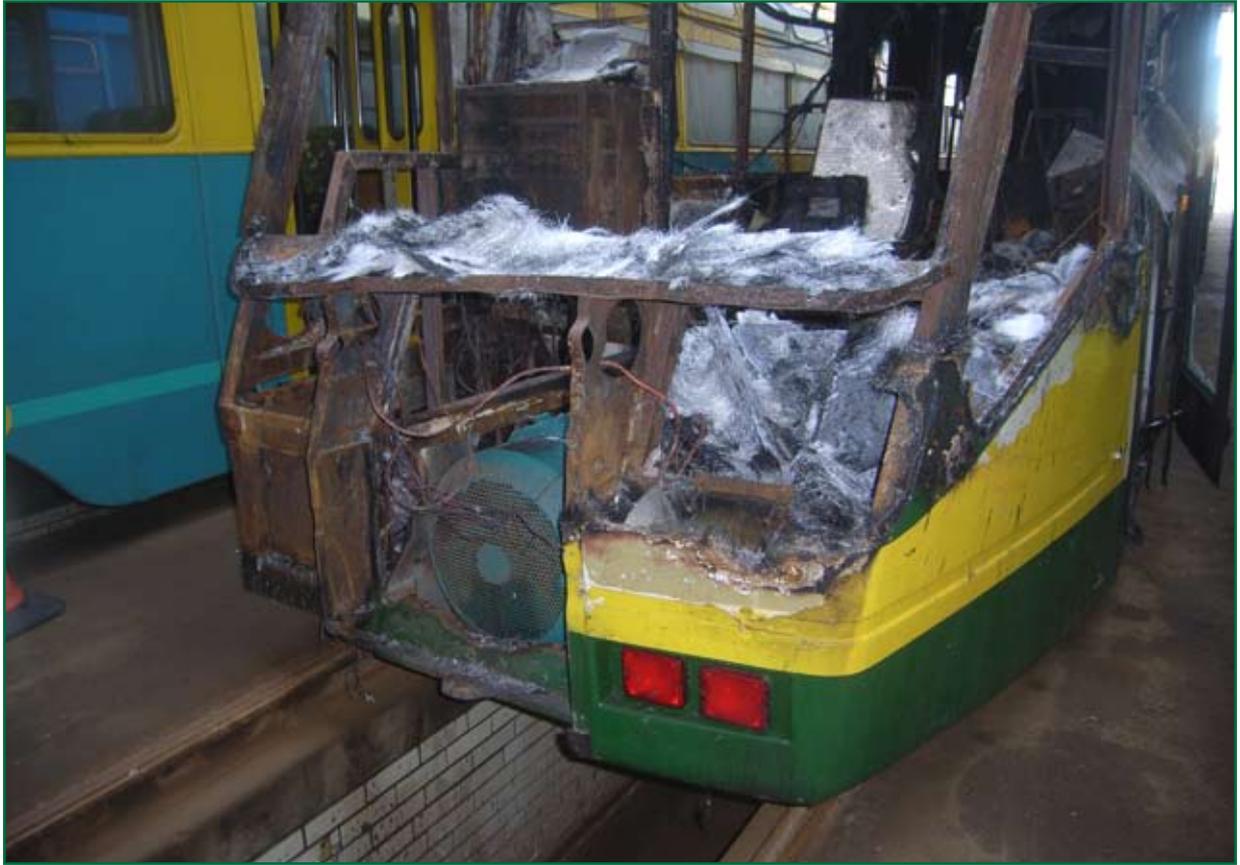
- 16 The RAIB carried out an inspection of the tram on Monday 29 January. The interior seating and panels, control and power equipment and external glazing and cladding of the tram sustained significant damage at the B end due to the fire. The remainder of the vehicle was damaged by smoke. Figure 4 and Figure 5 show details of the fire damage.

Figure 4: Fire damage to the exterior at the B end

- 18 The RAIB examination of the tram indicated that the seat of the fire was in an under-floor compartment below the first, rearward facing, passenger seat behind and to the right-hand side of the B end driving position. This compartment is constructed of plywood and houses both 24 and 650 volt electrical equipment including rheostatic brake resistors. The air to cool this compartment is drawn from a central channel that houses the traction motor.

- 19 There was no evidence of a defect or failure within the 650 volt power control system. The 24 volt wiring in the underfloor compartment was severely damaged and a conclusive analysis was not possible. It is probable that the fire began within the 24 volt electrical system. This view is shared by the forensic fire specialist.

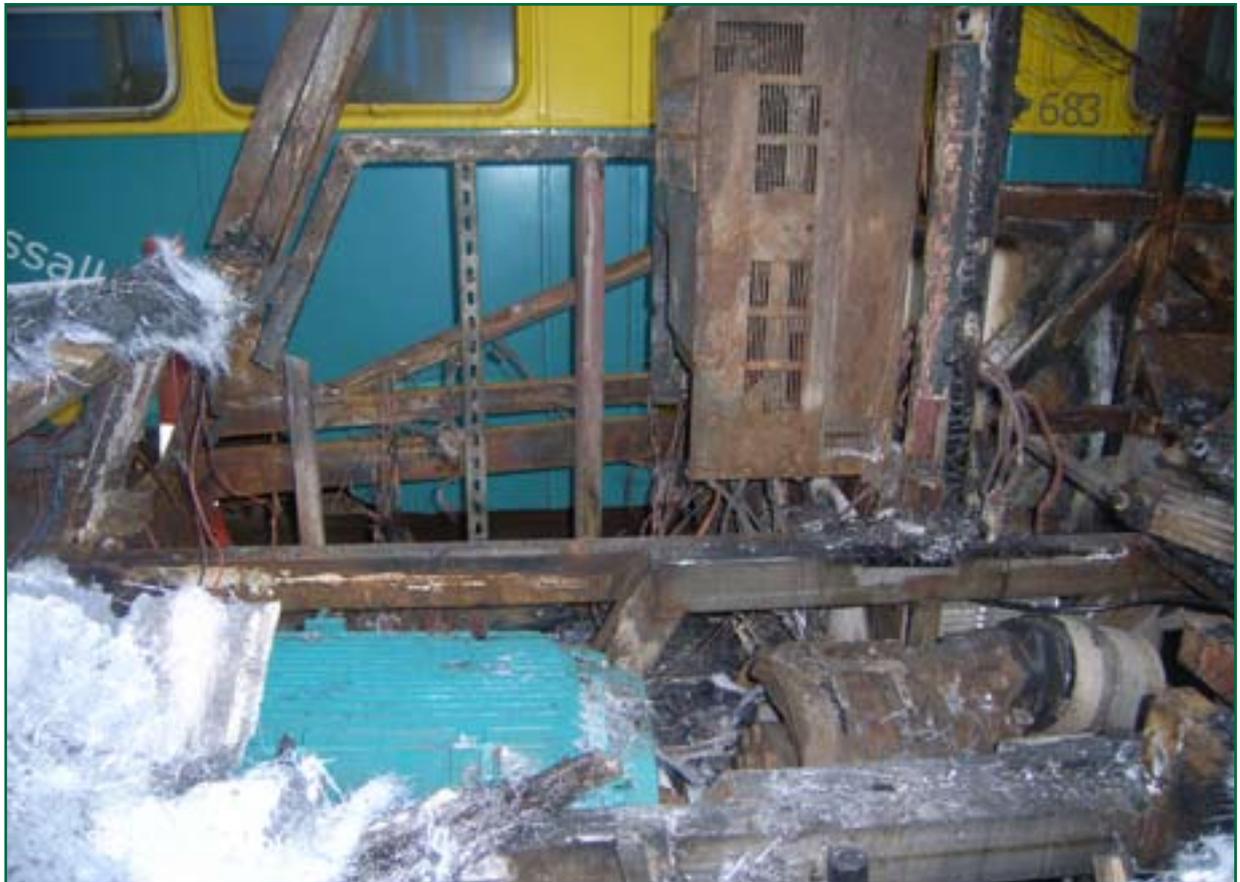
Figure 5: Fire damage to the B end driving position
