Rail Accident Investigation Branch

Rail Accident Report

Derailment of a passenger train near Kemble 15 January 2007

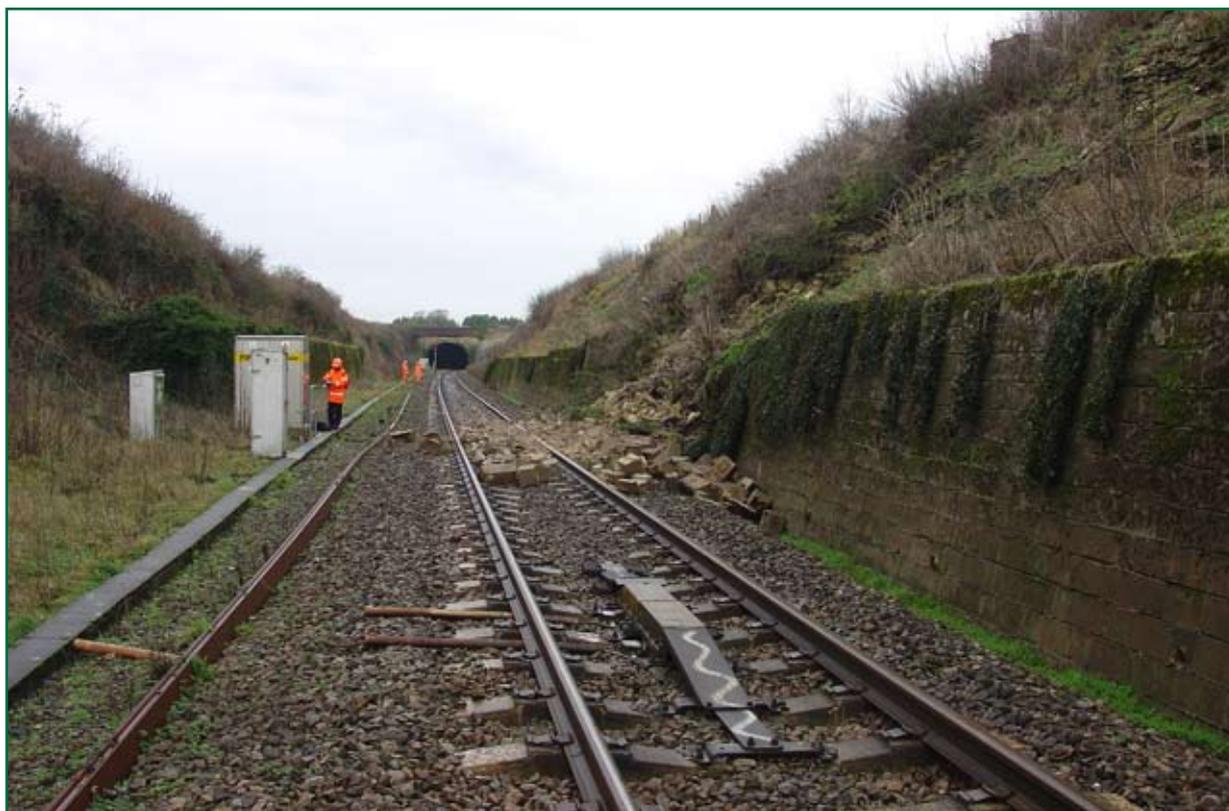
Figure 2: View of derailment site in the direction of travel

- 63 At the location of the cutting slip, the wall rises to a height of approximately 2.4 m above rail level. Its foundation is in the cess, set 2.4 m from the cess rail (Figure 2). The crest of the cutting rises a further 6 m above the top of the wall. The wall is constructed from a double row of hollow concrete blocks filled with a *lean-mix concrete* and has an overall thickness of approximately 450 mm. The face of the wall slopes away from the track at an angle of approximately 10 degrees.

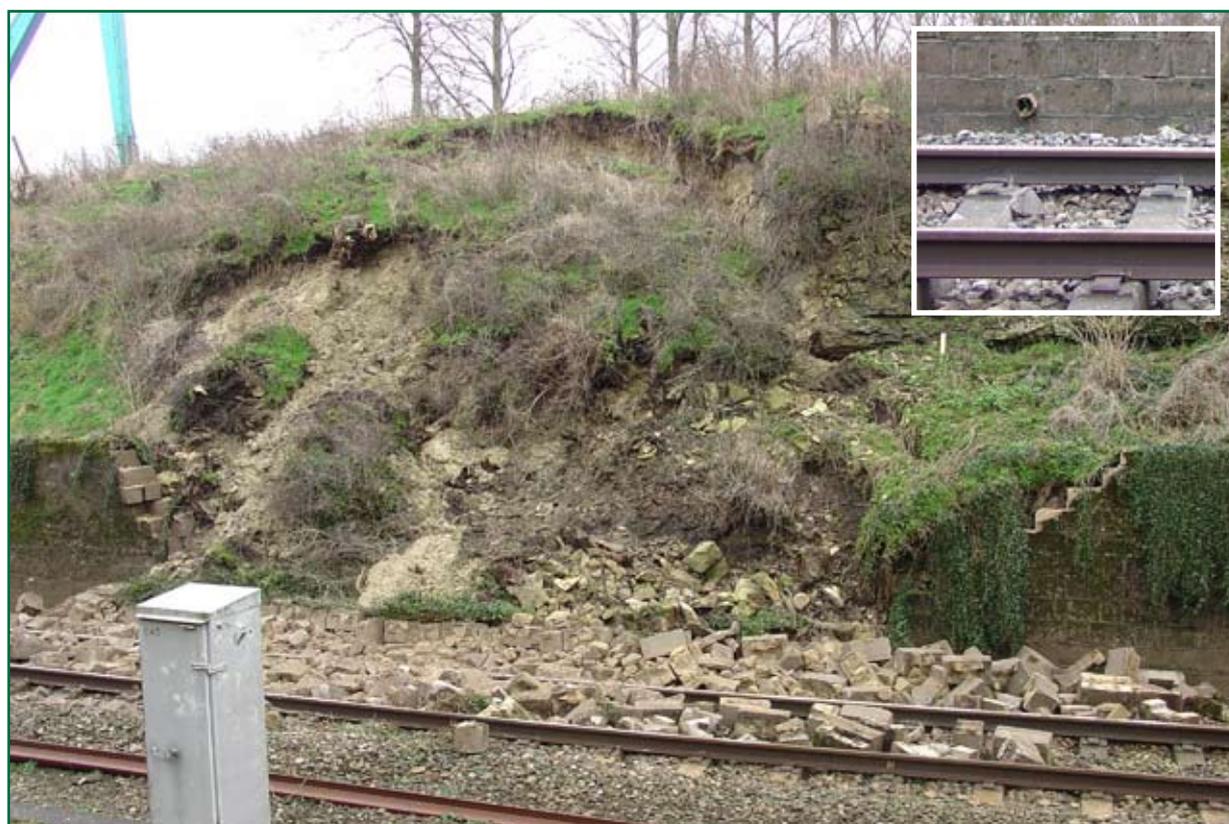
Figure 4: Derailed site showing cutting slips, state of backfill and typical weep hole (inset)

- 44 The cutting rises to a maximum height of approximately 9 m above track level and the *crest* is located 13 m from the cess rail. The geology of the cutting comprises soft limestone rock strata overlaid with a stiff clay. In places the clay has been weathered to a very soft, almost fluid, consistency. Towards the top of the slope, there was a primary slip (Figure 4) which had left a *scar* face approximately 10-14 m long and 1-1.5 m deep. Approximately half way down the slope, there was a secondary *slip*, approximately one third the size of the primary slip from which a soft clayey discharge, loose rocks and firmer clay layers had descended down the slope and run onto the back of the wall.

- 64 *Weep holes* were installed at the base of the wall, spaced approximately 3 m apart, to allow drainage of water from behind the wall. The weep holes in the portion of the wall that collapsed were destroyed. It was noted that the weep holes in the adjacent sections of wall, which remained intact, were clear at their exits but not discharging water as would be expected following the recent heavy rainfall in the area (paragraph 86), indicating that they were blocked. Such blockages are likely to cause a build up of water behind the wall, tending to destabilise it.

- 104 On the day after the derailment, it was noted that there was little or no water flowing from the weep holes in the vicinity of the failure although the clayey slurry which flowed out from behind the collapsed wall indicated there was a high water content. The weep holes were therefore probably blocked. The detailed wall inspection on 2 October 2001 noted the weep holes were blocked but there is no evidence of remedial action taken to clear them out. Therefore the blocked weep holes were a contributory factor in the collapse of the wall.
