Rail Accident Investigation Branch

Rail Accident Report

Collision at Badminton 31 October 2006

31 October 2006

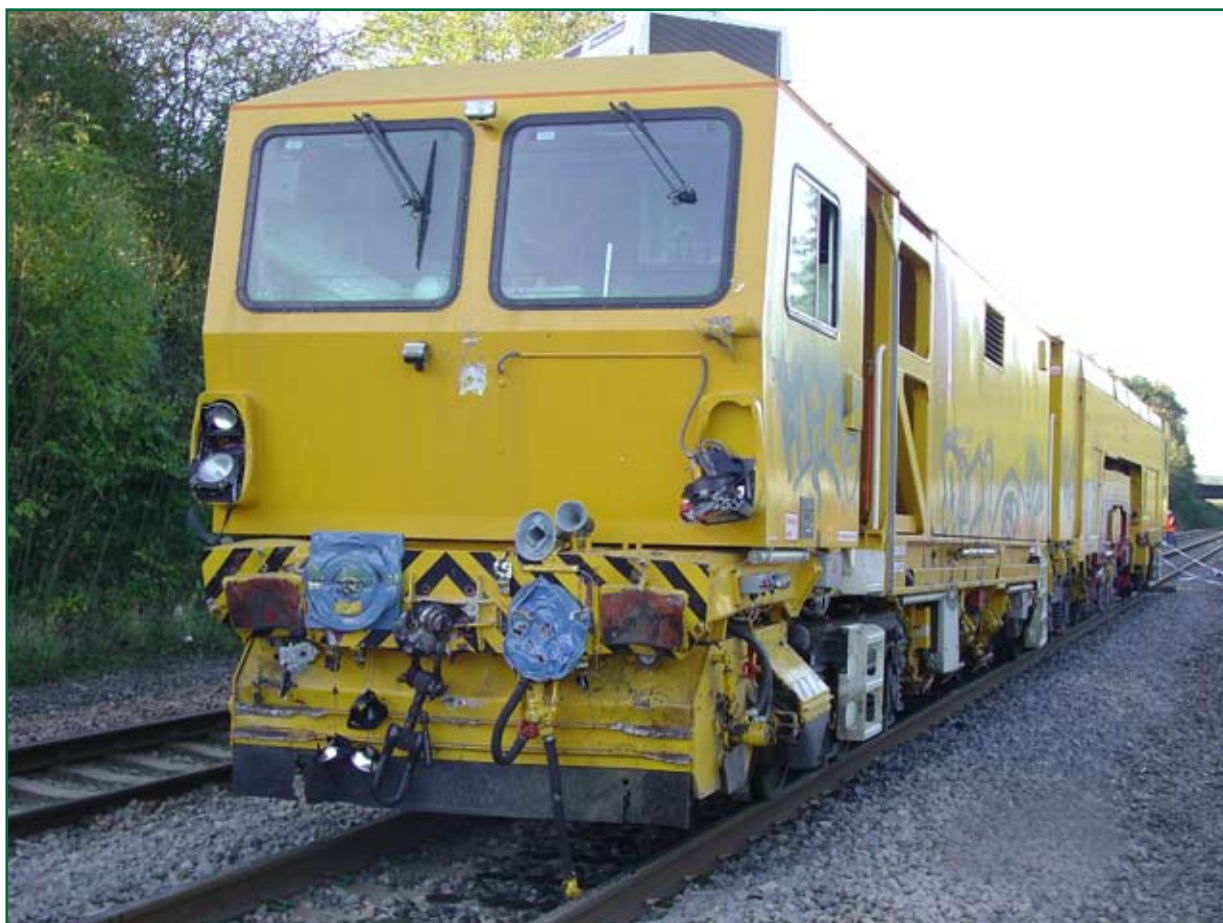
Figure 2: The tamper after the collision, showing damage to the front end

- 40 The tamper driver was seriously injured. The tamper was extensively damaged: the underframe was distorted and the articulation drawbar (which connects the two sections of the machine) was buckled. Both front buffers were knocked off, the bufferbeam was bent and the drawgear was distorted (Figure 2). Debris from the collision was spread along the line for about 28 m beyond the point of impact. One buffer was found near the yard access gate, about 13 m away from the line.
