Rail Accident Investigation Branch

Rail Accident Report

**Fatal collision between a Super Voyager train
and a car on the line at Copmanthorpe
25 September 2006**

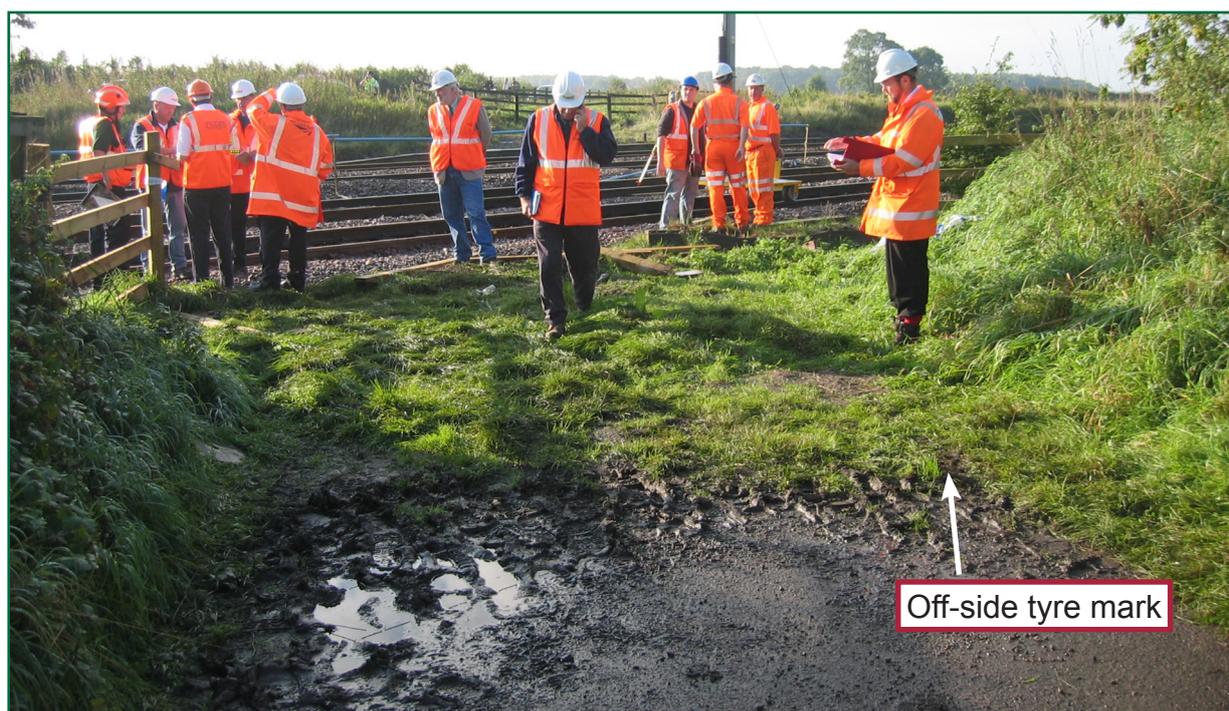
Figure 2: The site of the damaged fence

- 32 Shortly before 21:00 hrs the car collided with and broke through the fence at the end of Moor Lane, and ran onto the railway (see Figure 2 and Diagram 1). The front wheels of the car came to rest in the four foot of the down Leeds line.

57 The fence was substantially damaged by the collision with the car. However, the fence had been removed and reinstalled in August 2006 and was in a good condition.

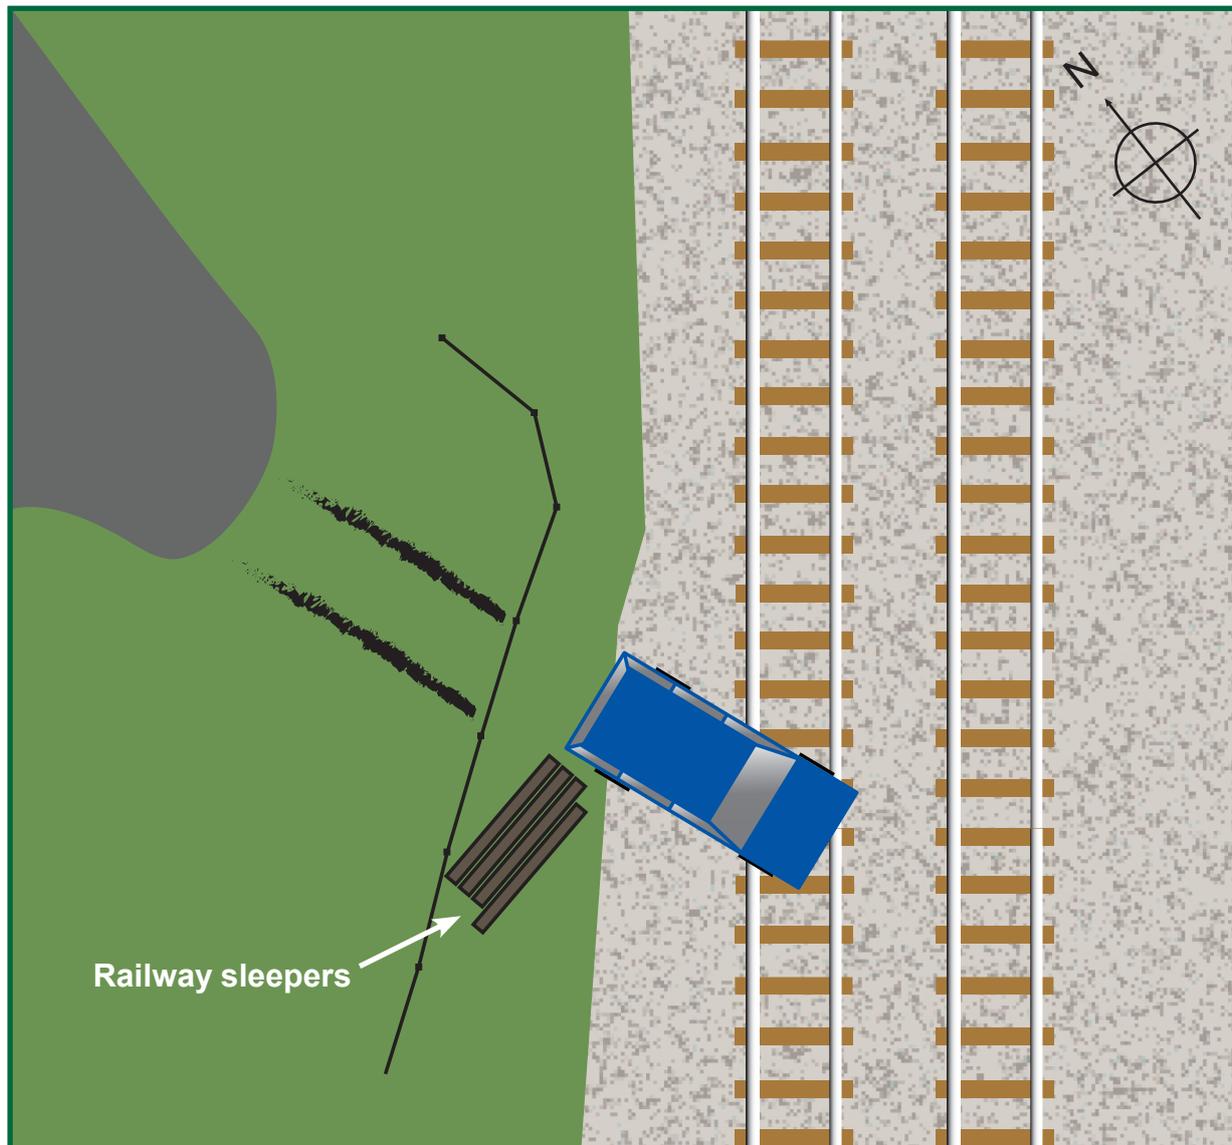
Diagram 1: Location where the car came to rest

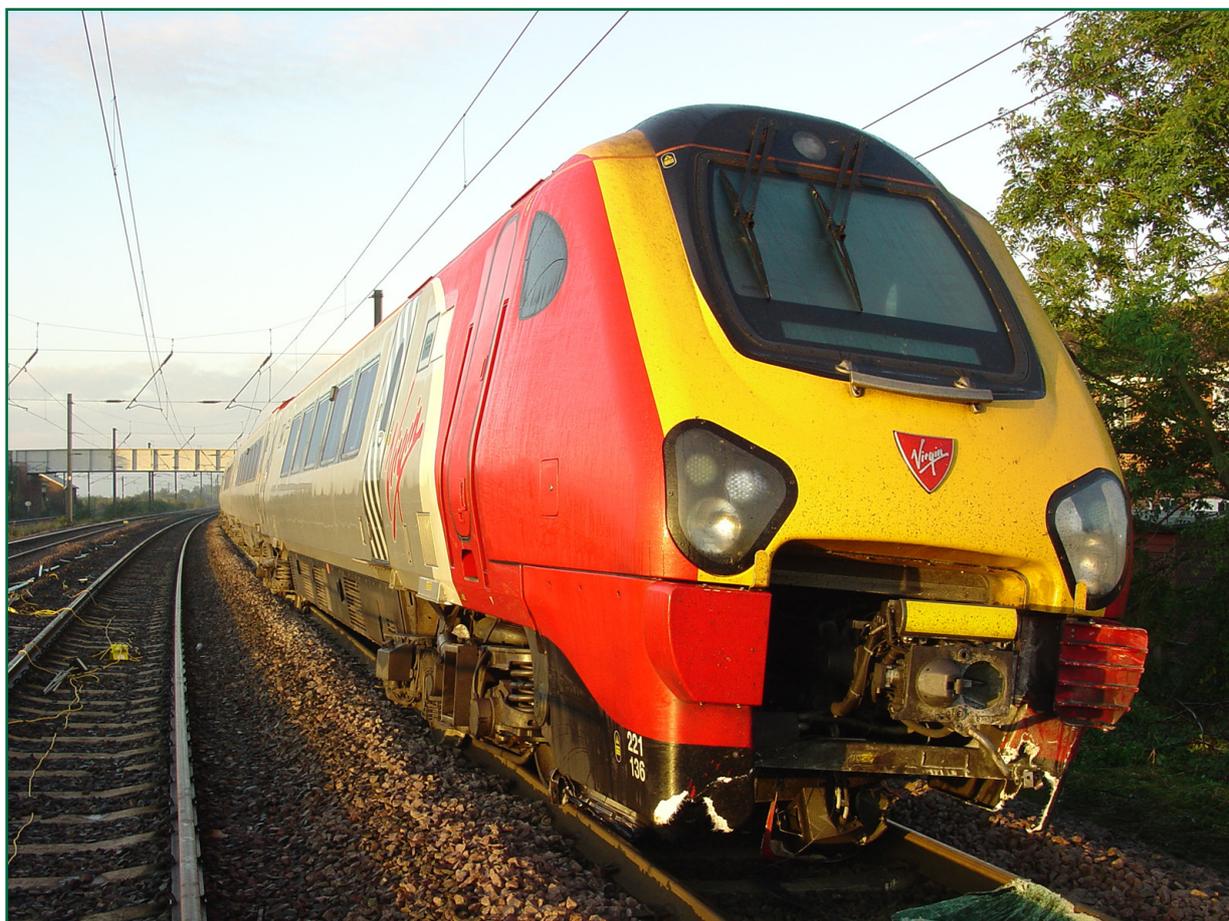
- 35 The leading wheels of the train remained on the track, but the second, third and fourth wheelsets of the train were derailed (Figures 3 and 4). All other wheels remained on the track, and the train decelerated to a halt 907 metres north of the point of collision. The train remained upright and inline on or close to the track throughout its deceleration.
- 36 At the time of the collision the car driver was still in the driving position of the car with his seat belt fastened.

Figure 3: The derailed train - front view

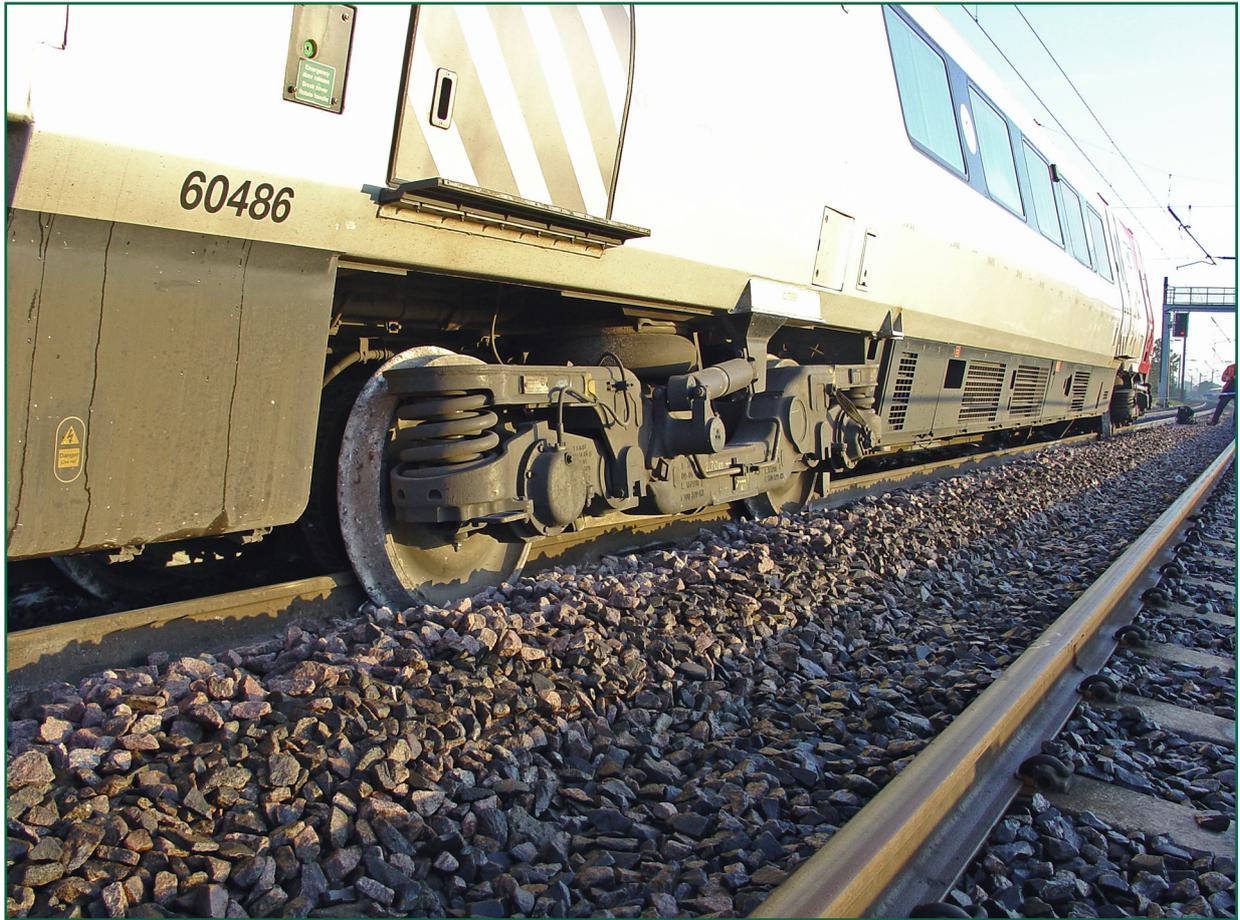
Figure 4: The derailed wheelsets, 2, 3 and 4 from the front, on the leading vehicle

52 Wheelsets two, three, and four of the leading vehicle became derailed and sustained damage by running on *track fasteners* and over collision debris. Marks on the derailed wheel flange crowns support this.

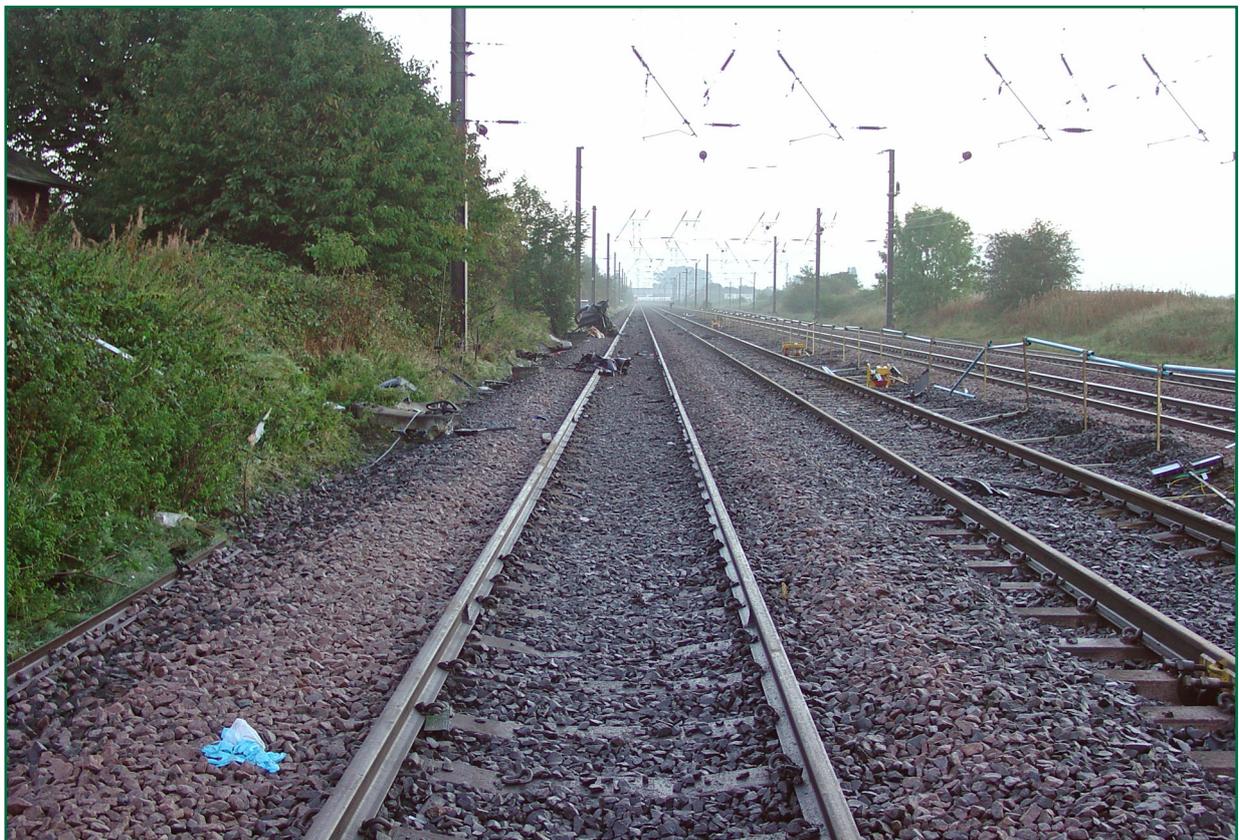
- 37 The car driver received fatal injuries from the collision. No one was injured on the train. The car broke into many parts and was scattered by the impact (see Figure 5).
- 38 The derailed train did not obstruct the adjacent line. There was considerable damage on the underside of the vehicles (see paragraphs 90 to 96); as a result fuel leaked into the track ballast from three of the train's fuel tanks and the *tilt system* became completely unlocked on two of its five vehicles.
- 39 The railway track and signalling were damaged.

Figure 5: Debris from the car after the collision

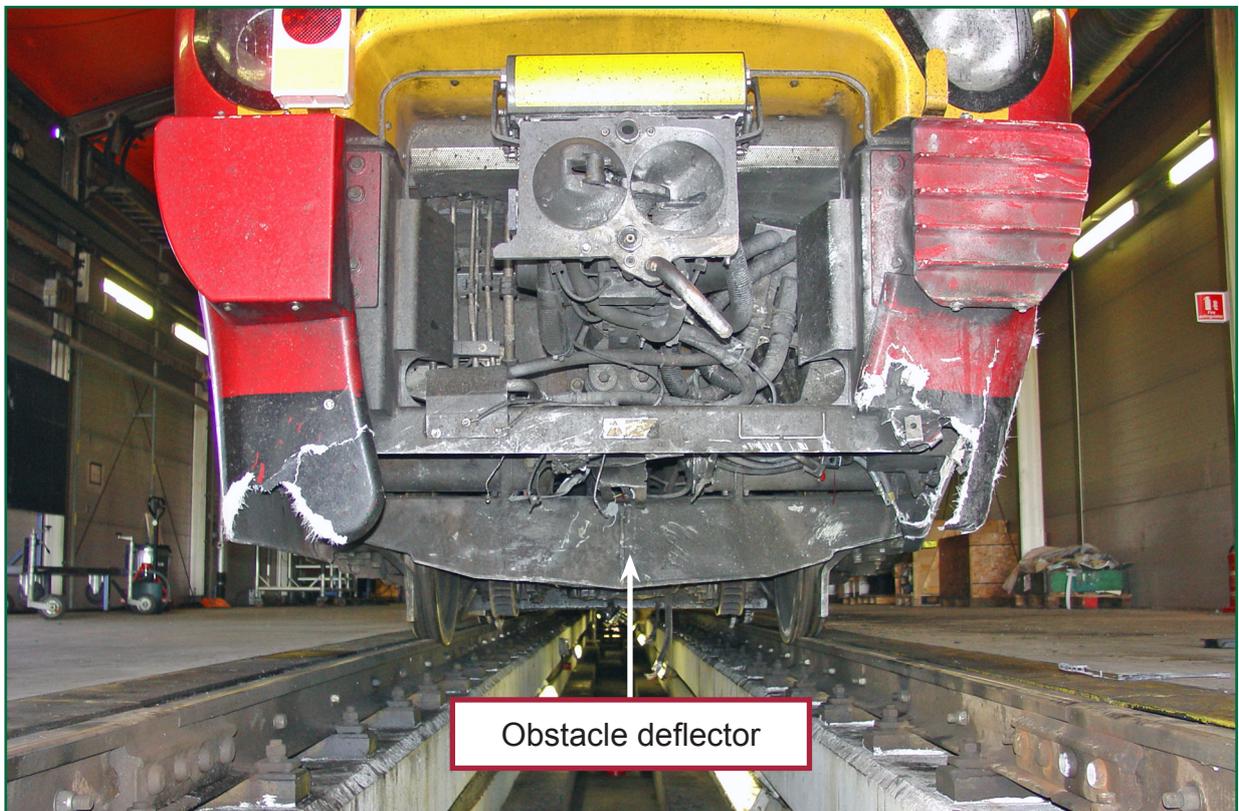
84 The performance of the obstacle deflector was contributory to the train remaining in-line and upright after striking the car as it prevented the leading wheelset from derailing and also ensured that only relatively small bits of the car passed under the train (see Figure 8).

Figure 8: Obstacle deflector at the front of the train after the accident

- 85 The obstacle deflector performed structurally in accordance with its design purpose. The obstacle deflector withstood the loading imposed by the collision with the car and remained attached to the train. There were no signs of distress at any of the attachment points. The deflector had rotated backwards before returning to a permanent plastic deflection on its mounts of seven to seven-and-a-half degrees.

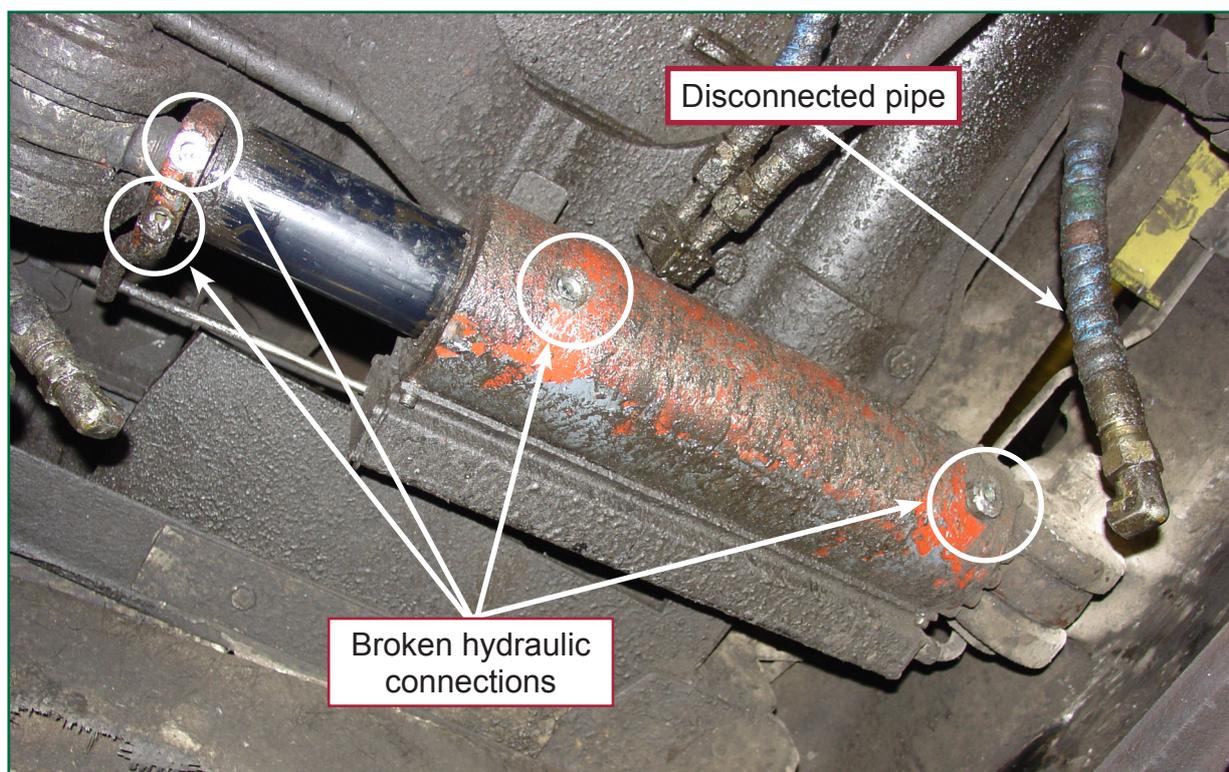
90 The debris from the car hit several elements of the train's tilt system. In particular it knocked two hydraulic connectors off the *tilt actuators* located on the trailing bogie of the leading vehicle, and 60 % of the *locking actuators'* hydraulic connections (see Figure 9) The removal of the connectors from the tilt actuators caused a loss of system pressure which was detected by the *tilt control system's* pressure monitors. In accordance with its programming, the tilt control system then commanded the locking actuators to centre the tilt system, and to lock it in that position. However, due to the damage to the locking actuators' hydraulic connectors, the locking system failed completely on two vehicles (the leading and the third vehicle from the front) and partially on the other three. This left the leading and third vehicles free to tilt in a passive mode as dictated by the kinematics of the unlocked tilt pendulum system interacting with the vehicle body's centre of gravity.

Figure 9: Tilt actuator showing all four hydraulic connections knocked off

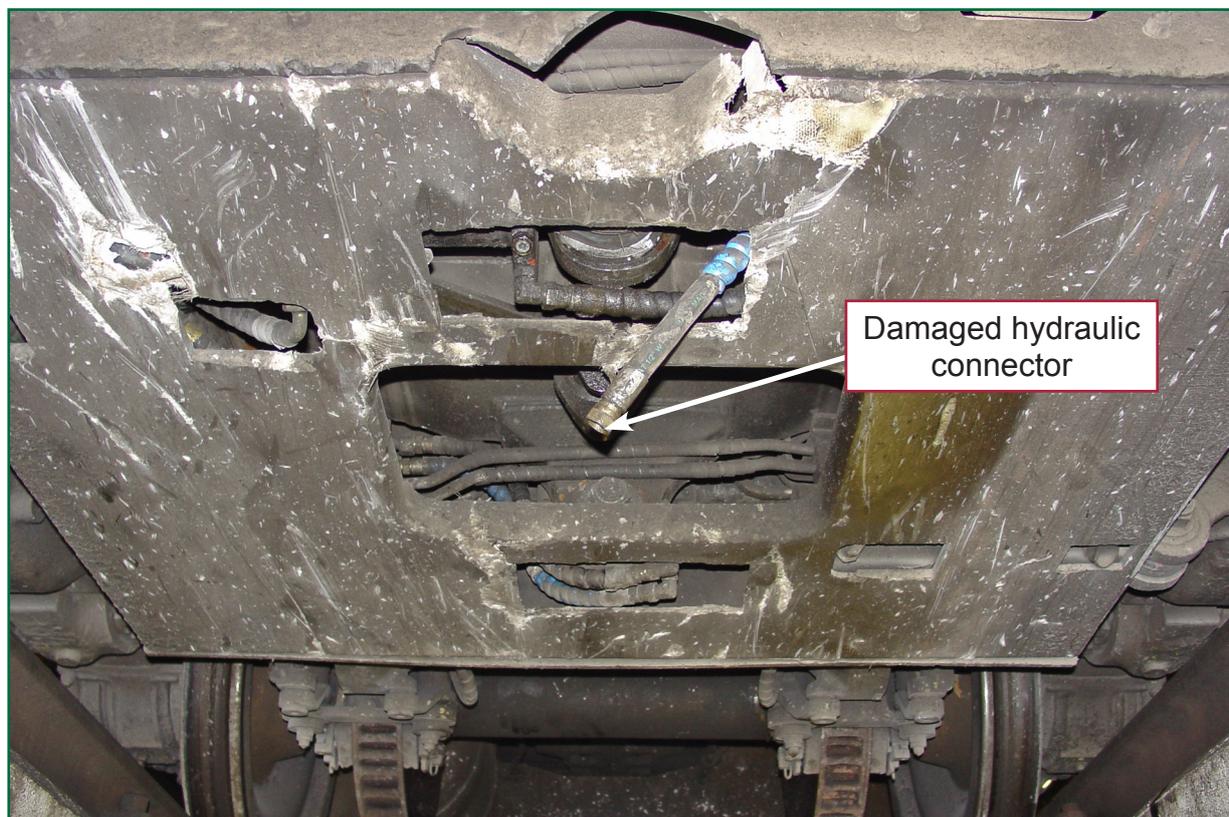
- 93 More locking connectors were knocked off than tilt connectors as the former are close to the longitudinal centre-line of the bogie, where the stone guard's design contains significant openings to facilitate access to the tilt pipe work, which expose the locking connectors (Figure 10). The tilt actuator connectors are off-set to either side and are better protected by the stone guard.

Figure 10: Stone guard showing openings and damaged hydraulic connector

105 The designed openings in the bogie stone guards meant that the car debris caused considerable damage to the tilt actuators' hydraulic connections (paragraph 93, Recommendation 3).

107 Bombardier, the manufacturer and maintainer of the Class 221 trains, commenced upgrading the stone guards of these trains in early 2006, prior to the accident. The new stone guards are of a more robust, single piece, construction, and have wire grids over the openings to prevent ballast incursion whilst not preventing inspection. The new guards are installed as and when existing guards need replacement as a result of damage, and there is no scheduled programme for completion.

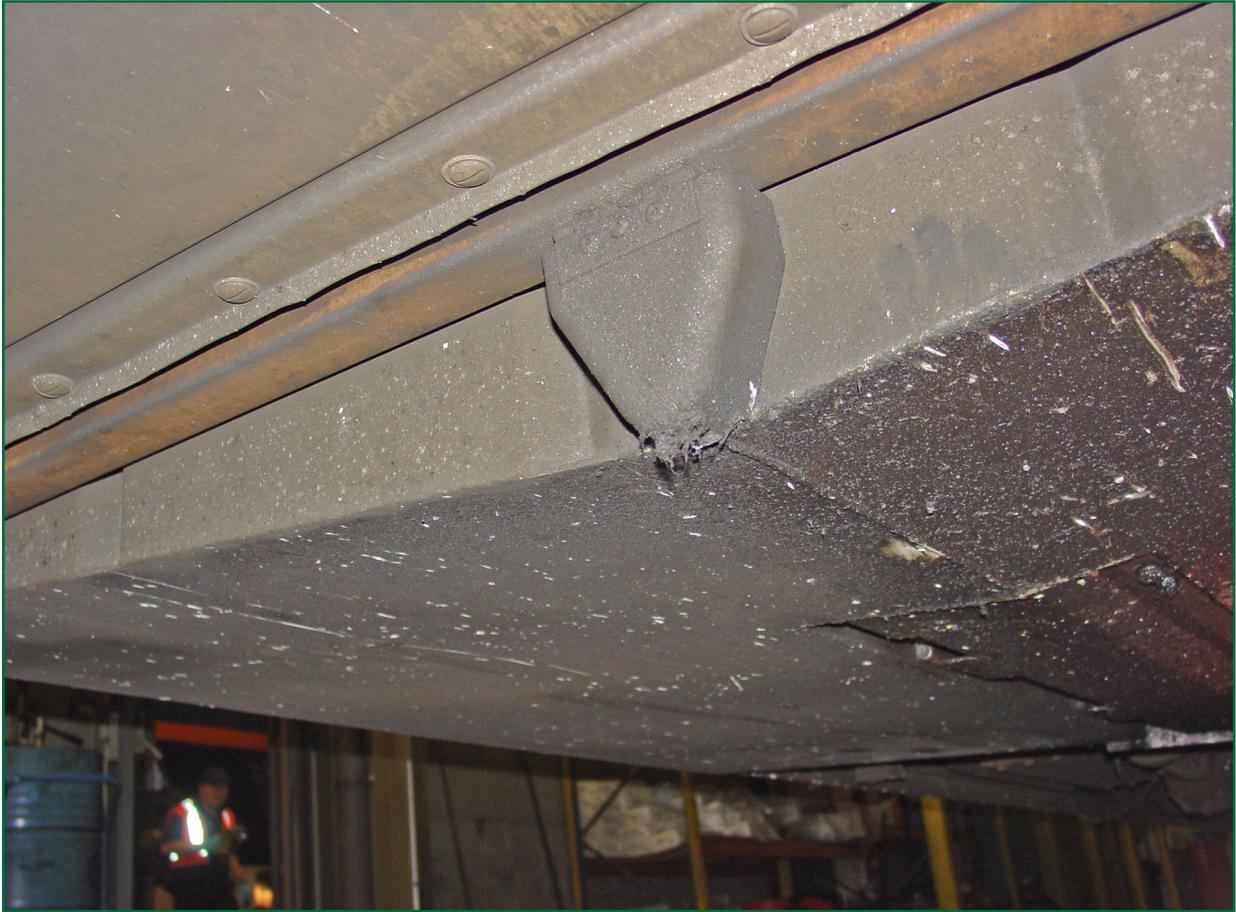
- 94 Debris from the car smashed the plastic protective cover on four of the five diesel tanks' 'dead-space' drain valves, and damaged the valves and their protective brass covers to such an extent that a large quantity of diesel fuel, possibly up to 1,500 litres from each of the four vehicles affected, leaked out into the ballast (see Figures 11 and 12).
- 95 The plastic cover, which was designed to protect against small objects such as pieces of track ballast, was not strong enough to withstand the impact with the collision debris at 100 mph (161 km/h) and therefore did not protect the valves or their protective brass covers.

Figure 11: Plastic cover over fuel tank 'dead-space' drain valve

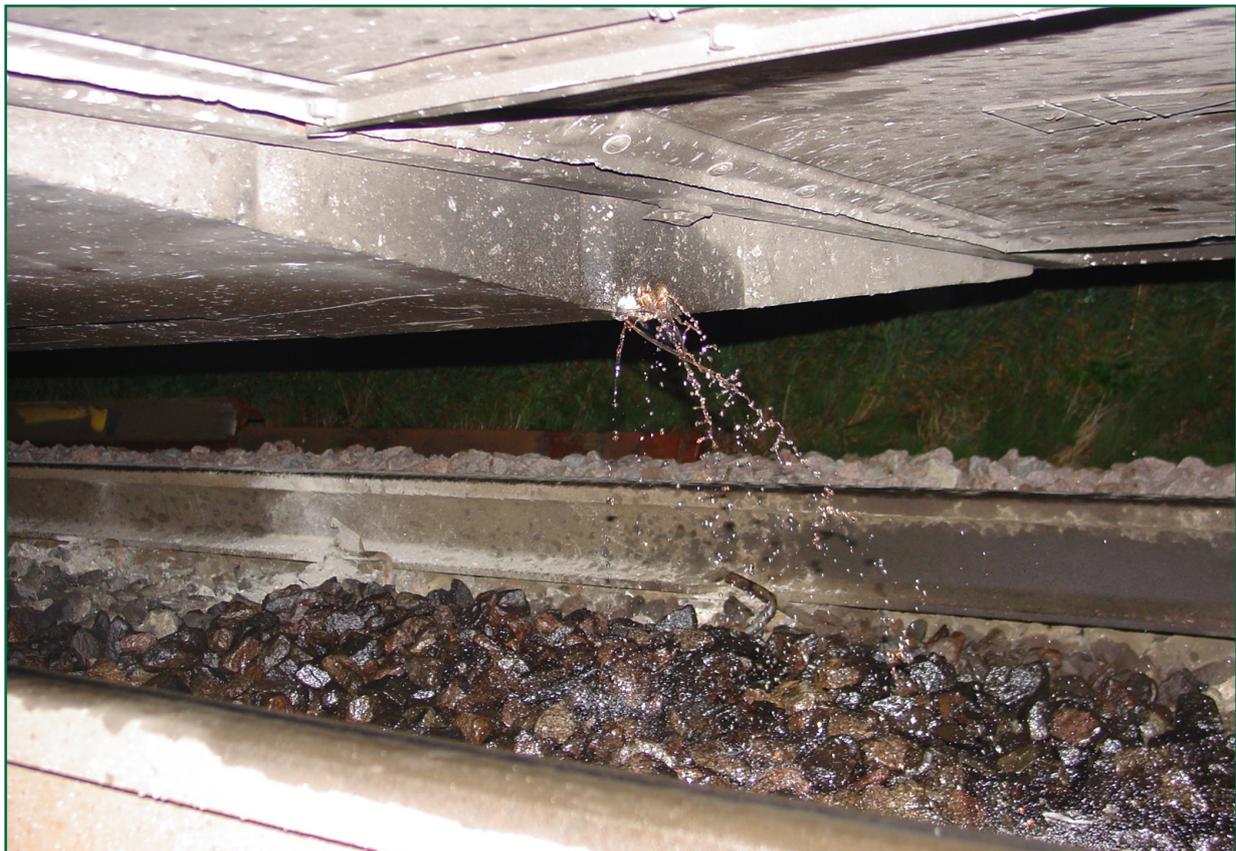
Figure 12: Fuel leaking from a damaged fuel tank 'dead-space' drain valve

104 The lack of robust protective covers to the fuel tank 'dead-space' drain valves resulted in damage to the valves from the impact of car debris under the train. This led to four of the five fuel tanks leaking fuel into the ballast (paragraph 95, Recommendation 3).
