Rail Accident Investigation Branch

Rail Accident Report

Derailment of a train at Croxton Level Crossing 12 September 2006

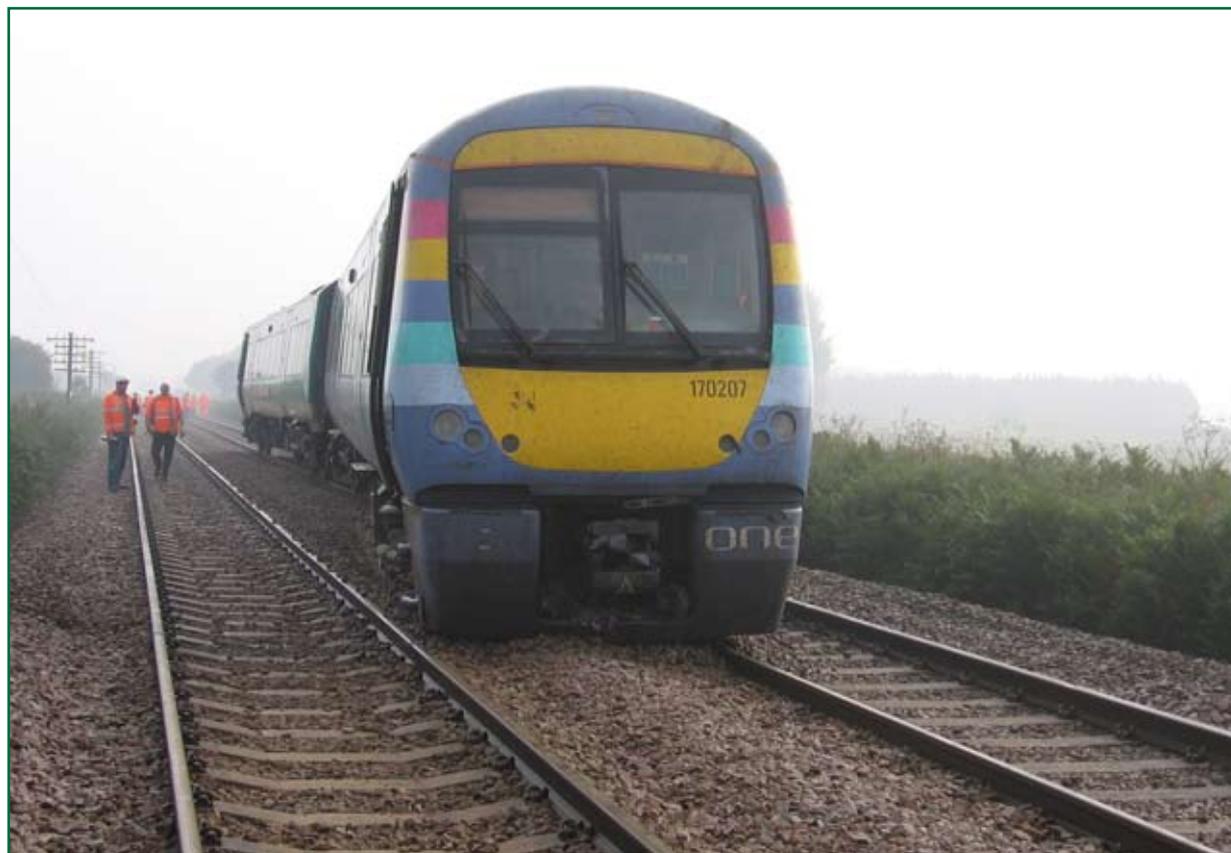
Figure 2: Derailed train after coming to a stop

- 89 At 06:03:23 hrs the train entered the crossing (Figure 8) and struck the dislodged panel. The collision derailed the leading bogie, but the rest of the train remained on the track. The train driver applied the emergency brake after realising that the train was running derailed, and the train ran 463 m before coming to a halt (Figure 2).

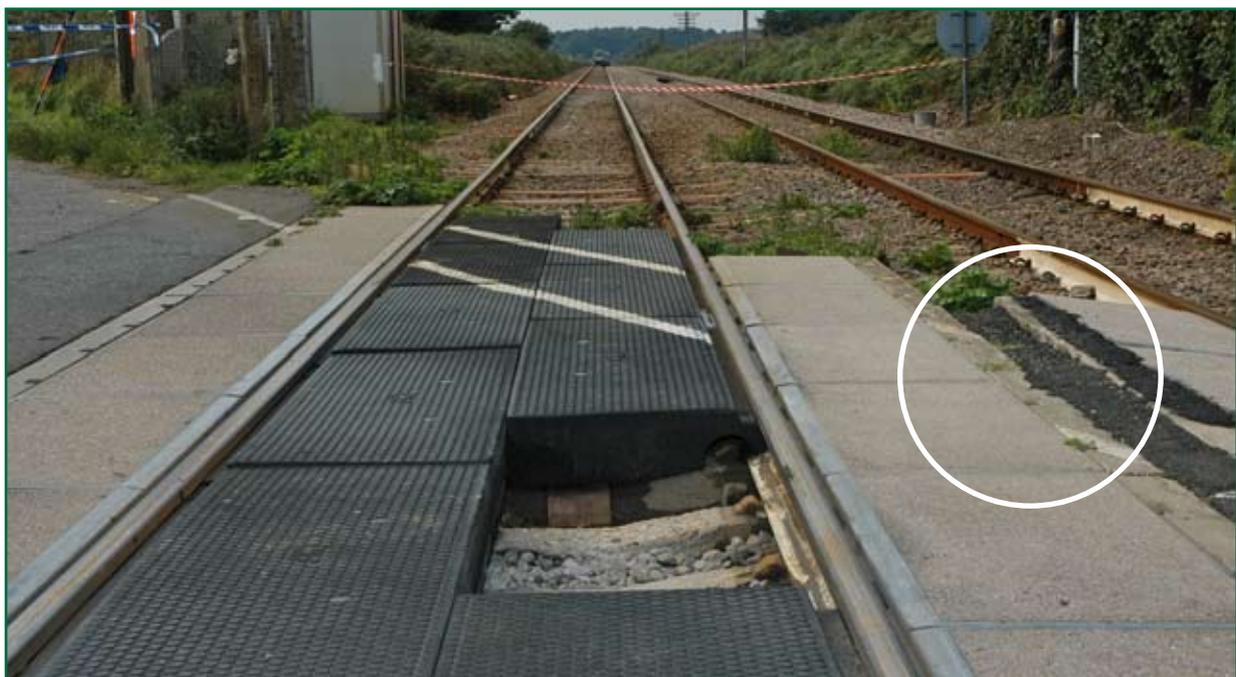
- 51 Network Rail *tamped* the down line of the crossing on 21 August 2005, which would again have required the removal of all panels on that line.
- 52 At some time between August 2005 and early 2006, and possibly related to the tamping in August 2005 Network Rail carried out track maintenance to correct *wet beds* on the down line at the crossing. During this work the staff carrying out the work accidentally lifted a concrete edge beam on the Thetford end of the down line. This was not corrected at the time and resulted in the edges of two of the six foot Bowmac panels being higher than the rest of the crossing surface (Figure 4).

Figure 4: Raised six foot Bowmac edge beams (circled)

- 53 A Network Rail Mobile Operations Manager (MOM) identified this during a regular inspection on 30 April 2006 and reported it to the Network Rail infrastructure fault control (IFC) at Cambridge, where it was entered into the Network Rail fault reporting system known as FMS.
- 54 In April 2006 Network Rail revised their method of inspecting level crossings, creating a dedicated level crossing team (paragraph 231).

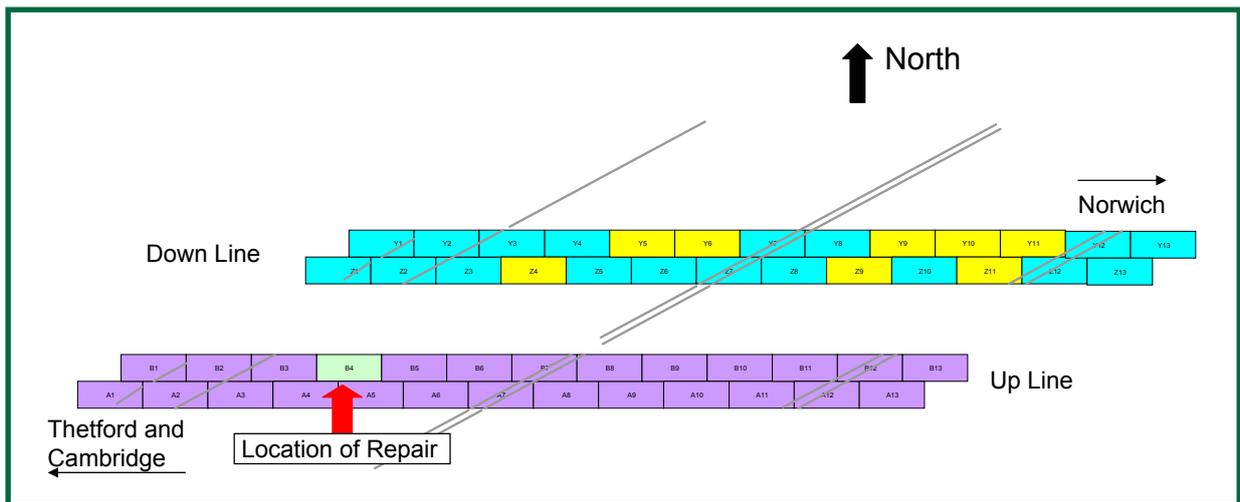
- 62 As a result, on 23 August the level crossing supervisor sent members of the level crossing team to visit the crossing. They noticed that a panel was rising a few inches when lorries travelled over it, and undertook a non-recognised repair. They inserted some timber strips, about 25 mm in thickness, between panel B4 and panels A4 and A5 of the crossing (Figure 5). They did this by forcing open a gap between the panels and hammering the timber down into the gap created. The team leader reported the finding of the loose panel, and the repair, to the level crossing supervisor and suggested that a road closure should be obtained to undertake a full inspection.

Figure 5: Position of panel B4 and region of repair on 23 August 2006 (arrowed)

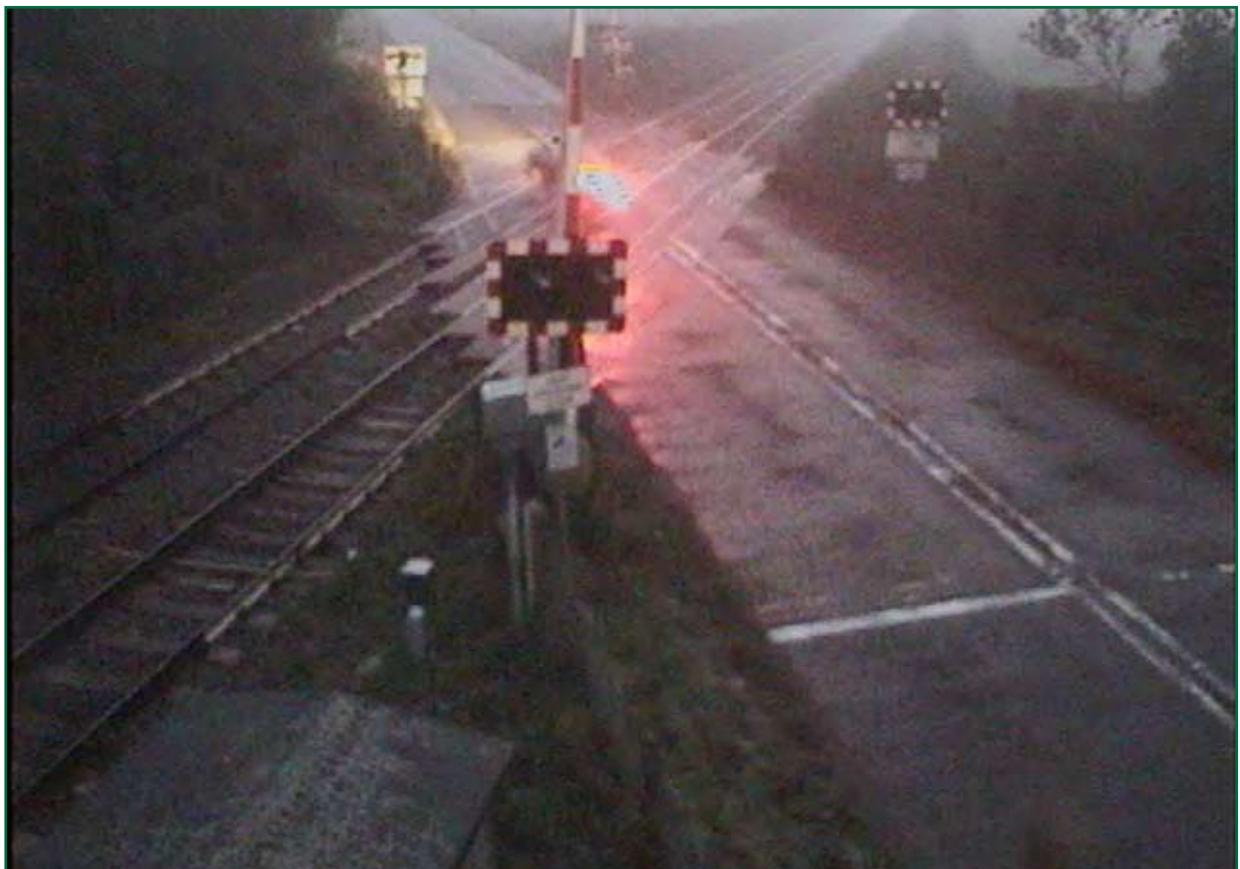
- 78 At 05:54:57 hrs a car passed over the level crossing. It struck the object and was lifted up on its nearside to an angle of around 30 degrees (Figure 7). The driver lost control of the car and it spun and came to a halt in the nearside road ditch some tens of metres north of the crossing, facing south-west. It was subsequently found that as a result of the collision with the object, two tyres had been punctured.

Figure 7: CCTV image of car striking dislodged HoldFast panel

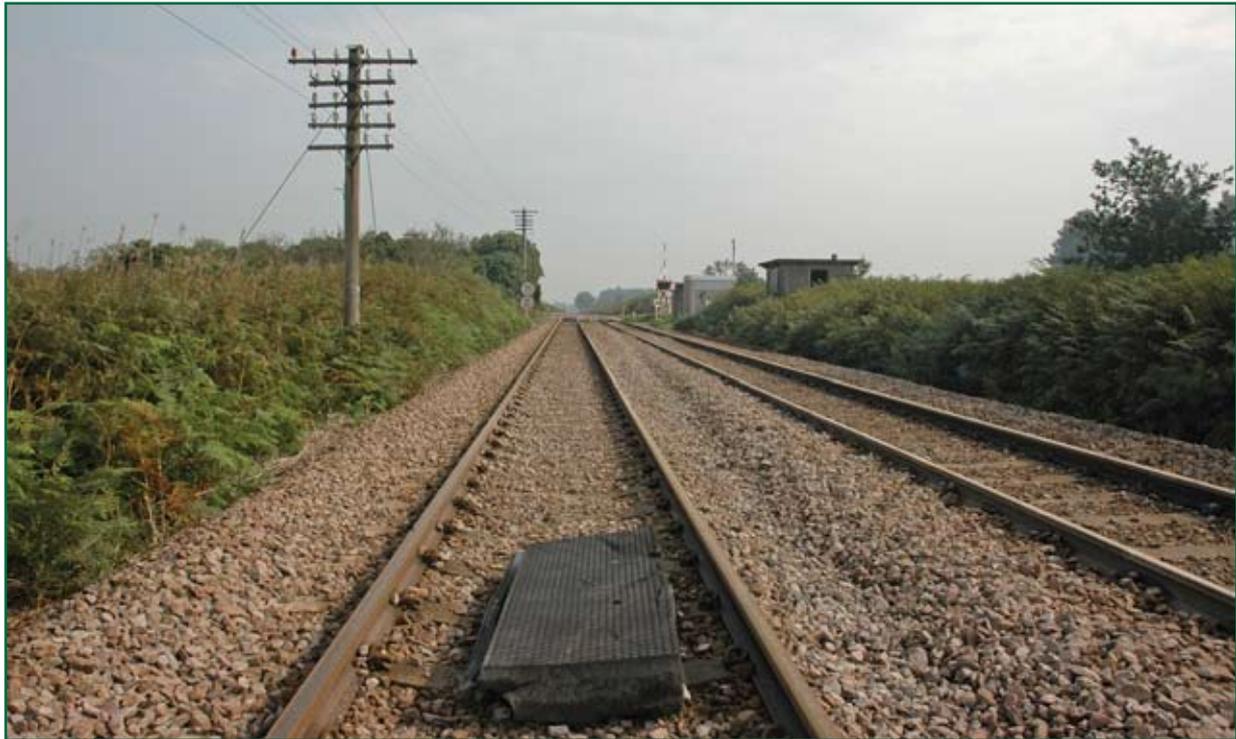
- 90 The dislodged panel was found in the four foot of the down line 83 m towards Thetford from the point of impact (Figure 9).
- 91 The dislodged panel had come from the six foot side of the up line four foot, and was the fourth panel from the Thetford end of the crossing. This panel is referred to as panel B4 (Figure 5).

Figure 9: Dislodged HoldFast panel looking towards Croxton level crossing

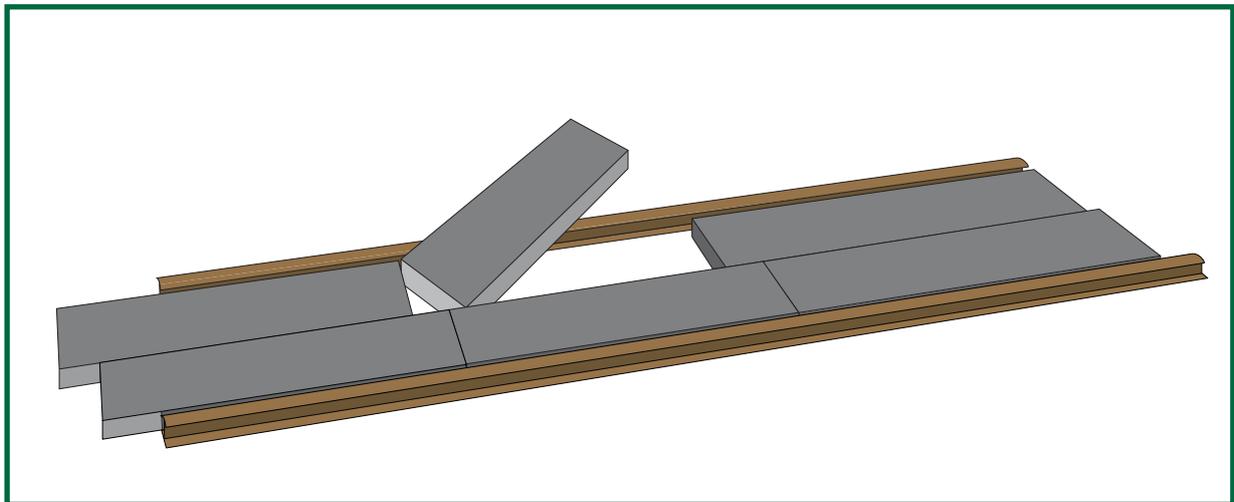
- 110 Witness and CCTV evidence confirm that the train was derailed by striking the level crossing panel B4.
- 111 Evidence from the witnesses, CCTV pictures and examination of the damage to the dislodged panel and the train all indicate that the panel was lying across the six foot rail of the up line, with one end remaining in or over the gap left by its displacement, and the other elevated over the six foot Bowmac panels of the crossing when the train hit it (Figure 10).

Figure 10: Likely position of panel B4 immediately before train impact

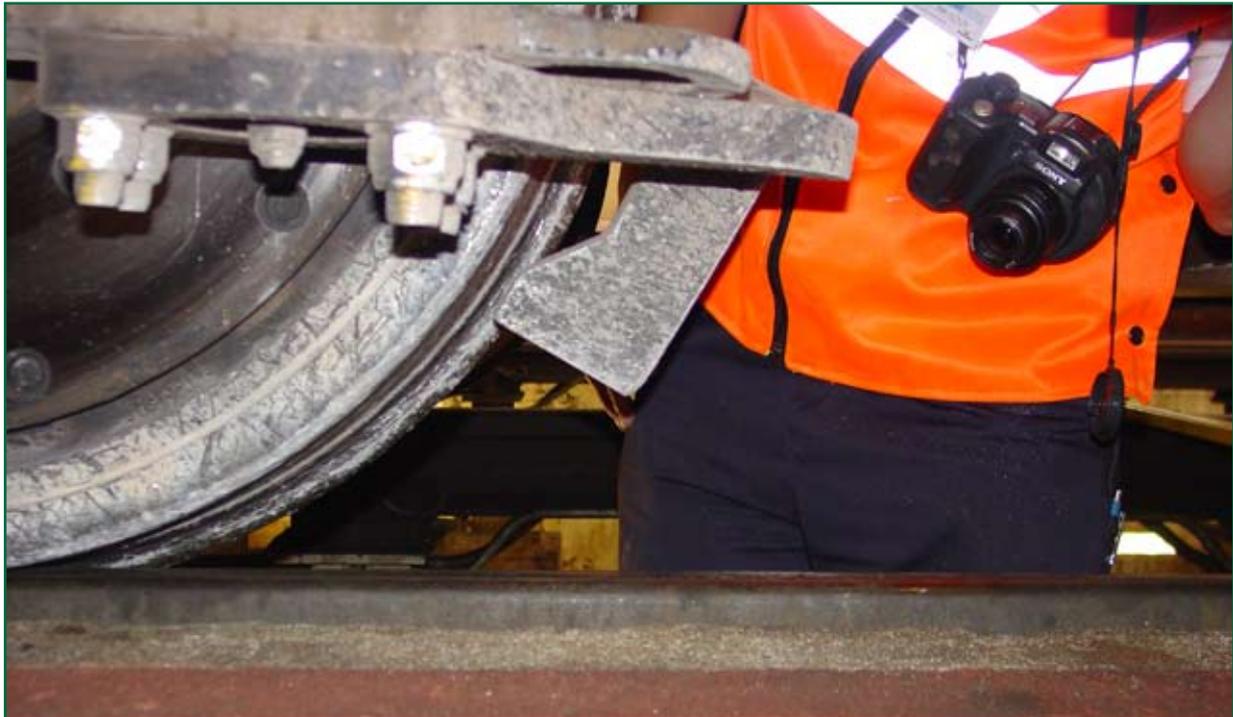
- 112 The most likely mechanism of derailment was that the bogie *lifeguard* of the leading six foot side wheel on the train and its mountings struck the dislodged panel. This lifted the wheel so that it was partially unloaded. The collision also created a yaw force, forcing the partially unloaded wheel to the right in the direction of travel. The partially unloaded right-hand wheel climbed the head of the rail, mounting onto it 6.1 m after the initial impact; the wheel then ran on the rail head until it derailed into the six foot after a further 6 m. The yaw angle of the bogie was sufficient to cause the wheels on the second axle to run into derailment.

Figure 11: Distorted lifeguard on leading right-hand (six foot) side of derailed train

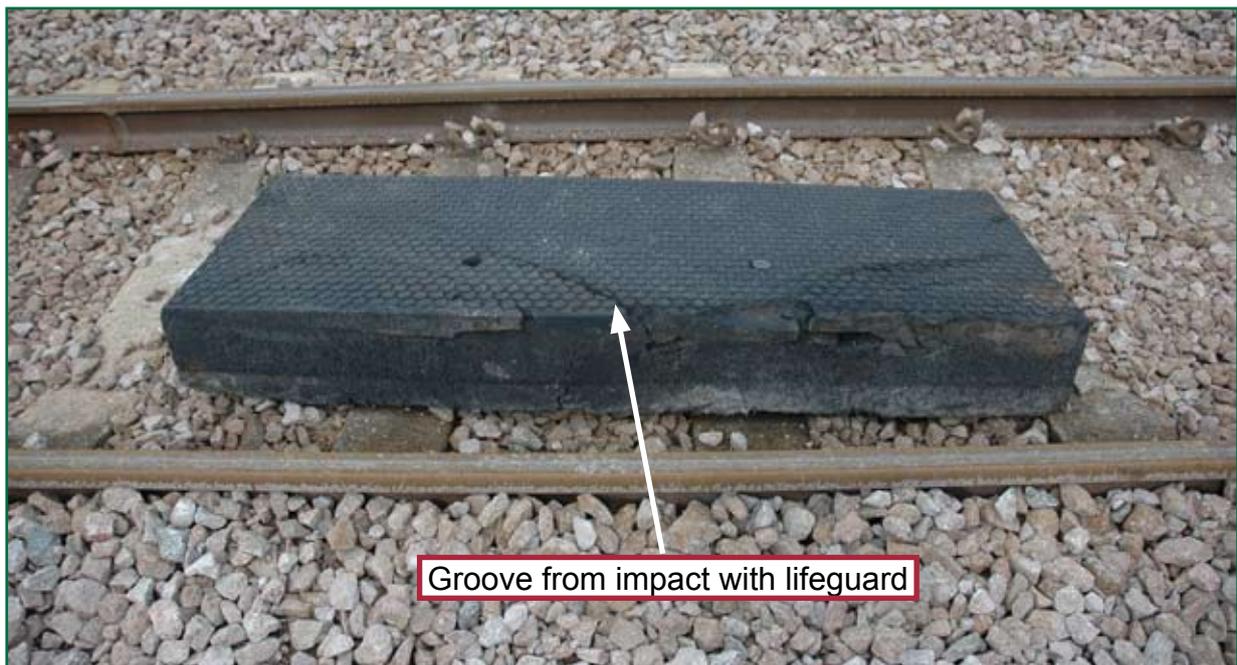
Figure 12: Impact marks to panel B4

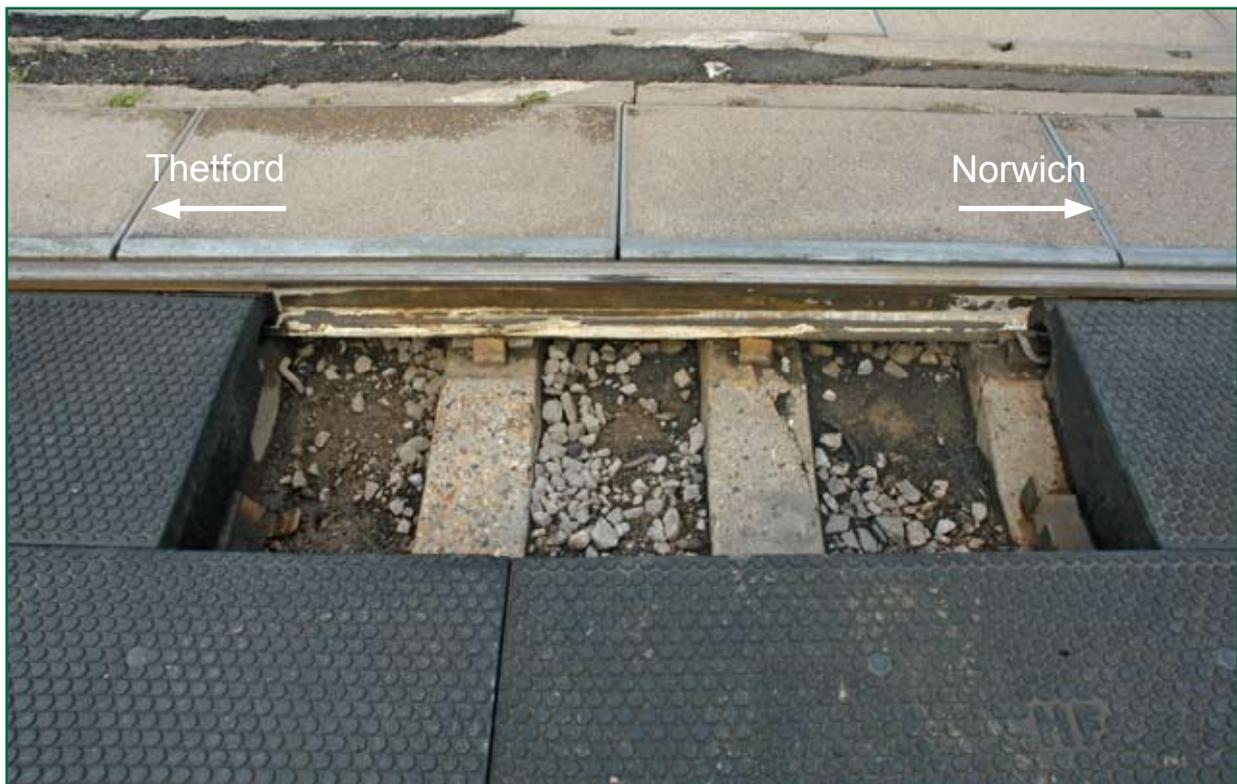
- 224 The ballast under the sleepers in the up line was eroded, with slurry having formed around the ballast (Figure 23).

Figure 23: Six foot rail and sleepers under dislodged panel B4

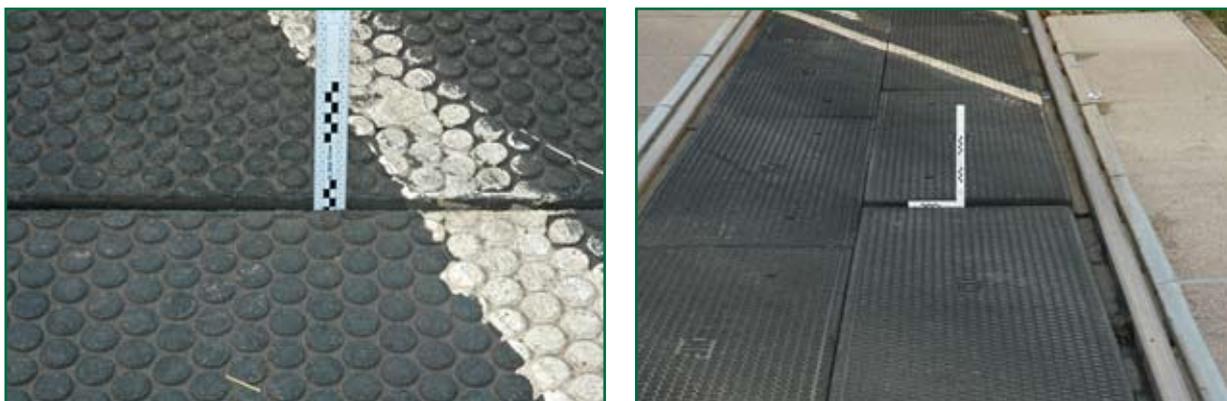
- 262 Examination of the crossing surface after the derailment showed that it was irregular, with vertical steps between different HoldFast panels in the four foot of both up and down lines. Some of these steps were in the order of 15 to 20 mm (Figure 24).

Figure 24: Vertical differences between upper surfaces of adjacent panels at Croxton

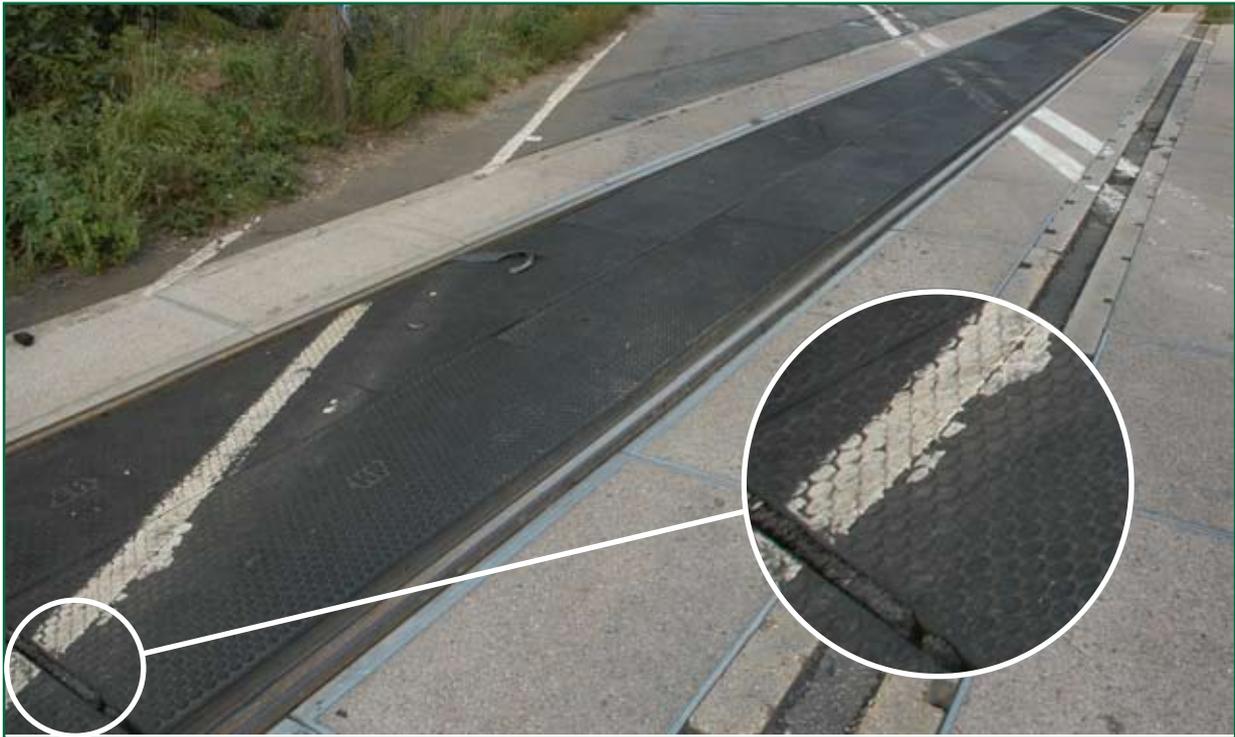
- 266 Contactors to Network Rail undertook a level crossing survey on 17 August 2006. This survey was to record the signalling infrastructure present at the crossing and was not related to the level crossing surface. A photograph from this survey, which was supplied to Network Rail by the contractor, shows a gap present between panels A5 and A6. This gap was in the order of 10 mm.

Figure 25: Gap with tarmac infill between panels in the down road (lower left corner)

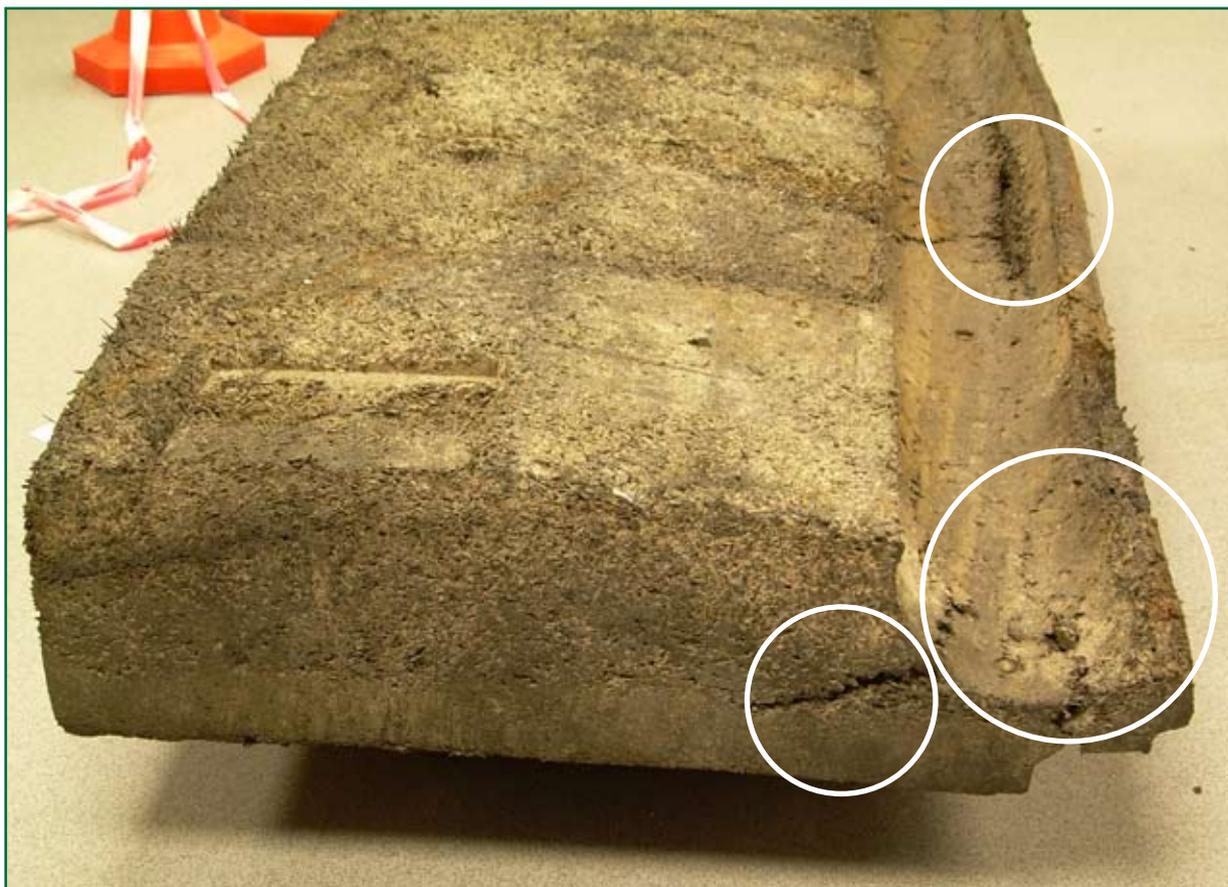
Figure 26: Panel B4 underside showing cracking in relief area and damage to nose

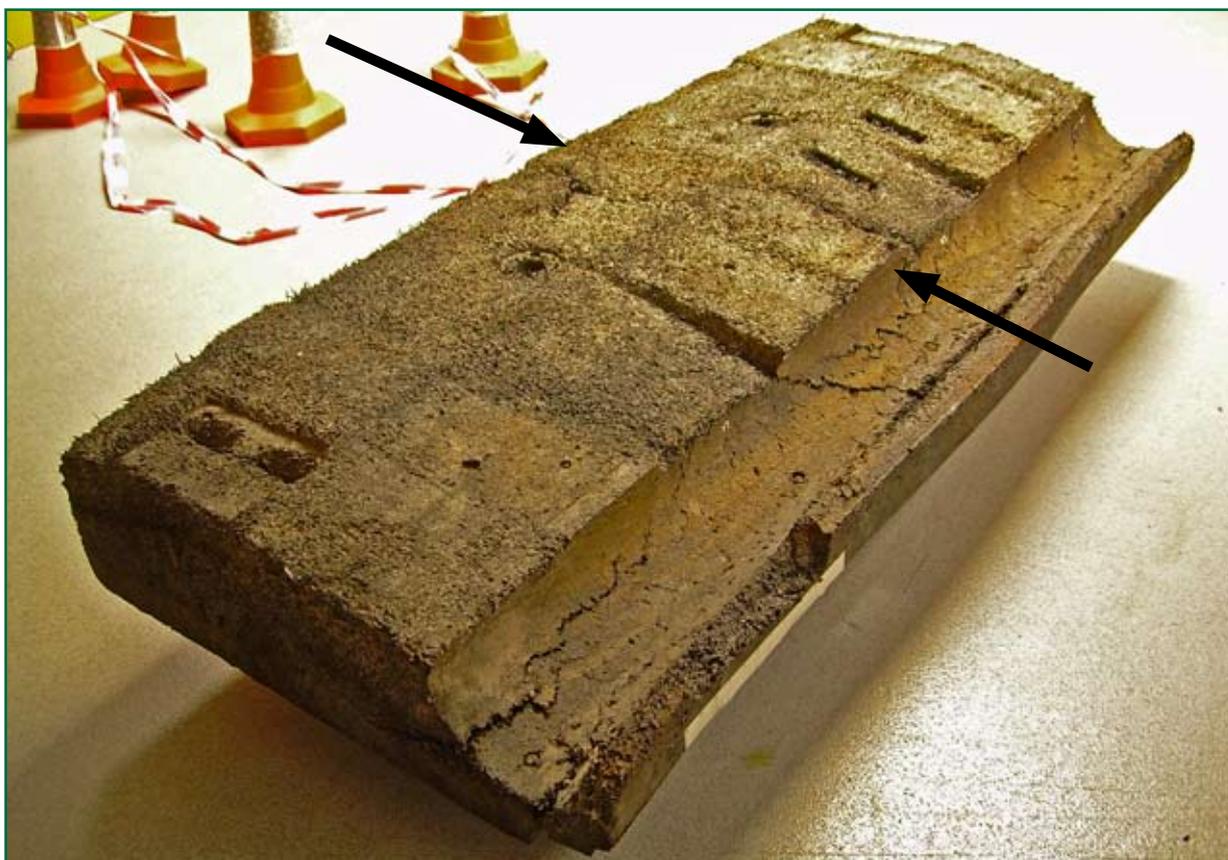
Figure 27: Panel B4 underside showing indentations from sleepers and transverse crack (arrowed)

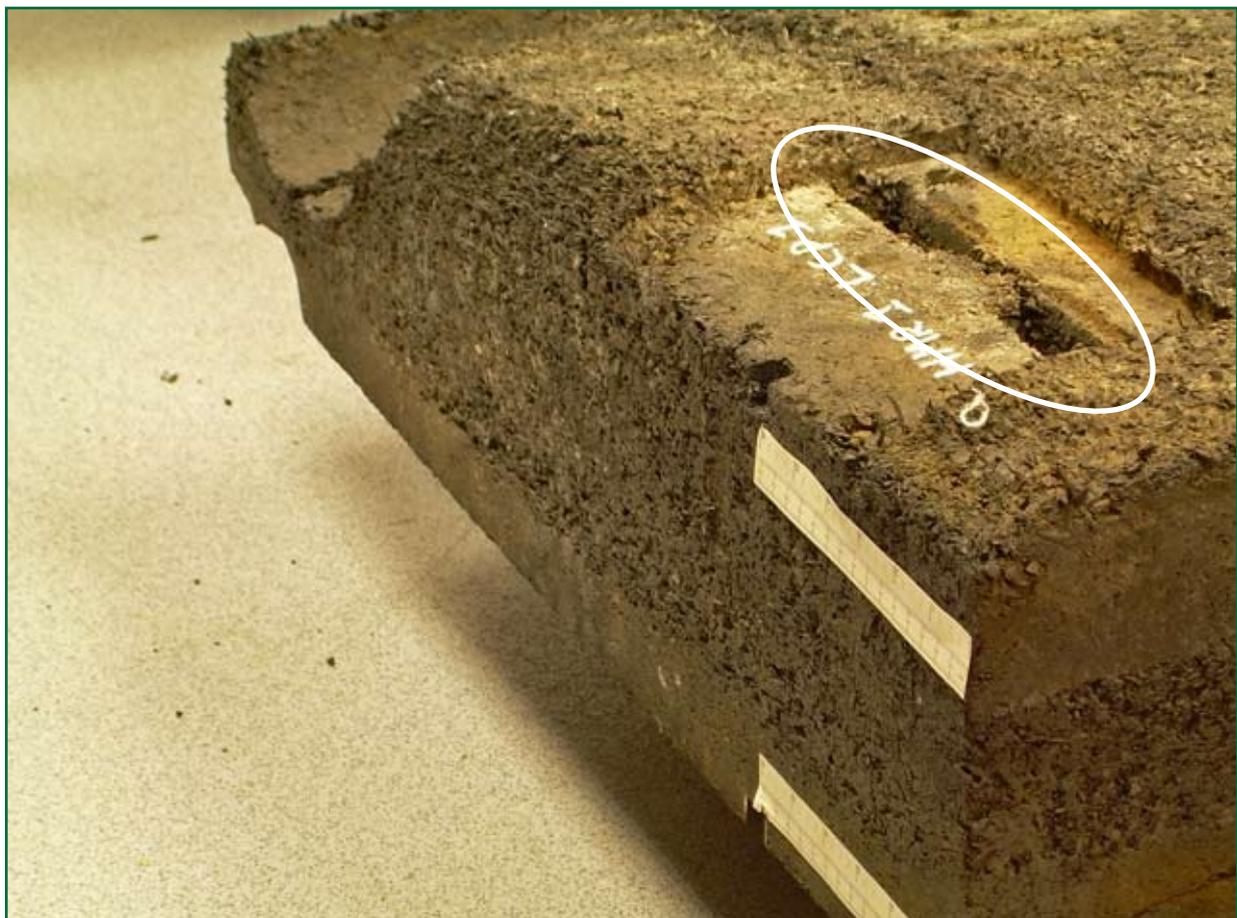
Figure 28: Panel B4 underside showing wear and cracking in the base plate location area

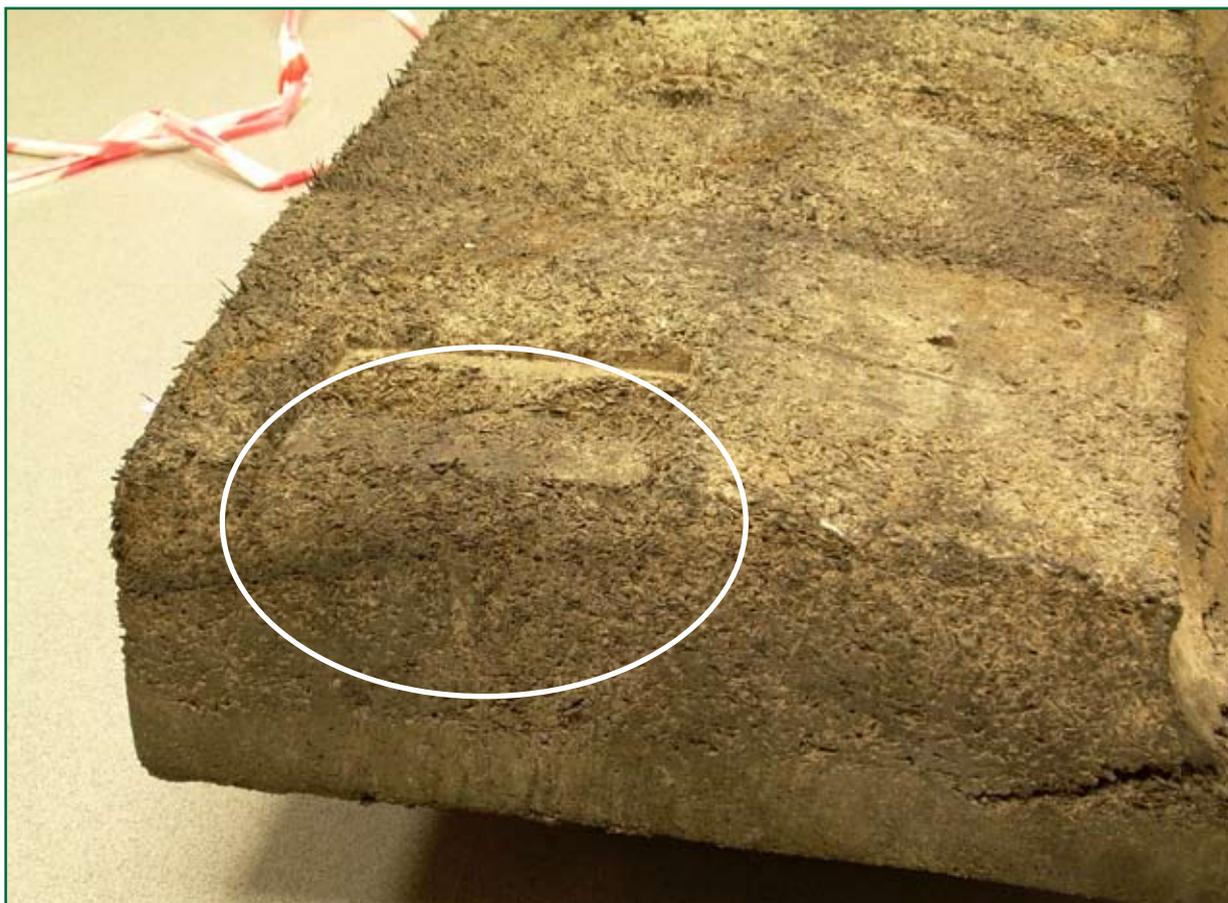
Figure 29: Panel B4 underside showing wear on panel edge in the base plate location area

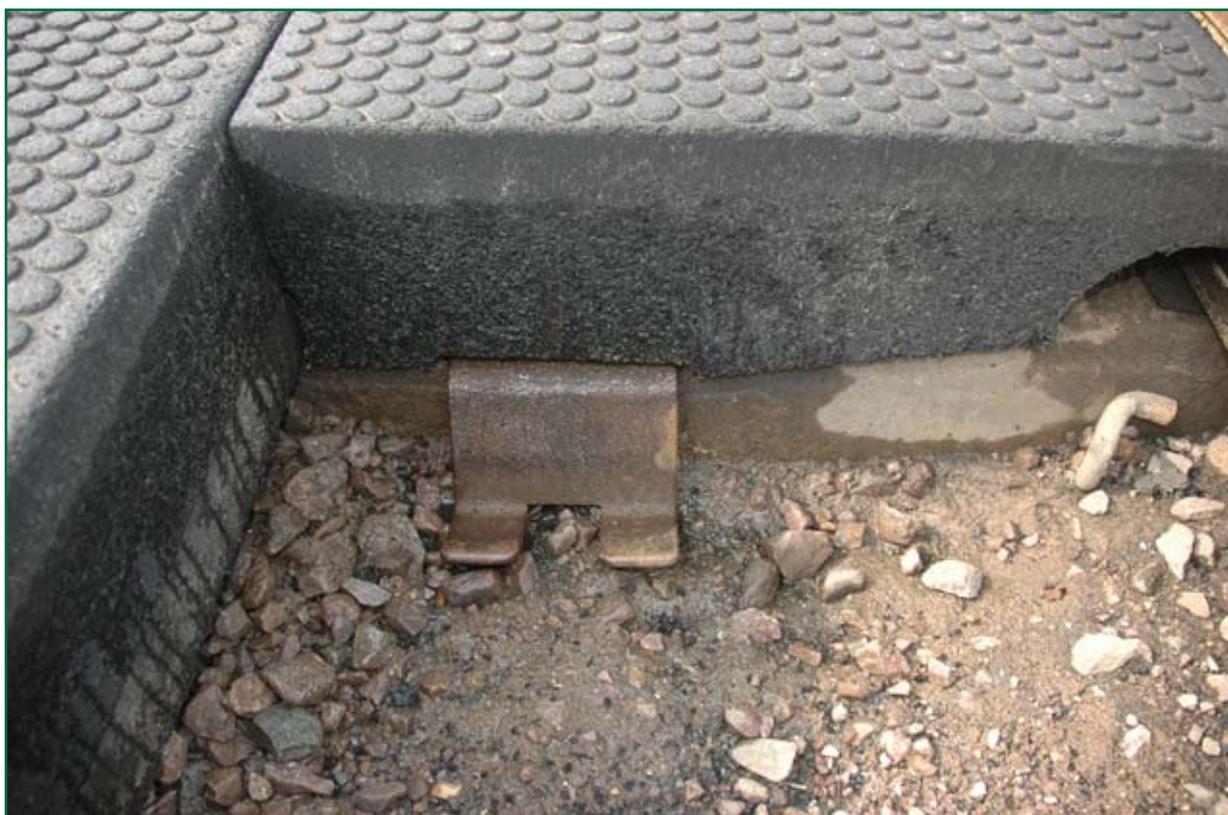
Figure 30: Deformed base plate under Thetford end of dislodged panel B4

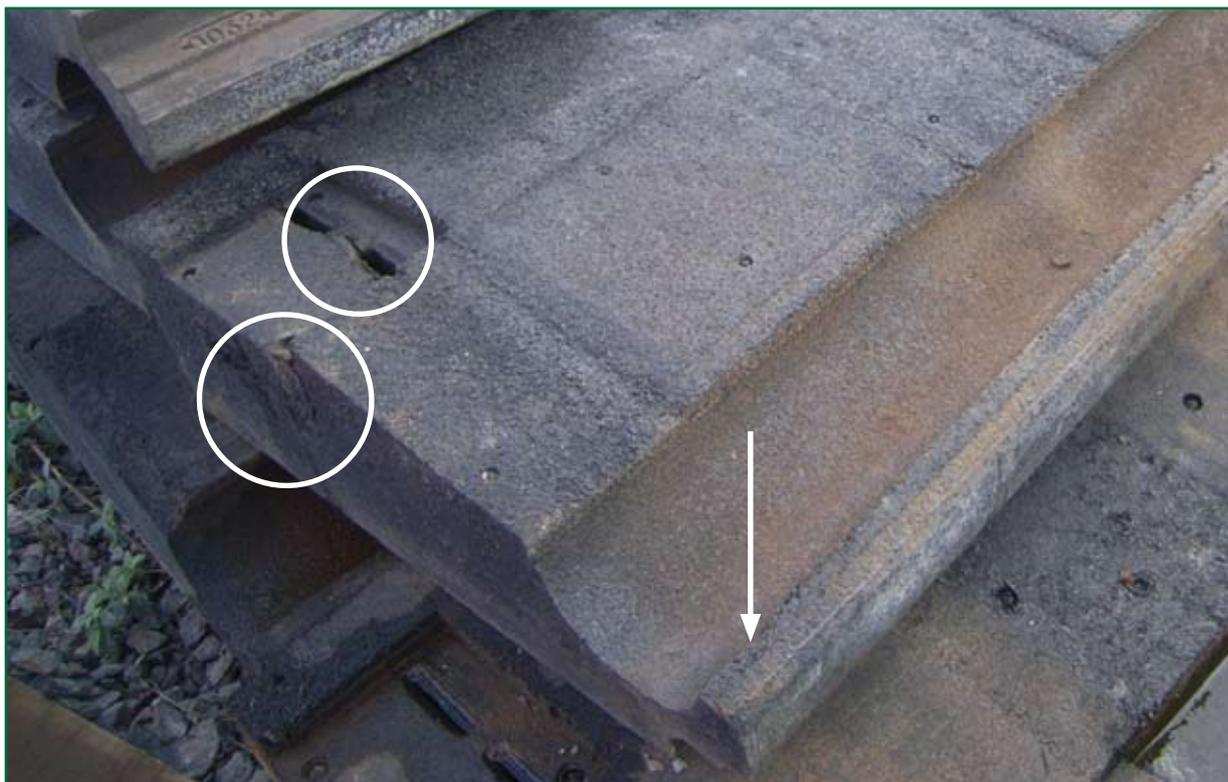
Figure 32: Side wall splits in panel base plate area (circled) and wear to nose (arrowed)

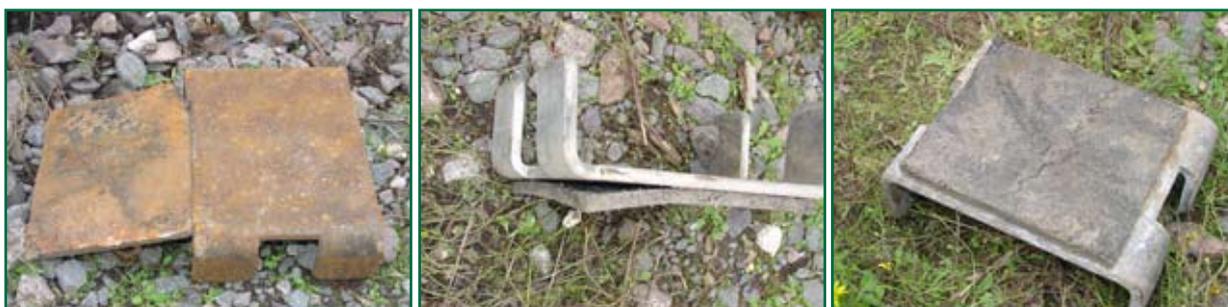
Figure 33: Loss of and damage to base plate pads

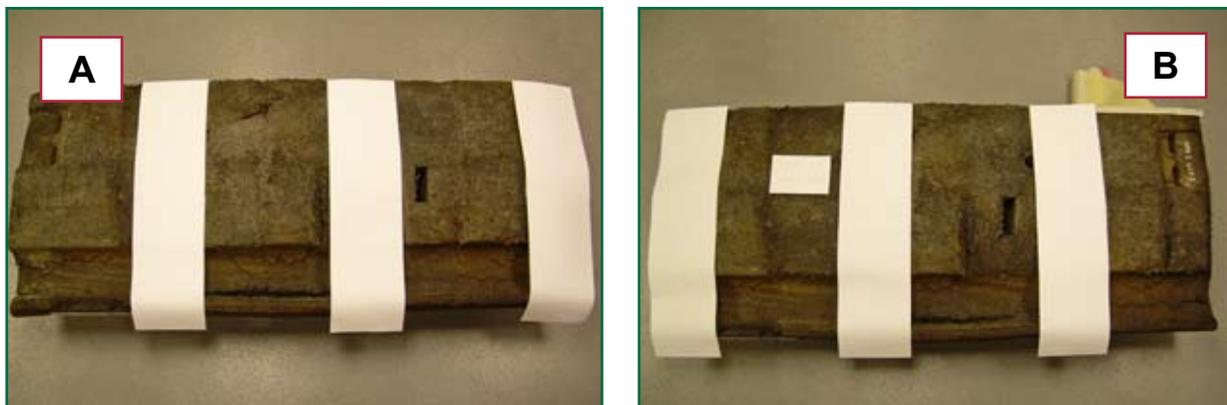
296 The other set of indentations on panel B4 indicate that at some other time panel B4 had been in a different position within the crossing. This is supported by the witness evidence that panels could have been in different locations at other times (paragraph 263). The distances between these other imprints indicate that the other end of the panel, ie its most recent Norwich end, may have been not fully supported when in this earlier location (Figures 35a and 35b).

Figure 35: Panel B4 underside showing sleeper positions : A - at time of accident; and B - at some earlier time

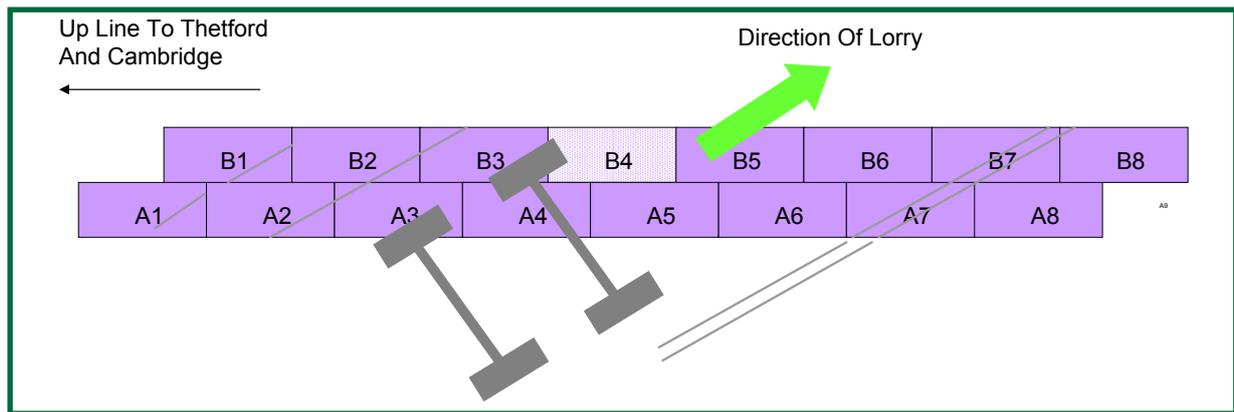
- 316 Records of the trailer's laden weight showed that it was within its allowable loading limit.
- 317 Analysis of the route of the lorry from the CCTV pictures indicates that its nearside wheels crossed panel B4 at its Thetford end, with the wheels crossing over the corner of the panel adjacent to the rail (Figure 36).

Figure 36: Likely path of lorry over panel B4
