# Rail Accident Report

Derailment at Epsom 12 September 2006

## Derailment at Epsom, 12 September 2006

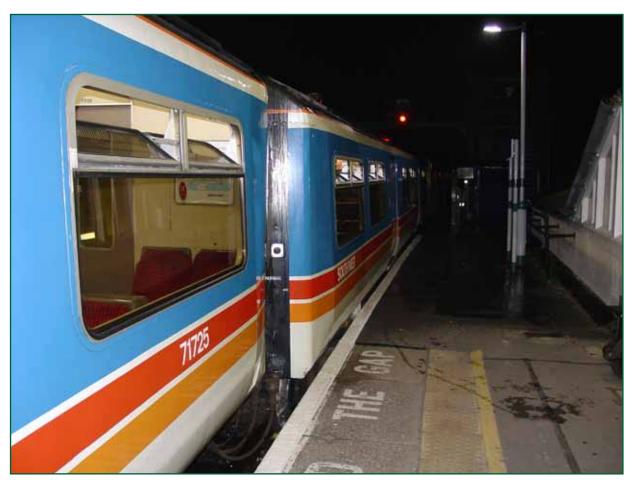
Figure 2: Third and fourth carriages of train, showing fourth carriage derailed and in contact with station platform

- 32 There was slight damage to the train where it contacted the platform edge, and distortion to the damper brackets of the derailed bogie caused by the excessive bogie rotation which occurred during the derailment. One 'hopper' ventilator window was dislodged when its stay bracket was broken, and fell into the passenger saloon, but it did not shatter and there was no other interior damage or displacement of internal fittings.
- 33 There was some track damage beyond the point of derailment, with minor damage to 840B points, the *diamond crossing* and some track fastenings and sleepers, but superficial damage only to the edge of the station platform.

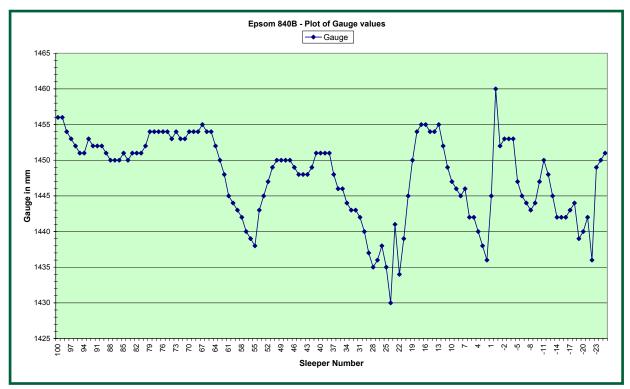
Figure 4: Track gauge at derailment site

- 117 The TISE noted the wide gauge (1460 mm) at the point of derailment on several occasions during the facing point inspections (paragraph 83). In April 2006 he recommended fitting tie bars to correct the gauge, pending replacement of the switches, but this was not done.

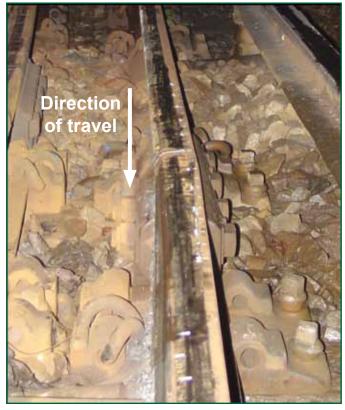
Figure 5: Outer rail at point of derailment, showing misalignment

- 102 The sidewear and misalignment had developed over a number of years, and had been identified by the patrol staff and the asset inspection team and recorded in their reports. Remedial work to realign the track and replace the rails had been planned, but had not taken place. The vertical misalignment was in the form of a step created by the head of the stock rail, worn down some 6 mm over the 22 years it had been in place, being adjacent to the rail on the curve which was relatively new, having been replaced in July 2005 (although it was already becoming sideworn to the point where it was proposed for rerailing in July 2006 (paragraph 123)). When this was done, the existing straight fishplates were used to form the joint. The use of stepped fishplates to bring the running surfaces into the same plane (in accordance with the relevant standard (paragraph 104)) would have reduced the impact loading on the end of the stock rail, and might have reduced the spalling which took place (paragraph 59).

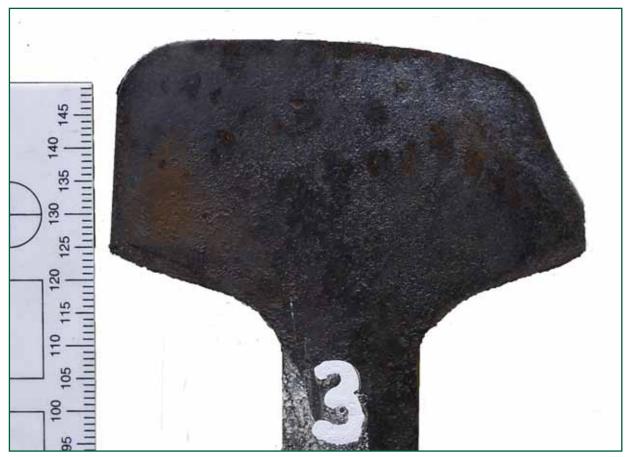
- During the investigation the rails at the point of derailment were examined. Two rails were involved: the plain line on the approach to the joint where derailment occurred (the *running-off rail*), and the stock rail of the right-hand half set of switches that formed part of points 840B (the *running-on rail*) (Figure 5). These were connected by an IBJ.
- 54 The running-off rail was marked as being made to the BS 113A standard profile, which is an appropriate section for this line and location. Measurements showed that it was, dimensionally, in accordance with this standard.

Figure 6: Section of end of running-on rail

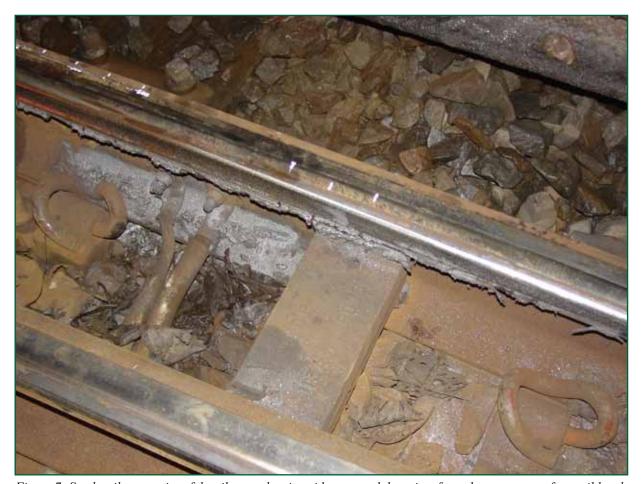
- The running-on rail was marked as being made of austenitic manganese steel (AMS), and was magnetically verified as such. AMS is used for point components because of its greater wear resistance. Both the rail head and foot were approximately 3 mm wider than specified. Other dimensions were within the tolerances for BS 113A rail, although the rail height was reduced from the nominal size by about 6 mm by wear.
- The effect of the wear on the head of the running-on rail was to produce a step of approximately 5 mm between the two rails when they were connected together with *fishplates*. This rail was also sideworn at the running-on end (Figure 6). There were heavy deposits of powdered metal on the gauge face and on the foot of the rail: these deposits were fresh and had not oxidised (Figure 7).

Figure 7: Stock rail near point of derailment, showing sidewear and deposits of powder worn away fron rail head

- 110 Because of the lack of lubrication, the rate of sidewear on the curve had increased, and after the derailment a large quantity of metal particles was found on the rail head and spread over the rail foot immediately beyond the heel joint.

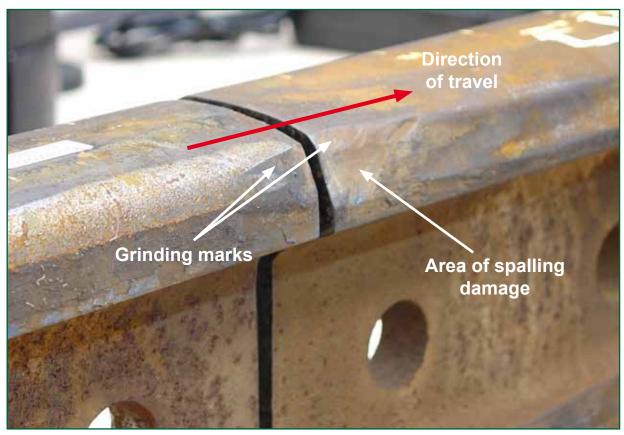
- 57 On the running-on rail, there was evidence of 'batter' damage (localised plastic deformation generated by wheels passing over the stepped joint) to the top of the rail head. Damage to the top of the rail extended approximately 530 mm from the joint.
- 58 There was an area of damage to the head of the running-on rail, approximately 55 mm long extending from the rail end, consistent with the application of a rotary abrasive disc grinder (Figure 8).
- 59 There was also damage to the gauge face immediately below the grinding marks that appears to have been caused by 'spalling' of the surface, a phenomenon in which repeated impact loading of the surface material of the rail causes it to become work hardened and embrittled to the point where it breaks off (Figure 8).

Figure 8: Wear and grinding damage on rail head adjacent to joint (photographed in laboratory)

- 99 The dynamic predictions are consistent with the derailment being caused by low speed flange climbing arising from the combination of high friction conditions and the local geometry of the heel joint at points 840B. The reason why this particular set of wheels derailed cannot be positively identified, but it is likely to have been related to interaction between a single flange and the 'ramp' produced on the gauge face by the grinding marks (paragraph 58) (Figure 8).

- 103 Some work had been carried out to grind the rail ends at the joint. It is not certain who did this or when, although it is likely to have been done when the running-off rail was replaced in 2005. This grinding may have been an attempt to blend-in the mismatched rail profiles at the joint. However, the short length of the grinding would be insufficient to produce a smooth transition between the rails, which were worn to different section profiles.

- 105 The grinding carried out in this case did not meet any of these requirements. It is possible that this particular piece of grinding was carried out with the intention merely to remove an obvious sharp edge that would have been battered over by wheel flanges and might have caused failure of the IBJ.
