Rail Accident Investigation Branch

Rail Accident Report

Derailment at Epsom 12 September 2006

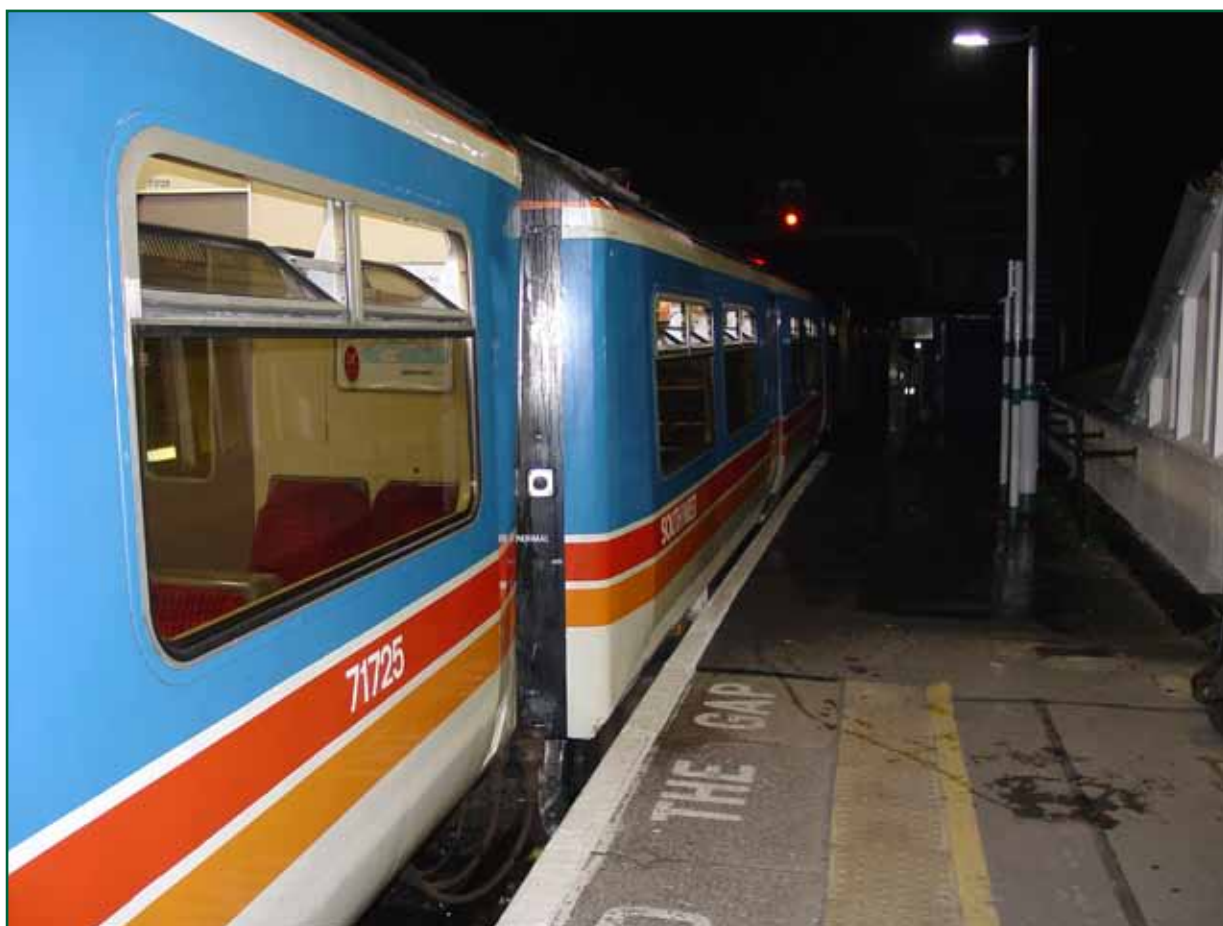
Figure 2: Third and fourth carriages of train, showing fourth carriage derailed and in contact with station platform

- 32 There was slight damage to the train where it contacted the platform edge, and distortion to the damper brackets of the derailed bogie caused by the excessive bogie rotation which occurred during the derailment. One ‘hopper’ ventilator window was dislodged when its stay bracket was broken, and fell into the passenger saloon, but it did not shatter and there was no other interior damage or displacement of internal fittings.
- 33 There was some track damage beyond the point of derailment, with minor damage to 840B points, the *diamond crossing* and some track fastenings and sleepers, but superficial damage only to the edge of the station platform.

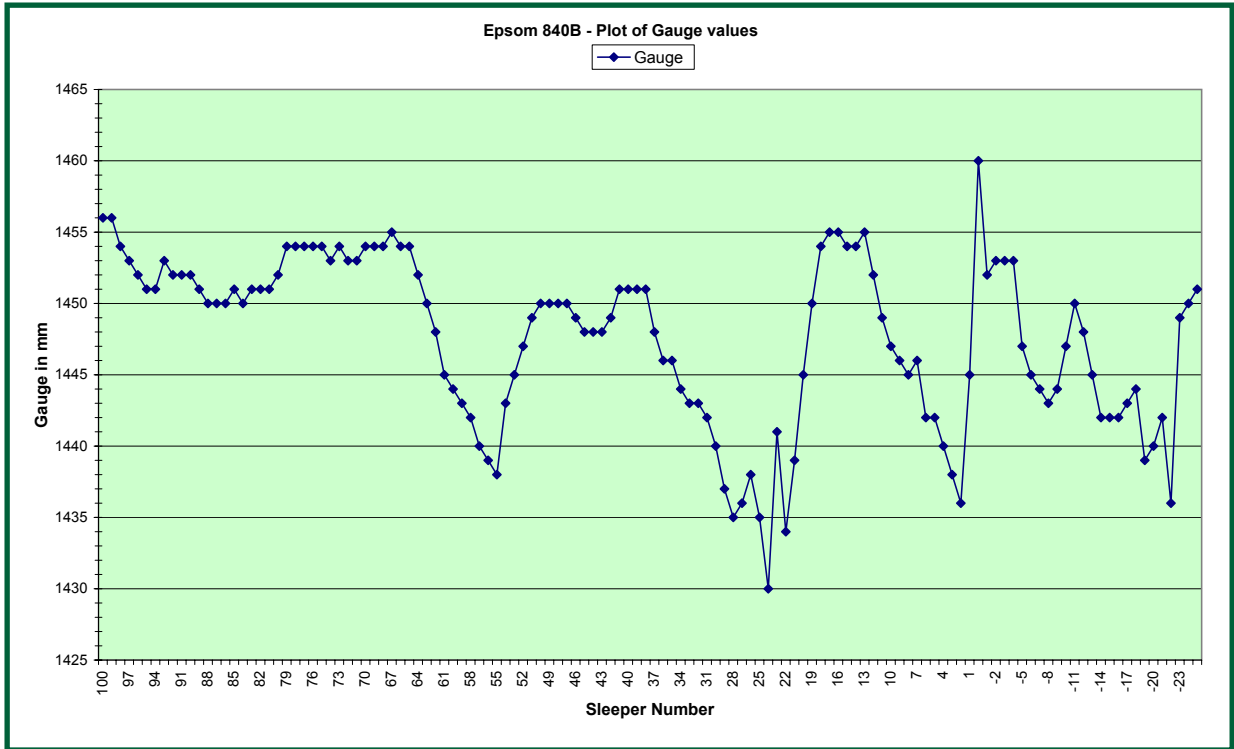
Figure 4: Track gauge at derailment site

- 117 The TISE noted the wide gauge (1460 mm) at the point of derailment on several occasions during the facing point inspections (paragraph 83). In April 2006 he recommended fitting tie bars to correct the gauge, pending replacement of the switches, but this was not done.

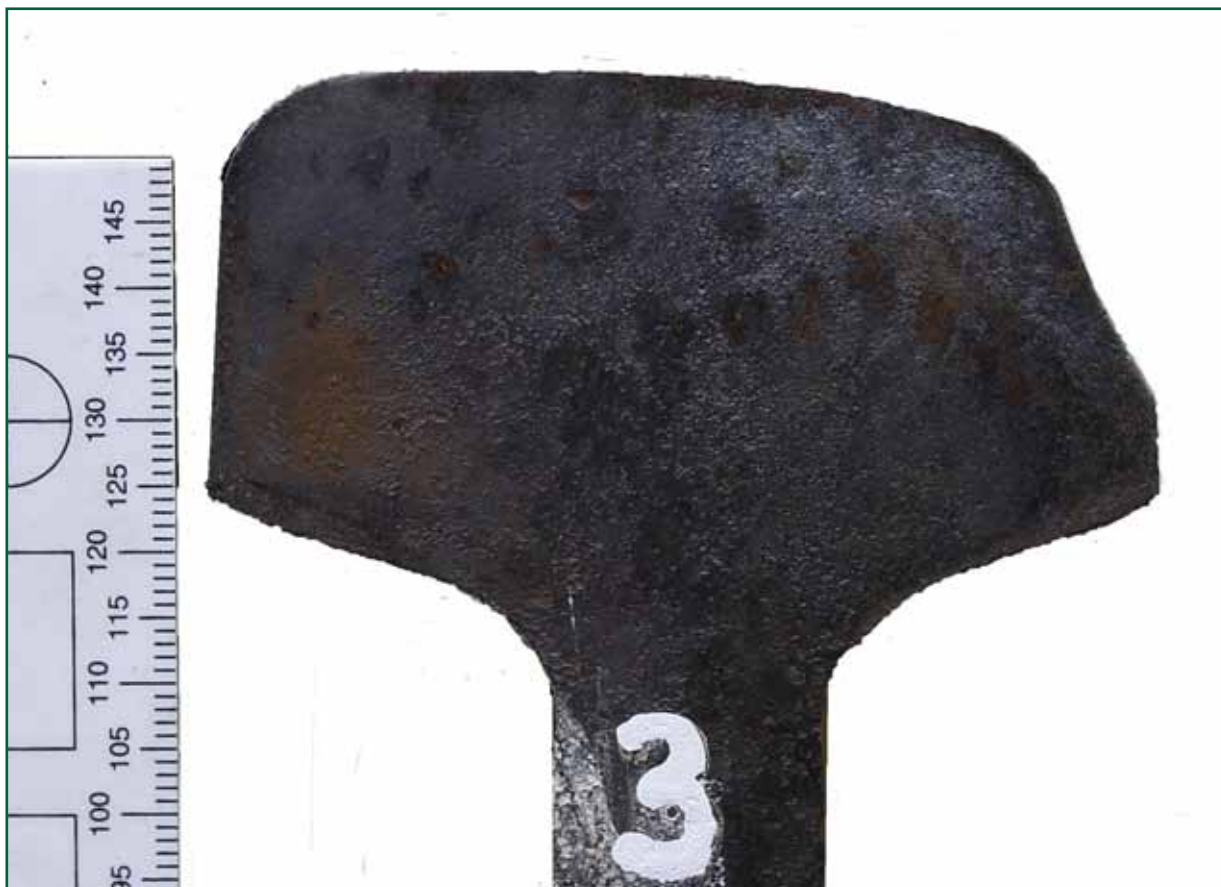
- 55 The running-on rail was marked as being made of austenitic manganese steel (AMS), and was magnetically verified as such. AMS is used for point components because of its greater wear resistance. Both the rail head and foot were approximately 3 mm wider than specified. Other dimensions were within the tolerances for BS 113A rail, although the rail height was reduced from the nominal size by about 6 mm by wear.
- 56 The effect of the wear on the head of the running-on rail was to produce a step of approximately 5 mm between the two rails when they were connected together with *fishplates*. This rail was also sideworn at the running-on end (Figure 6). There were heavy deposits of powdered metal on the gauge face and on the foot of the rail: these deposits were fresh and had not oxidised (Figure 7).

Figure 6: Section of end of running-on rail

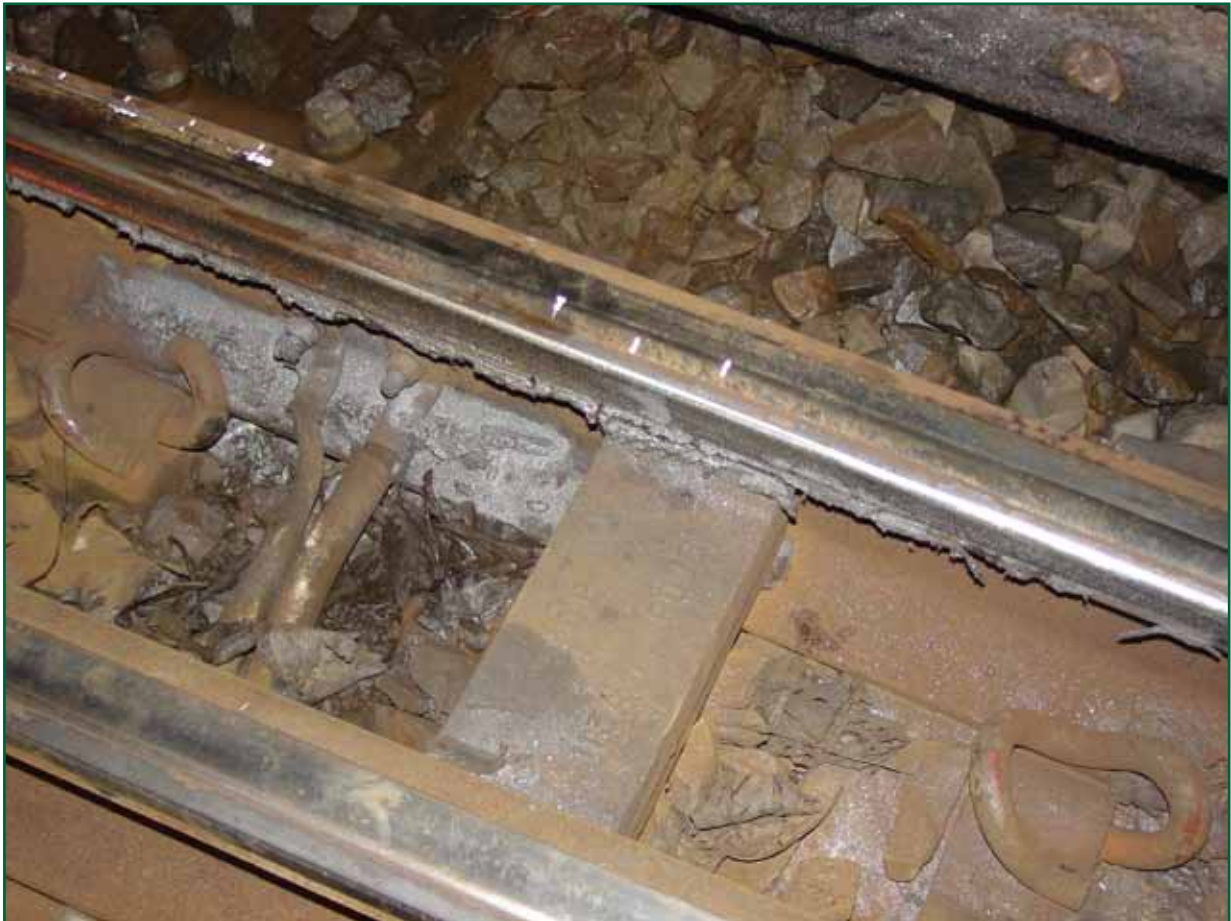
Figure 7: Stock rail near point of derailment, showing sidewear and deposits of powder worn away from rail head

Lubrication

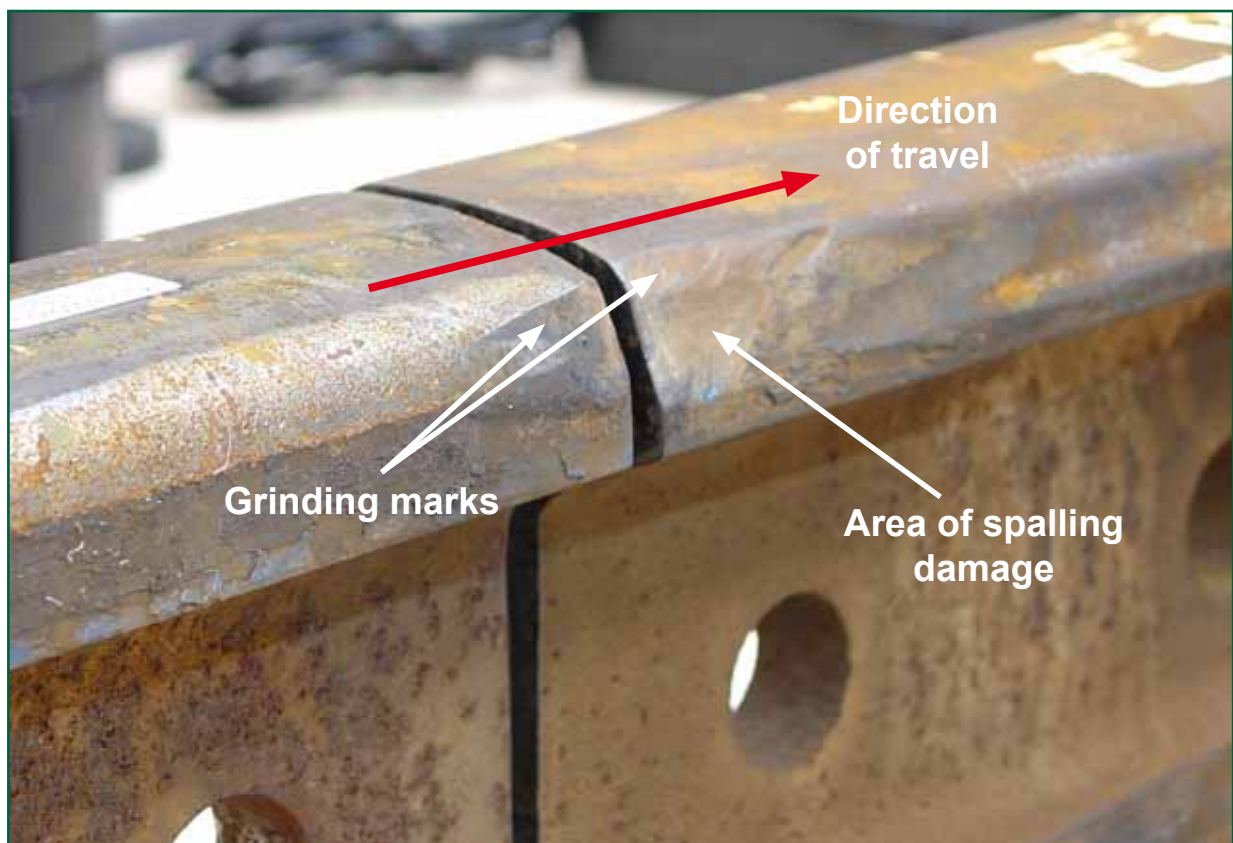
- 57 On the running-on rail, there was evidence of ‘batter’ damage (localised plastic deformation generated by wheels passing over the stepped joint) to the top of the rail head. Damage to the top of the rail extended approximately 530 mm from the joint.
- 58 There was an area of damage to the head of the running-on rail, approximately 55 mm long extending from the rail end, consistent with the application of a rotary abrasive disc grinder (Figure 8).
- 59 There was also damage to the gauge face immediately below the grinding marks that appears to have been caused by ‘spalling’ of the surface, a phenomenon in which repeated impact loading of the surface material of the rail causes it to become work hardened and embrittled to the point where it breaks off (Figure 8).

Figure 8: Wear and grinding damage on rail head adjacent to joint (photographed in laboratory)

- 99 The dynamic predictions are consistent with the derailment being caused by low speed flange climbing arising from the combination of high friction conditions and the local geometry of the heel joint at points 840B. The reason why this particular set of wheels derailed cannot be positively identified, but it is likely to have been related to interaction between a single flange and the 'ramp' produced on the gauge face by the grinding marks (paragraph 58) (Figure 8).

- On completion of any joint the running surfaces, both rail head and running edge, shall be coplanar.’
- 105 The grinding carried out in this case did not meet any of these requirements. It is possible that this particular piece of grinding was carried out with the intention merely to remove an obvious sharp edge that would have been battered over by wheel flanges and might have caused failure of the IBJ.
