Rail Accident Investigation Branch

Rail Accident Report

Locomotive runaway near East Didsbury 27 August 2006

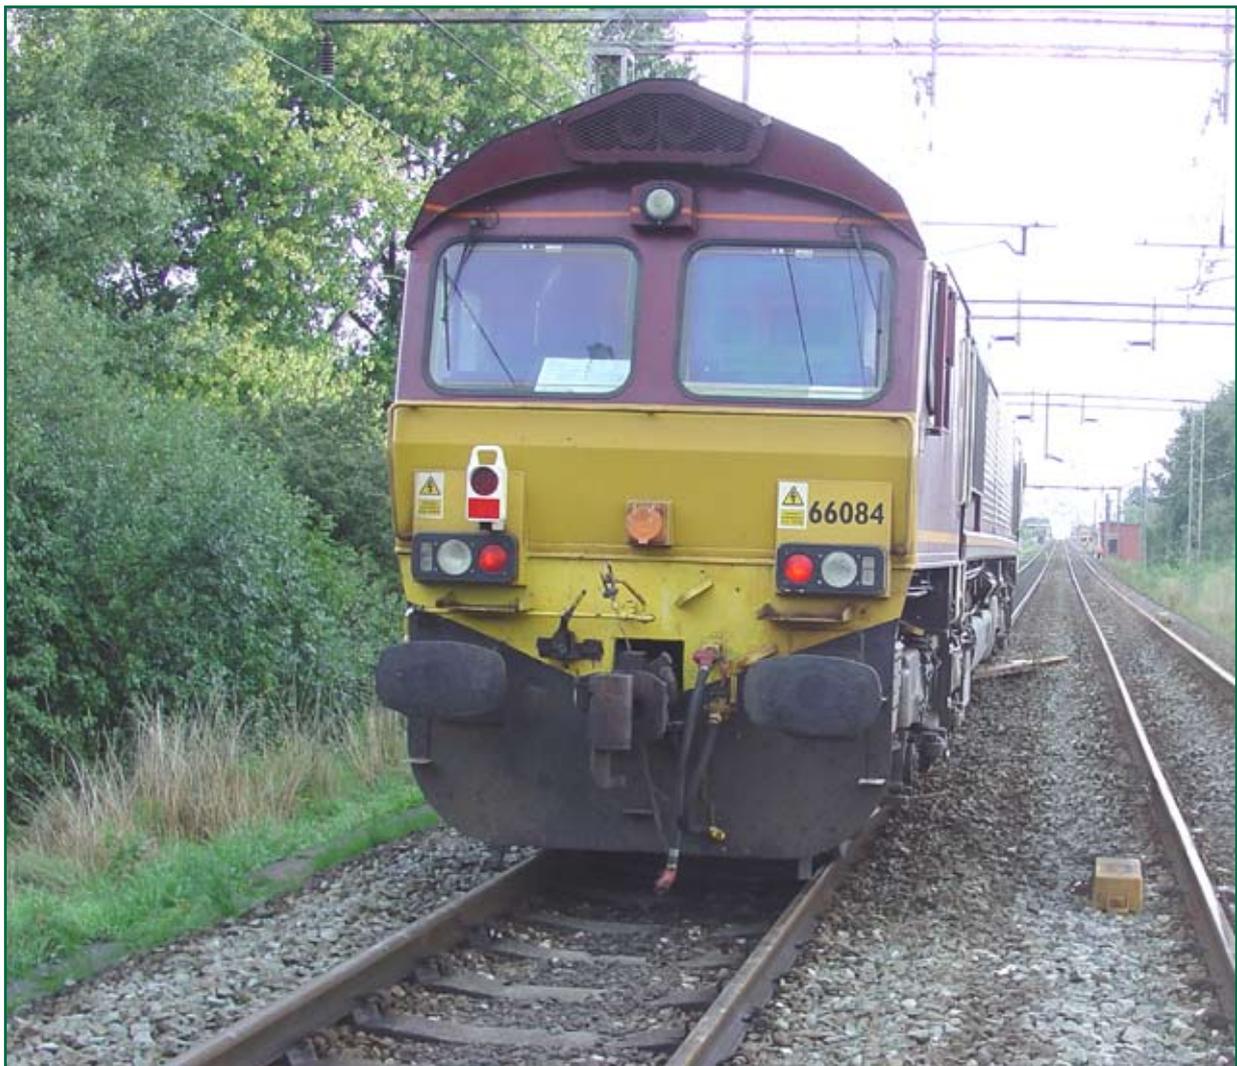
Figure 3: Locomotive 66 084 in its final position looking northwards towards East Didsbury

- 44 Once south of East Didsbury, the locomotive ran back and forth around the trough in the alignment to the south of East Didsbury station and was eventually brought to a stand as a result of the gradient profile and workers wedging a wooden post in front of one of the locomotive's wheels. The locomotive is shown in its final position with the wooden post protruding in Figure 3.

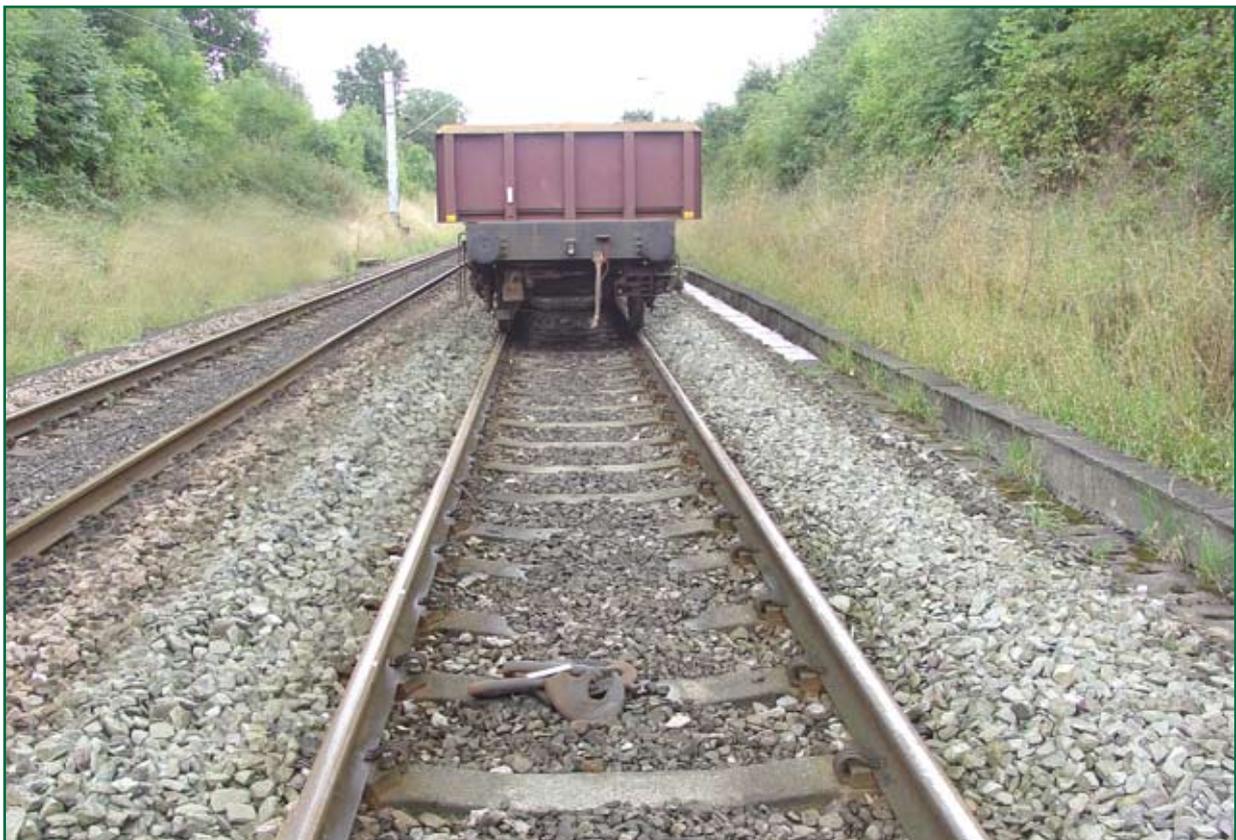
Figure 4: Wagon MHA 394620 and broken coupling as found after the runaway

- the broken coupling was found in the *four foot*, 9 m from the back of wagon MHA 394620 indicating the approximate position at which the coupling broke (Figure 4 refers);

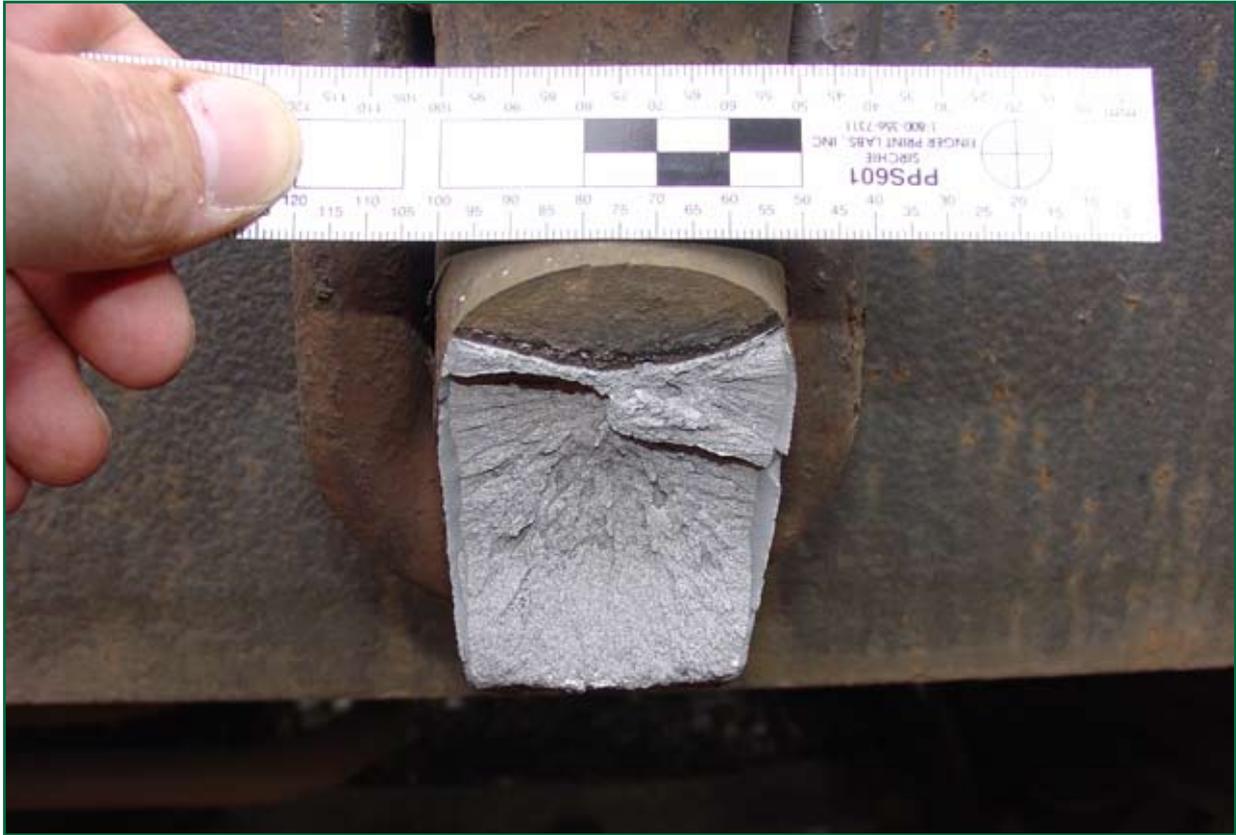
Figure 5: Wagon drawhook fracture face

- the drawhook on wagon MHA 394620 had fractured below the gedge slot (Figure 5 refers);
- after the incident with both 6L22 locomotives shut down, the runaway locomotive, 66 084, showed zero readings on all cab air gauges and the leading locomotive, 66 185, had its main air reservoir charged at 9.5 bar (951 kPa);

- 68 On-site observation and subsequent metallurgical examination (paragraphs 53 second bullet and 54 refer) indicate that the drawhook included a large, pre-existing, slow growing fatigue crack below the gedge slot reducing the effective cross section. This combined with the application of a sudden tensile load caused the drawhook to break. As the crack was slow growing, the magnitude of the tensile load must have been larger than any that the drawhook had experienced in the recent past. There is no evidence that side impacts on the coupling from an unlatched buckeye coupler occurred or contributed in any way.

- 69 The presence of the pre-existing fatigue crack and the application of a sudden, larger than recently experienced tensile load, are therefore causal factors.

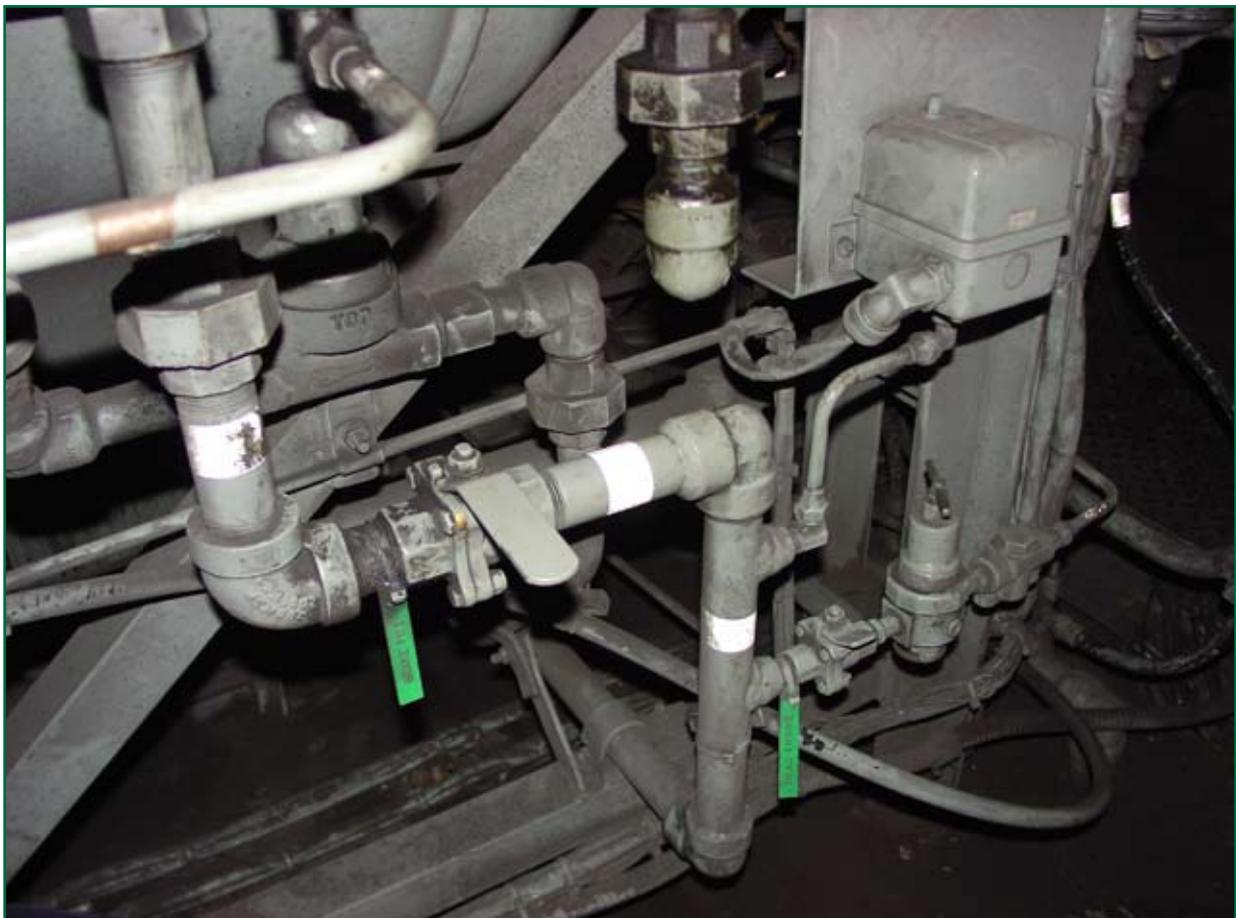
Figure 6: Locomotive 66 084 brake rack as found after the runaway

- the brake rack of locomotive 66 084 was found with the *Brake Pipe Pressure Control Unit Isolating Cock* (BPPCUIC), labelled 'BRAKE PIPE', closed, and the AFT cock, labelled 'DEAD ENGINE', closed (Figure 6 refers);

- the AFT cock was labelled 'DEAD ENGINE' and the labelling did not indicate the open and closed positions. Had the labelling been clearer, the driver's long term misunderstanding may well have been corrected (Recommendation 6).

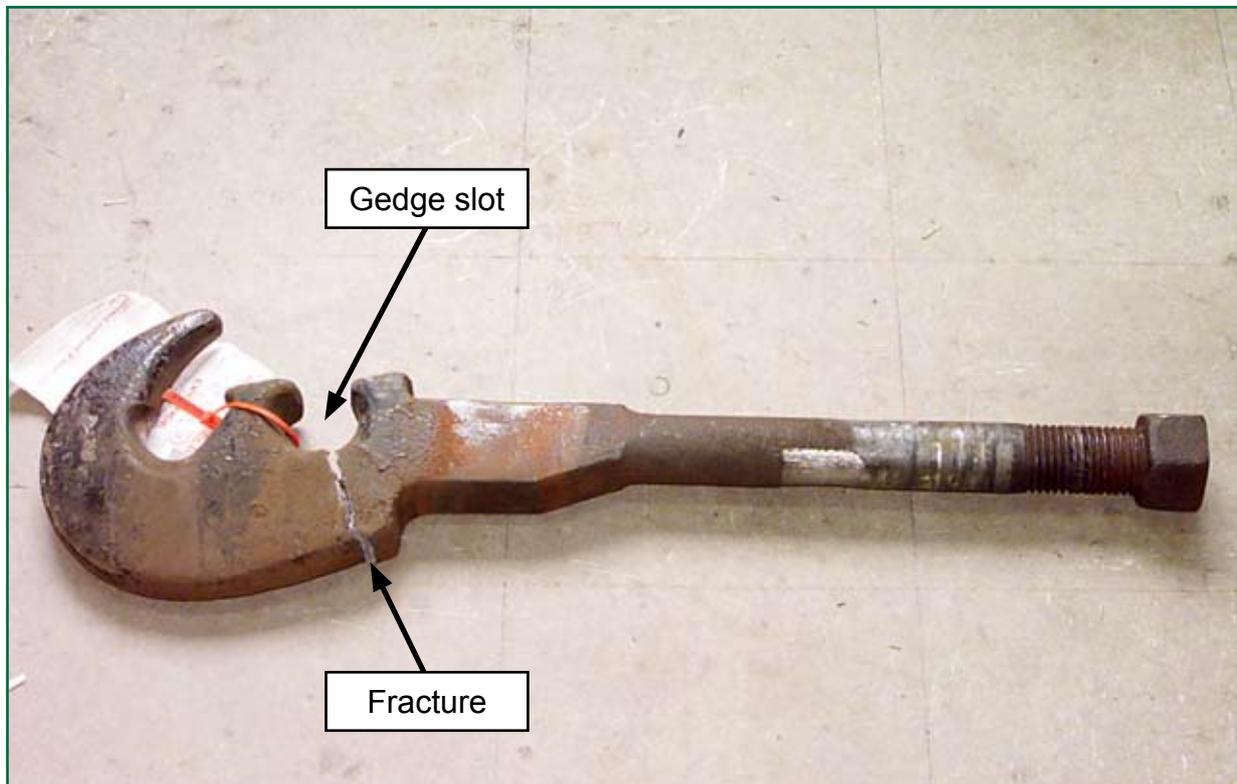
Figure 7: View of loosely reassembled drawhook (photograph courtesy of Serco Assurance Railtest)

- the drawhook had fractured as a result of a fatigue crack having grown to a depth of 16 mm just to the rear of centre of the gedge slot. A sudden, larger than recently experienced tensile load then fractured the remainder of the cross section (Figure 7 refers);

- the size of the fatigue crack was larger than those generally found in other broken drawhooks;
- the extent of oxidation of the fatigue crack indicated that it had been very slow growing and had been present, likely at a detectable size, for a year or more; and

- there was another significant crack in the main hook throat and several smaller cracks throughout the drawhook.
