Rail Accident Investigation Branch

Rail Accident Report

Fatal accident involving a train driver, Deal 29 July 2006

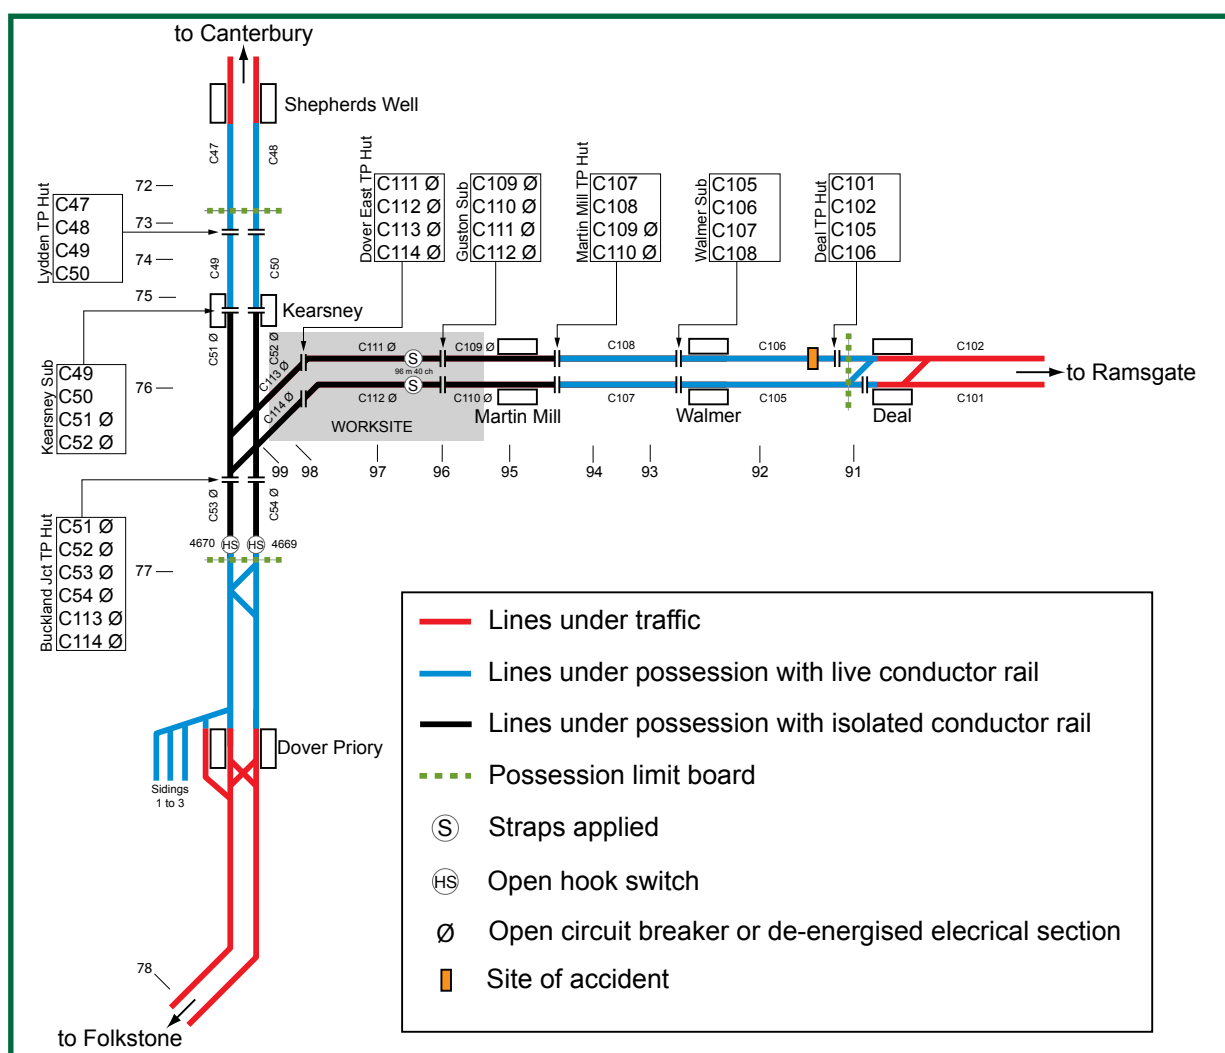
Figure 5: Protection of the engineering works associated with WON 18 item 34 on Saturday 27 July 2006

- 67 A diagram of the WON 18 item 34 possession limits, the worksite and the associated conductor rail isolation is to be found at Figure 5.

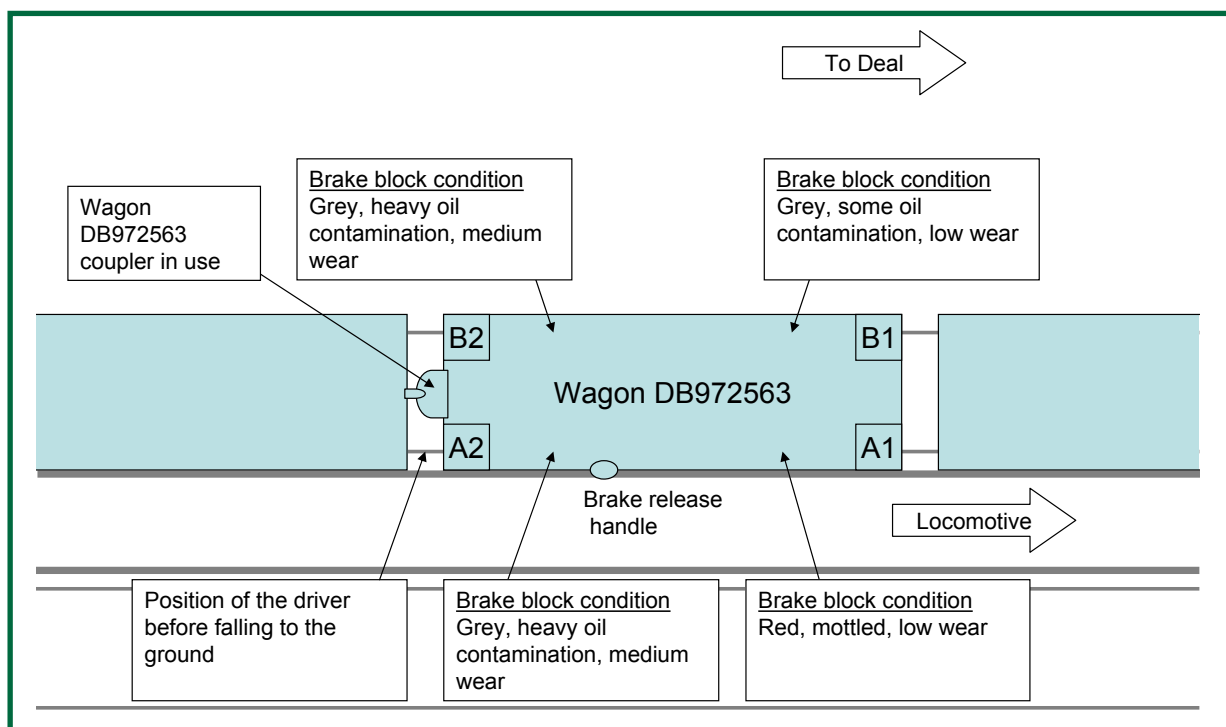
Figure 6: Sketch of wagon DB 972563

110 On arrival at wagon DB 972563 (the 14th wagon on the train) the blockman drew Driver B’s attention to the brake block on corner A1 of the wagon (Figure 6). It appeared to the blockman that this brake block was glowing red (Figure 9).

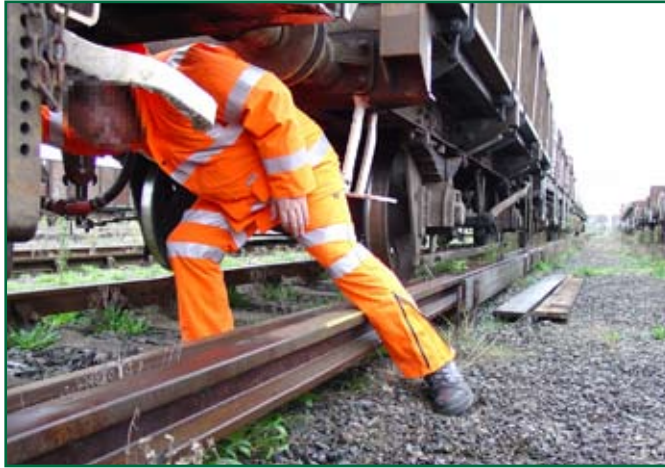
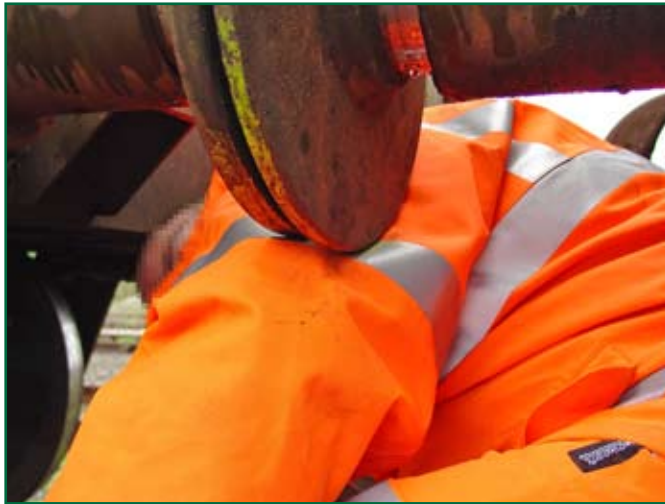
Figure 7a: Likely position of Driver B at the point he received an electric shock

- 120 The reconstruction demonstrated that simultaneous contact was possible between the inside of the left leg on the conductor rail and the back of the upper left arm on the underside of the buffers. These points of contact are closely aligned with the marks observed on Driver B's body (see paragraph 154).

- 121 Figures 7a and 7b show the likely position of Driver B at the point he received an electric shock.

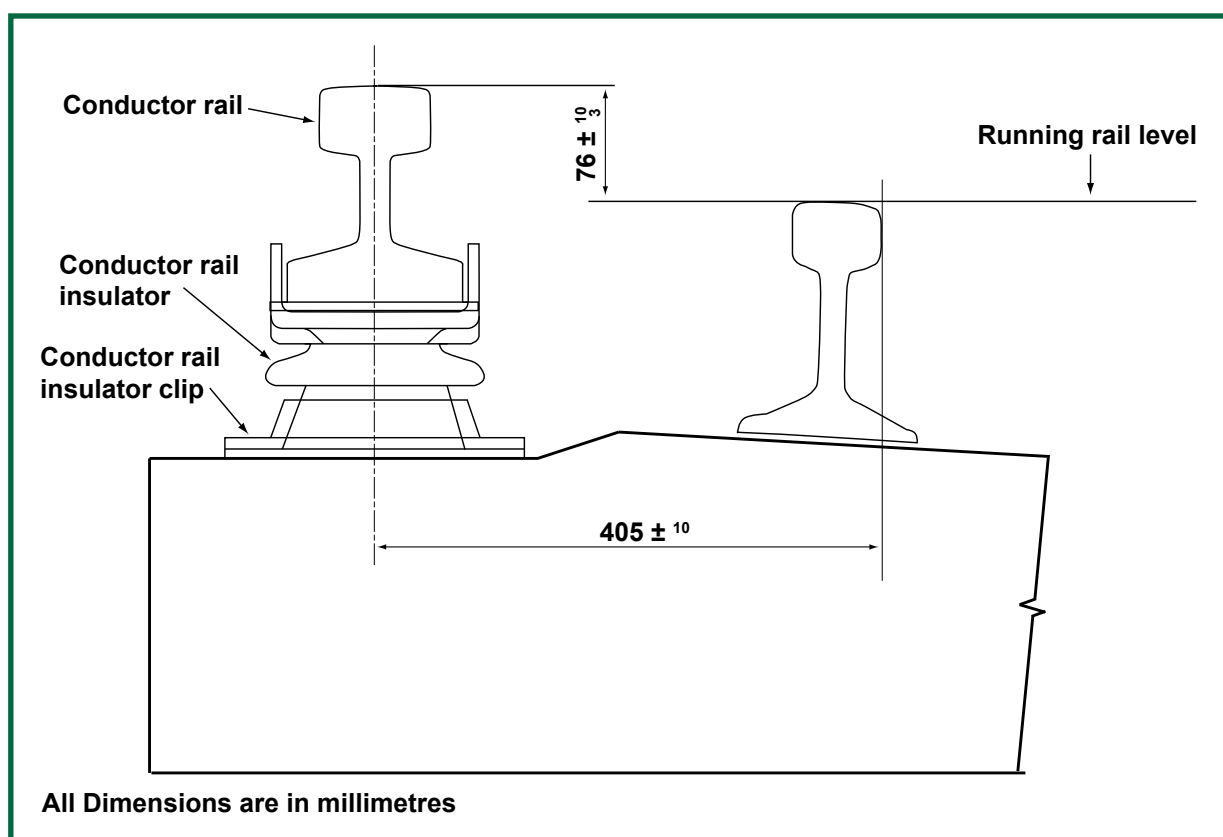
Figure 10: Dimensions of the conductor rail and its relationship to the running rail

74 It is the view of certain managers within EWS that a significant proportion of their drivers were unclear about the extent of conductor rail isolations within possessions. Nevertheless, EWS is of the view that all drivers always treated the conductor rail as being live, even when within a worksite in line with the message conveyed to drivers during *Personal Track Safety* (PTS) training. This view is consistent with RAIB's own view following interviews and discussions with EWS managers and drivers.

Issues associated with the driver of train 6Z25 attending his train in an area of DC electrification
