Rail Accident Investigation Branch

# Rail Accident Report

## Derailment at Ropley (Mid Hants Railway) 25 July 2006

## 25 July 2006

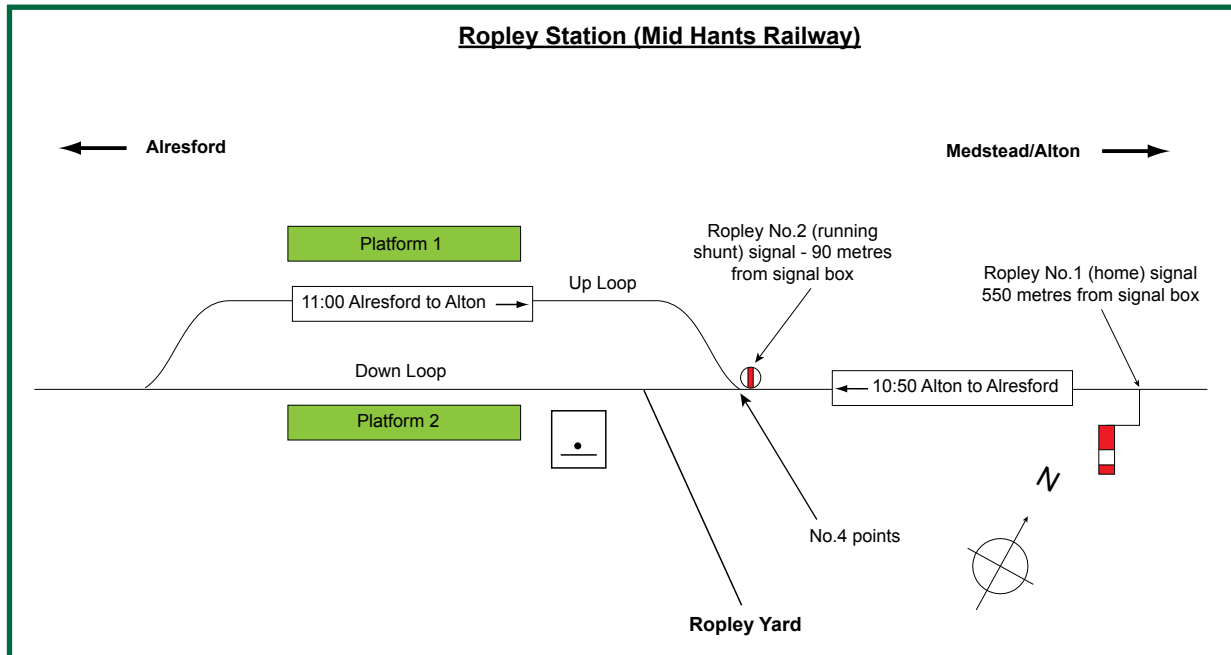
Figure 3: The track layout at Ropley

- 18 At approximately 11:15 hrs on Tuesday 25 July 2006, the leading bogie of the 10:50 hrs MHR service from Alton to Alresford derailed on No.4 points (see Figure 3) approaching Ropley station. There were no injuries to passengers or staff as a result of the accident. The train and track suffered only limited damage. Train services were suspended for the remainder of the day.

- 22 Soon after the leading bogie of the train passed the *switch toes* of No.4 points, it derailed. The derailed bogie followed a path midway between the routes to platforms 1 and 2, while the second bogie remained on the track, but followed the route towards platform 1.
- 23 The derailment became apparent to the trainee driver and instructor almost immediately because of the severe jolting that occurred as the leading bogie left the rails and ran over sleepers. The instructor applied the emergency brake and the train stopped within 20 metres of the point where the front bogie derailed.

- 57 However, on the morning of 25 July, the signalman on duty in Ropley signal box replaced signal No.1 to danger before receiving the token from the driver of the down train, replaced signal No.2 and unlocked the facing point lock before the down train had reached No.4 points. Then, just before the leading wheels reached No.4 points, the signalman operated lever No.4 and commenced the movement of the points at precisely the moment the down train arrived at the points, causing the leading wheels to take a path between the routes to platform 1 and platform 2.

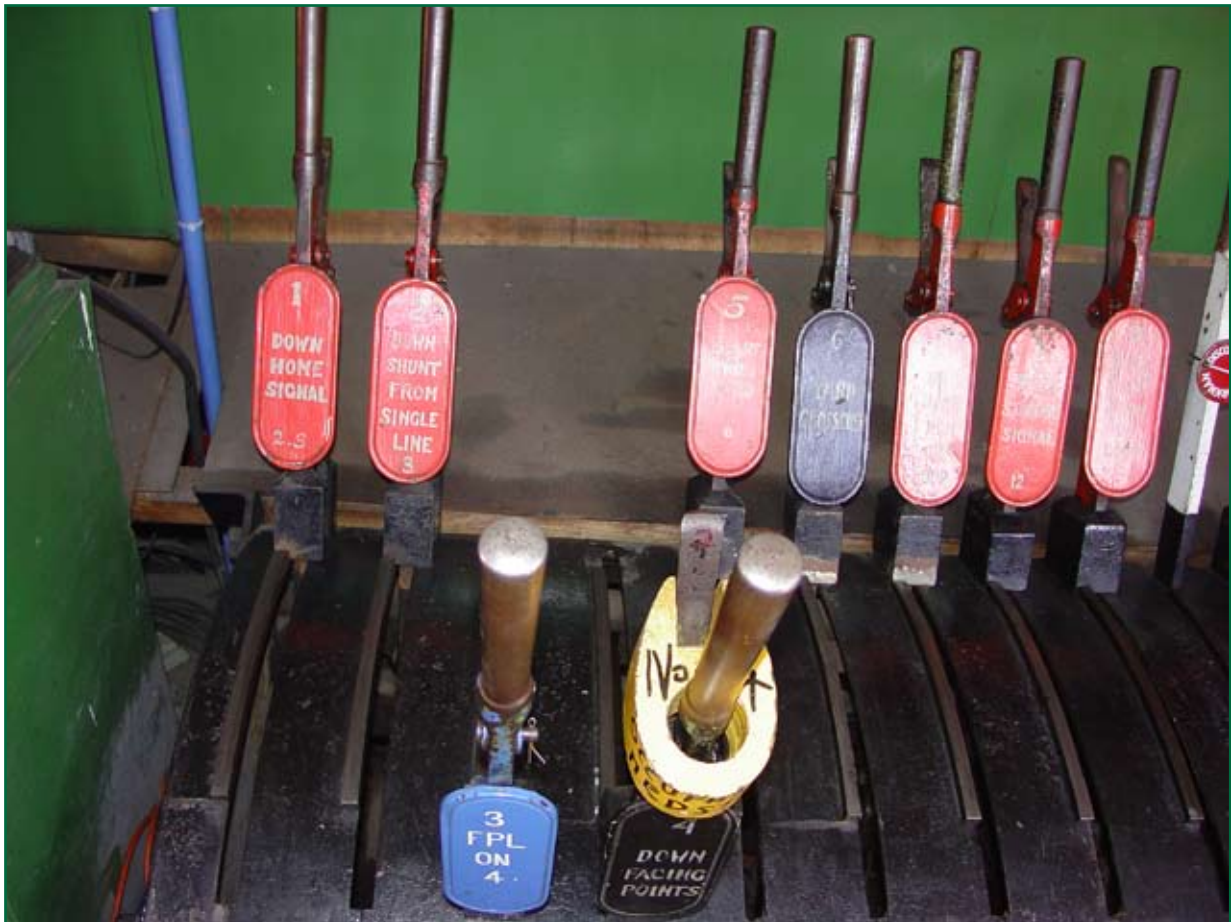
Figure 4: The lever frame in Ropley Signal Box

- the signalman was able to move the points under the train and did so.
- 82 The only source of power used to move the points is human; the points therefore could not have moved as a result of spurious operation of a motor. At an early stage in the investigation, the signalman accepted that he had caused the points to move under the train. For this reason, testing of the points for faults was not undertaken. The action of the signalman is the immediate cause of the derailment.

- 90 Another possible explanation is that having replaced signal No.1 and signal No.2 to danger and unlocked the facing point lock, the signalman realised that the down train had not arrived and, being concerned about the passage of the train over unlocked points, returned to the frame to lock the points again. The levers for the facing point lock and No.4 points are adjacent (see Figure 4). If the signalman accidentally pulled the lever for the points instead of that for the facing point lock, the fact that the facing point lock was already unlocked would allow No.4 points to be moved.
