Rail Accident Investigation Branch

Rail Accident Report

Derailment at Archway 2 June 2006

Report 24/2006
December 2006

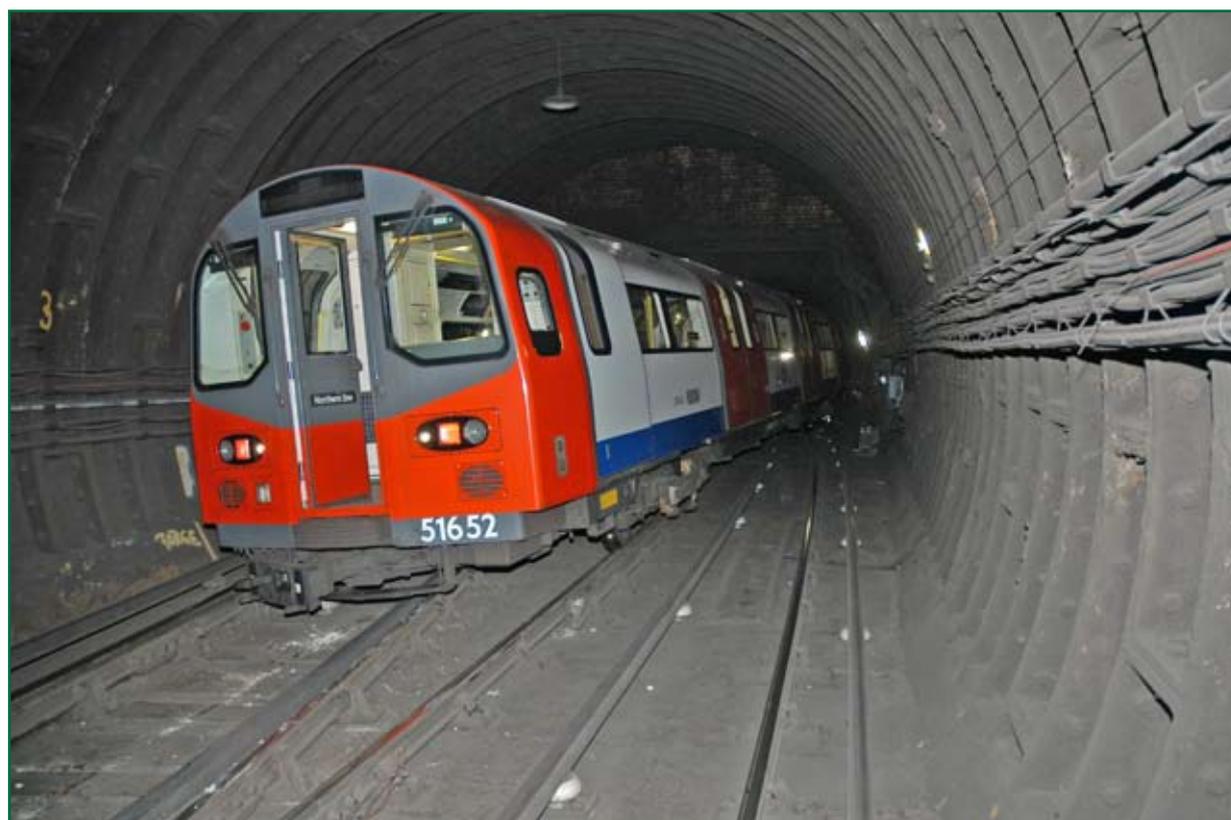
Figure 2: The derailed train seen from the rear.

- 49 The last two wheels of the train, however, appear to have been forced to the left on hitting the broken rail end, to the extent that their flanges climbed the opposite (left-hand) switch rail (Figure 5). These wheels passed over the top of the left-hand switch rail and dropped down to run along the northbound main line. The increasing angle between the front and rear bogies exerted a substantial lateral force on these wheels, and after a short distance their flanges climbed the right-hand rail and the bogie became derailed to the right of the northbound running line. It displaced the negative conductor rail and damaged some cables in the tunnel before the last car became wedged in the entrance to the siding tunnel, stopping the train (Figure 2).

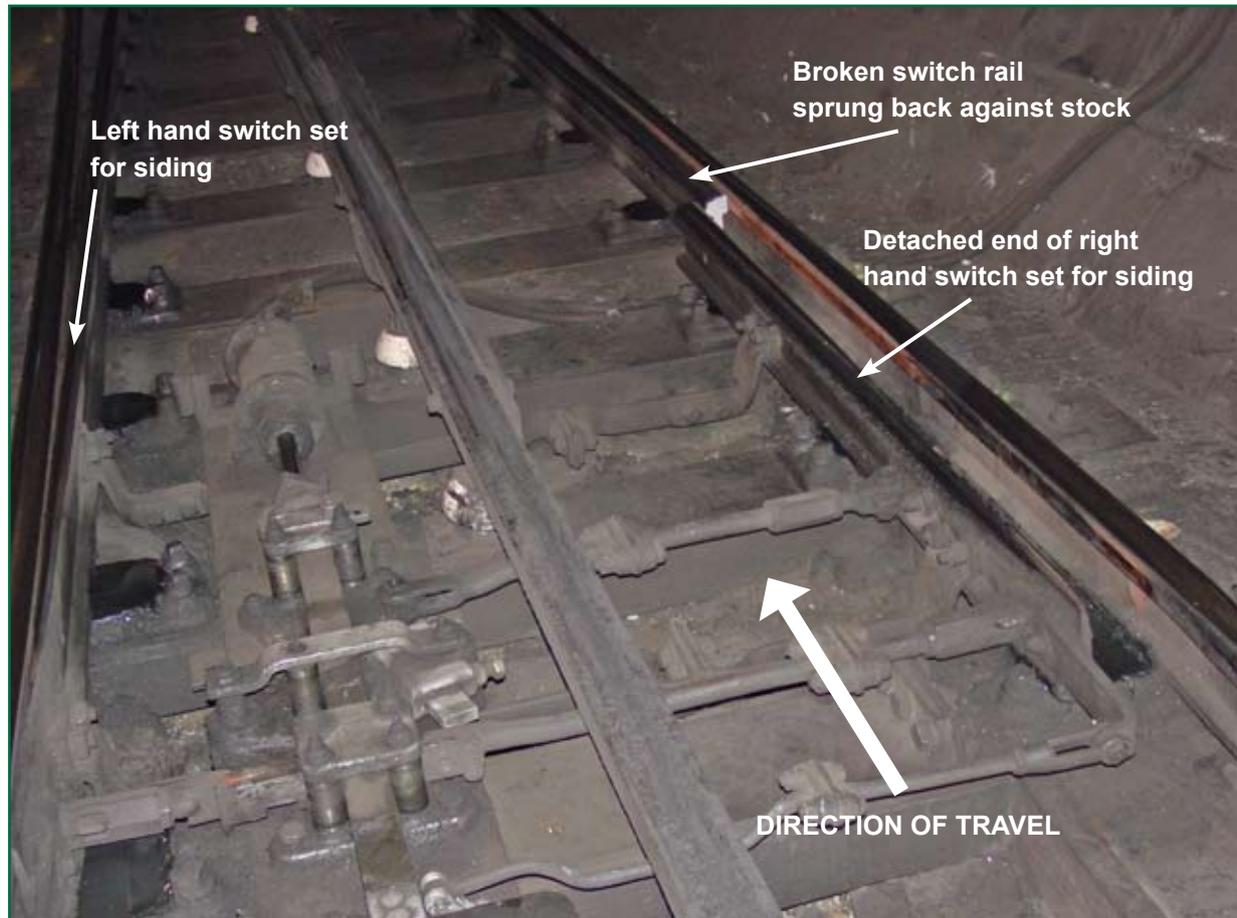
Figure 4: Points 8A as found after the derailment, showing broken switch rail.

- 39 The broken switch rail was the immediate cause of the accident. The position of the switches combined with the extensive bruising of the running-on end of the broken switch and the absence of any marks on the other portion, showed that the wheels of the train had been following the correct path before encountering the broken end of the switch.

76 The immediate cause of the accident was the breakage of the right-hand switch rail of points 8A at Archway.

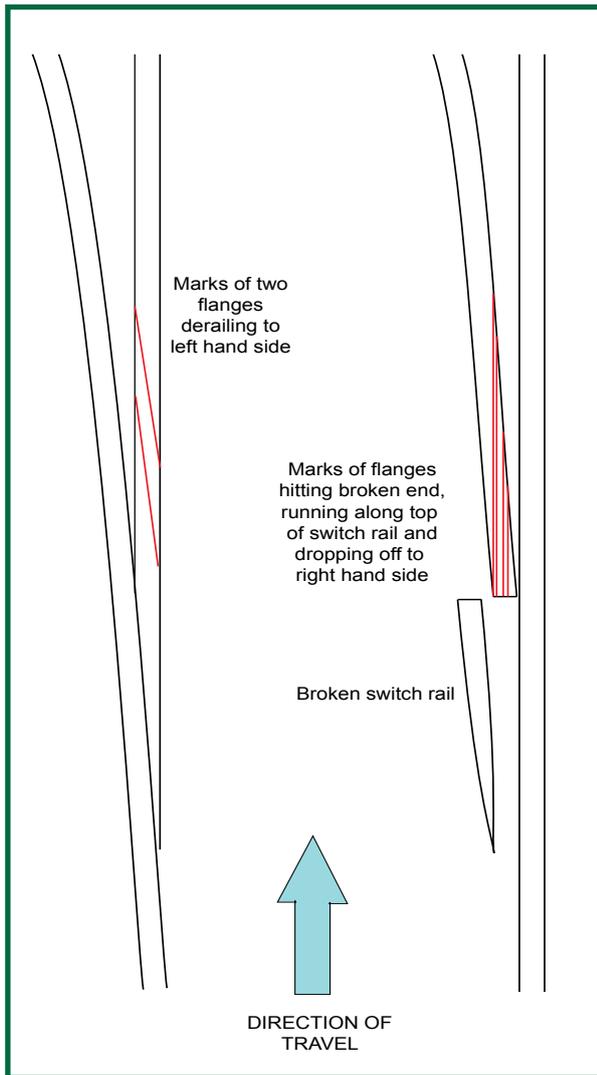
- 40 There were marks on the broken switch consistent with wheel flanges running along the top surface of the rail, and then dropping off on the right hand side, beginning with the leading wheels of the train. The remainder, except for the last bogie, followed the path taken by the wheels in front (Figures 5 and 6).

- 41 On the left hand switch there were marks of two flanges climbing over the rail and derailing to the left, corresponding to the trailing bogie of the last car which was found derailed after the accident (Figure 5). It is probable that these wheels were able to be diverted to the left because there were no further vehicles behind to restrain the bogies in line.

Figure 5: Derailment marks on the rails of points 8A.

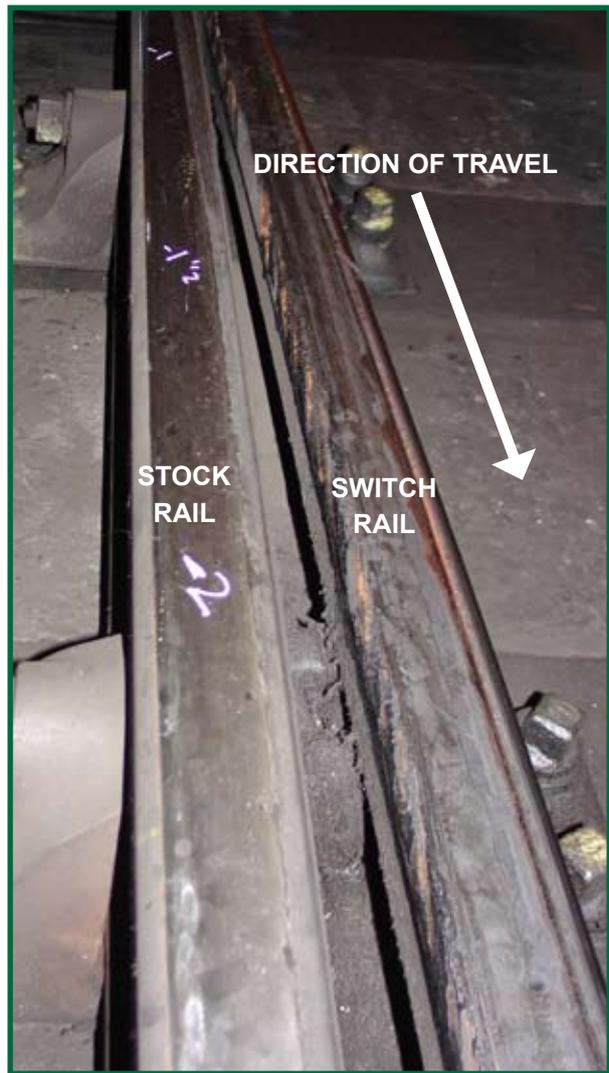
Figure 6: Right-hand switch rail showing wheel marks.

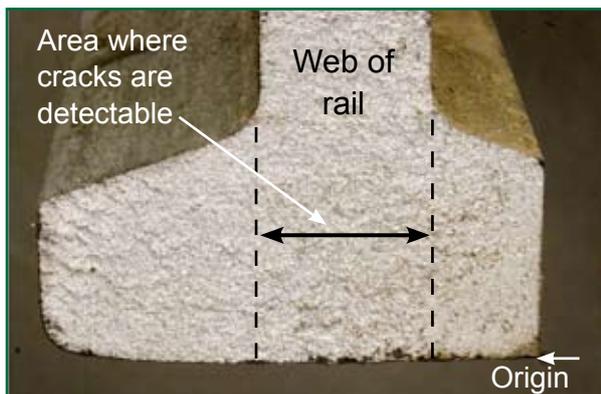
- 43 Laboratory examination of the fractured rail section showed that the failure of the rail was caused by the growth of a single fatigue crack which had originated on the bottom machined edge coincident with a piece of surface scale. It is likely that the surface scale was present since the time of manufacture as it is a common type of rolling defect. The presence of the scale defect and a shallow indent that it had made on the lower surface of the rail acted as a stress-concentration, initiating a crack at this particular location (Figures 7 and 8).

Figure 7: Broken end of rail showing fracture origin and limits of area in which crack detection is possible.

- 44 The fracture occurred 1.81 m from the switch tip approximately mid-way between rail supports, at a position where the lower surface would have been under maximum tensile stress when trains were passing. The bright, clean and undamaged nature of the fracture surface indicates that the crack had occurred relatively recently. Laboratory analysis confirmed that the features of the surface were consistent with a fatigue crack.

- 45 Crack detection in rails is normally done by ultrasonic testing, using probes carried on hand trolleys. These can detect cracks in the head and web of the rail, but are unable to detect defects which originated from the bottom corners of the rail until they have developed to the point where they impinge on the area below the web (Figure 7). With this equipment, it is not possible to test the tapered, machined portions of switch rails because the probes are not designed to run on the rail head where it is reduced in width.

- 46 The crack was in the lower back edge of the switch rail, hidden from visual inspection. There was therefore no practicable means of detecting this crack.

- 63 Where switches with this sharp edge are already in use in the track, there is currently no method available for detecting a crack which originates at the lower back corner (see paragraphs 45 and 46). Therefore any such bullhead switch has the potential to crack, and the risk associated with its continued use needs to be assessed (**Recommendation 2**)

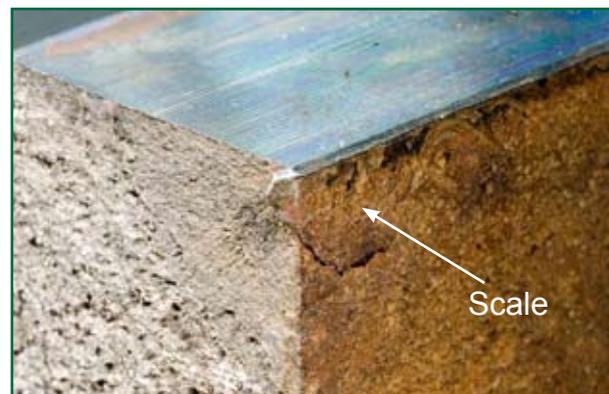
Figure 8: Detail of fracture origin and adjacent 'scale' at edge.

- a piece of surface scale and associated shallow indent at the lower back edge of the switch rail and the lack of a chamfer on this edge, which together created the conditions for a fatigue crack to develop from the lower back edge (**Recommendations 1 and 2**).

- 62 The originating point for the fatigue crack was the sharp edge at the lower back of the switch rail. If this sharp edge were replaced by a chamfer or radius the stress concentration in this area would be reduced, and hence fatigue cracks would be less likely to originate there (**Recommendation 1**). Flat-bottom switches in use on LUL already have a chamfer for this purpose.

- 1 LUL should modify their design specification for bullhead switch rail to include a chamfer or other means of reducing the likelihood of stress raisers occurring on the machined lower edge of the rail (paragraph 77).
- 2 LUL should assess the risk arising from the continued use of unmodified bullhead switch rails in junction work (particularly facing points) and replace such rails where appropriate (paragraph 77).
- 3 Tube Lines should carry out a review of their track inspection system to ensure that faults are being consistently detected and correctly identified, and the appropriate level of remedial action is being programmed (paragraph 78).

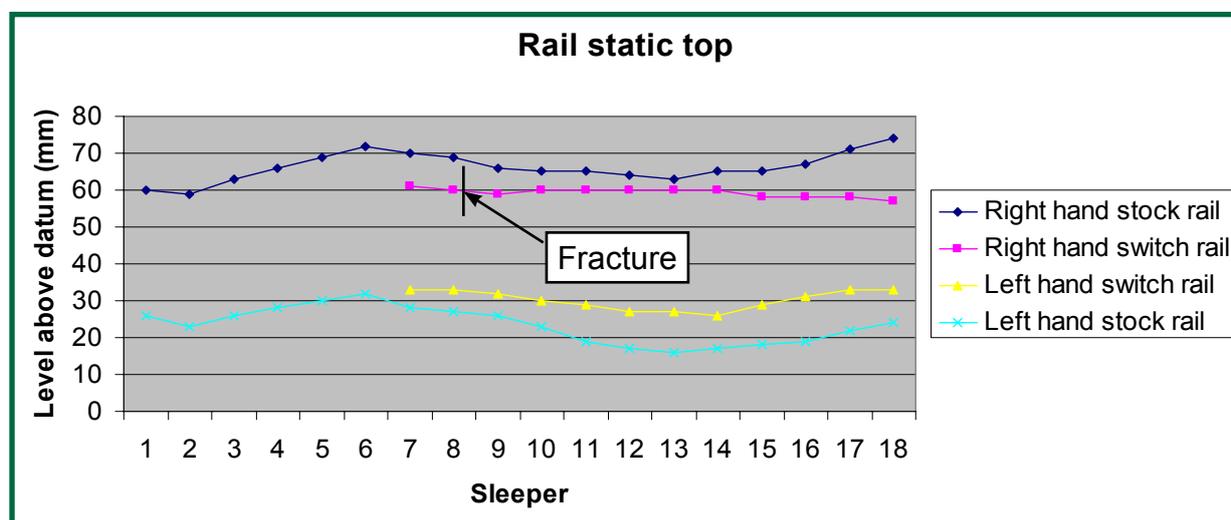
Figure 9: Rail height, points 8A.

- 51 Figure 9 shows that the head of the right hand switch rail was 7 mm below the head of the stock rail at the point where the rail broke. High dynamic loadings occurred as wheels dropped from the stock rail onto the lower head of the switch rail. Void measurements taken after the derailment indicate that there was about 5 mm gap beneath the bearer at the point where the rail broke. This, combined with the low height of the switch rail, would have reduced the impact experienced by the train operator when the right-hand wheel encountered the broken rail end. The total flange height is about 27 mm, and so there would have been a lift of about 15 mm (less some deflection of the rail end) when the flange of the leading wheel struck the broken end of the rail.

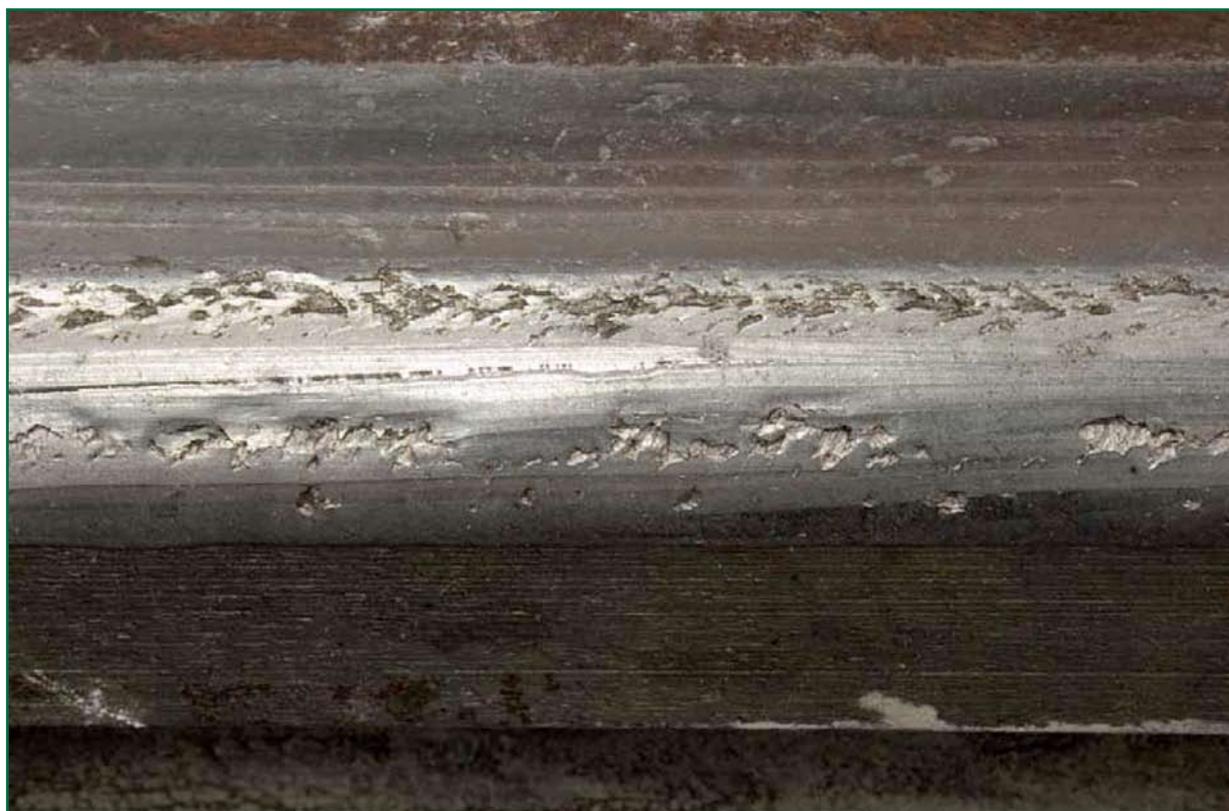
- 64 Whilst the head and gauge face of the broken rail showed evidence of *rolling contact fatigue* (Figure 10), the degree of wear was not significant (paragraph 74).

Figure 10: Rolling contact fatigue marks on the switch rail, overlaid by wear on the gauge corner.
