# Rail Accident Report

## Passenger train derailments on the Ravenglass & Eskdale Railway 29 May & 5 July 2006

Report 07/2007  
March 2007

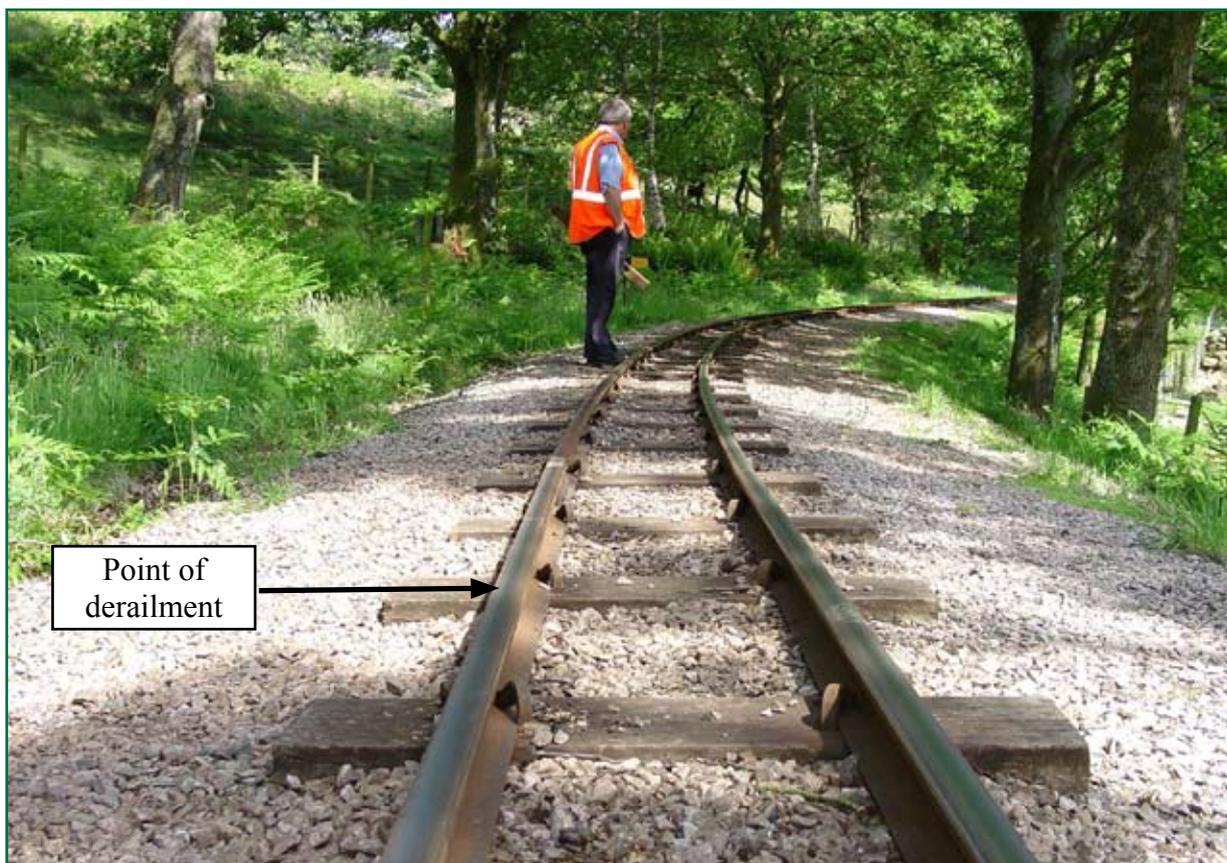
Figure 2: Site of derailment at Spout House Curve.

- 45 When inspected by RAIB, on 7 June 2006, the *track top*, alignment and general condition of the rails, sleepers and fastenings was satisfactory. However, some voiding below the right hand rail at the POD, estimated to be approximately 3 mm deep, had been found by R&ER and repaired on the morning after the accident, before the RAIB had been notified.
- 46 The track gauge narrowed from 15¼ inches (387 mm), 2 sleepers before the POD to 15 inches (381 mm) 1 sleeper before the POD. The cant varied from a maximum of ¾ inch (19 mm) 10 sleepers before the POD to zero (ie level) 4 sleepers before the POD. These values are generally in accordance with R&ER's standard track design parameters.

- the track narrowed in gauge from 387 mm (the value used for curves) at 0.9 m before the POD to 381 mm (the value used for straight track) at the POD. Gauge widening in curves is standard design practice and is a normal condition, but the narrowing of the gauge at the POD would have tended to exacerbate the flange contact in these circumstances. The gauge narrowing on approach to the POD was therefore also a contributory factor.

- the presence of voiding below the right hand rail at the POD, due to degradation of the ballast foundation, which created some track twist and exacerbated the degree of wheel unloading (Recommendation 2);
- the normal curving behaviour of rail vehicles, where wheel flanges make contact with the gauge face of outside rails as bogies steer through relatively tight curves;
- narrowing of the track gauge from the curve to the adjoining straight track in line with standard R&ER track design practice, which contributed to the flange contact.

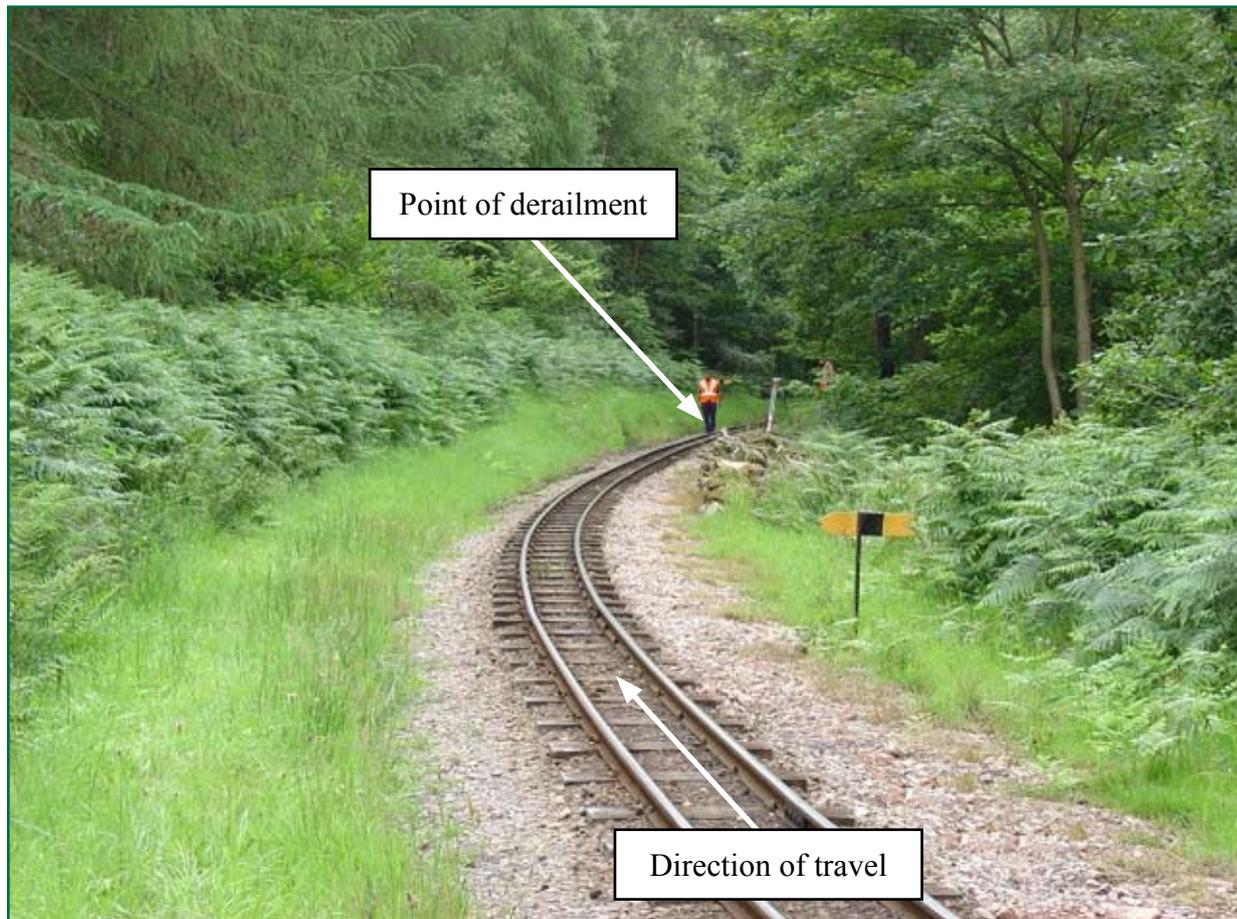
Figure 3: Site of derailment at Millwood Bank

- 79 Track voids were noted at 9 of the last 20 sleepers on the approach to the POD and their depth was measured using void meters. The recorded void depths varied from 1 mm to 7.5 mm; the deeper voids were further away from the POD.

81 The track foreman and other drivers were aware of the degraded condition of the track at Millwood Bank, which has a history of similar degradation at this location. Monitoring of track condition is the responsibility of the track foreman, who walks the whole length of the track on average every 2 weeks to inspect it. In addition, he assesses track condition whilst carrying out his own driving duties and also relies on reports from other drivers to inform him of developing track problems. There are no standards or guidance on the R&ER that set out specific remedial actions to be taken when a track fault is identified. It is the responsibility of the track foreman, using his experience and judgement to decide the type and timing of any intervention (eg urgent remedial work or temporary speed restriction) to reduce risk.

- 92 The investigation identified three causes of the excessive sway and the resulting wheel unloading.
- 93 The survey of the track at Millwood Bank revealed voids, variations in gauge and cant and alignment problems at regular intervals on the approach to the POD. The track would have generated periodic force inputs to passing vehicles, which at a speed of 15-18 mph (24-29 km/h), excited the natural sway frequency of coach 110. The reason the track problems existed at the time of the derailment was that remedial work to correct this known problem had not been carried out. This was because the risk at Millwood Bank had not been recognised by the track foreman, although the deterioration of the track condition had been recognised and was being monitored by him. The lack of timely remedial action was a causal factor.

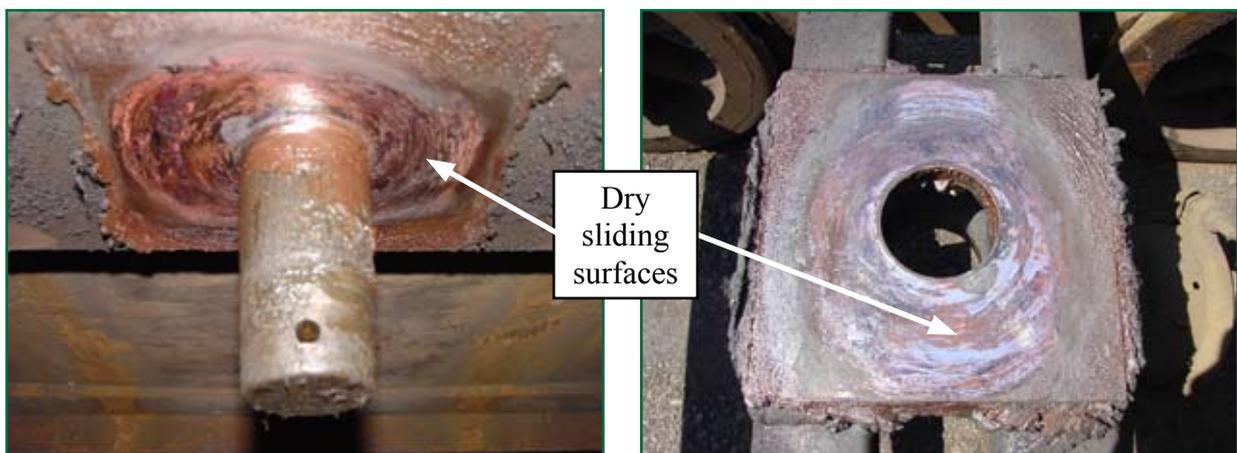
Figure 5: Vehicle body bolster (left) and bogie bolster (right)

- 47 The sliding interface between the body and leading bogie *bolsters* was devoid of grease in the load bearing areas (Figure 5) and there was evidence of metal pick up and scoring indicating a high level of friction between the surfaces.

- 69 The body and bogie bolster plates, which support the weight of the body and which slide against each other as the bogie negotiates curves, were devoid of lubrication at the load bearing points. Although not causal or contributory to this accident, high friction at this interface can increase bogie rotational resistance and could be a hazard (Recommendation 8).

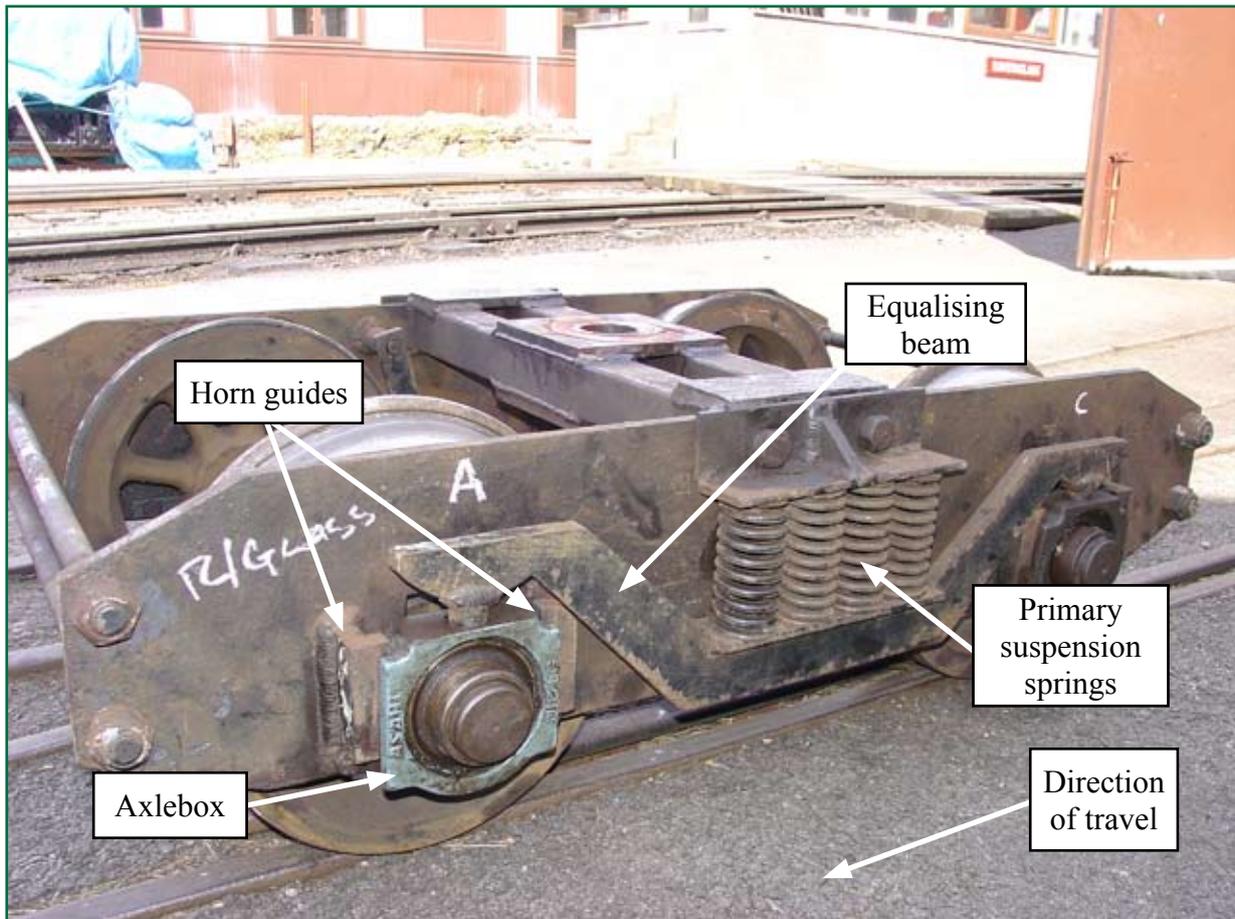
Figure 6: Derailed bogie of coach 134 (after reassembly)

- 48 On the leading bogie, the longitudinal clearance between the leading left axlebox and its horn guides (Figure 6) was 0.3 mm (ie 0.15 mm per side). This was much smaller than the corresponding clearances on the other three axleboxes, which varied between 1.7 mm and 4.3 mm. The lack of clearance on the leading left axlebox was due to a combination of the bearing and horn guide spacing being slightly bigger and smaller respectively, than at the other three axlebox positions. The sliding surfaces were dry, without any oil or grease lubrication. Parts of the inboard surface were also scored and pitted indicating that there had been high friction between the two surfaces and that free movement of the axlebox had been restricted. This was later found to be the case (paragraph 50).

- 49 The left leading axlebox had been changed around March 2001, when the previous one was found to be cracked, and had run without incident for several years.

- there was no specific requirement to check clearances of axleboxes in the horn guides on assembly or at maintenance or lubricate this interface, which resulted in the lack of sufficient clearance going undetected (Recommendation 1).

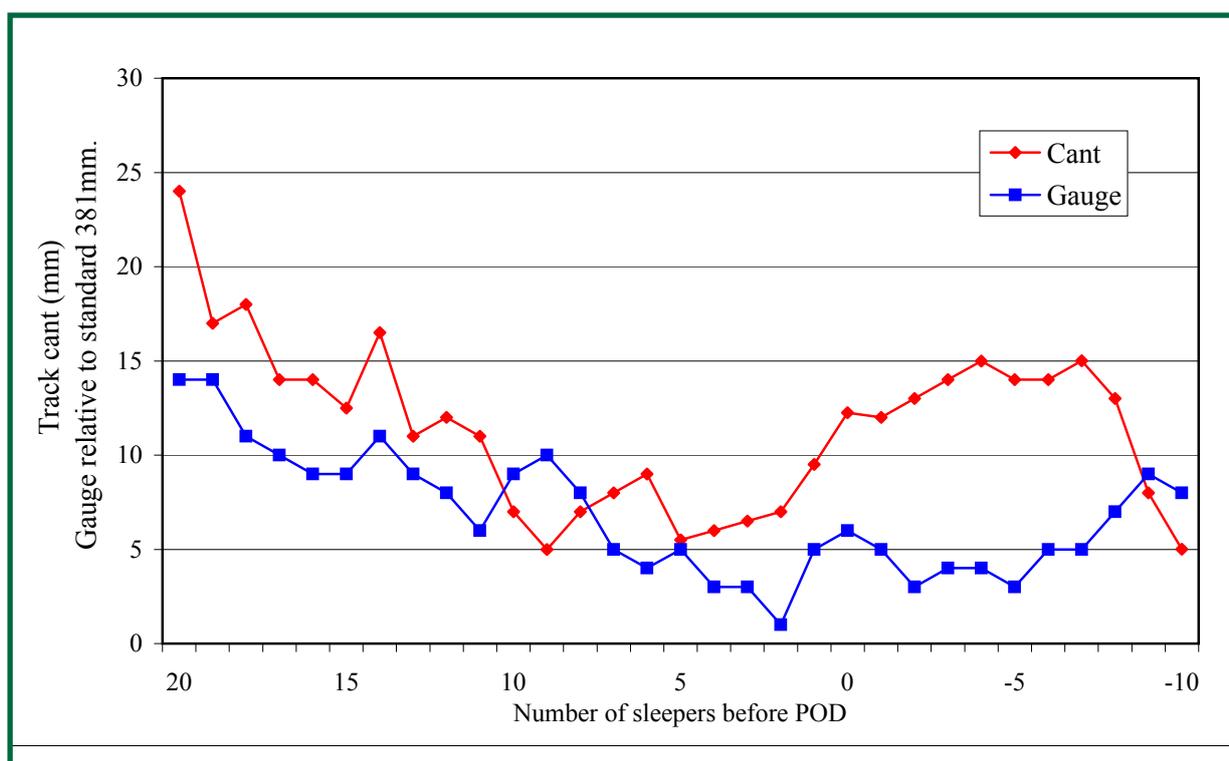
Figure 8: Cant (height of left rail above right rail) and gauge relative to standard 381 mm.

- 80 Track levels were also taken from 20 sleepers before the POD to 10 sleepers beyond the POD and adjusted to include the measured void depths. From this data, the level of the (low) right rail relative to the (high) left rail (ie the cant) as seen by the passing train was obtained. The track gauge was also measured at the same sleeper positions and the results of both are shown in Figure 8, from which the following were noted:

- The cant varied from 24 mm at 20 sleepers before the POD to 5 mm at 9 sleepers before the POD. It then rose again to 12 mm at the POD. For the curve radius and line speed the *balancing cant* is 5 mm and therefore there was excess cant over most of the measured section, which would have caused a small net lateral force (up to 6 % of the static weight of about 1.5 tonnes) on the vehicle acting towards the inside of the curve;

- The variation in cant was not smooth, with rapid changes occurring, on average, every 4.5 sleeper bays or 4 m. The vehicle would therefore have been subjected to force inputs at a relatively regular frequency as it passed these positions. Taking a train speed at the middle of the estimated range of 16.5 mph (7.3 m/s), the regular force inputs would have occurred at a frequency of approximately 1.8 Hz, which is the same as the sway frequency of the vehicle (paragraph 85);

- The track gauge varied from 395 to 382 mm over the last 20 sleepers before the POD. The peaks and troughs in the gauge variation also showed a regular spacing in a similar manner to the changes in cant. This indicated that there were small variations in the lateral alignment of on one or both running rails. The effect of this would have been to apply additional lateral force inputs to the vehicle at a frequency close to the sway frequency.

- excess cant over the last 20 sleepers before derailment which would have caused a small lateral force acting towards the inside of the curve.
  - lateral misalignment of the track on approach to the POD as observed from the variations in track gauge (Figure 8) and the video record (paragraph 88).

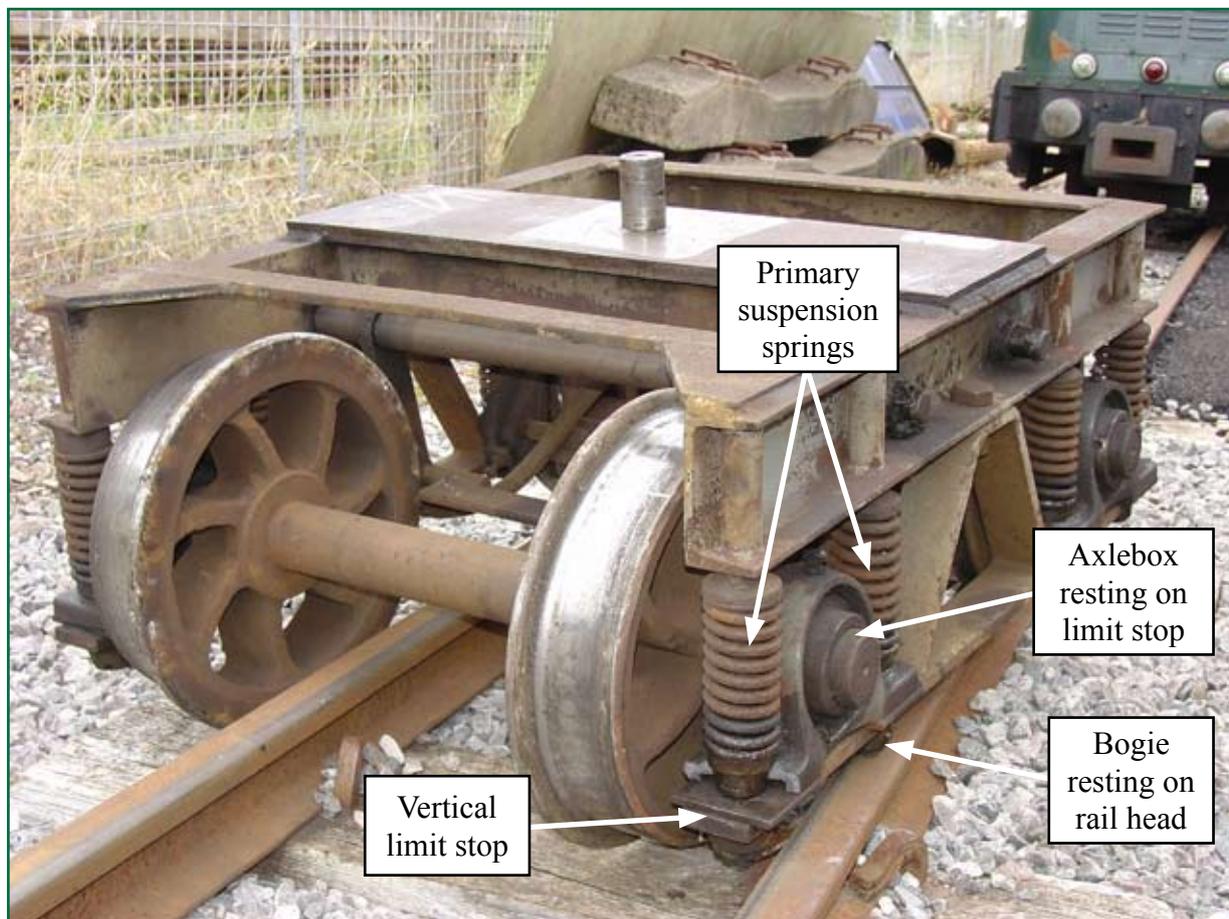
Figure 9: Leading bogie of coach 110 in initial derailed position.

82 There were gouge marks at the bottom of the leading left primary suspension locking nuts on the bogie. This indicated that the leading end of the bogie had slid along the rail head, propping up the leading wheelset in the position shown in Figure 9, and preventing heavy contact with sleepers and ballast.

83 The vehicle primary suspension comprises two vertically mounted springs either side of each axlebox which are located on two spring posts (Figure 9). When the vehicle is in tare condition, the axlebox sits directly on the vertical limit stop, which is fixed to the bogie frame. Hence the suspension has little or no flexibility in the wheel unloading (springs extending) direction and wheelsets will tend to unload excessively when traversing track with even moderate *twist faults* or dips caused by voiding.

84 There are no formal records or drawings of the bogie design or its optimum set up with regard to suspension clearances. Information available from the memories of R&ER staff indicated that when the bogies were first delivered in 1968, there was a clearance of 12 mm between the bottom of the axlebox and the vertical limit stop of the bogie in the tare condition, allowing that amount of flexibility in the unloading direction. However the ride performance at that time was unsatisfactory and vehicles were found to roll excessively. The decision was then taken by R&ER around 1970 to fit 12 mm spacers at the bottom of the springs. This spacer had the desired effect of improving ride quality, but flexibility in the unloading direction at tare had been virtually eliminated.
