Rail Accident Investigation Branch

# Rail Accident Report

## **Derailment at Phipps Bridge on Croydon Tramlink 25 May 2006**

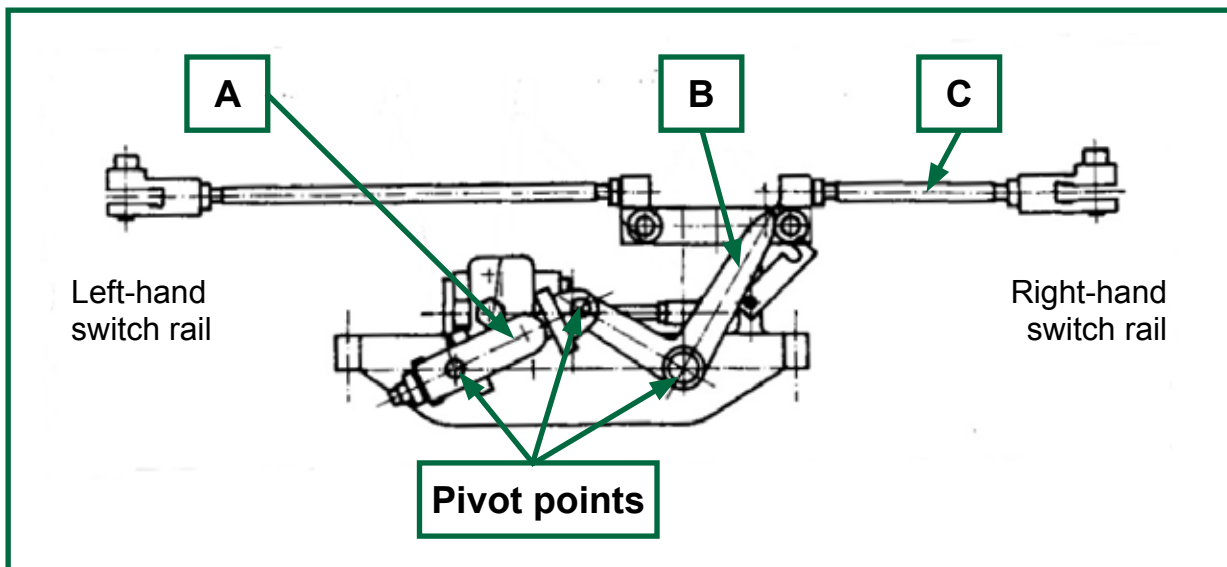
Figure 3: Hanning & Kahl spring point mechanism

- 23 A characteristic of this type of mechanism is that if the spring carrier is rotated sufficiently to line up all three pivot points in the linkage, it will reach a *dead-centre* position in which there is no turning moment to restore the mechanism to normal, and it will remain in that position until disturbed. In this position, although the spring is compressed to its greatest extent, the force required to disturb the mechanism is very low, and only a small impulse is required to cause the mechanism to spring back to the set position. As with all such mechanisms, whilst the theoretical dead-centre state only exists when all the pivots are exactly aligned, in practice the effect of friction in the pivot pins is such as to widen the range in which the mechanism can become stuck.

- 24 In normal operation, the movement of the stretcher bar (which is limited by the throw of the switches) should never push the operating lever into the dead-centre position. The dead-centre band is approximately  $15^\circ$  either side of the centre line (when the three pivot points line up as described in paragraph 23). To avoid this, the normal movement of the lever should be in the range  $30^\circ$  to  $75^\circ$  from the centre line, with the area from  $15^\circ$  to  $30^\circ$  allowing for wear or errors in setting. The manufacturer's instructions specify a maximum switch movement of 80 mm to achieve this. However, the length of the stretcher bar is adjustable using the threads at both ends of both portions, so it is possible for a wider range of movement to exist if the stretcher bar is not set up correctly. It is also possible to set the stretcher bar so that the throw is correct, but the range of movement of the operating lever (B) is asymmetrical.

- 33 At the time, the TCL chief engineer concluded from this that the operating lever was being pushed close to the vertical position as the trams trailed through the points, and was remaining in this position because of the over-centre action of the mechanism. The throw of the switch rails was measured and was found to be approximately 85 mm. The maximum throw specified by the manufacturers for this type of mechanism (see paragraph 24) is 80 mm.

- 34 To make the mechanism work correctly, TCL decided to significantly reduce the throw of the points by extending the stretcher bars, thus bringing the throw within the manufacturer's specification. To do this it was necessary to manufacture new stretcher bars because the required dimension was outside the range of possible stretcher bar adjustment. The new bars were fitted on 31 March, and the speed restrictions were withdrawn. The reliability of the points improved dramatically, although there were some failures in the following days, which led to the imposition of temporary speed restrictions on 3 and 10 April while the points were given attention. The attendant was withdrawn from 10 April.

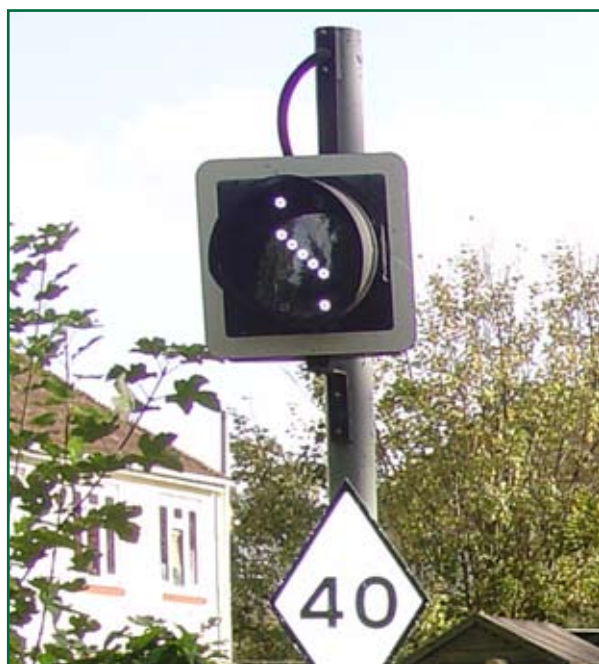
Figure 4: Points position indicator - Points correctly set

- 26 When the points are set and detected normal, the PPI indicates the left-hand route (see Figure 4). If the points are not correctly set, only the central white light of the PPI is lit (see Figure 5).

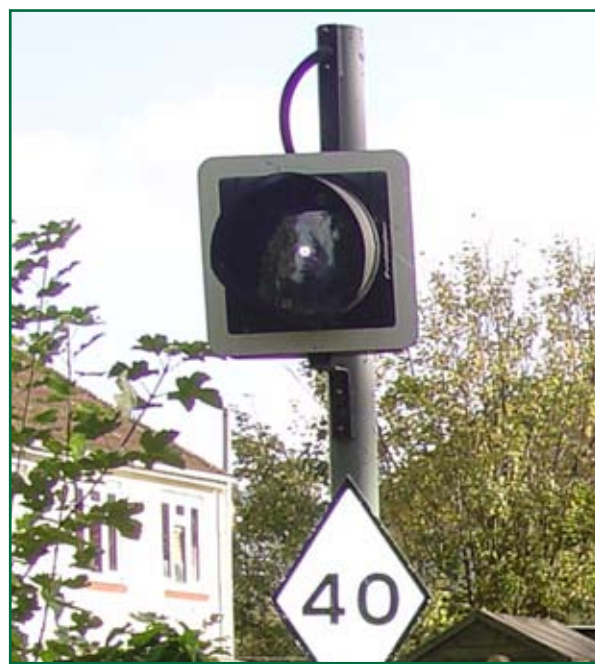
Figure 5: Points position indicator - Points not correctly set

- 44 The CCTV evidence from the forward-facing camera on the tram shows that the PPI was displaying a single white dot as tram 2532 approached the points at Phipps Bridge. The image recorded by the CCTV may not be what could be seen by the driver, especially in strong sunlight. The sun was shining on the indicator, which further reduced the clarity of the indication (see report<sup>1</sup> on the previous derailment, paragraph 29). The points can be seen to be lying reverse. Following the derailment the points were found to be set normal. The points had moved as the tram passed over them, and they were not correctly set (and indicated as such) as the tram approached.

- 46 The driver was presented with the ‘no detection’ indication of the PPI, a single white dot, the conspicuity of which was degraded (both because of its general appearance, and the sun shining on it), at the time that he was concentrating on bringing the speed of the tram down to 40 km/h to pass over the points (which he did, 26 m before reaching the points). The driver gained the impression that the indicator was showing that the points were correctly set, and continued to concentrate on controlling the speed of the tram. The sun was shining over the driver’s right shoulder onto the face of the PPI. This reduced the conspicuousness of the single dot indication, and may also have created a false impression that the route lights were lit. In the past the driver had encountered ‘two-way’ points indicators with the sun shining on them and giving the impression that both sets of route lights were lit (see picture below, Figure 6, in which only the centre dot is actually lit). Drivers’ representatives have also expressed concern about the visibility in sunlight of another signal on the system, and this signal has since been re-angled as a mitigation measure. It is TOL’s intention to carry out a system-wide review to try to identify any other signals or PPIs where similar problems may be experienced.

- 60 Recommendation 1 of the report into the above derailment was that 'the conspicuity of the PPI 'abnormal' indication should be assessed and improved by an appropriate means, such as display of a horizontal white bar when the points are not correctly set.'

63 TOL commissioned Human Engineering Ltd to carry out a human factors assessment of PPIs. This study was completed on 16 May 2006, and concluded that the greatest impact would be achieved by changing the existing 'no detection' aspect from a single white dot to a white horizontal bar. This is consistent with recommendation 1 of the RAIB report into the previous derailment. TCL were provided with a copy of the Human Engineering Ltd report, but decided to commission their own analysis of the human factors issues surrounding tram driver errors at signals, PPIs and elsewhere on the system. The results of this are not yet available.

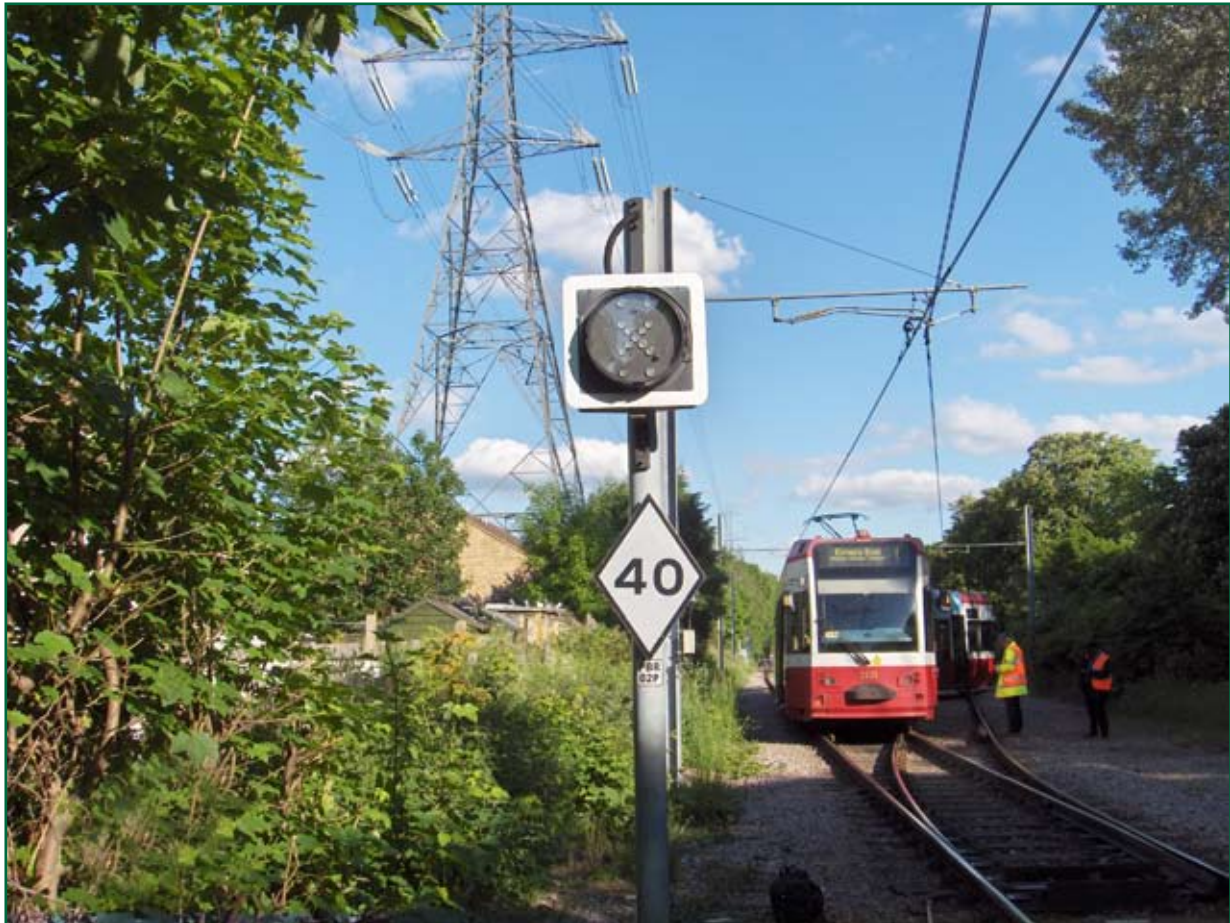
*Figure 6: Phipps Bridge soon after the derailment. This picture is not taken from the viewpoint of the driver, and may not represent what he saw on this occasion. The points have been manually changed since the derailment, and are set for the right hand route*

48 If the points had returned to the normal position after the previous westbound tram had run through them, the derailments on 21 October 2005 and 25 May 2006 would not have occurred. The history of points failing to return to the normal position is described in paragraphs 28 – 36 above. The steps taken by TCL to deal with it had not solved the problem.

49 Following the derailment, TCL removed the points mechanism from the track and replaced it with another mechanism taken from the siding at Wimbledon, which had had very little use because that siding is only used for stabling defective trams. There were no further reports of points failures at Phipps Bridge in the first two months following this action.

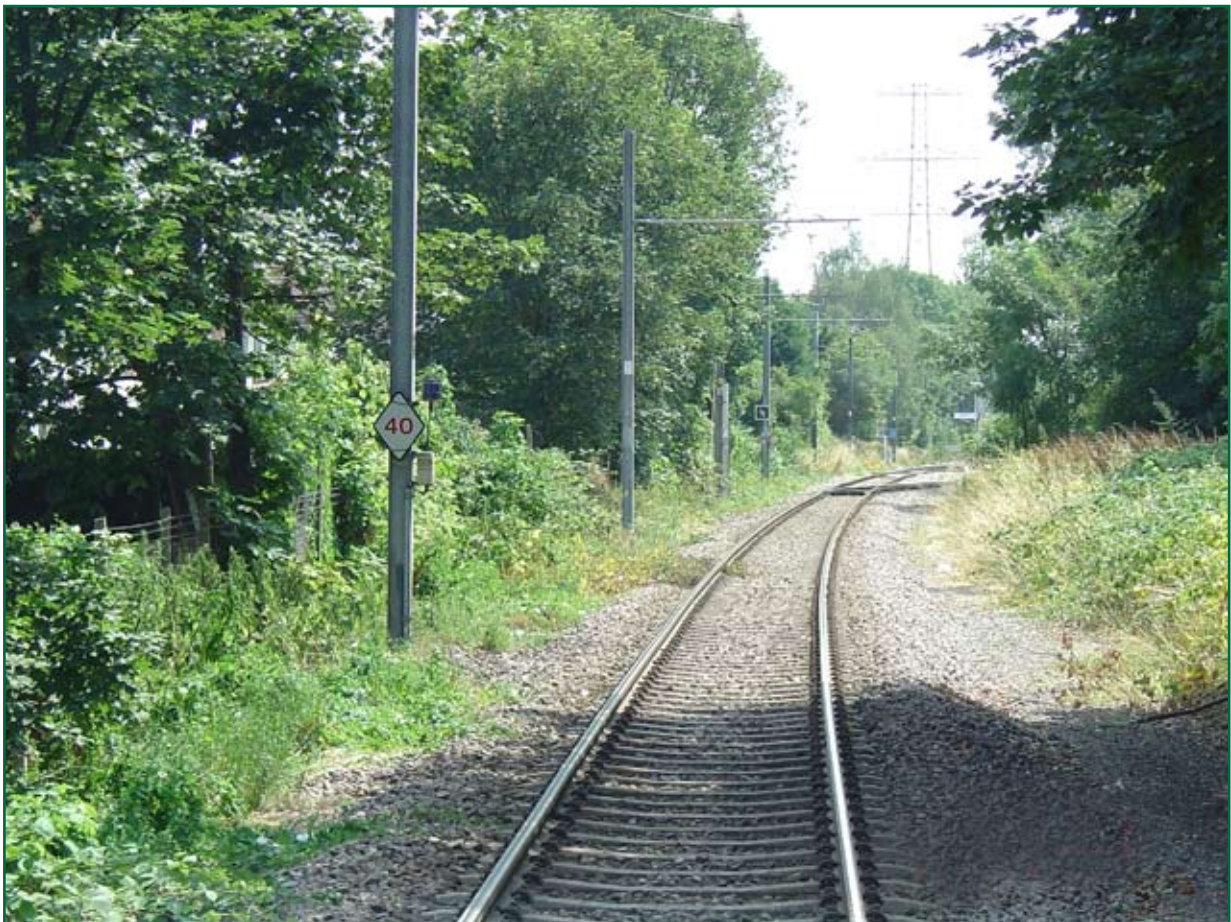
Figure 7: The approach to Phipps Bridge, showing the re-sited speed restriction and the PPI

- 76 Following the derailment, TOL and TCL modified the 40 km/h speed restriction through the points at Phipps Bridge to commence two OLE stanchions (approximately 80 m) before the points, rather than at the PPI. This will make it easier for the driver to bring the speed of the tram down to 40 km/h and then transfer attention from the speedometer to the PPI as the tram approaches the points (Figure 7).
