Rail Accident Report

Runaway permanent way trolley at Notting Hill Gate 24 May 2006

Report on a runaway permanent way trolley at Notting Hill Gate, 24 May 2006

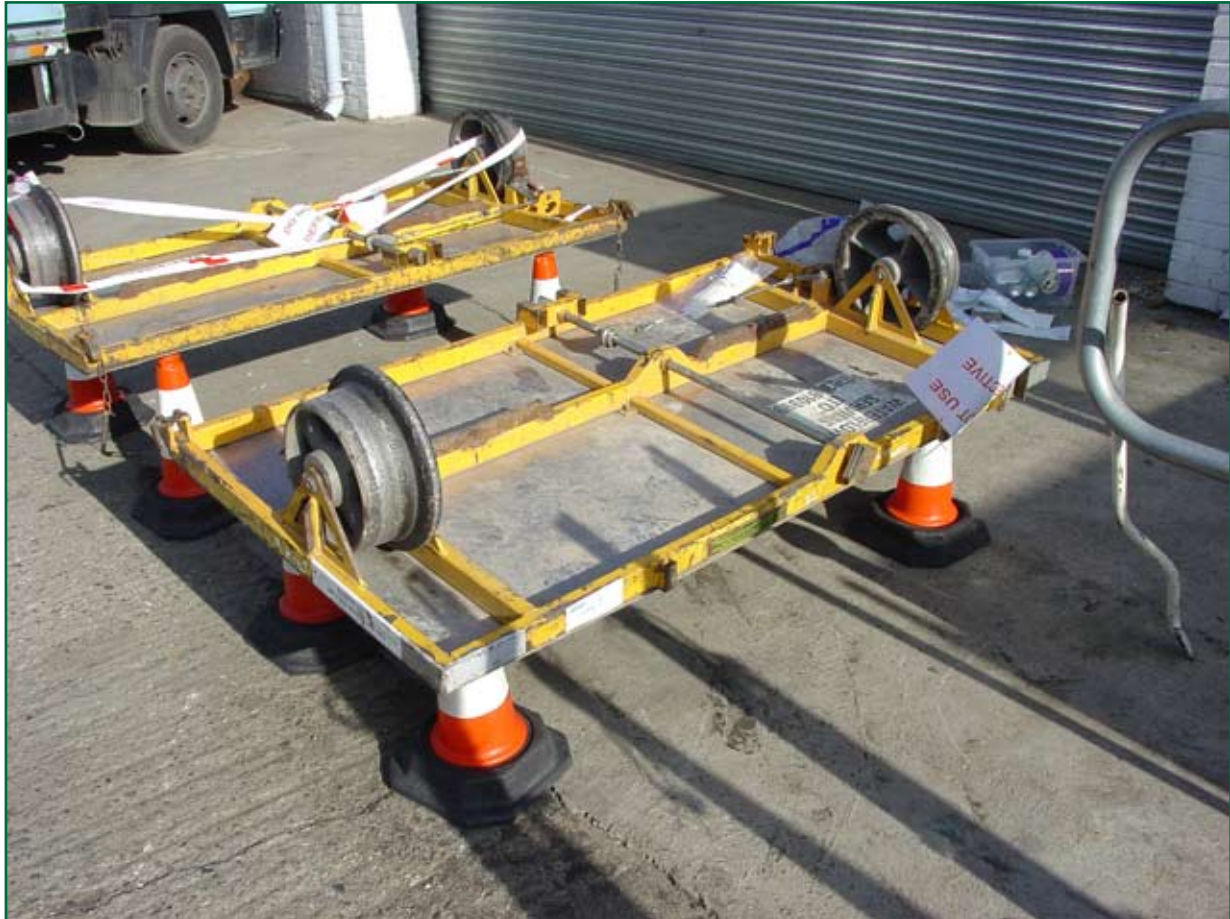
Figure 4: An underside view of the incident trolley.

29 One wheel on each half of the trolley is directly braked via a spring-applied shoe. The brake is released when the TTO depresses a handle at the end of the trolley, rotating a longitudinal shaft and pulling the brake release cables via a brake release arm describing an arc around the longitudinal shaft. An underside view of the incident trolley is shown in Figure 4.

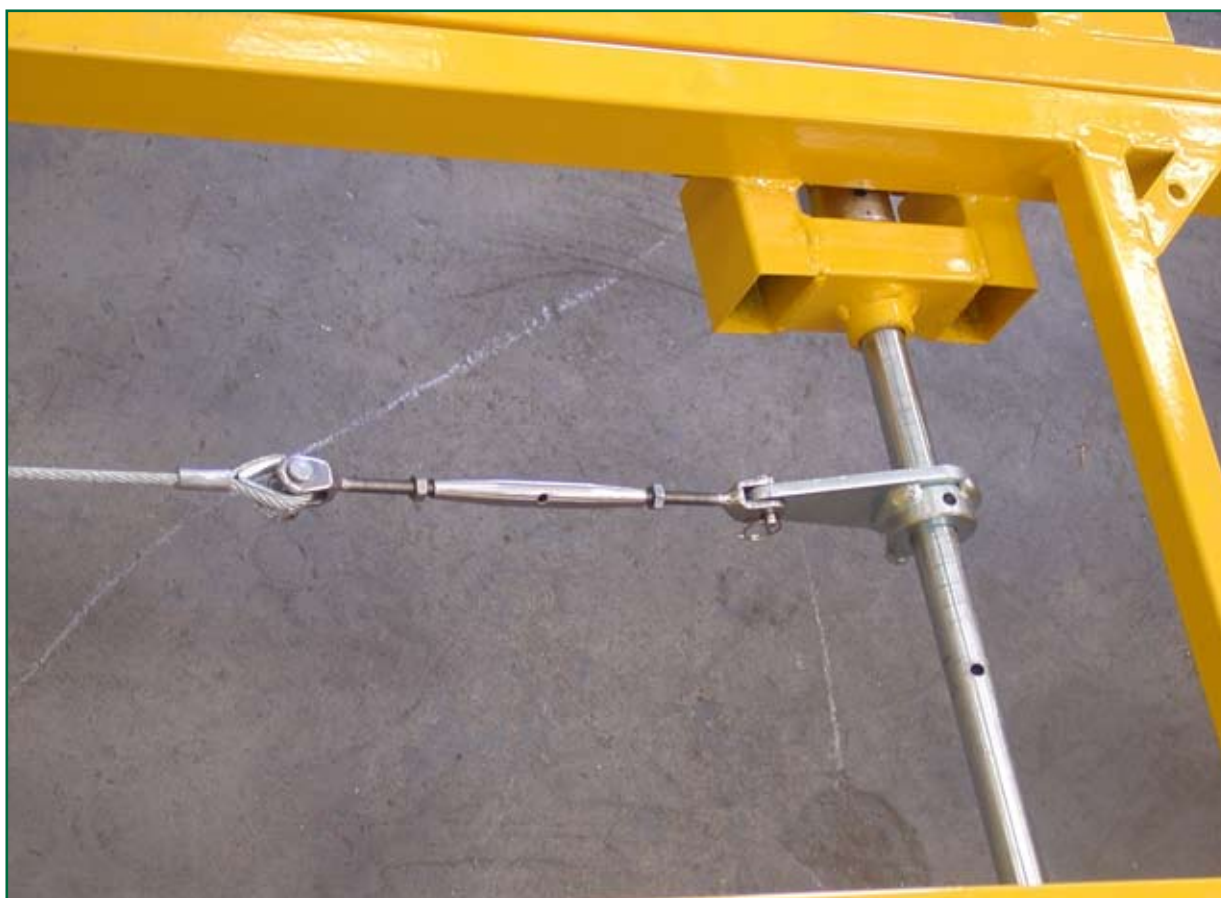
Figure 5: A Rotamag slack adjuster.

- 31 Each slack adjuster consists of a turnbuckle, the rotation of which will loosen or tighten the cable dependent upon the direction of rotation. When the correct degree of slack is achieved in the cable, the turnbuckle is locked in position using a 6 mm threaded nut. A slack adjuster is shown at Figure 5.

- 97 The slack adjusters are of simple but robust construction. It is highly improbable that four lock nuts, two on each slack adjuster, could all have become loose in the three weeks since the previous maintenance and in the case of three of the four move away from the adjuster fitting. It cannot be conclusively established if the condition of the trolley resulted from deficiencies in the preceding maintenance or as a result of some subsequent occurrence. However, the balance of evidence suggests that the adjusters had been modified after the return from maintenance and before the night of the incident. It is therefore concluded that the unauthorised modification of the brakes is a causal factor. The missing roll-pin was the likely motive for this modification and is therefore a contributory factor.

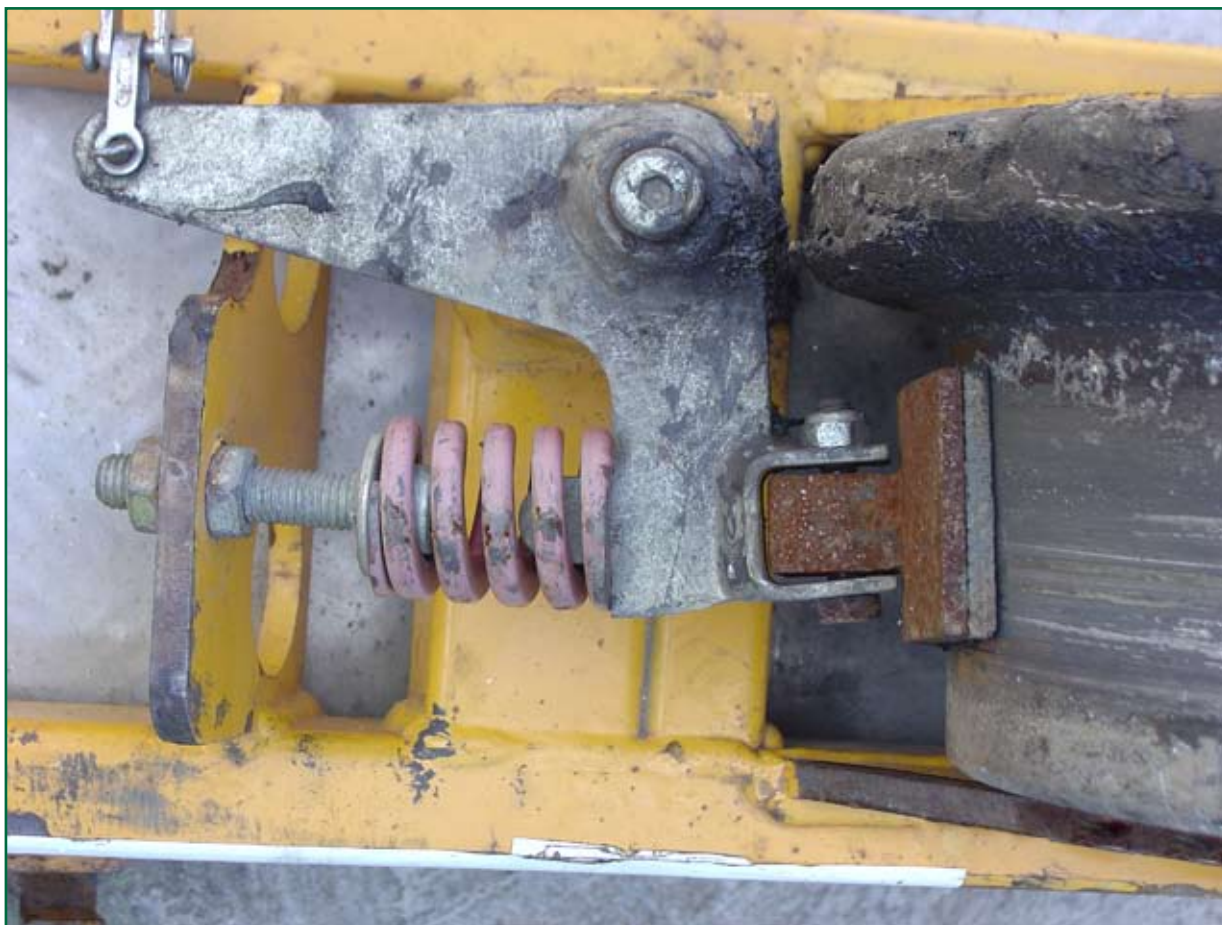
Figure 8: Detail of the application spring seat and mounting.

77 The lock nuts on the brake application springs were both undone. However, there was no reduction in the application spring pressure as a result. Details of the spring seat and its mounting bracket are shown in Figure 8.
