Rail Accident Investigation Branch

Rail Accident Report

Runaway permanent way trolley at Notting Hill Gate 24 May 2006

Report 12/2007
May 2007

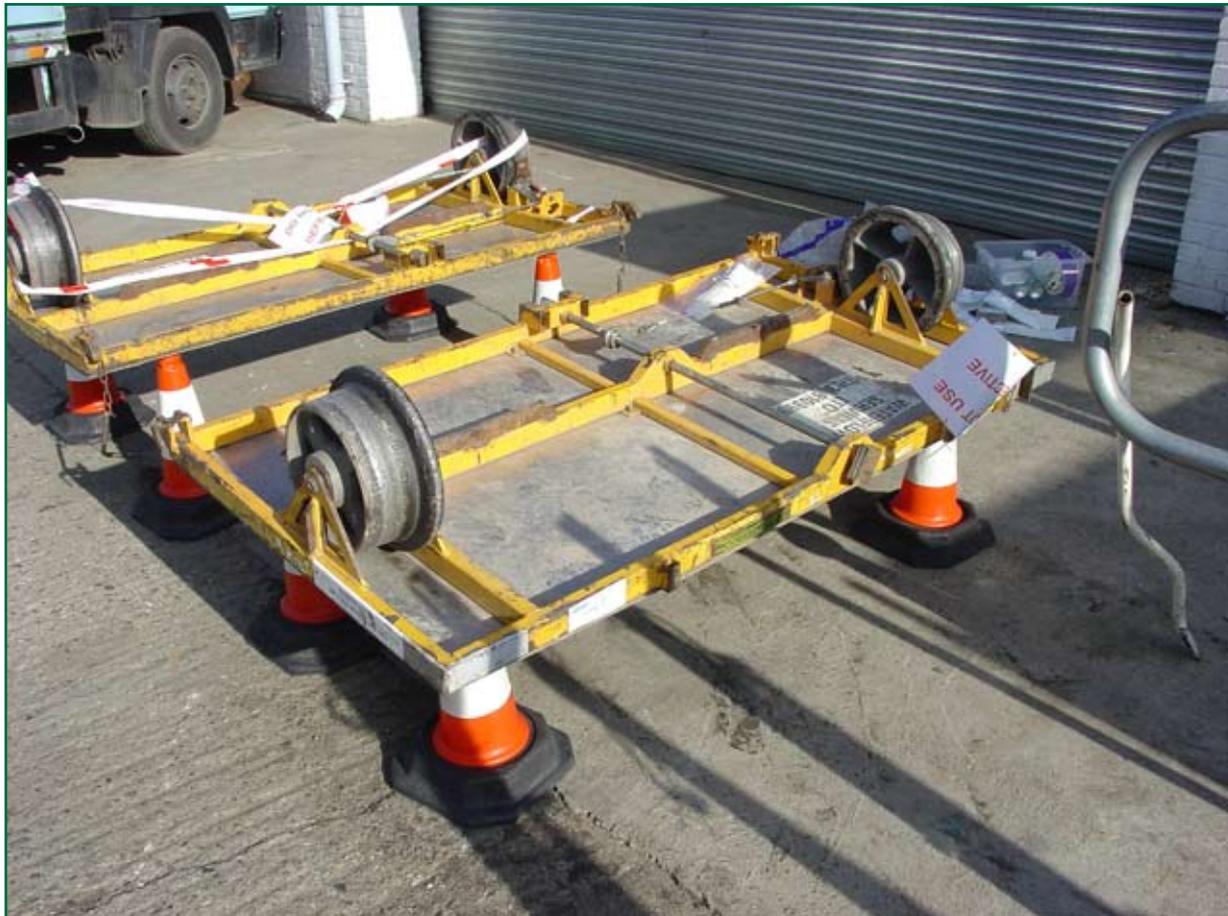
Figure 4: An underside view of the incident trolley.

29 One wheel on each half of the trolley is directly braked via a spring-applied shoe. The brake is released when the TTO depresses a handle at the end of the trolley, rotating a longitudinal shaft and pulling the brake release cables via a brake release arm describing an arc around the longitudinal shaft. An underside view of the incident trolley is shown in Figure 4.

- 73 The inspection and testing of the trolley identified significant deficiencies in braking performance. With the brake handle removed and the brake in the fully 'on' position, the resistance of the braked wheels to rotation was negligible. It was possible to rotate each wheel easily by hand.

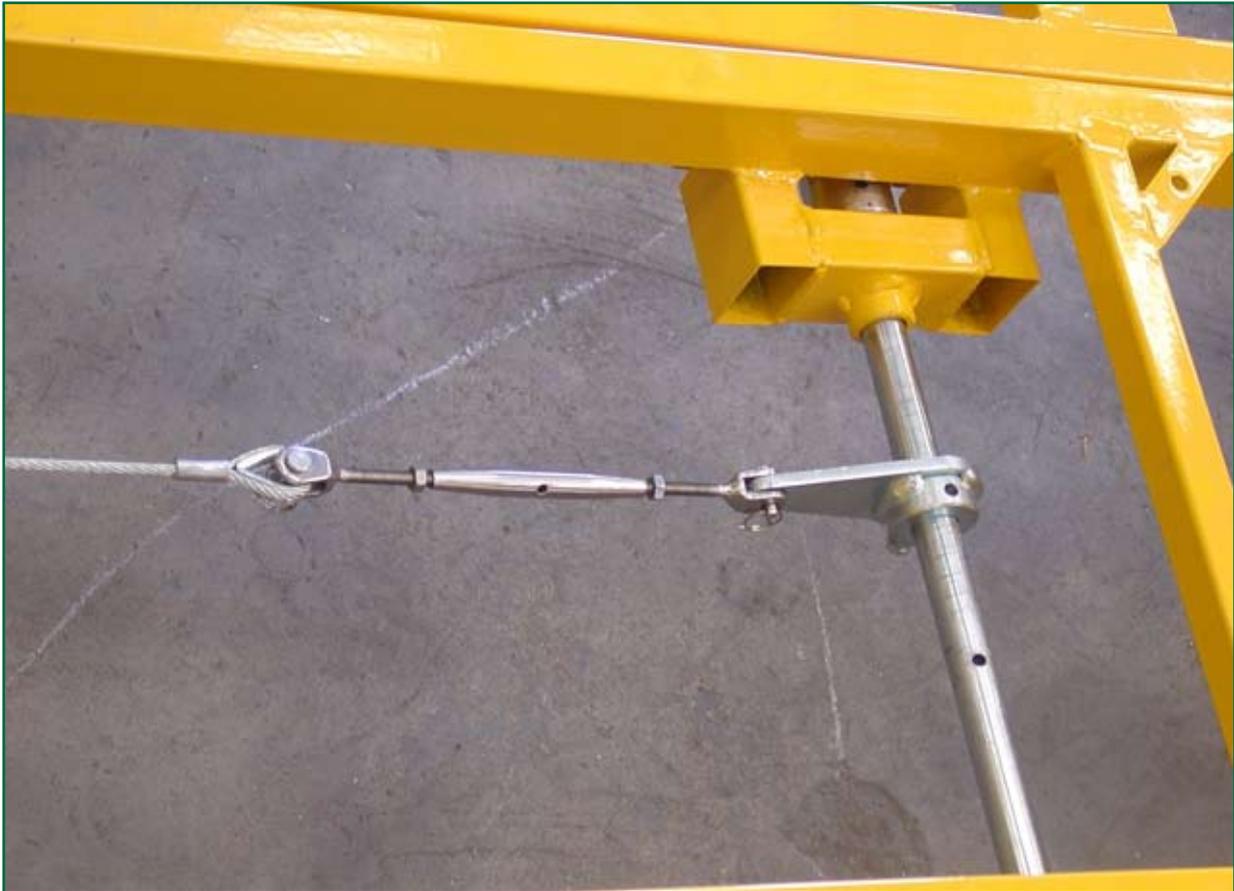
Figure 5: A Rotamag slack adjuster.

- 31 Each slack adjuster consists of a turnbuckle, the rotation of which will loosen or tighten the cable dependent upon the direction of rotation. When the correct degree of slack is achieved in the cable, the turnbuckle is locked in position using a 6 mm threaded nut. A slack adjuster is shown at Figure 5.

- 97 The slack adjusters are of simple but robust construction. It is highly improbable that four lock nuts, two on each slack adjuster, could all have become loose in the three weeks since the previous maintenance and in the case of three of the four move away from the adjuster fitting. It cannot be conclusively established if the condition of the trolley resulted from deficiencies in the preceding maintenance or as a result of some subsequent occurrence. However, the balance of evidence suggests that the adjusters had been modified after the return from maintenance and before the night of the incident. It is therefore concluded that the unauthorised modification of the brakes is a causal factor. The missing roll-pin was the likely motive for this modification and is therefore a contributory factor.

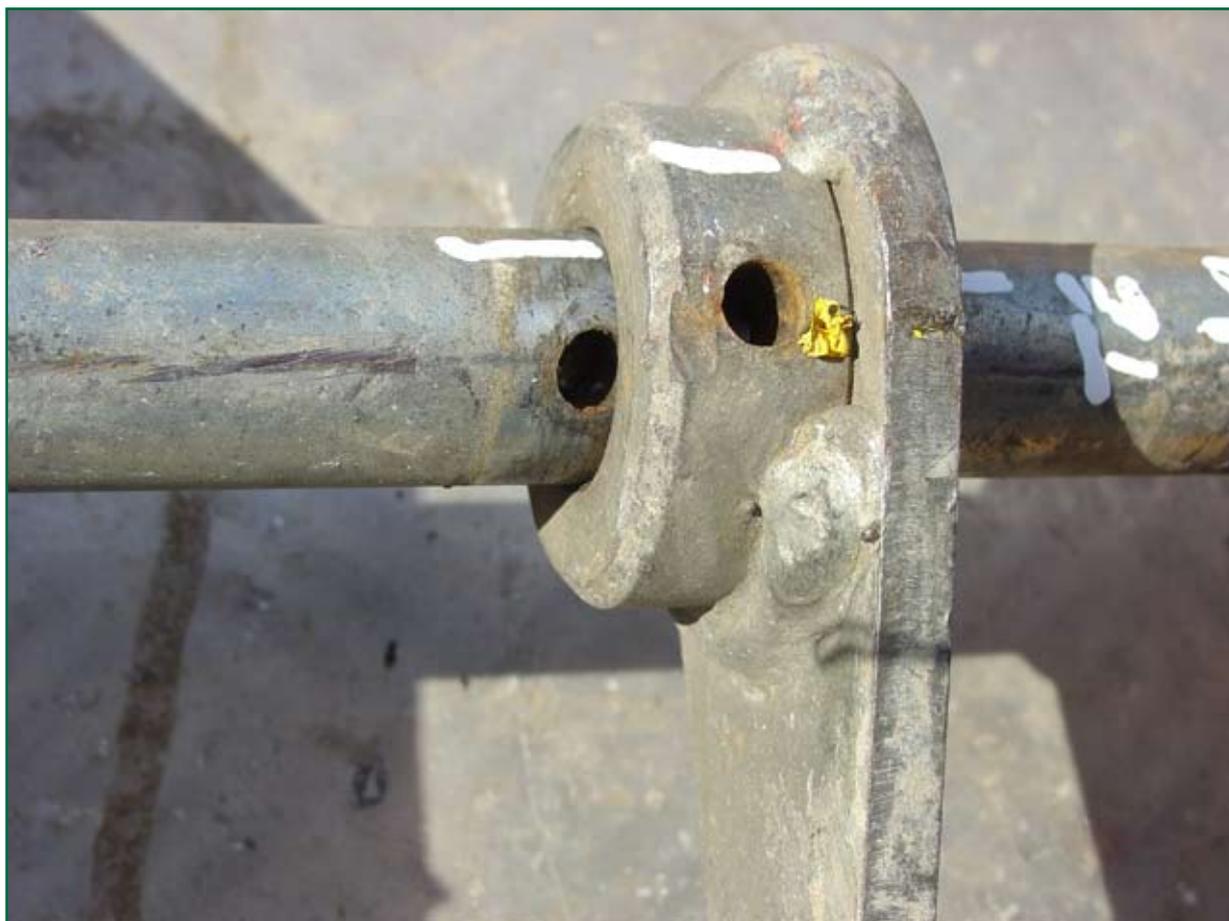
Figure 7: Detail of the release arm boss.

- 75 One brake release arm had become disconnected from the longitudinal shaft, because of the loss of the roll-pin, which passes through the boss of the arm the shaft. There was a distinct bruise and fresh yellow paint residue on the arm boss, which matched that on the frames of the trolleys. Figure 7 shows the detail of the release arm boss. There was light corrosion to the bore of the drilled hole in both the arm boss and longitudinal shaft.

- 76 Because of the loss of connection between the longitudinal shaft and the arm boss, the operation of the brake handle no longer rotated the arm to pull the cable and release the brake on the associated wheel.

- 95 The post incident inspection revealed a number of mechanical issues on the trolley.
- 96 There was visible corrosion to the roll-pin hole. This suggests that the pin had been missing for some time. If the pin had been missing at the time of maintenance three weeks earlier, it would not have been possible to adjust the brake mechanism correctly. The bruise mark to the arm, and fresh yellow paint residue, indicates that there had been an impact of some magnitude with another trolley section, probably during stowage on or unloading of the trolley from the road vehicle.

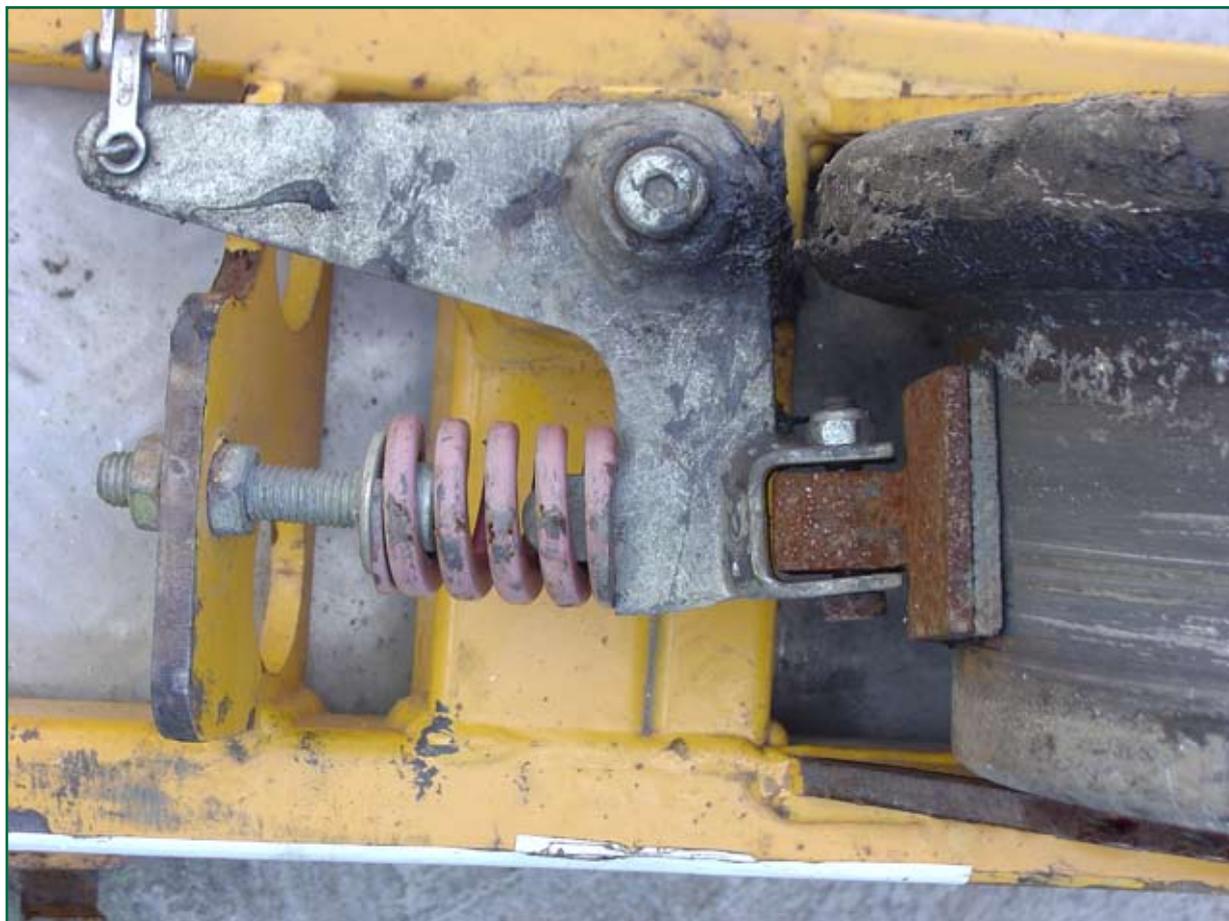
Figure 8: Detail of the application spring seat and mounting.

77 The lock nuts on the brake application springs were both undone. However, there was no reduction in the application spring pressure as a result. Details of the spring seat and its mounting bracket are shown in Figure 8.
