Rail Accident Investigation Branch

Rail Accident Report

Derailment at Long Millgate, Manchester 22 March 2006

Report 08/2007
April 2007

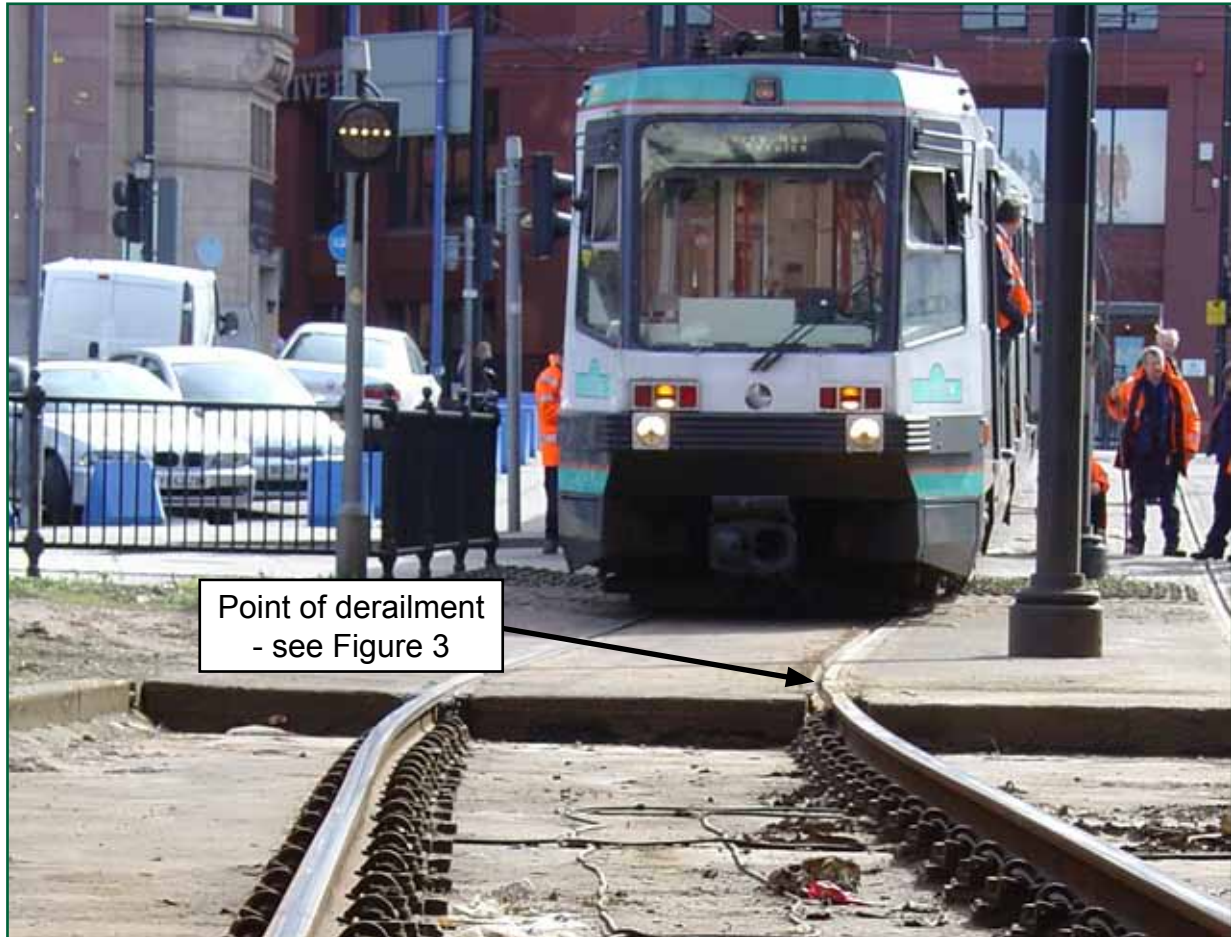
- 18 After liaising with the Metrolink control room the driver got out of the vehicle to assess the problem and discovered that the front axle of the centre bogie was derailed to the left.

Figure 2: Derailed tram seen from the rear

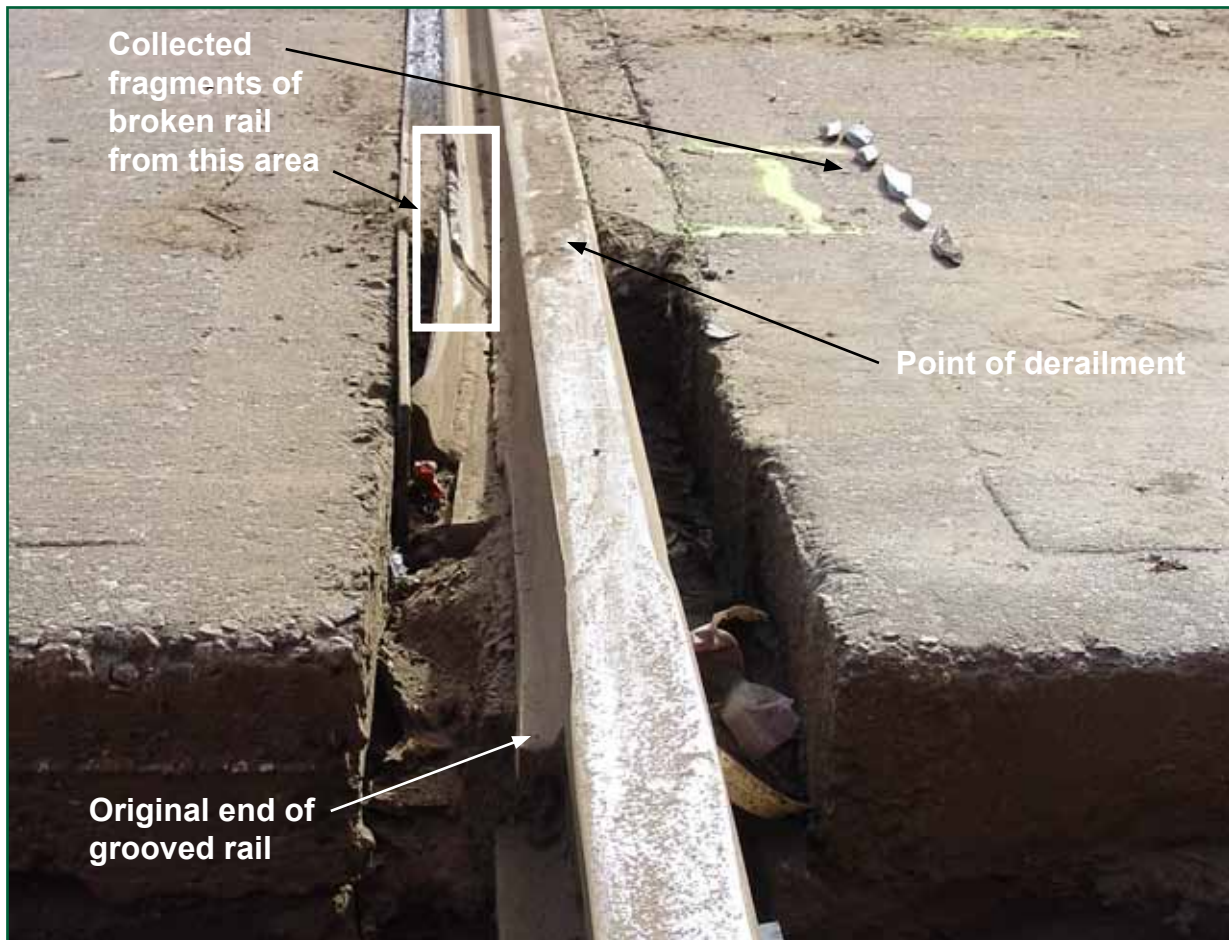
- 23 There were no injuries to staff or passengers, and no damage to the tram. The track was damaged over a length of about 0.6 m (see Figure 3), and the right-hand rail in this area required replacement.

Figure 3: Right hand rail at transition showing extent of cutting-back from original end of grooved rail (see paragraph 27 for a description of the rail).

- 54 The welding-in of this wedge was sub-standard. The weld applied to the top of the wedge had not been sufficient to join the metal together, so the wedge was connected to the flare but not to the body of the rail. When the flare broke, it did so largely along this weld (Figure 3).

- 79 Serco Metrolink removed the defective flare and the keep on the remainder of the curve, which had the effect of relocating the entry to grooved rail on to the straight section. The side worn rail opposite the new entry to the groove was built up by weld repair to tighten the gauge.

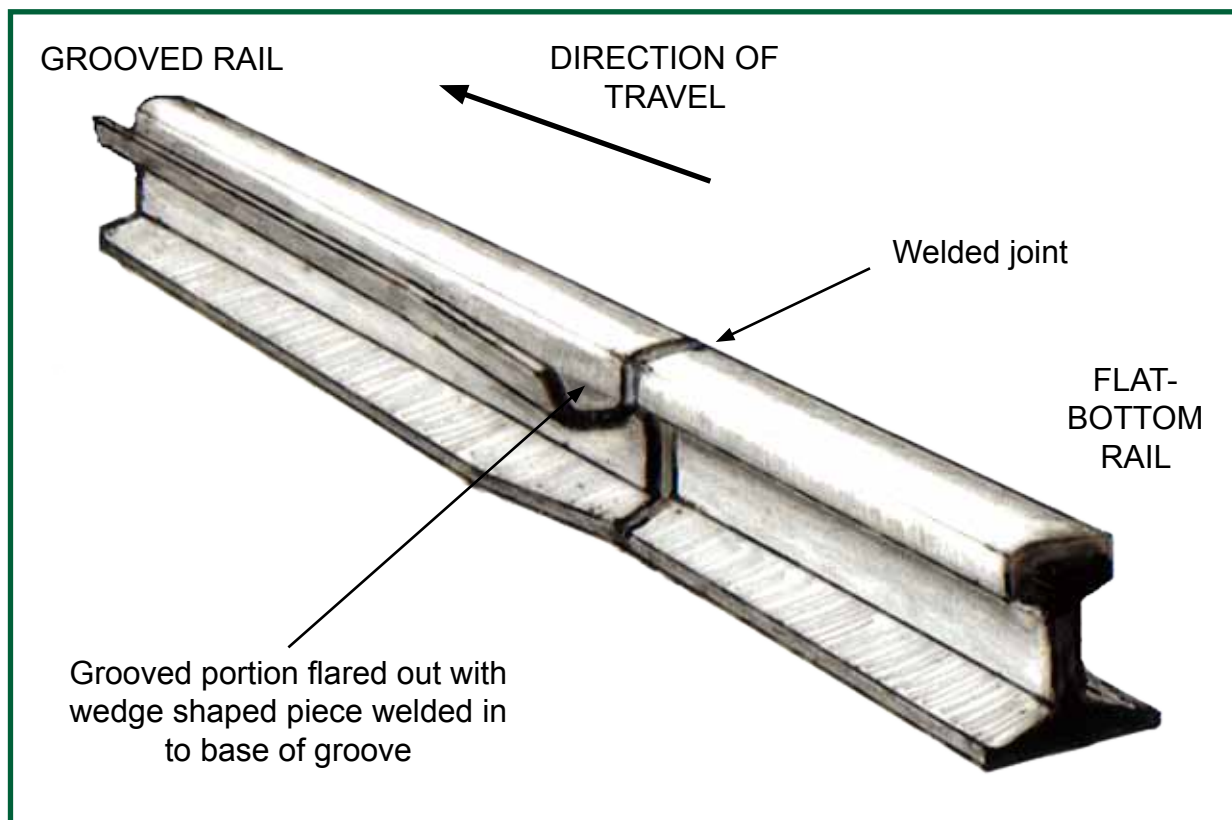
- 26 The derailment occurred at the point where the track changes from flat-bottom rail to grooved rail. The track through Victoria Station consists of a reinforced concrete slab with an 80 lb flat-bottom rail clipped into baseplates that are bolted to the slab. The track formation alters just outside the station entrance (known locally as the ‘hole in the wall’), where the rails change to Ri59 grooved rail embedded in ‘Edilon’ polymer and surrounded by a pavement surface.
- 27 The transition from flat-bottom to grooved rail is made by the use of transition pieces; these were originally fabricated by *flash butt welding* the two rail sections together and adapting the rail foot to create a tapered section. The transition pieces included a ‘flared’ arrangement to the end of the *keep* section of the rail to provide a wider groove where the wheel flange enters the grooved rail (Figure 4).

Figure 4: Simplified sketch of transition between rail profiles

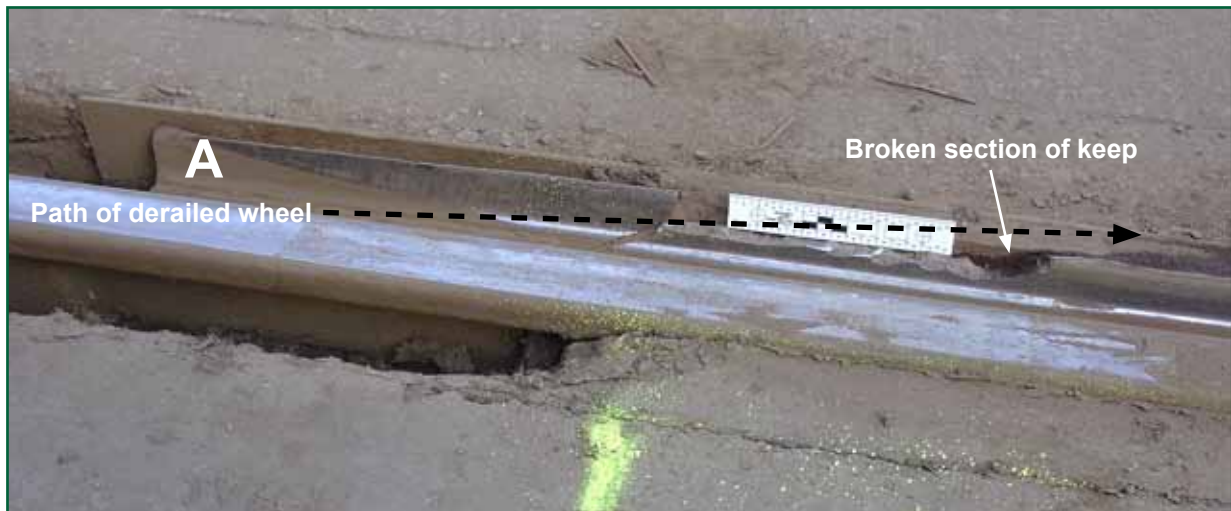
- 28 As tram 1011 passed over it, the flared portion of the grooved right-hand (inner) rail broke away from the rest of the rail at the weld, and consequently the keep was shattered over a further length of 230 mm by the force exerted by wheel flanges which were no longer being guided and restrained by the flared portion. This permitted the flanges of the right-hand wheels of the leading wheelsets of the centre and trailing bogies to pass the wrong side of the keep, forcing the left-hand wheel over the railhead and into derailment (Figure 5).

Figure 5: details of broken rail

- 31 At the Victoria curve, the back of the flanges of the inner (right-hand) wheels of trams had been contacting the keep of the grooved rail, commencing at the point where the groove narrows in the flared portion of rail (‘A’ in Figure 5). This had placed a load on the flared portion, and the combination of the load and the consequent wear eventually caused the *flare* to break under the tram which derailed on 22 March. The flare had previously cracked and had been cut back and remade in October 2005. This work was not designed or carried out to a good standard (paragraph 54), and consequently the flare was weak and had a relatively short life before it failed again. The flare was not, however, intended to be of sufficient strength to withstand being struck by passing wheelsets.
