Rail Accident Investigation Branch

Rail Accident Report

Derailment of a Ballast Plough Brake Van at Carlisle 6 February 2006

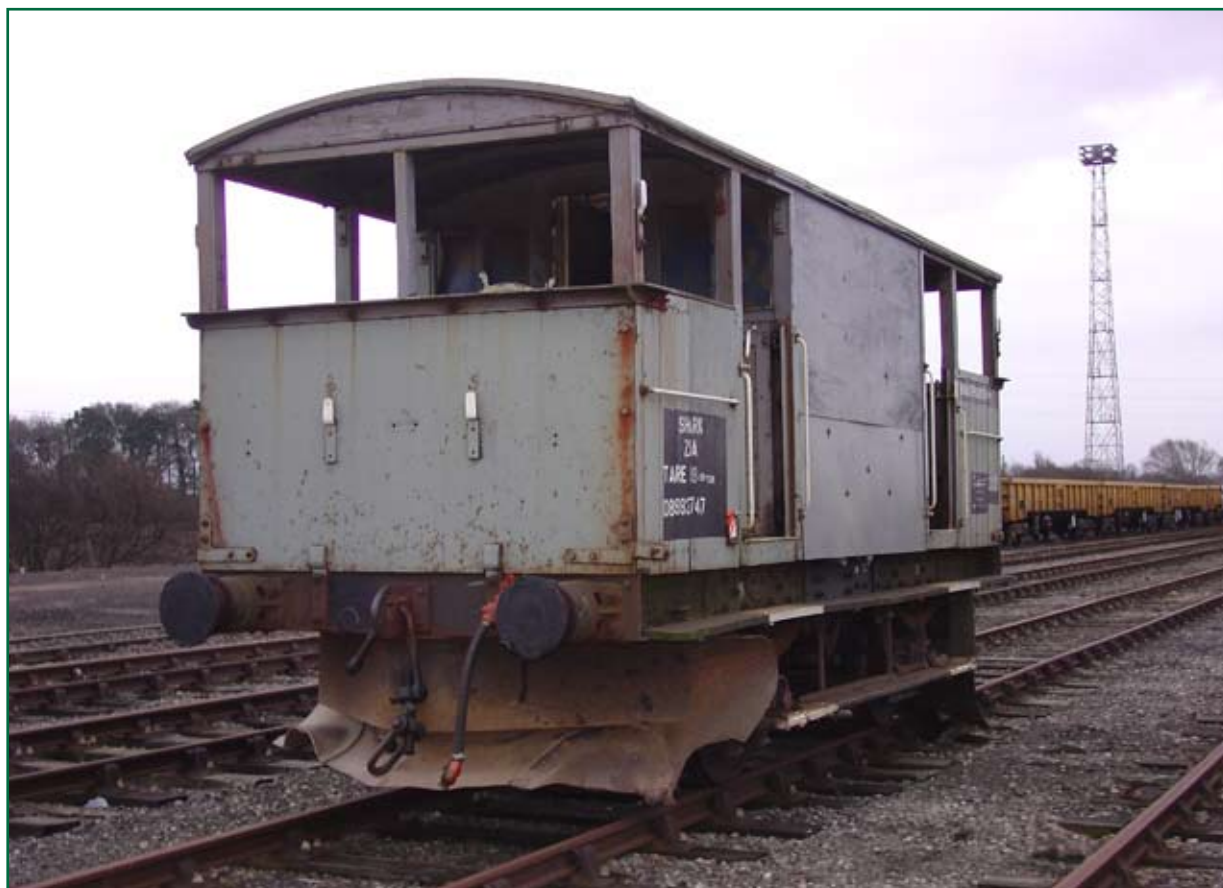
Figure 2: Shark Plough van DB993747

- 58 The left hand side of the ballast plough at the leading end of the Shark plough brake van had contacted a converging rail on the approach to 756A points and derailed the vehicle all wheels. This had caused the brake pipe between the brake van and the wagon immediately in front to part and initiate the brake application.

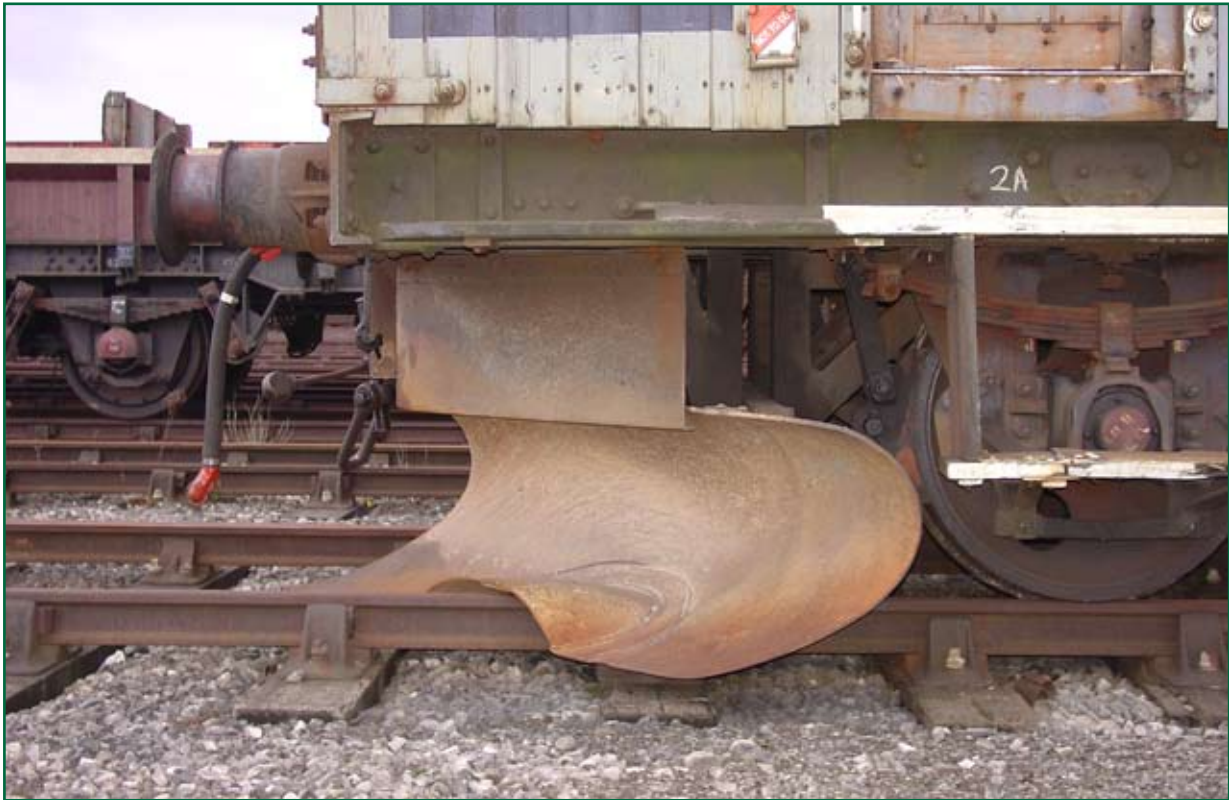
Figure 3: Detailed view of the ballast plough

- 66 At the point of derailment, the left hand side tip of the plough was below rail surface sufficiently to strike the rail and not be deflected away. At Maryport, 50 miles into the 75 mile journey, the left hand tip, considered to be the cause of the mark observed on the foot crossing surface, was some 30 mm to 50 mm above rail head surface. Extrapolation of this dimension would suggest that the plough was at its stowed height, 150 mm above railhead, when train 6L57 left the site. It is therefore concluded that the plough was raised and the securing screws wound down at site but the locking keys were not inserted. During the journey the securing screws rotated due to motion and vibration, allowing the plough to gradually lower.

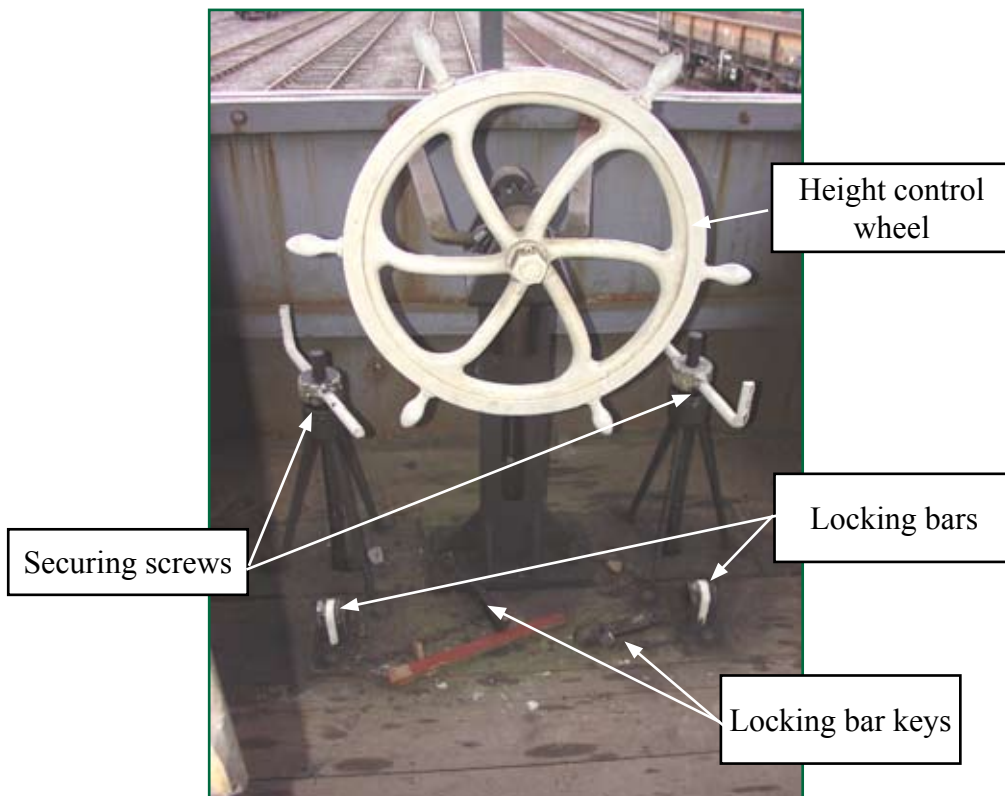
Figure 4: Inside view of a Shark plough brake van showing height control wheel, securing screws and locking bars with plough in working position

- 15 Plough brake vans are unpowered and are towed or propelled. When in use the height of the plough is adjusted using the control wheel, shown in Figure 4 and Figure 5, to achieve the desired degree of ballast distribution and level. The plough must be raised above railhead height where obstructions exist in the four foot or on the sleeper ends, eg at points or at *AWS magnets*.

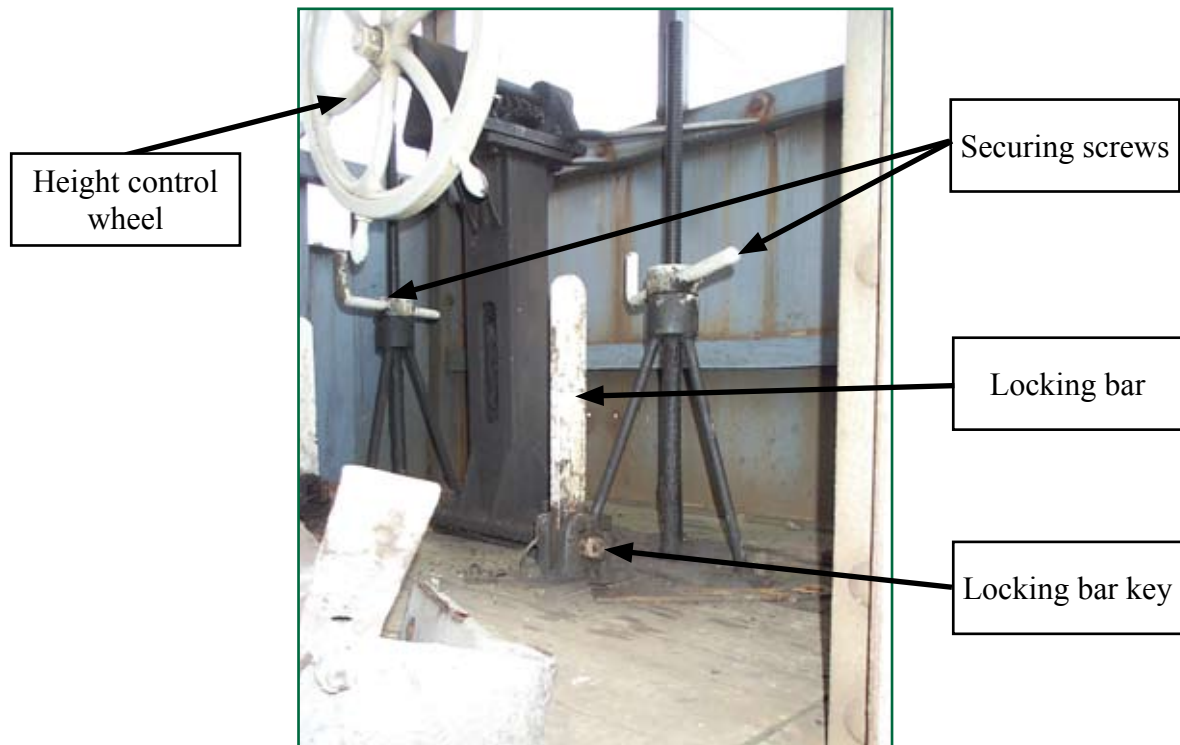
Figure 5: Inside view of a Shark plough brake van, with ballast plough in travelling position, showing securing screws and locking bars with keys inserted.

- put both keys into the locking bars – these will only fit with the plough fully raised.
- 61 The design of the locking bars and keys is robust and proven. There was no damage to the locking or securing system and therefore a failure of these is discounted. The keys, which are inserted into the locking bars, have a ‘drop end’ latch to prevent keys vibrating or falling out or being displaced unintentionally. They are also retained to the vehicle by short chains, to prevent loss. These are shown fitted in Figure 4. Both keys being properly inserted and subsequently coming adrift is discounted.

- 63 A subsequent trial was carried out to establish the securing capability of the plough height control system. The vehicle was static and the locking keys and securing screws released. The height control wheel and its gear mechanism together with the securing screw handles and their screw threads were free to move and adequately lubricated. With the plough in the raised position a small amount of rotational input to the control wheel resulted in the plough descending easily and the wheel continued to rotate for a short period of time. It is considered in a moving train, with the added vibratory input, the plough would descend rapidly to rail level. Because this did not occur in this incident it is reasonable to conclude that the securing screws were wound down before the train left the site.

- 80 EWS have issued an Operating Digest Advice (Number 121) instructing site train preparers', who prepare trains at the point of departure from engineering worksites, to check that the plough is correctly raised, secured and locked before permitting Shark brake vans to move outside of possessions.

- 1 EWS should ensure that the advice and instructions given to site train preparers' in Operating Digest Advice Number 121 (Actions already taken or in progress: paragraph 80) are incorporated into normal working procedures.
- 2 EWS should consider providing further assistance to train preparers in regard to plough stowage by painting locking keys a bright colour and/or placing reminder/warning notices on the exterior of the vehicles.
