# Rail Accident Report

**The collision of a locomotive with carriages at  
Great Central Railway's Loughborough Central  
station,  
4 February 2006.**

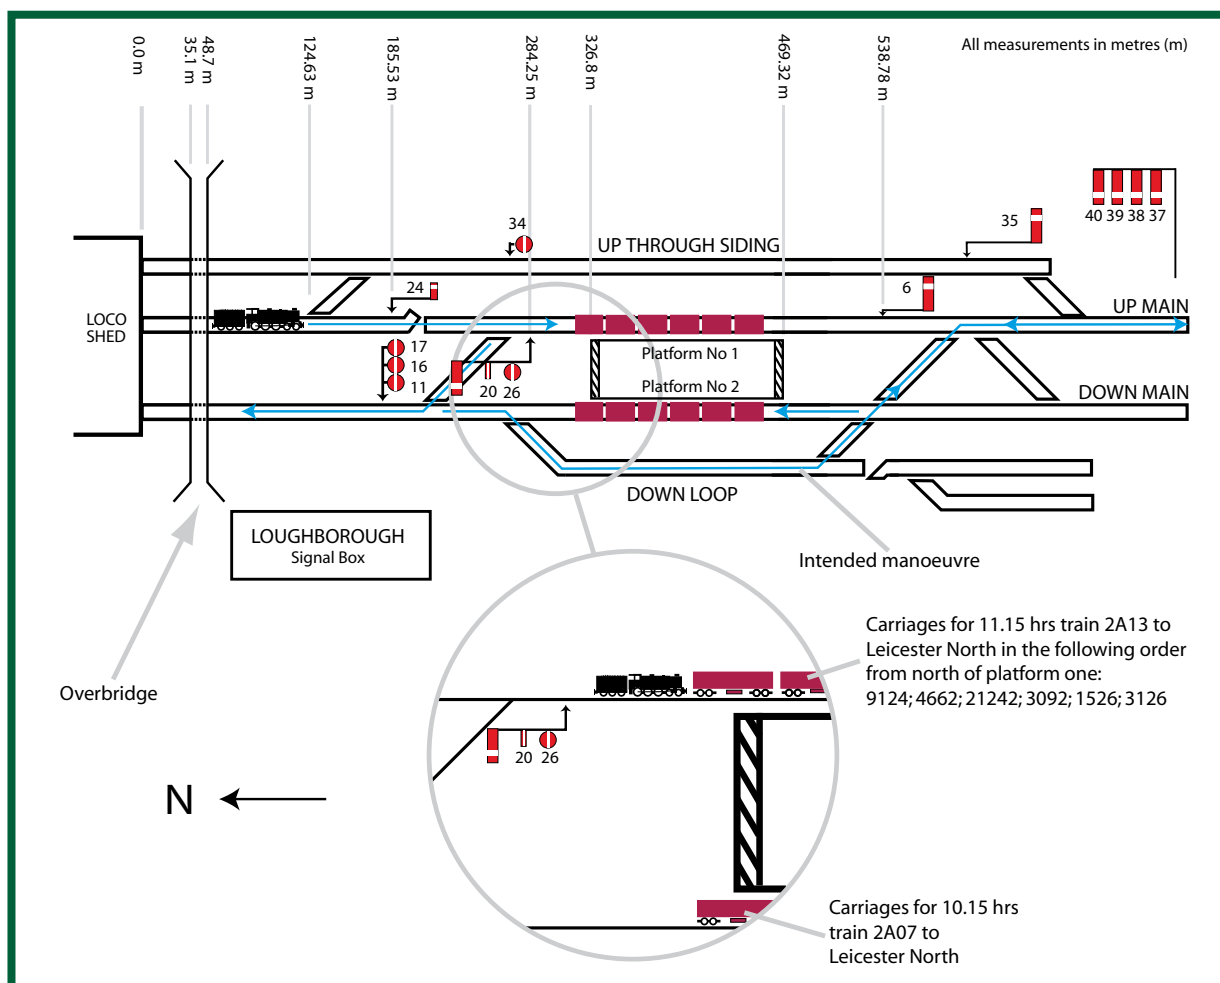
Figure 2: Loughborough Central station plan showing signals and signal reference numbers

- 20 The location of carriages in platforms one and two required the driver to manoeuvre locomotive 45305 as shown in Figure 2. This manoeuvre was routine and not subject to time pressure.

35 The driver was aware he was to execute a routine manoeuvre using the *Down* loop to run around and couple to the carriages at platform two south. See Figure 2 for details. The *Down* loop is a *bi-directional*, fully signalled and *track circuited* line.

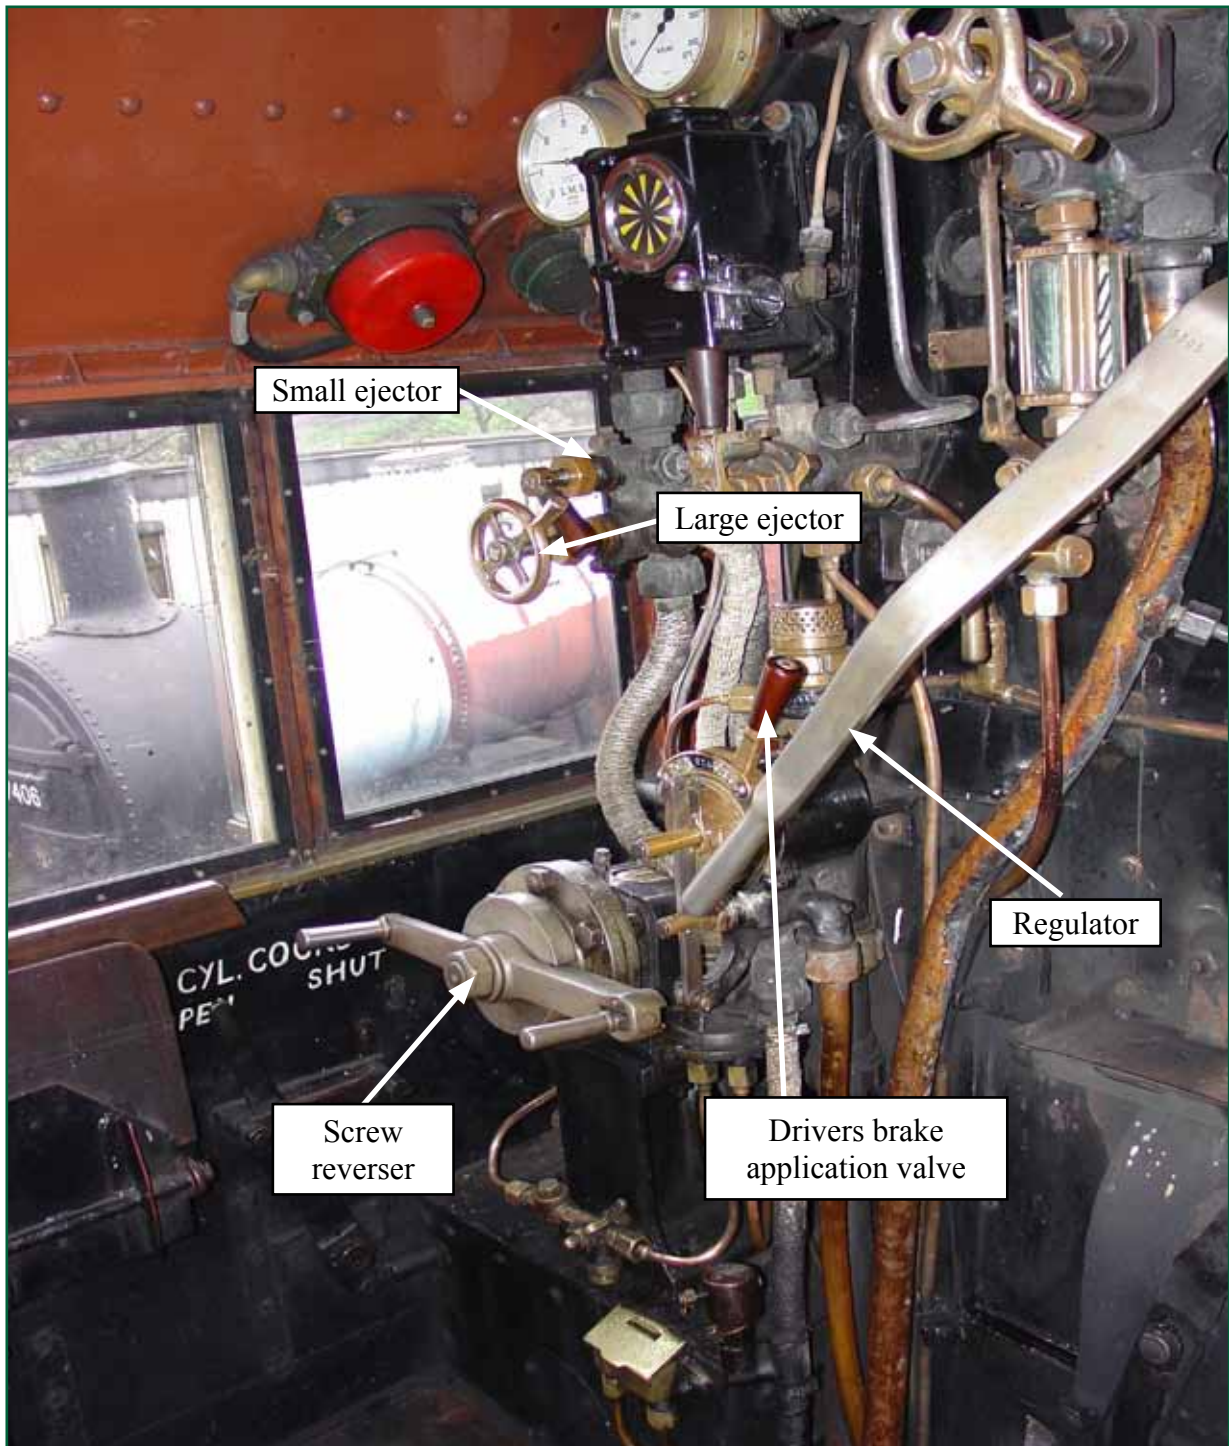
Figure 3: Locomotive 45305 cab controls

- 29 The fireman remained standing, coming to rest against the boiler. The fireman was not injured and applied the locomotive brake when instructed to do so by the driver. See Figure 3 for the location of the locomotive brake and cab controls.

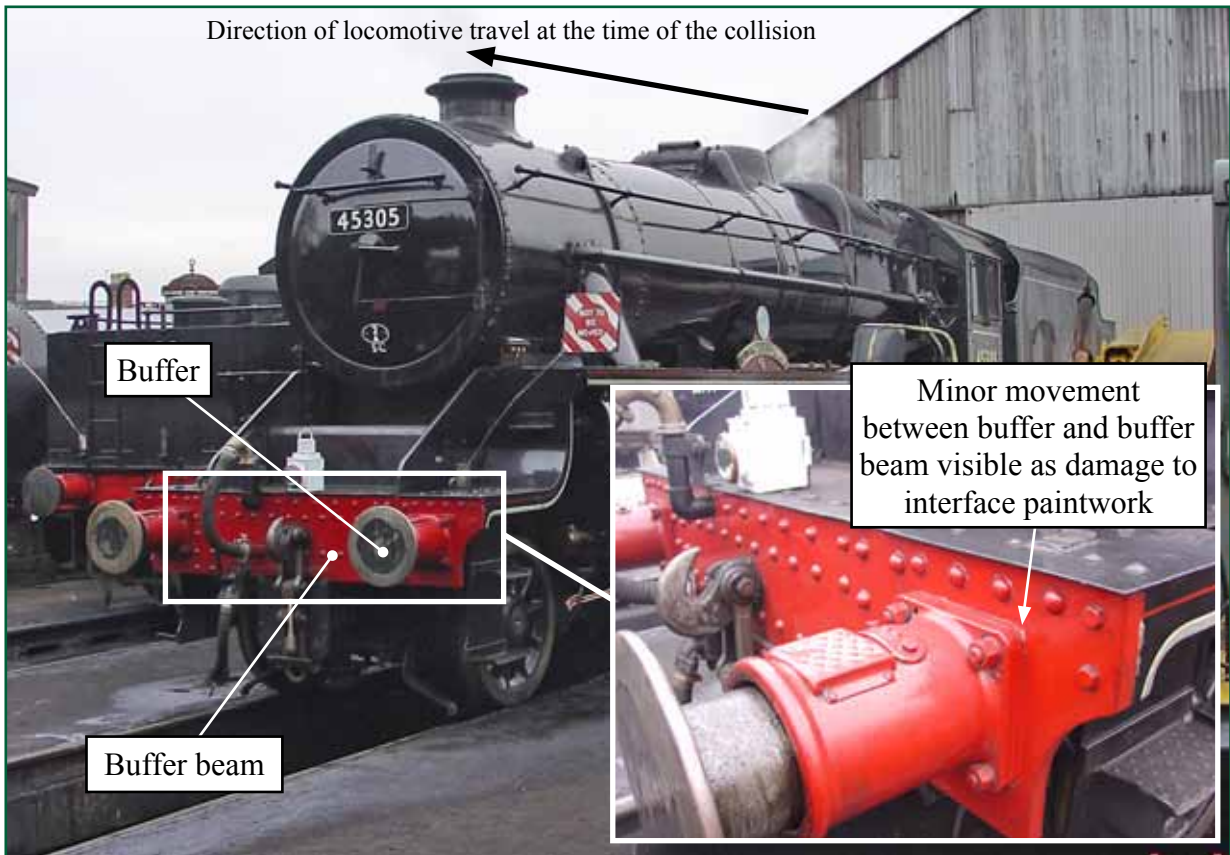
Figure 4: Locomotive 45305 with damaged buffer and buffer beam

33 Only the locomotive and carriage 9124 sustained minor damage. There was minor movement of the locomotive *buffers* relative to the *buffer beam* as evidenced by cracked paint at the interface (Figure 4). The buffer beam was slightly deformed. Carriage 9124 sustained damage to its buffers and the coupler casting at its coupling to carriage 4662. The buffers had moved relative to the buffer beam, evidenced by cracked paint at the interface. The coupler casting was cracked (Figures 5, 6 & 7).

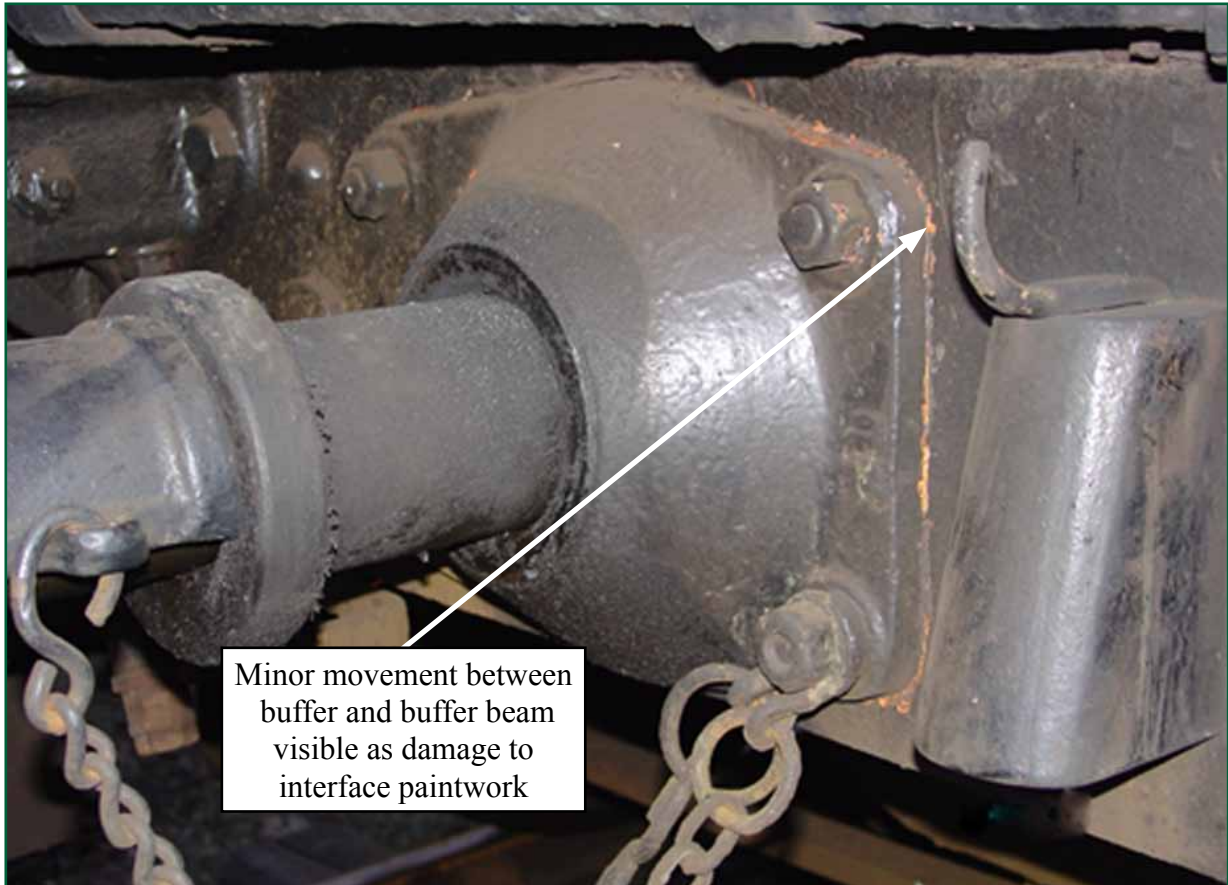
Figure 6: Carriage 9124 buffer struck by locomotive

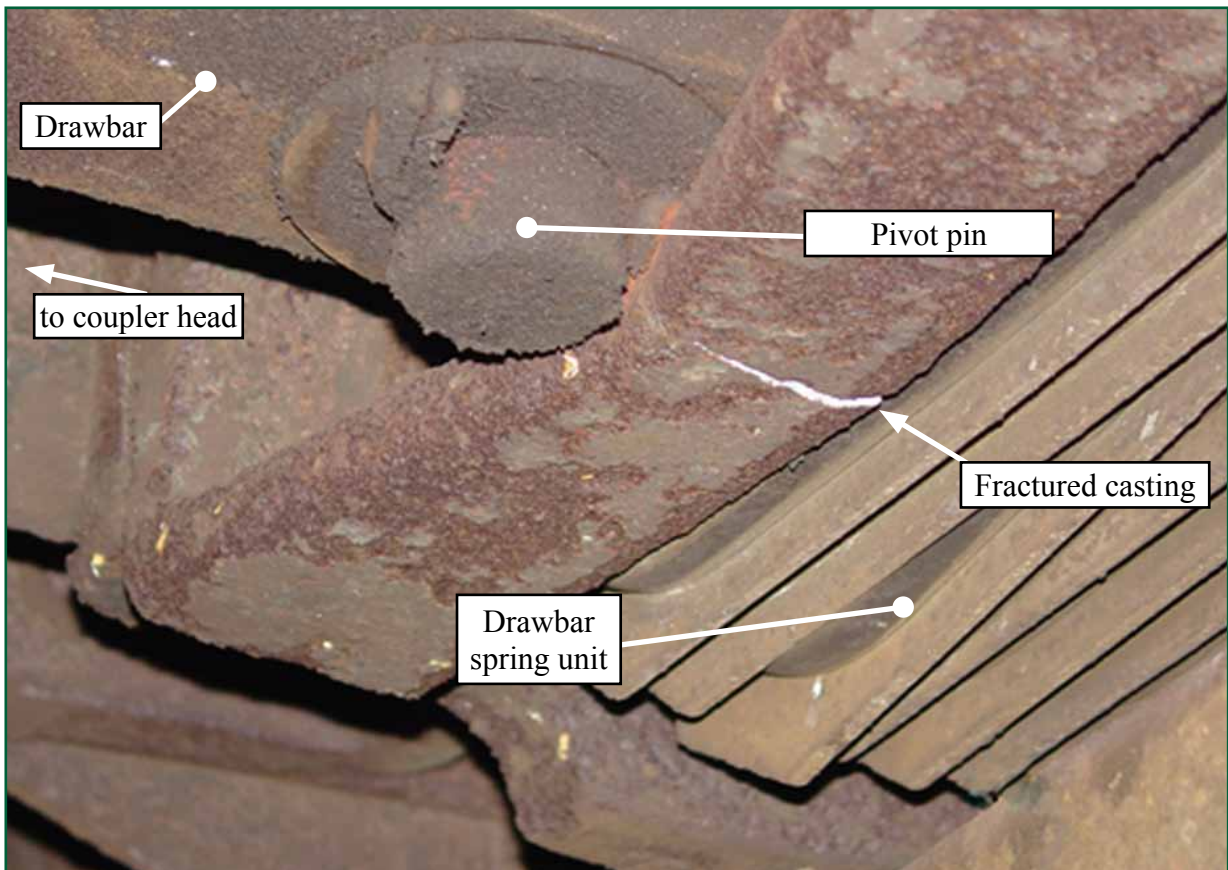
Figure 7: Carriage 9124 coupler connected to Mark 1 carriage 4662

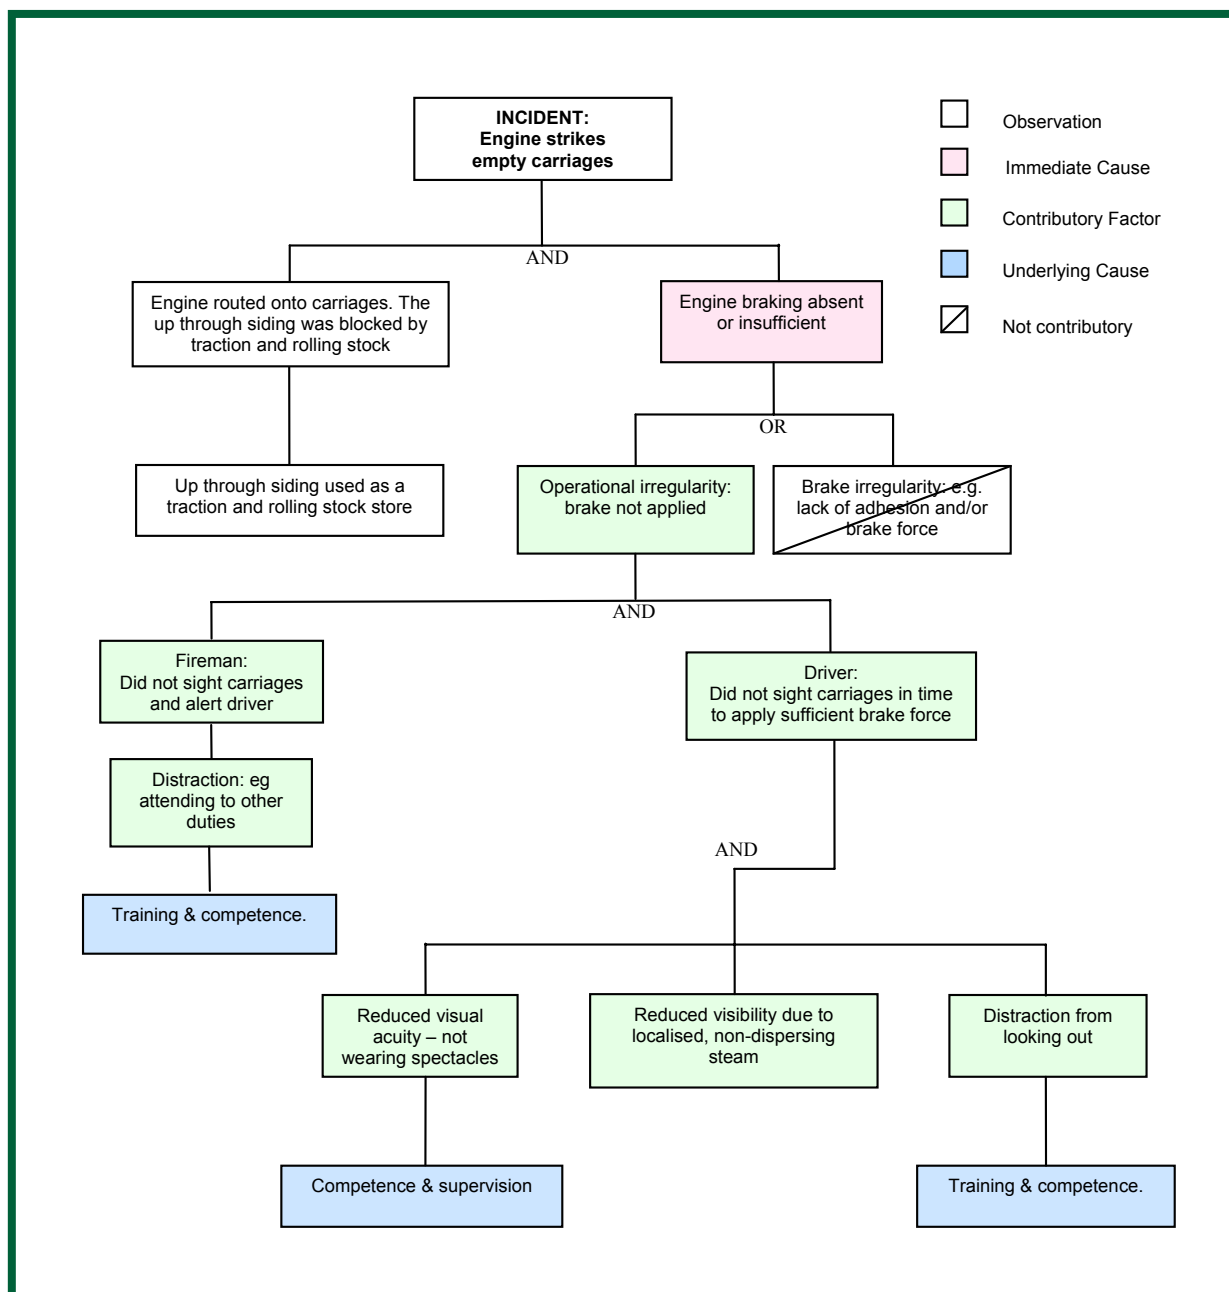
Figure 8: Causal Analysis

34 The causal analysis into the incident is given in Figure 8. The locomotive passed braking tests during daily exam, during the driver's brake test and in a post incident test. Neither the wheels nor the railhead were contaminated, therefore adhesion conditions were normal. Thus a brake irregularity was not contributory to the incident.

- 47 The crew misjudged the separation of the locomotive from the carriages, most likely due to reduced visibility - a combination of collecting steam and the driver’s uncorrected eyesight - and distraction from keeping a good look out due to doing other things. The immediate cause of the incident was that the driver did not apply the locomotive brake to stop and therefore the locomotive collided with the carriages.
