Rail Accident Investigation Branch

Rail Accident Report

Wagon derailment at York station 18 January 2006

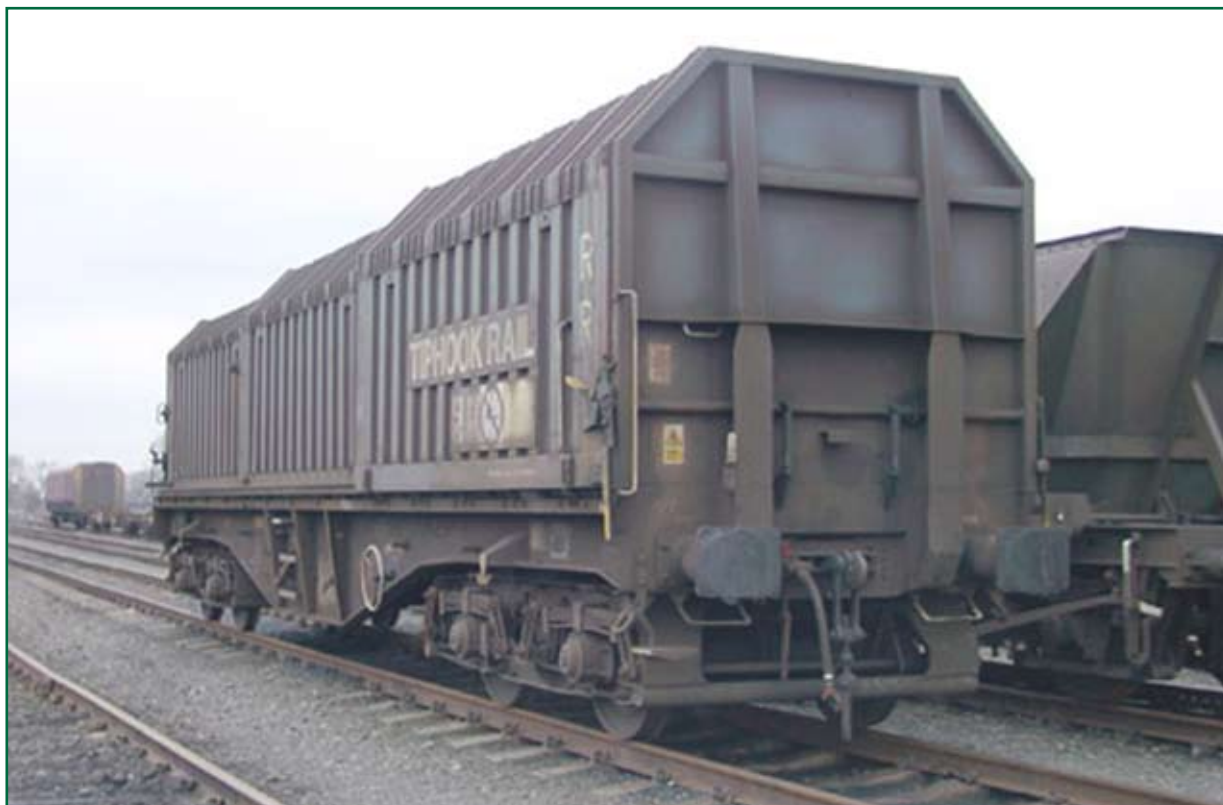
Figure 2: Wagon 7008990380

- 14 Wagon 7008990380, empty at the time of the incident, was the fifteenth wagon from the locomotive. A photograph of the wagon is shown in Figure 2.
- 15 The wagons were designed and certified for international traffic in accordance with the *Regolamento Internazionale Veicoli* (RIV) regulations of the *Union Internationale des Chemins de Fer* (UIC). The design of the wagons was scrutinised for compliance with UIC codes (standards) rather than Railway Group Standards. By this process, compliant wagons are considered to have satisfied the requirements of Railway Group Standard GM/RT2000, Engineering Acceptance, and are approved for use on Network Rail Infrastructure.

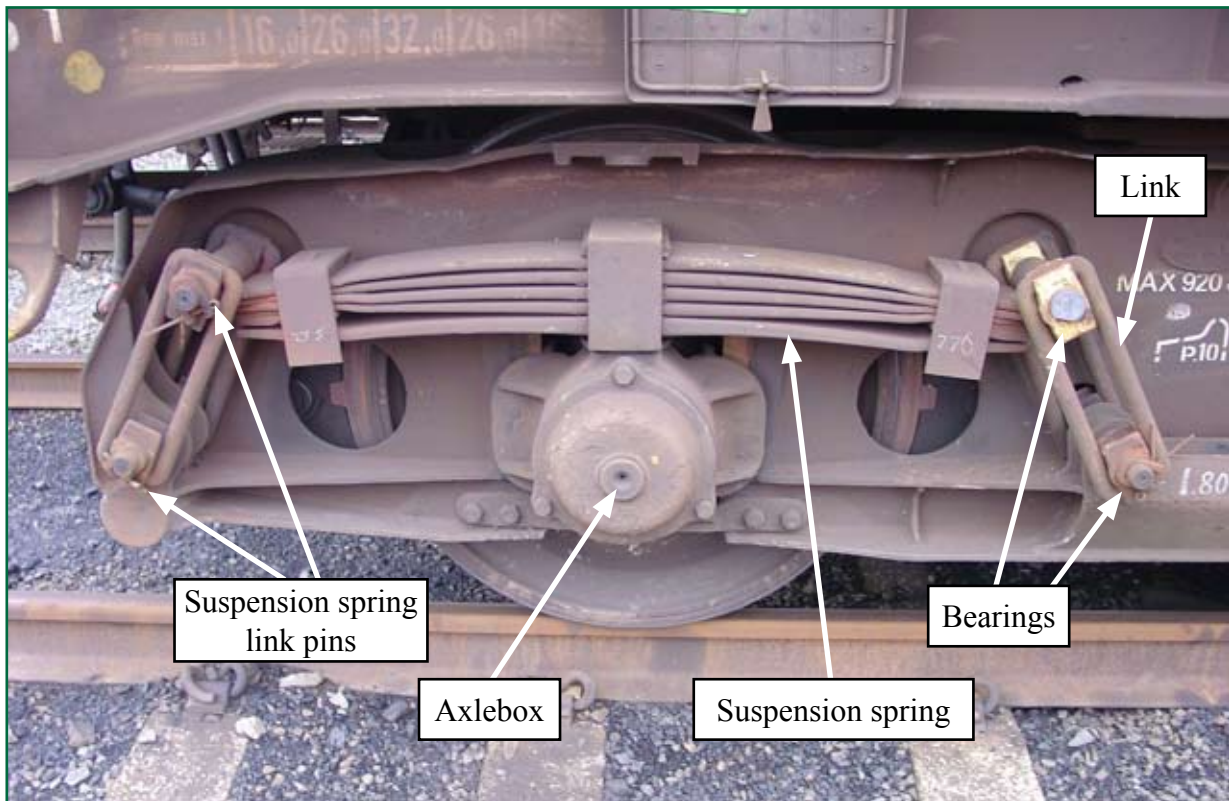
Figure 3: Bogie suspension

- 16 The wagon is fitted with bogies and has a maximum load per axle of 22.5 tonnes. The suspension is attached to the bogie frame via an assembly of links, link pins and bearings - see Figure 3. This type of bogie suspension is fitted to hundreds of wagons in the UK and is used extensively in other parts of Europe.

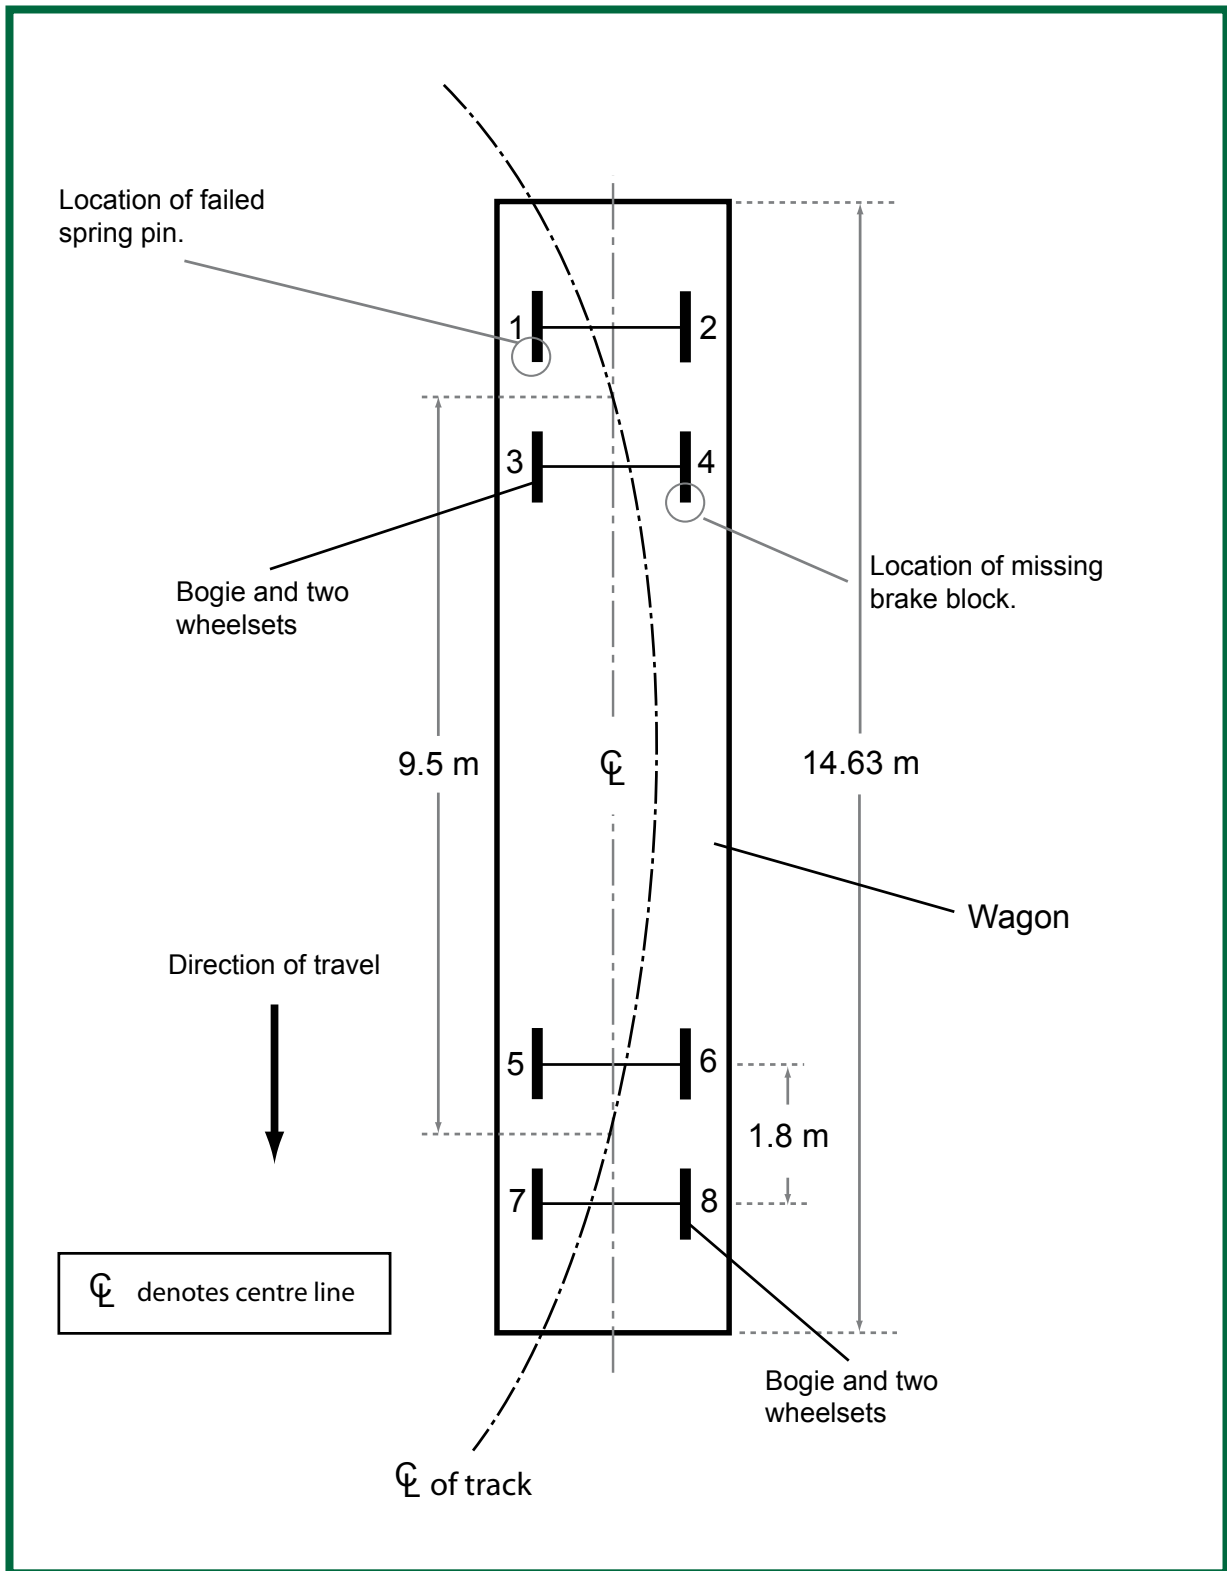
Figure 6: Plan view of wagon 7008990380 and the derailed wheelset

- 35 The driver re-examined the train with the Network Rail Mobile Operations Manager (MOM) who had arrived on site. They found a collapsed suspension at wheel one and a missing brake block at wheel four on bogie serial number 89 - see Figure 6.

- 50 The causal factor of the derailment was the loss of the link pin and the collapse of the suspension at wheel one on bogie serial number 89 of wagon 7008990380.

1. GE Rail Services should review their maintenance arrangements for link and pin type suspensions to ensure that degraded link pins are detected and replaced at a periodicity that minimises the risk of in-service failure (paragraph 64).

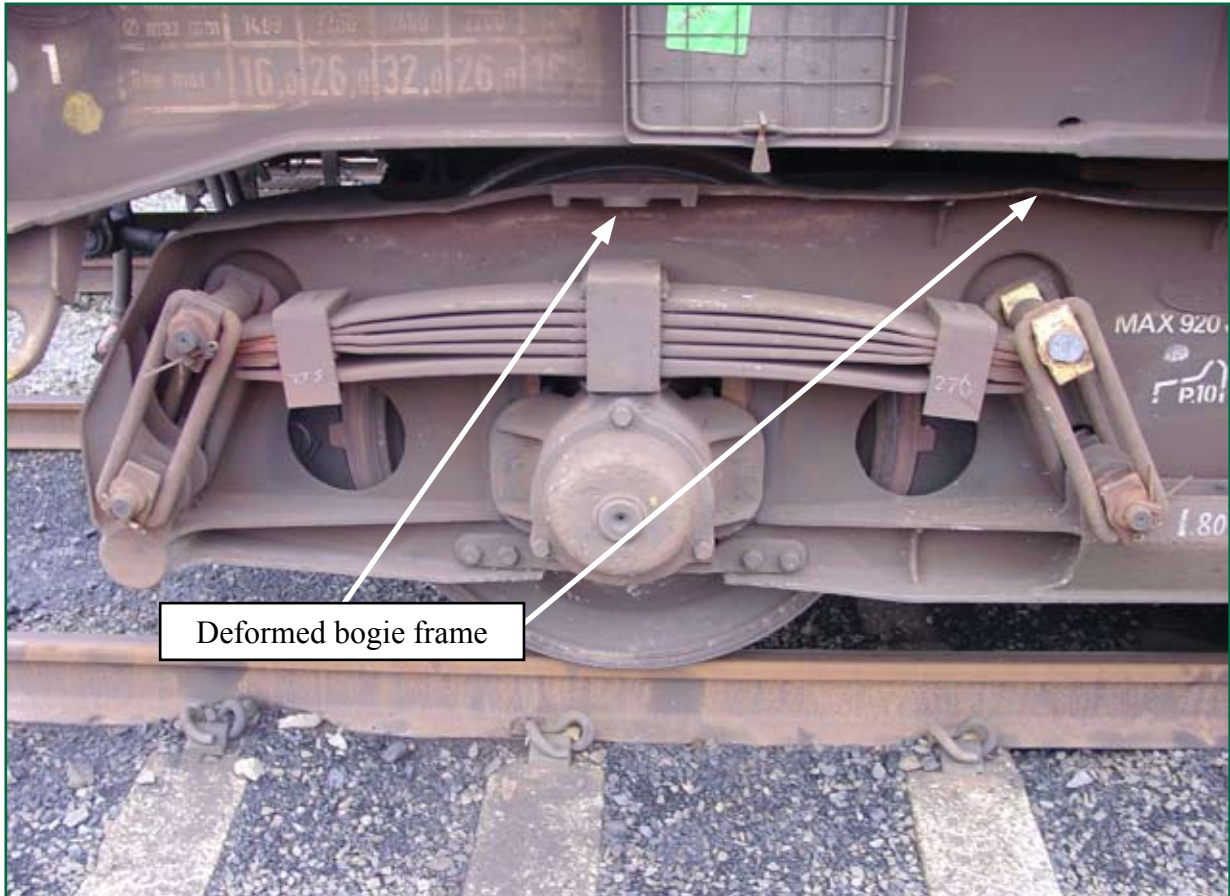
- 36 Damage to the wagon from the incident included: (i) deformation of the bogie frame due to impact by the suspension spring - see Figure 7; (ii) deformation of the bogie frame by the wagon structure due to excessive relative movement during derailed running – see Figure 8 and (iii) damage to wheel three from number 788 points check rail – see Figure 9.

Figure 7: Photograph of deformation of the bogie frame due to impact by suspension spring

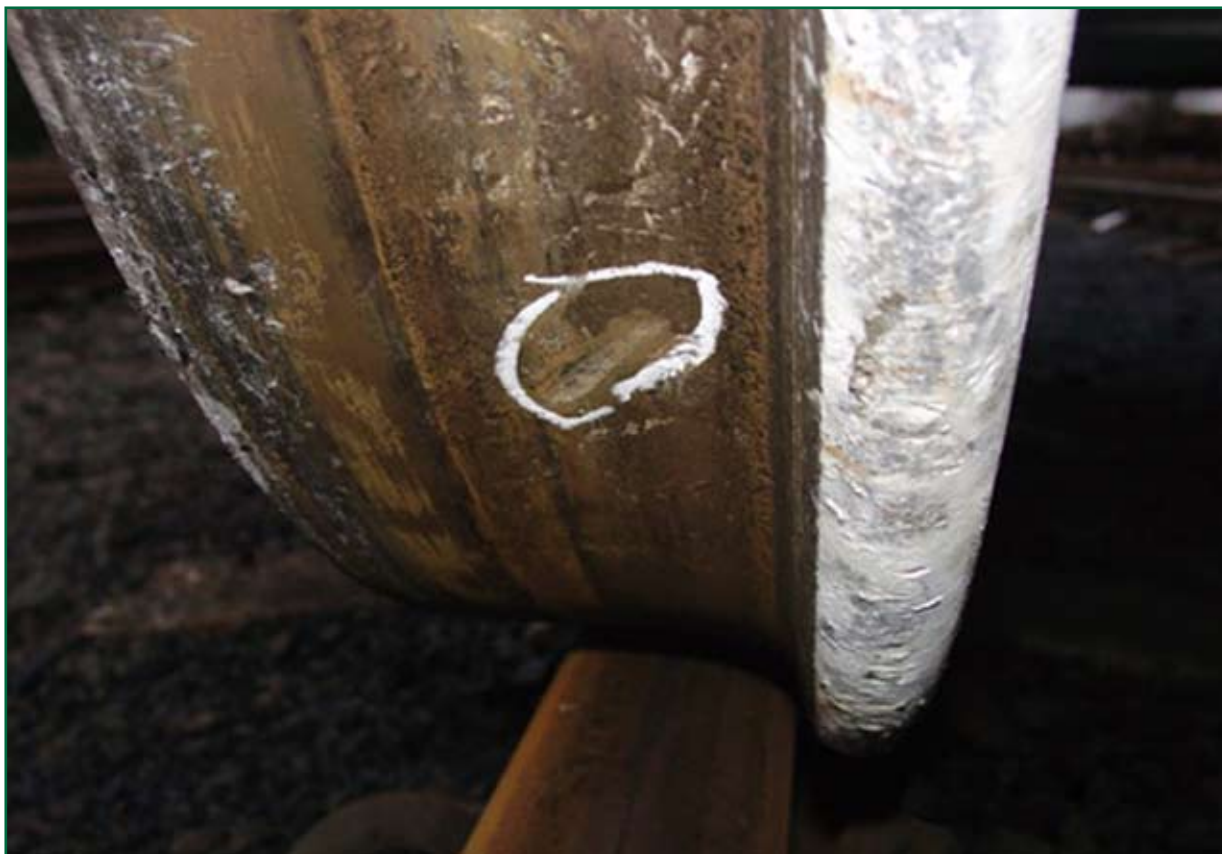
Figure 9: Damage to wheel three from number 788 points check rail

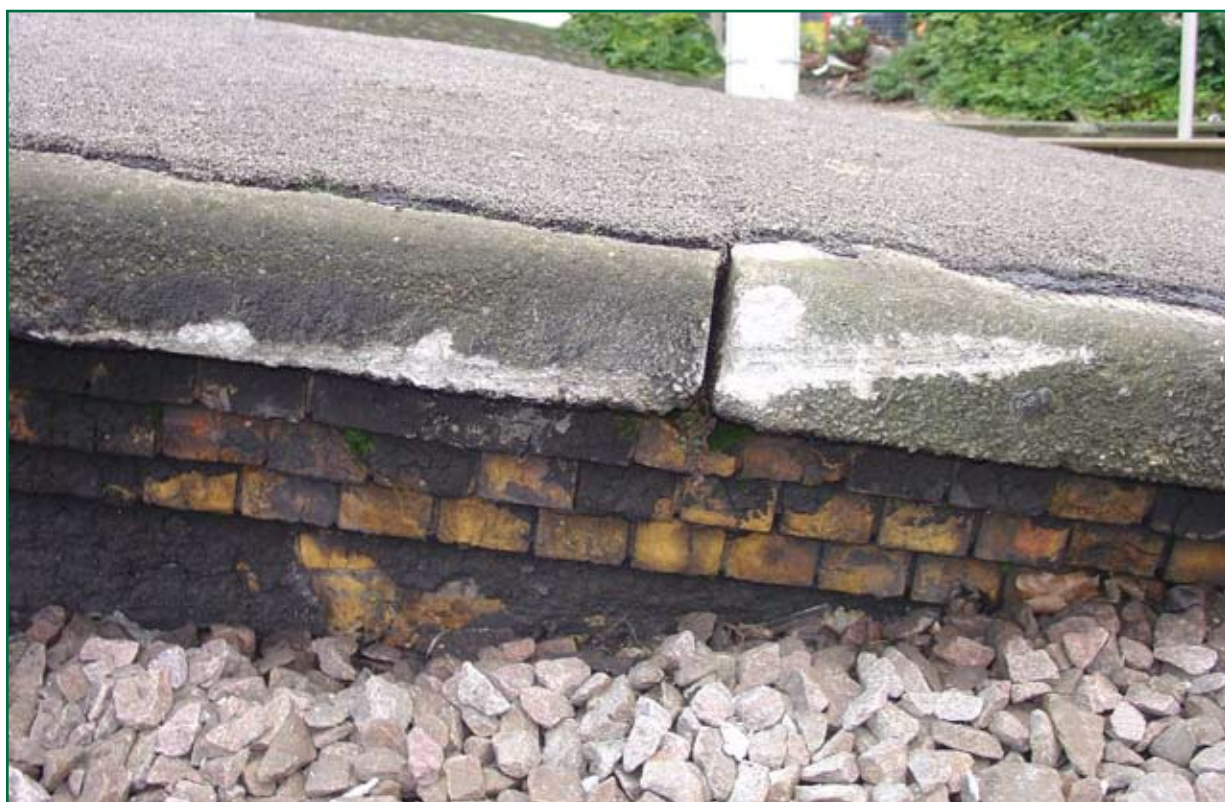
- 37 Infrastructure equipment damage extended over approximately 250 m and included: (i) approximately 400 *sleepers*; (ii) 20 *Pandrol* clips; (iii) 18 *bearers*; (iv) 8 track circuit cables; (v) *Train Protection and Warning System* (TPWS) equipment mounting bars and (vi) check rail and *fish plates* at number 788 points. The coping stone at platform three was misaligned and scored by impact with the bogie as shown in Figure 10.

Figure 10 Platform three coping stone misaligned by impact with bogie
