Rail Accident Investigation Branch

Rail Accident Report

Wagon derailment at York station 18 January 2006

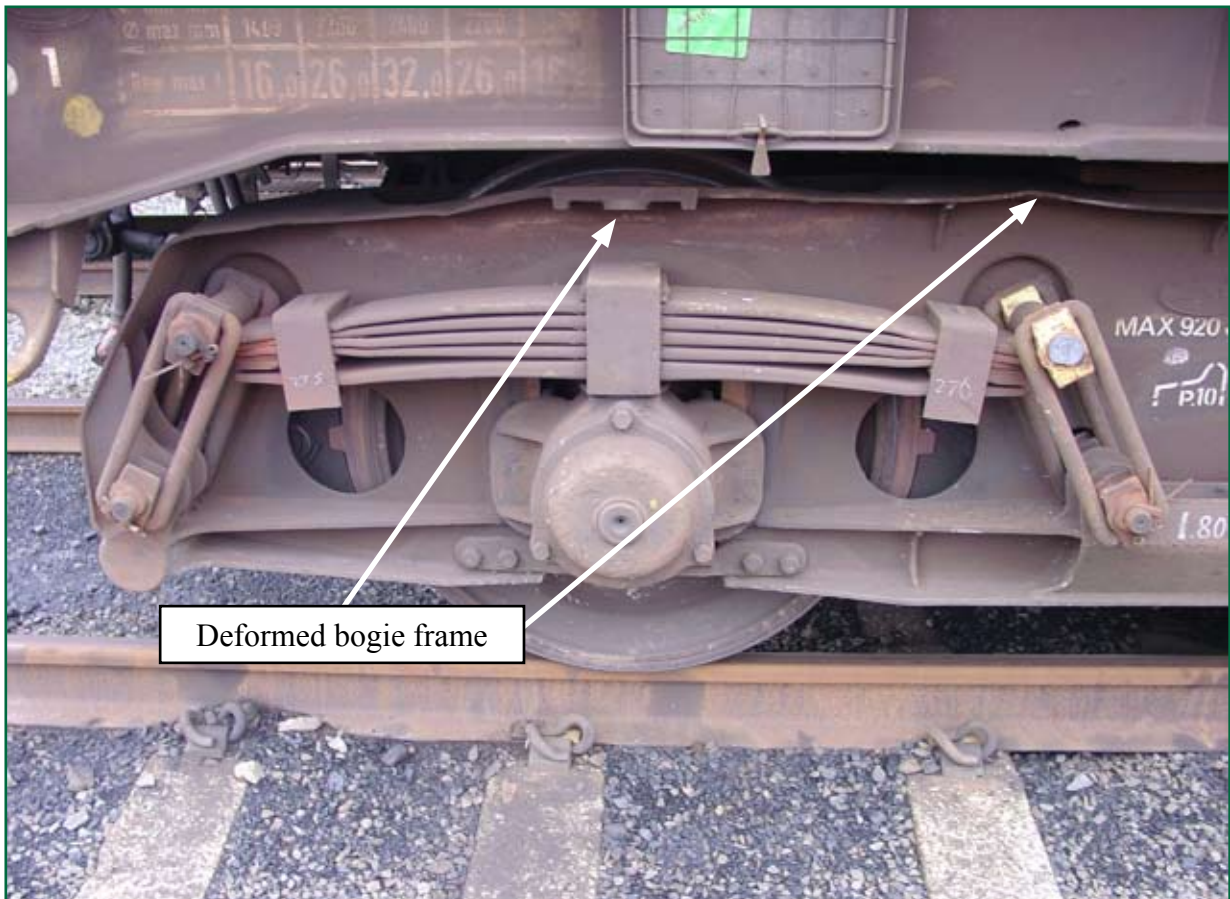
- 36 Damage to the wagon from the incident included: (i) deformation of the bogie frame due to impact by the suspension spring - see Figure 7; (ii) deformation of the bogie frame by the wagon structure due to excessive relative movement during derailed running – see Figure 8 and (iii) damage to wheel three from number 788 points check rail – see Figure 9.

Figure 7: Photograph of deformation of the bogie frame due to impact by suspension spring
