Rail Accident Investigation Branch

Rail Accident Report

Station over-run at Haywards Heath 12 January 2006

Report 10/2006
July 2006

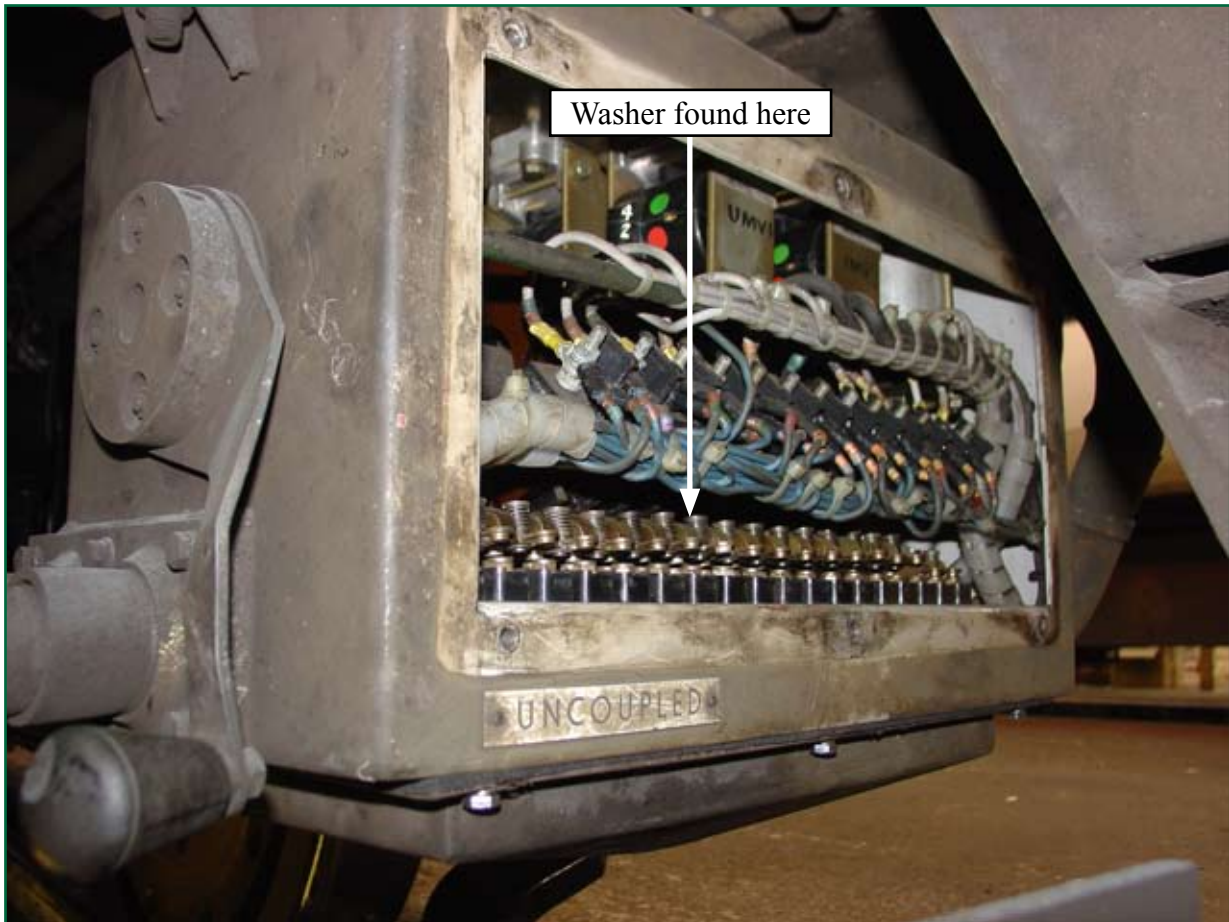
- 14 The fault was traced to the presence of an extraneous 6 mm washer in the *drumswitch* adjacent to the coupler on vehicle 77297 of unit 319004 in the centre of the train. The washer was causing a short circuit, and therefore a false feed, between two wires operating the brakes.

- 15 Figure 2 shows the drumswitch with a cover removed to reveal the terminals where the washer was found.
- 16 Class 319 units have a brake with 4 positions, Steps 1 – 3 and Emergency, Step 1 providing the lowest braking rate.

- 17 The false feed caused by the washer was such that when the brake controller was placed in either Step 2 or 3 positions no brake application occurred. Step 1 and Emergency brake positions worked satisfactorily. The brakes worked correctly immediately the washer was removed. Their operation was confirmed by a functional brake test.

Figure 2: Class 319 drumswitch with cover removed showing terminals where the washer was found

- 20 The origin of the washer is not known. It is likely that it had been loose in the drumswitch and became dislodged from its resting place by the movement of the train, falling onto the terminals of the wires concerned. It is possible that it may have been originally part of the securing assembly for a pair of valves in the upper part of the drumswitch.

- 22 The rear and bottom sections of the drumswitch are reasonably accessible. Examination of the front section, where the washer was found, is severely hindered by the presence of the obstacle deflector and, unless a mirror is used, only an oblique view can be obtained. The view shown in Figure 2 was obtained by placing the camera in a position adjacent to the coupler which cannot be reached by the naked eye.

- 23 The maintenance instructions have been altered to require the use of a mirror where a direct line of sight cannot be obtained (Recommendation 1).
- 24 The maintenance records do not show any 'out of course' attention to the drumswitch on vehicle 77297 in the 12 months before the incident. However, the unit underwent classified attention at Alstom's Wolverton Works in August 2005. During that attention the drumswitches were opened to change the magnet valves.

1. First Capital Connect (formerly Thameslink) and Southern should arrange for an inspection mirror to be used when examining the interior of the drumswitch. This recommendation has already been implemented (paragraphs 31, 32, 34 and 35).
2. Alstom to review procedures, processes and equipment in order to identify an effective means of preventing loose material from interfering with the operation of the drumswitch (paragraphs 24, 25 and 31).
