Rail Accident Investigation Branch

Rail Accident Report

**Broken Rails at Urchfont and Kennington
following the passage of a freight train
5 January 2006**

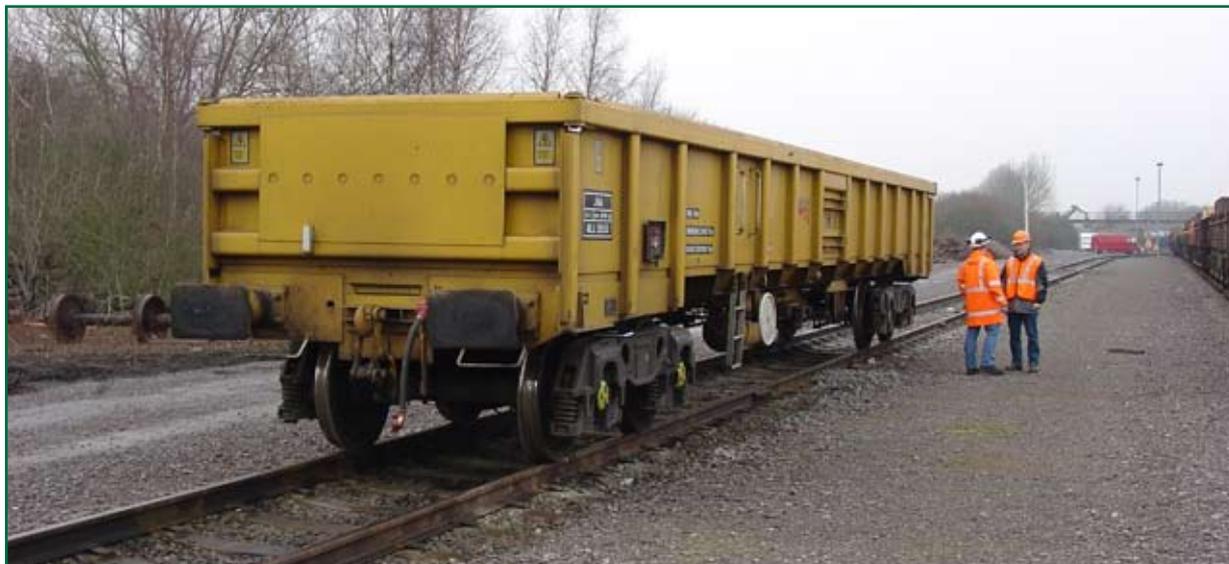
Figure 2: Wagon NLU 29553 at Hinksey Yard on 6 January 2006.

- 53 The only significant damage to wagon NLU 29553 was the wheel flats on axle 3. There was some minor damage to suspension components on the affected bogie and the wheel bearings had also lost some of their grease due to the harsh vibration caused by the wheel flats.

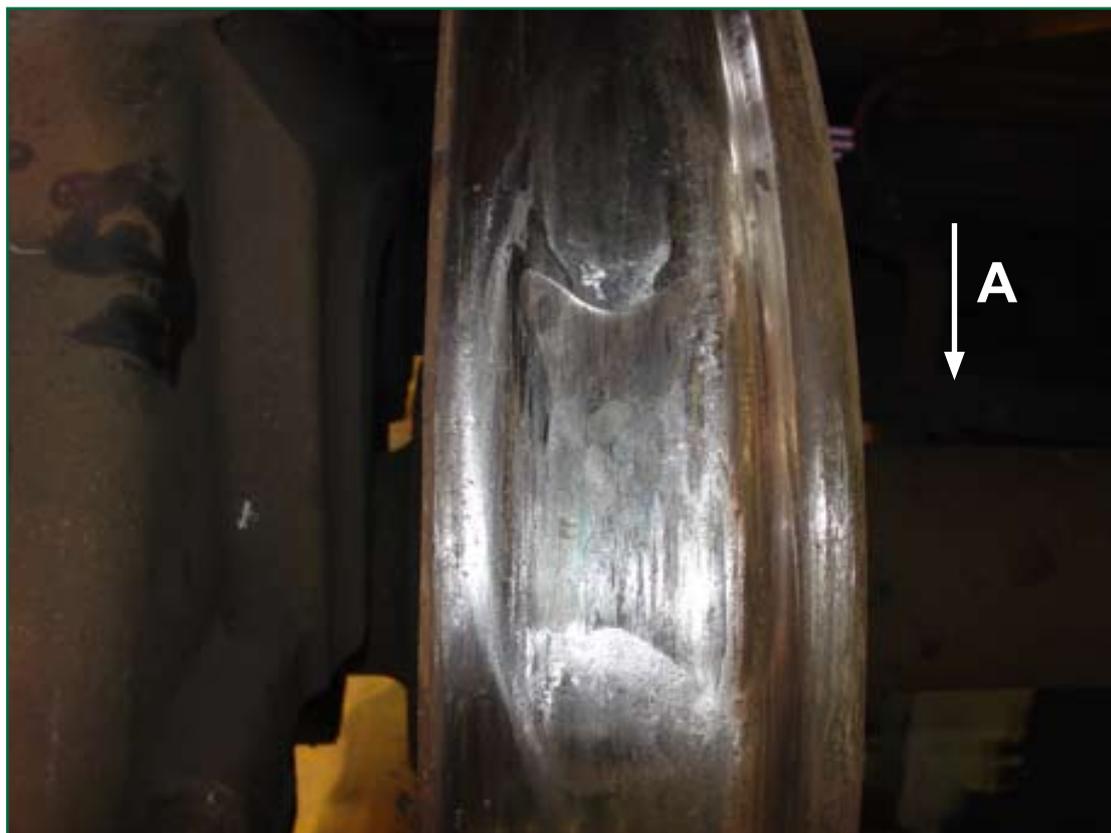
Figure 5: Flat on wheel 3 of axle 3 (serial no. ZB 362/9/057) on wagon NLU 29553

- 58 Each wheel flat (Figure 5) measured approximately 120 mm in length, but the wheels were damaged over a greater portion of their circumference of between 255 and 285 mm in length (including the flatted portions). The majority of the deformation was above the upper edge of the flat as shown in Figure 5. Between Exeter and Hinksey the wheel would have been rotating as shown by arrow A in Figure 5. The depth of the flats were measured at 6.9 mm on wheel 3 and 8.1 mm on wheel 6. These depths are 3-4 mm greater than would be expected for a freshly slid flat 120 mm long, and correspond to a flat length of approximately 160-170 mm. This indicated that, at some point in the journey, the flat length had been longer than the final visible length of 120 mm. The forces generated by such severe flats is discussed later in paragraphs 77 and 122.

- 59 The fore and aft edges of the flat were battered, confirming that the wheel had been rotating for some considerable distance after the flats had been created. This battering of the edges also explains how a longer flat of the order of 160-170 mm had reduced in size to the final 120 mm length. There was also evidence of metal flow at the edges of the flat portions, as seen by the curved upper and lower edges of the flat in Figure 5. The shape of the edges indicated that the flat had formed first at some point in the journey from Meldon to Exeter, followed by rotation and further skidding in the Exeter - Hinksey direction of travel.

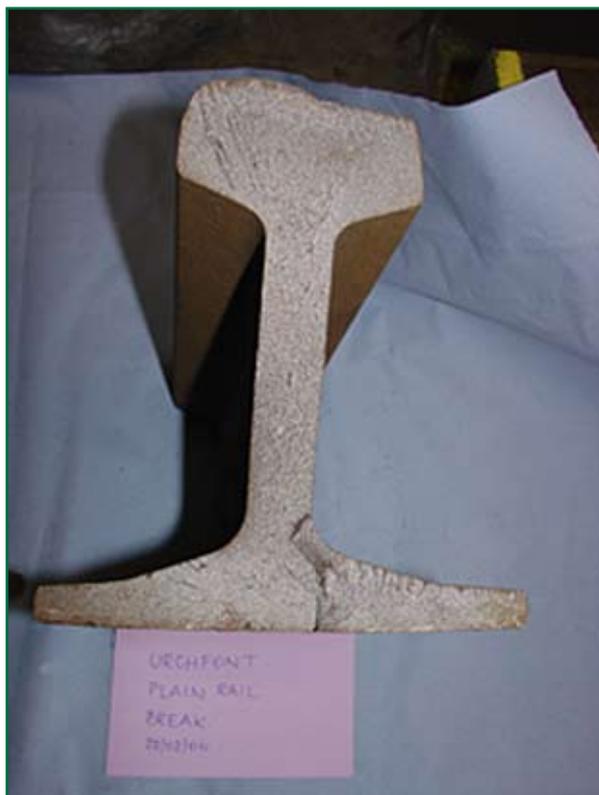
Figure 6: Broken left-hand rail from Urchfont

- 73 Detailed metallurgical examination of the broken rail from Urchfont (Figure 6) showed that it contained a rolled-in lack of fusion defect in the rail foot which had been there since the rail was manufactured circa 1970. The inclusion of such defects was inherent in the manufacturing process used at the time. The rail foot is in tension as rails bend under vertical loading. However, the size of the defect was too small to have been detected using the standard in-situ manual and train based ultrasonic scanning equipment used on the network. The fracture faces were consistent with mechanical overload and there was no evidence of any fatigue crack growth.

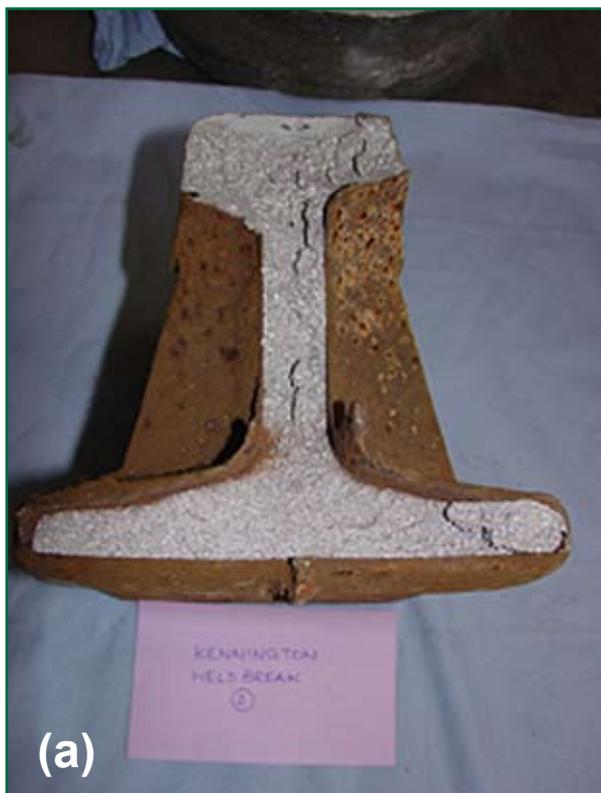
- 74 Examination of the broken left hand rail from Kennington (Figure 7a) revealed that it had fractured rapidly from the bottom of the rail foot at the edge of the weld collar, where there were three small fatigue cracks, the largest of which had a surface length of 4 mm and depth of 1 mm. The fatigue cracks had initiated at slag inclusions formed during the weld manufacture in 1968. The crown of the rail had been weld repaired at some unknown point in its history, leaving a horizontal defect.

Figure 7: Broken left (a) and right (b) rails from Kennington

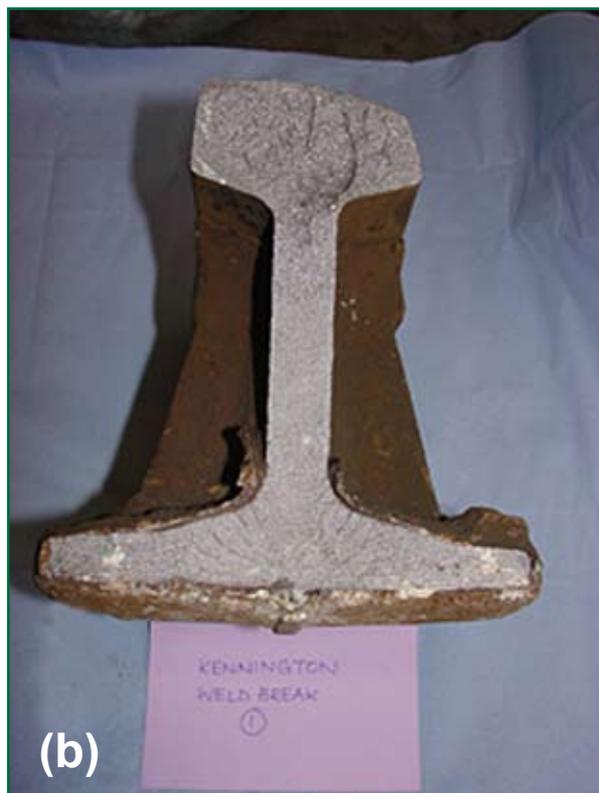
- 75 The right hand rail from Kennington (Figure 7b) had also fractured rapidly from the edge of the weld collar, having initiated at 2 fatigue cracks, 1 mm deep and 3.5 mm deep at the bottom of the rail foot. The rail and weld were manufactured in 1968.
