Rail Accident Investigation Branch

# Rail Accident Report

## Collision at New Addington on Croydon Tramlink, 23 November 2005.

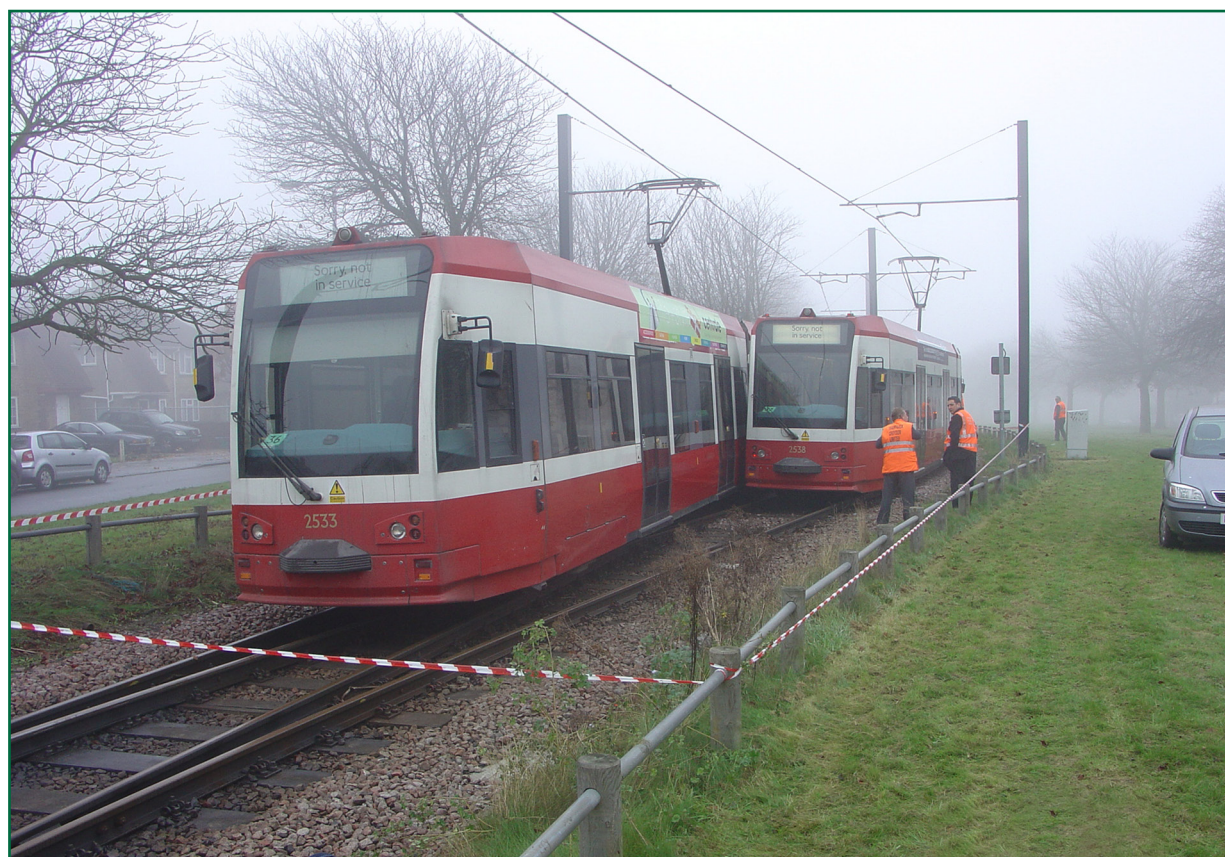
Figure 2: Site of the collision looking towards King Henry's Drive tramstop, showing the rear of tram 2533 (on left) and the front of tram 2538 (on right). The rear of KHD02 signal is on the shorter post to the right of tram 2538.

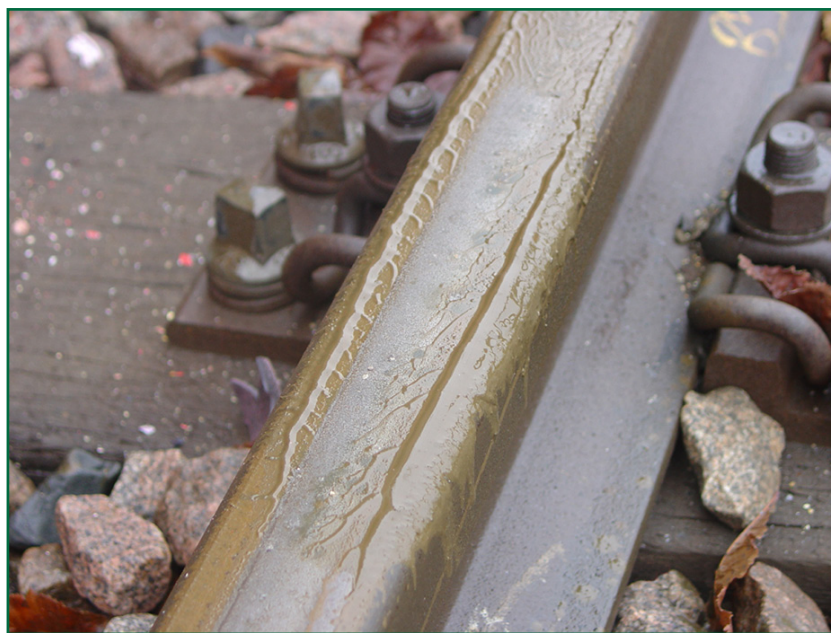
Figure 5: Rail condition in the vicinity of KHD02 signal

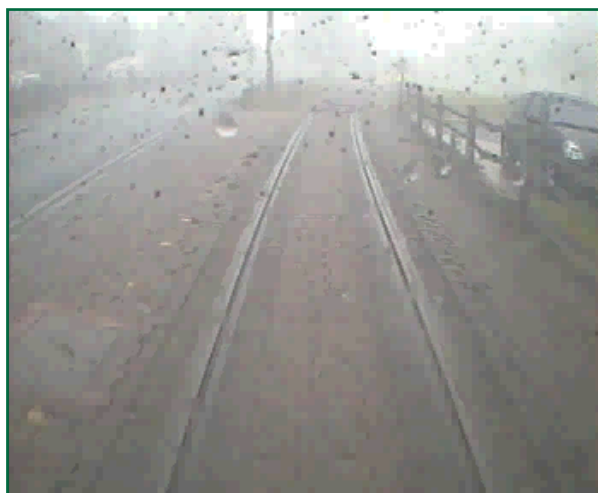
*Figure 6: CCTV record from Tram 2533.  
Tram 2538 not visible.*

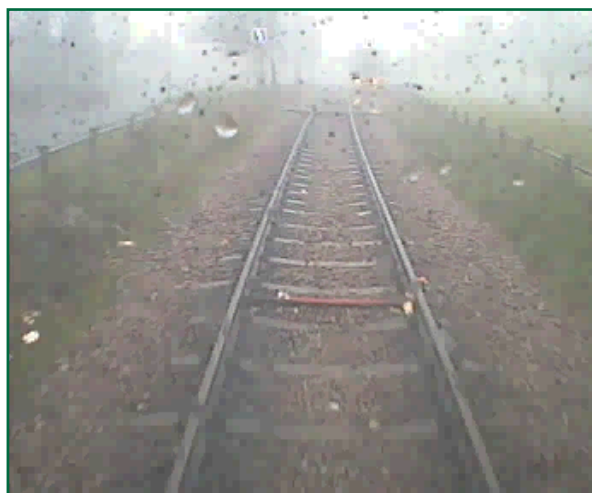
*Figure 7: CCTV record from tram 2533.  
First sighting of headlights of tram 2538.*

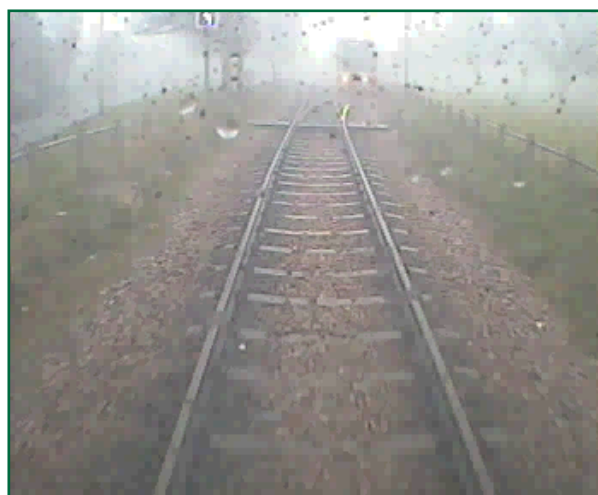
*Figure 8: CCTV record from tram 2533.  
Tram 2538 outline and headlights just visible*

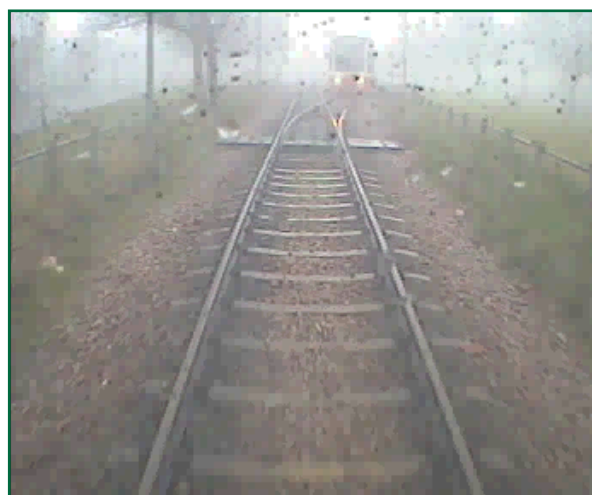
*Figure 9: CCTV record from tram 2533.  
Tram 2538 clearly foul of running line*

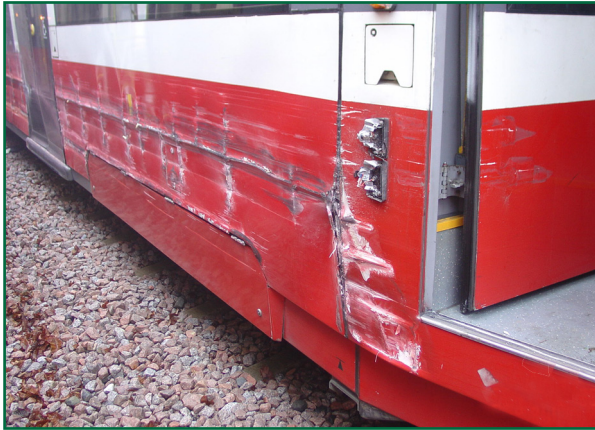
Figure 10: Tram 2533: leading end of front section

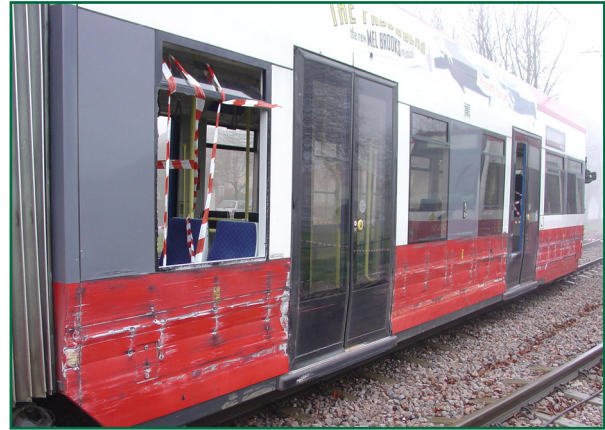
Figure 11: Tram 2533: trailing end of front section

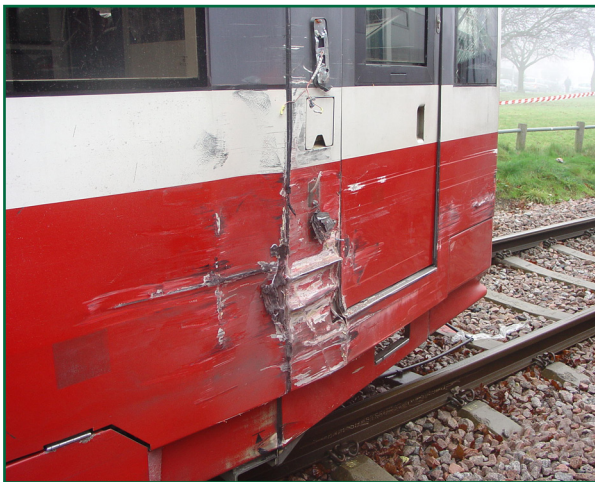
Figure 12: Tram 2538: leading end of front section

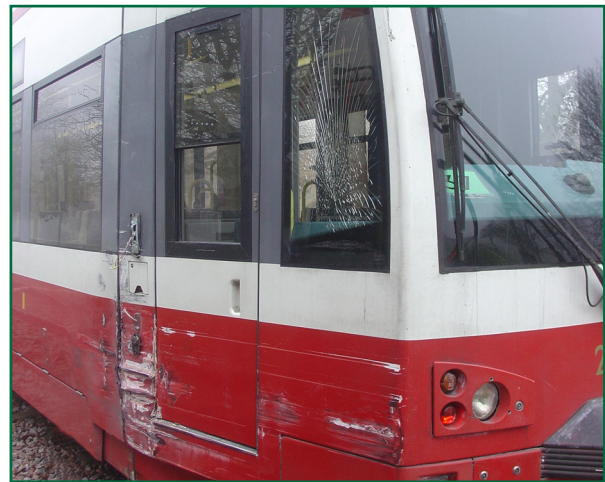
Figure 13: Tram 2538: leading end of front section

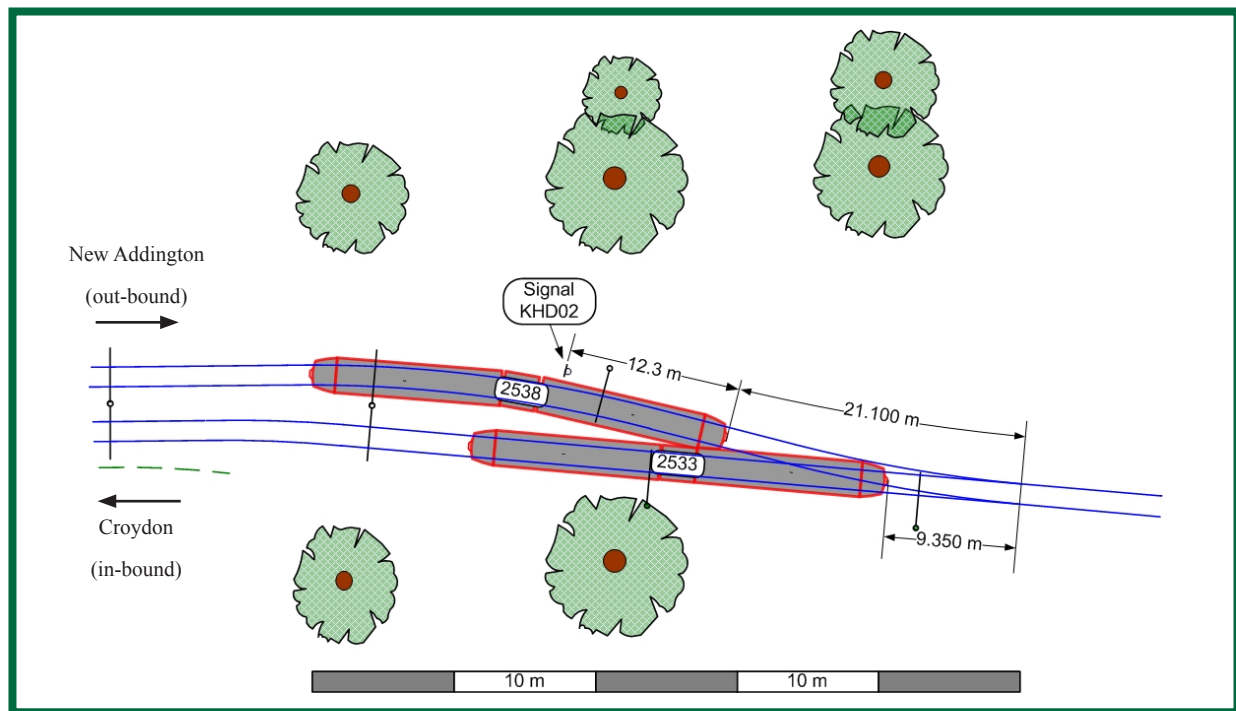
Figure 14: Diagram showing final positions of trams 2533 and 2538 in relation to toe of points

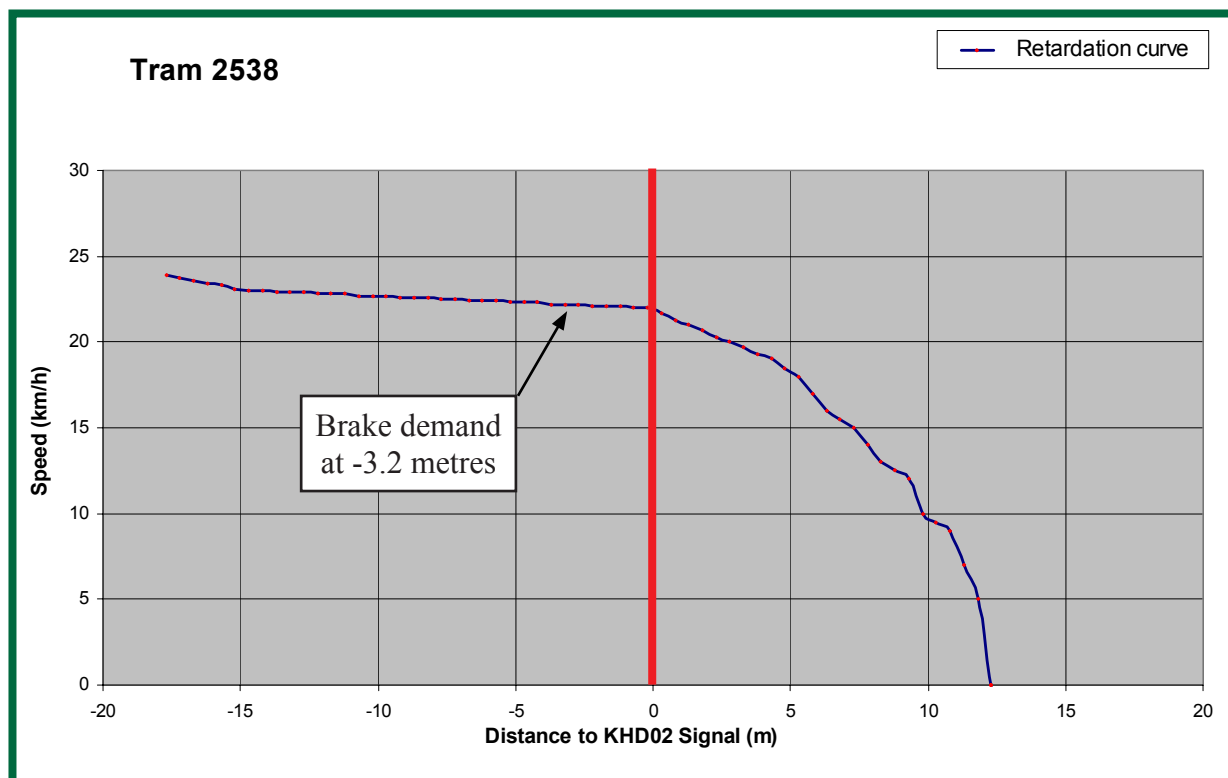
- 47 Prior to the accident the driver of tram 2538 was fully familiar with the approach to KHD02 signal which usually cleared on approach to show a proceed aspect. This was a feature of the timetable which for much of the operating day plans for one tram to arrive at New Addington followed quickly by the departure of another. This provides a layover time of about 6 – 7 minutes and ensures that a tram is waiting for intending passengers. It is only when the service is slightly disrupted that the sequence is altered. Just prior to the collision, KHD02 signal did not clear because the ‘Ready-to-Start’ switch had already been operated at New Addington, clearing signal NAD04 and giving authority for tram 2533 to proceed over the route. The driver of tram 2538 expected signal KHD02 to clear as evidenced by the traction brake controller only being moved to a service braking condition when the tram was 3.2 m from the signal. Using a service brake, the tram came to rest 12.3 m beyond the signal and approximately 2.3 m beyond the fouling point. Had the driver applied the hazard brake at the same position as the service brake was applied the tram would have come to a stand at least 1.5 m before the fouling point – see calculations at Figures 16 and 18. The conditions for a collision would thus have been avoided.

Figure 15: Speed - Distance record for tram 2538, (Negative distances are on approach to signal)

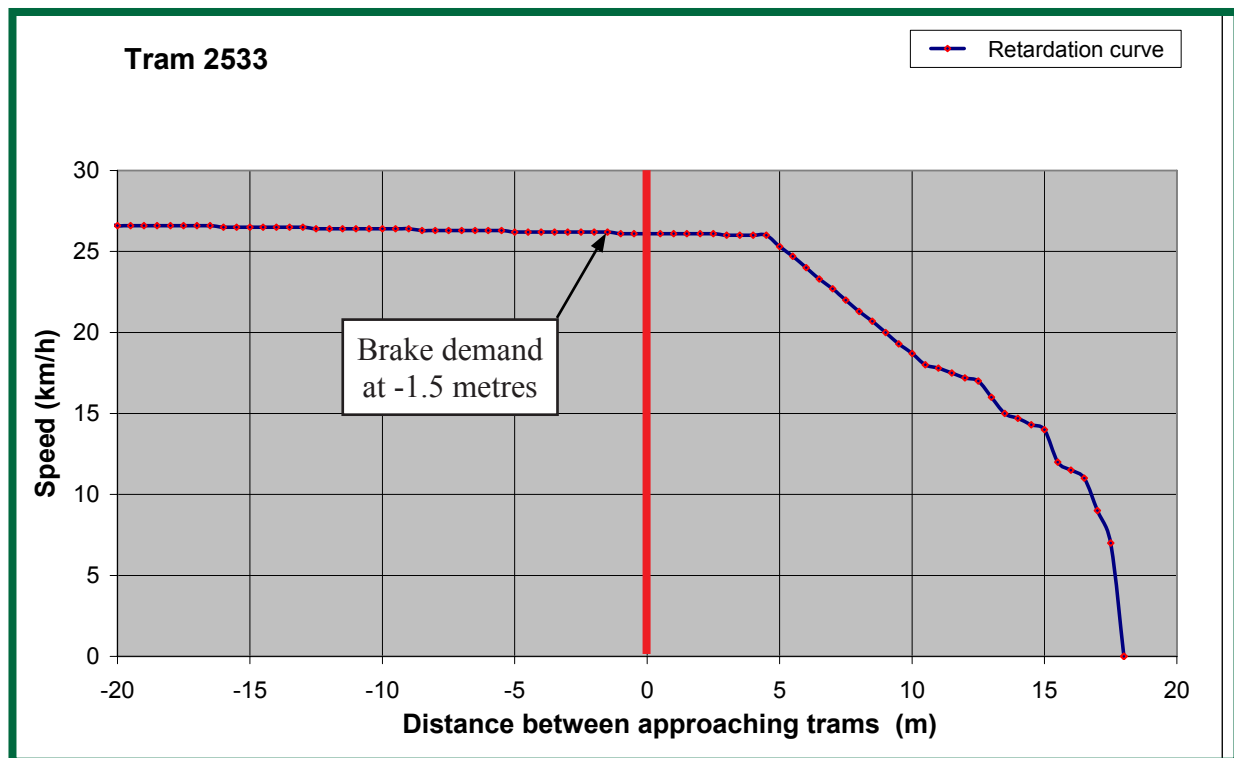
- 48 The driver of tram 2533 departed normally from New Addington after a slightly shortened layover. From inspection of the CCTV record, at 10 m from the toe of points, even with the poor visibility then present, tram 2538 can clearly be seen to be foul of the line. Had a hazard brake application been made here, the tram would have come to rest about 15 m from tram 2538. If the hazard brake application had been made still later, at the toe of the points, a collision would still have been avoided. The driver did not take any action until the distance between the trams was only 1.5 m, only then applying a full service brake.

Figure 17: Speed - Distance record for tram 2533 (negative distances are on approach to point of collision)
